Inspection Photos
Location Name: Bird-State 32-1
API: 05-005-06589
Inspection Date: September 7, 2017

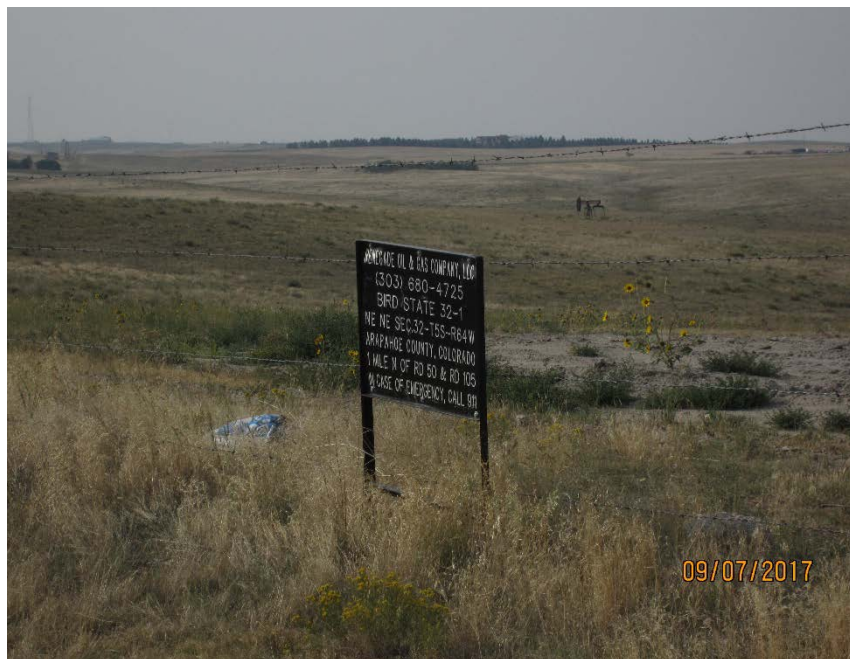
Photo #1 – Well sign on south side of entrance from access road.

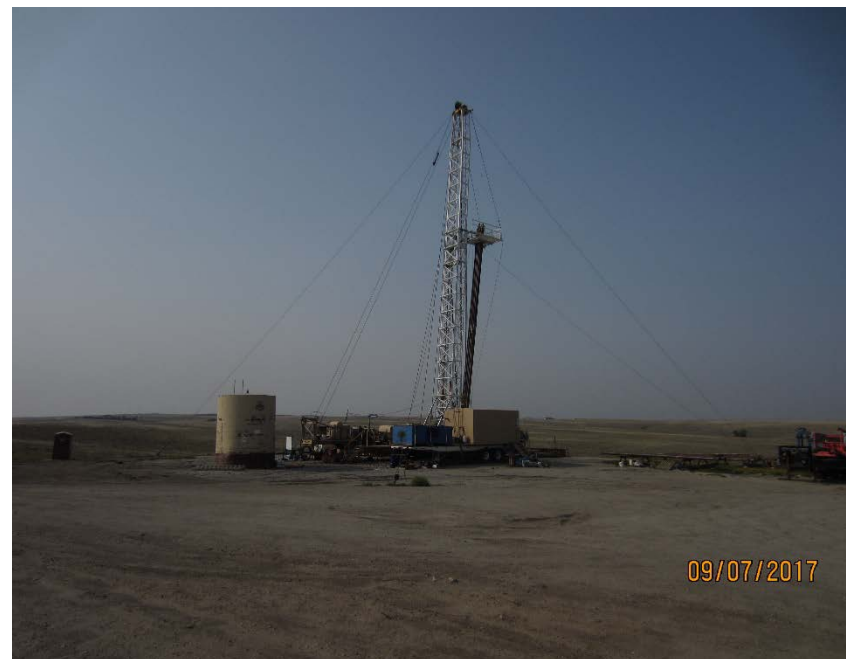
Photo #2 – Workover rig on-site on date of inspection.

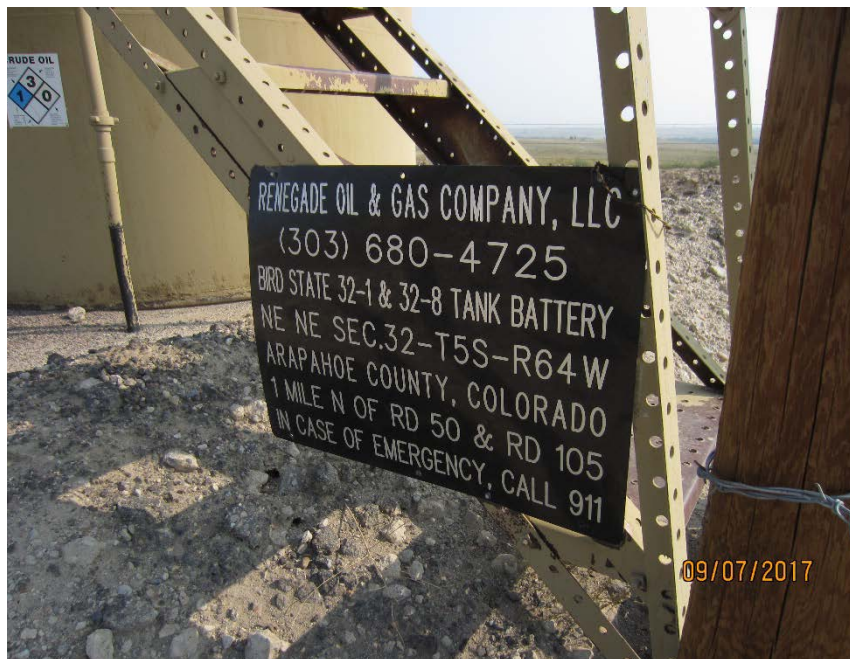
Photo #3 – Battery sign.

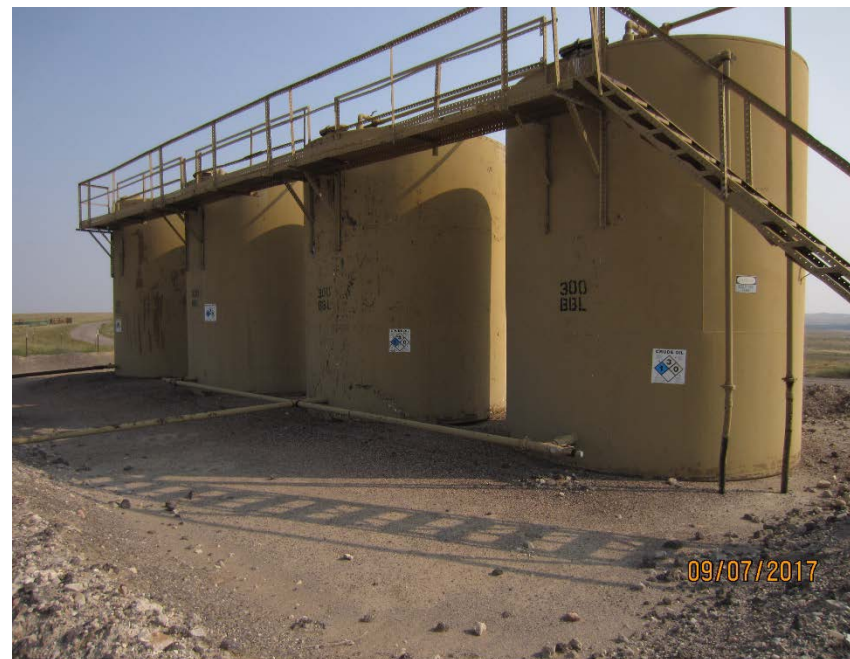
Photo #4 – Tank battery.

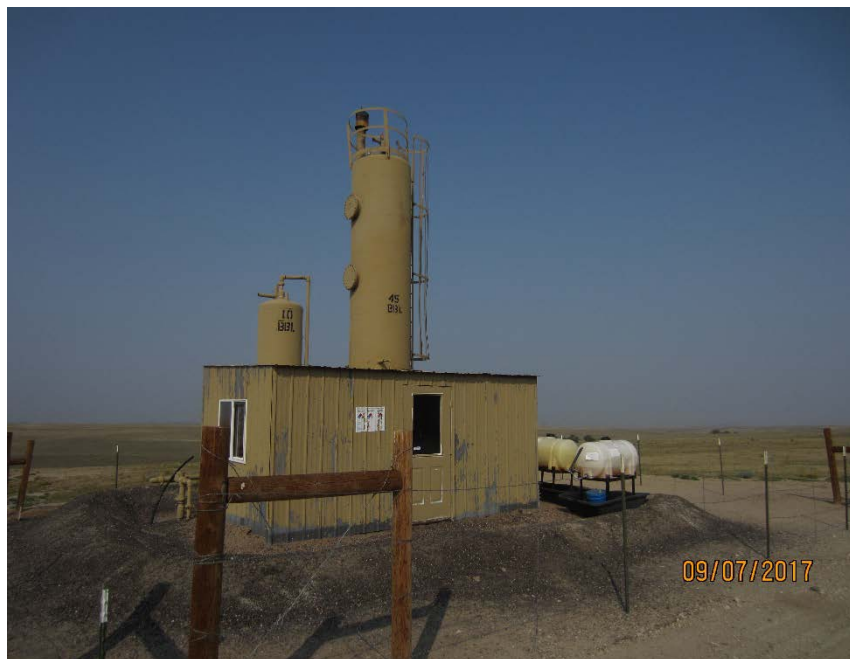
Photo #5 – VHT shed with day tanks inside of berm.

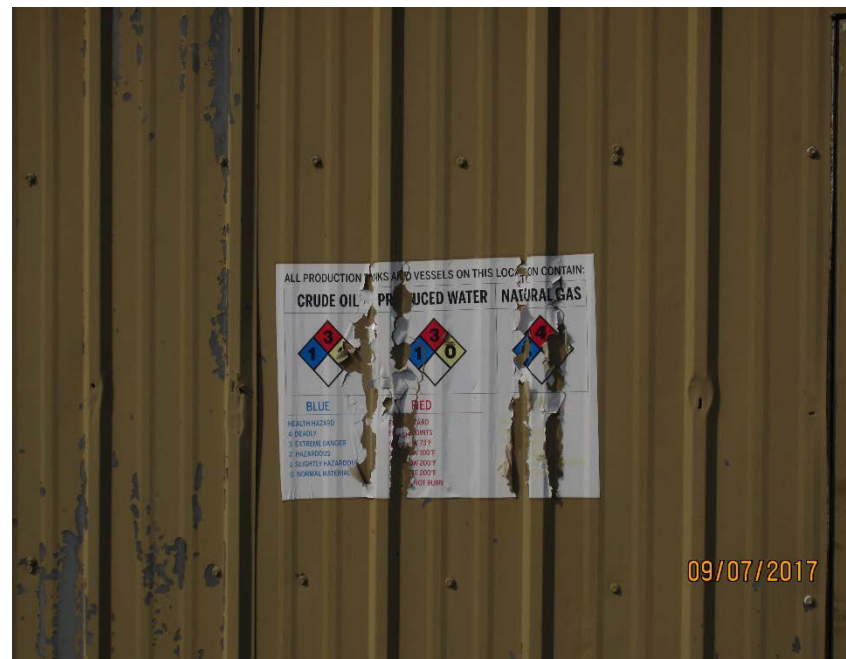
Photo #6 – NFPA placard for VHT shed is damaged.

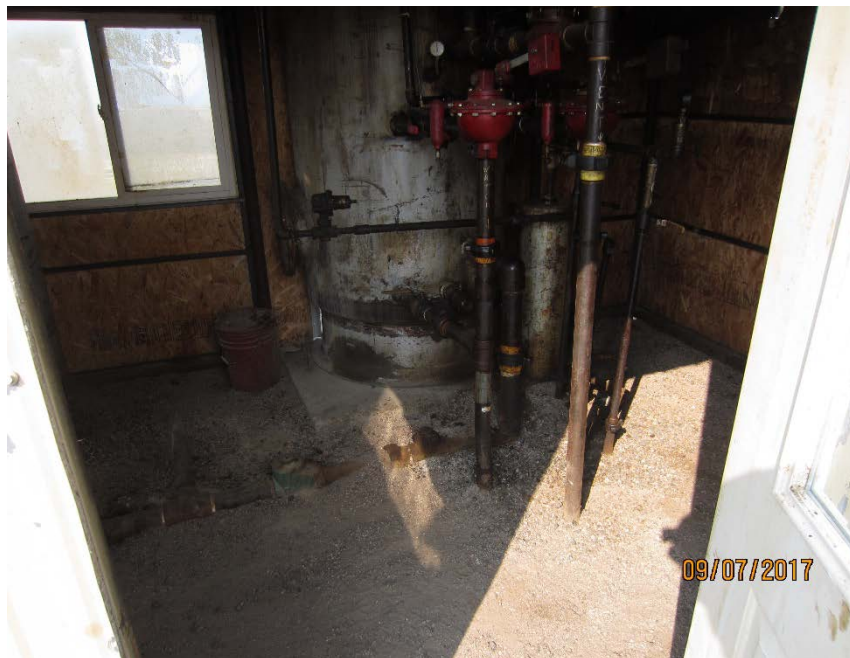
Photo #7 – Inside of the VHT shed has been cleaned in response to corrective actions listed on previous FIR.

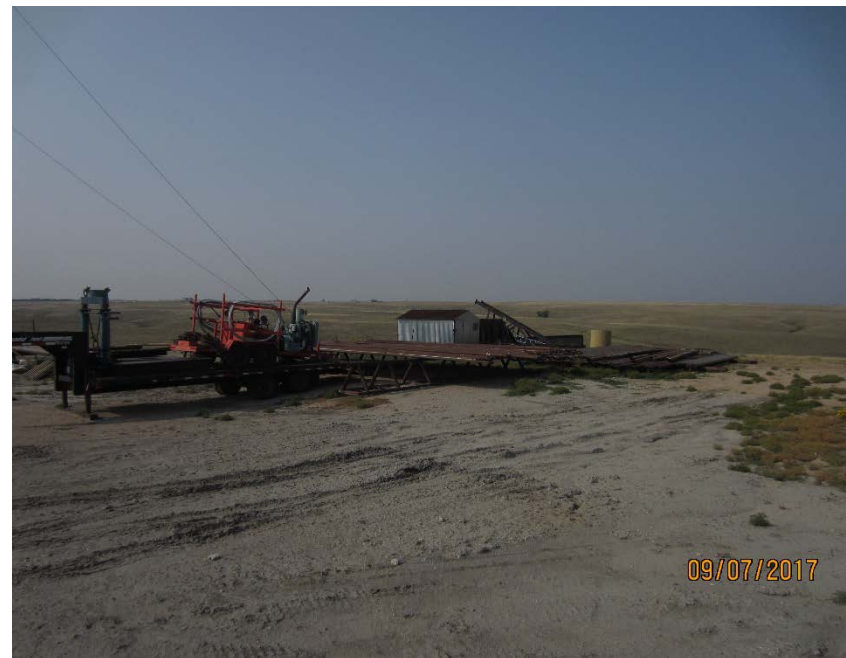
Photo #8 – Laydown yard with pipe racks located on west side of location. Note that cuttings have been applied to yard (grey material overlying soil).

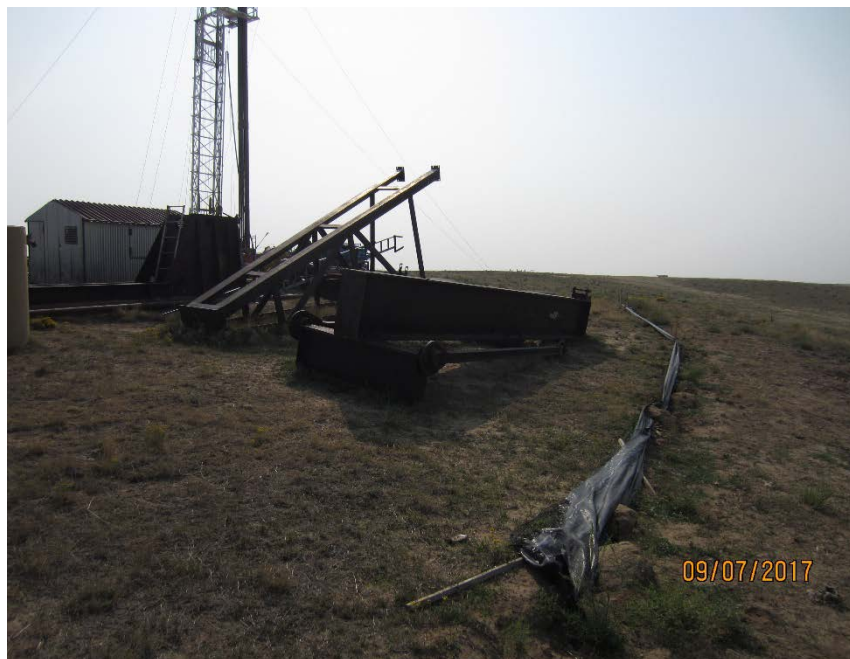
Photo #9 – Northern end of silt fence that runs along west side of location.

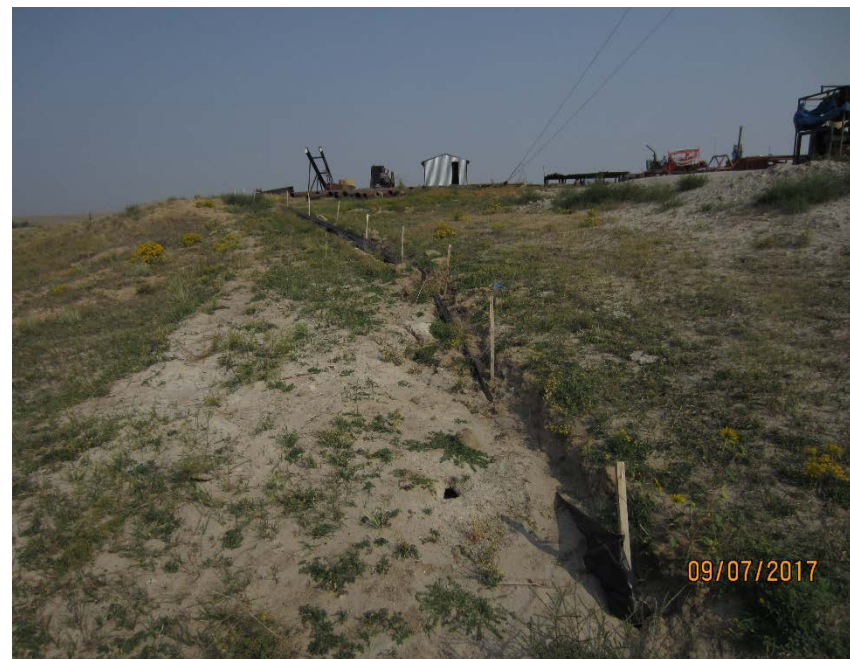
Photo #10 – Southern end of silt fence that runs along west side of location. Silt fence in need of repair/maintenance. Note sediment transport west of silt fence.

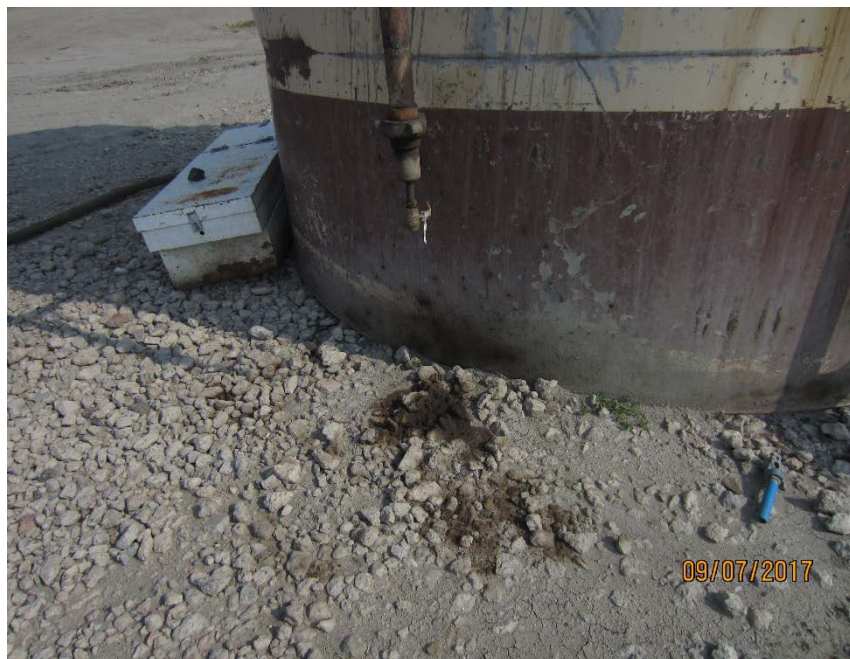
Photo #11 – Localized, oil-stained soil and gravel beneath 1” valve on SW side of AST located at workover rig.

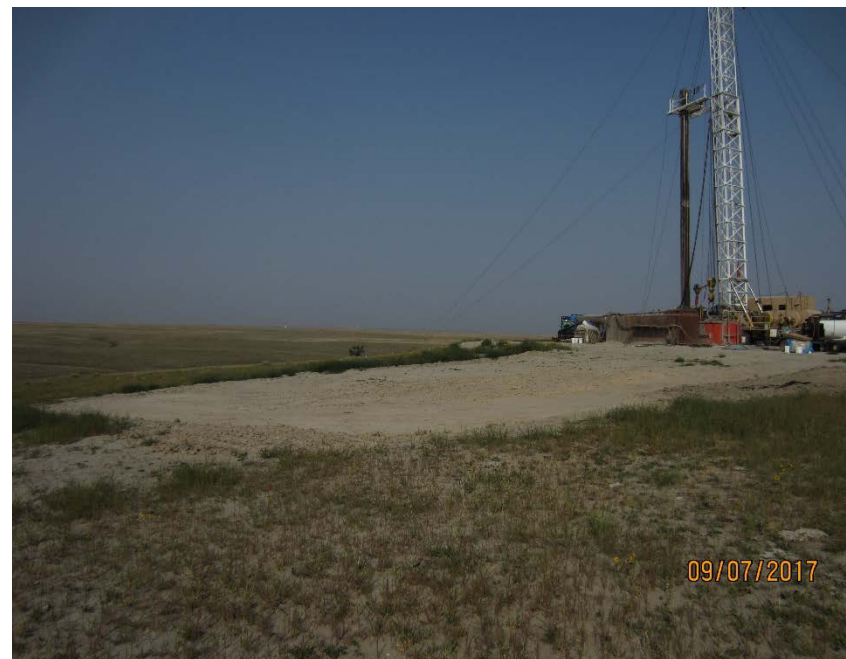
Photo #12 – Area being remediated under Remediation Project #9615 had been scraped prior to inspection date.

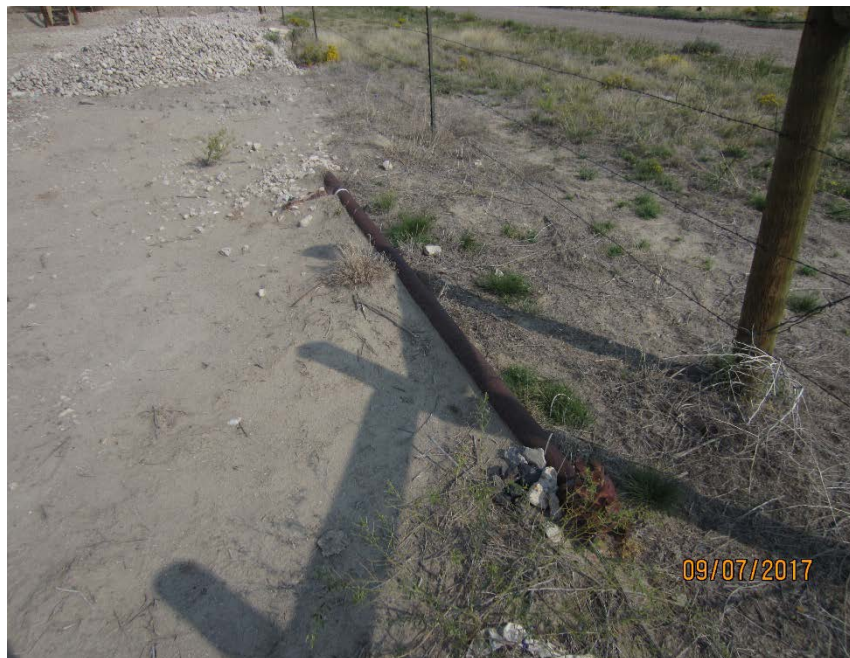
Photo #13 – Junk pipe and gravel north of entry to location.

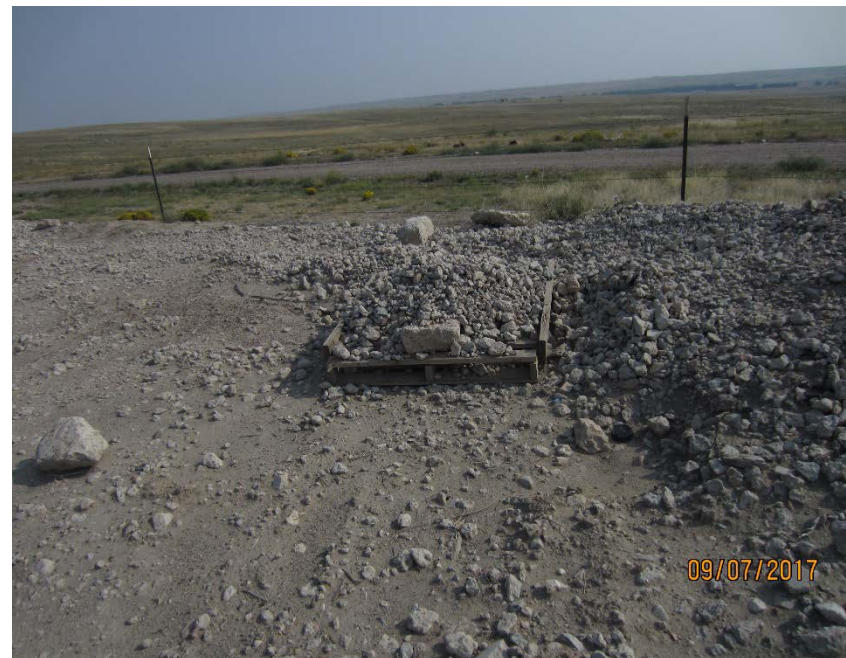
Photo #14 – Junk pallet, wood debris, and gravel north of entry to location.
