Inspection Photos

Lat/Long:37.17655,-102.06051

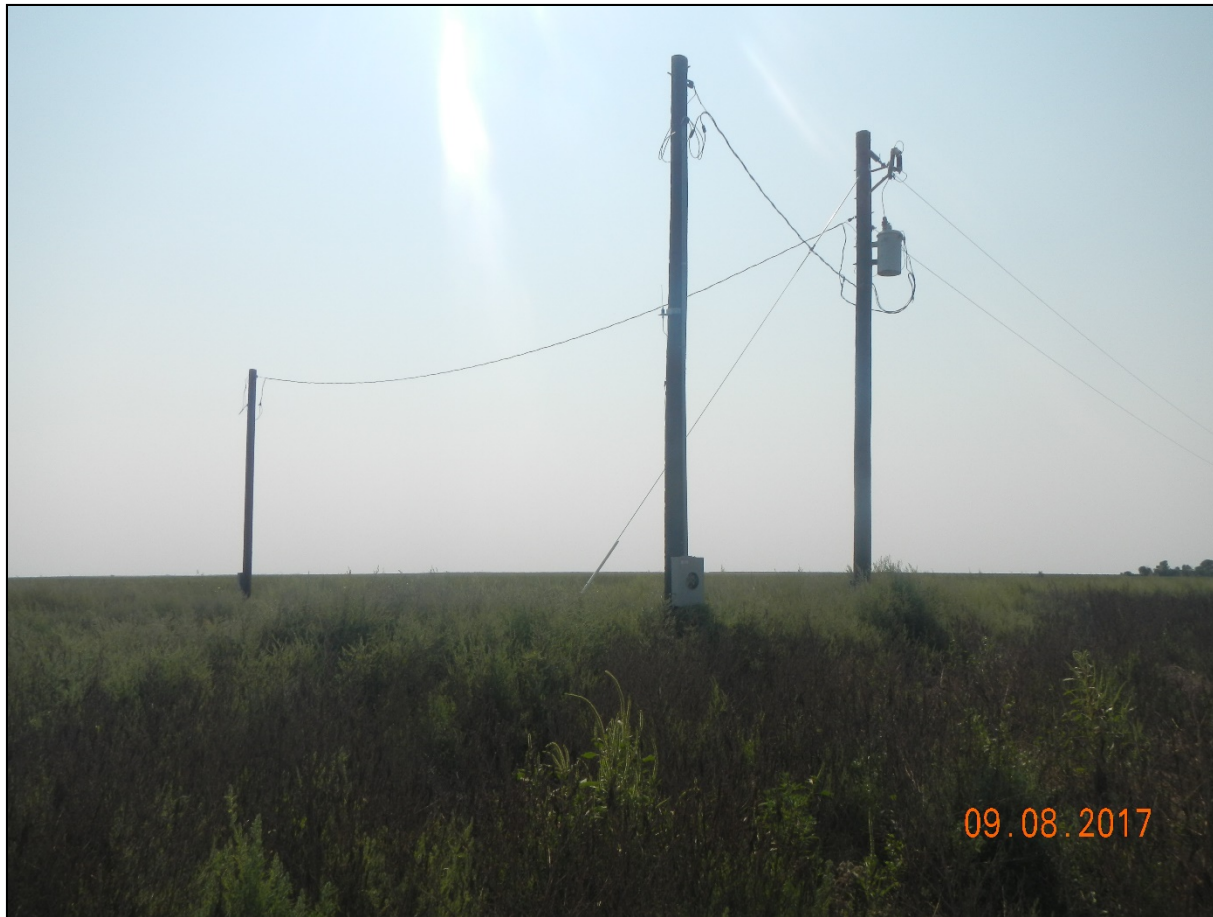
Photo 1. The powerline utility remains at CO Rd 56 which appears to have serviced the location and now appears to be abandoned.

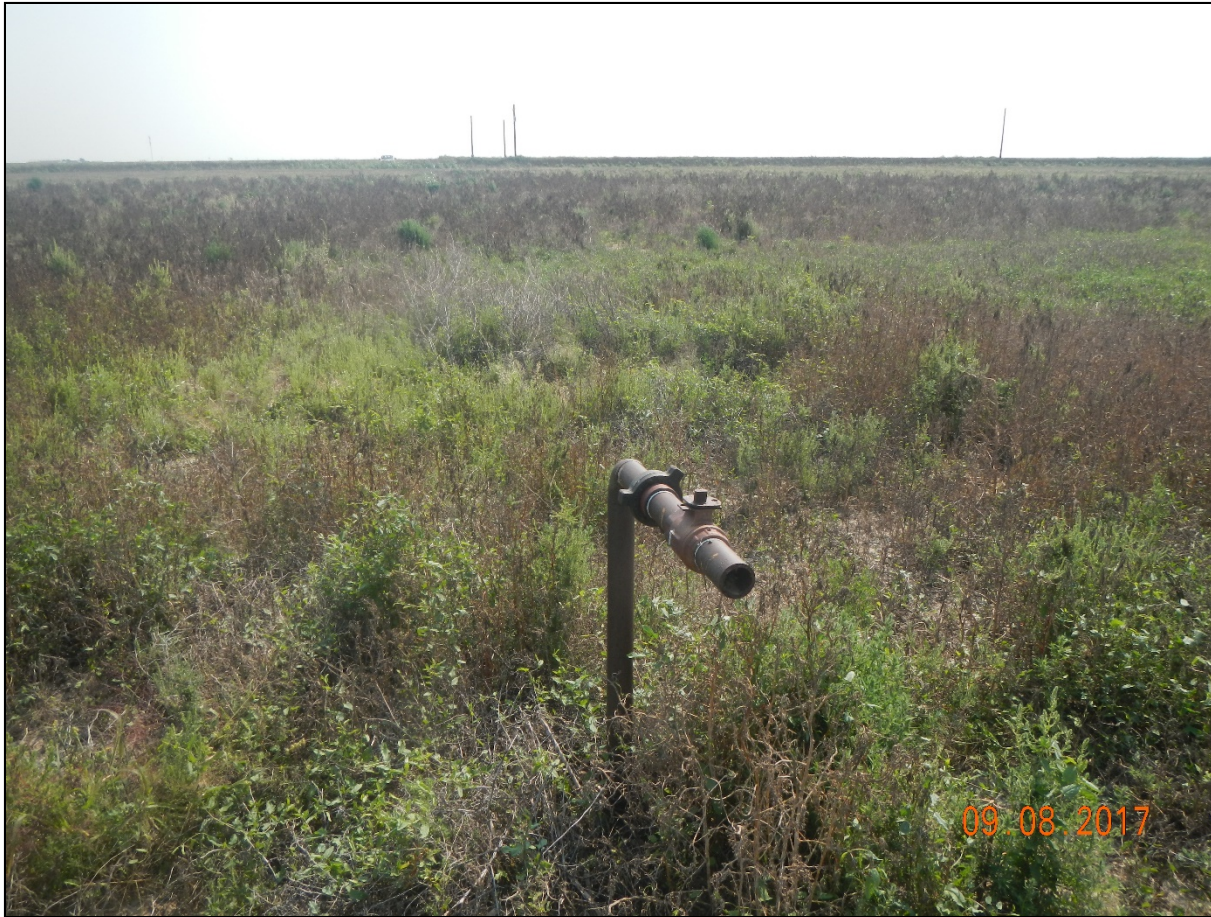
Photo 2. An abandoned pipe riser remains at the location.

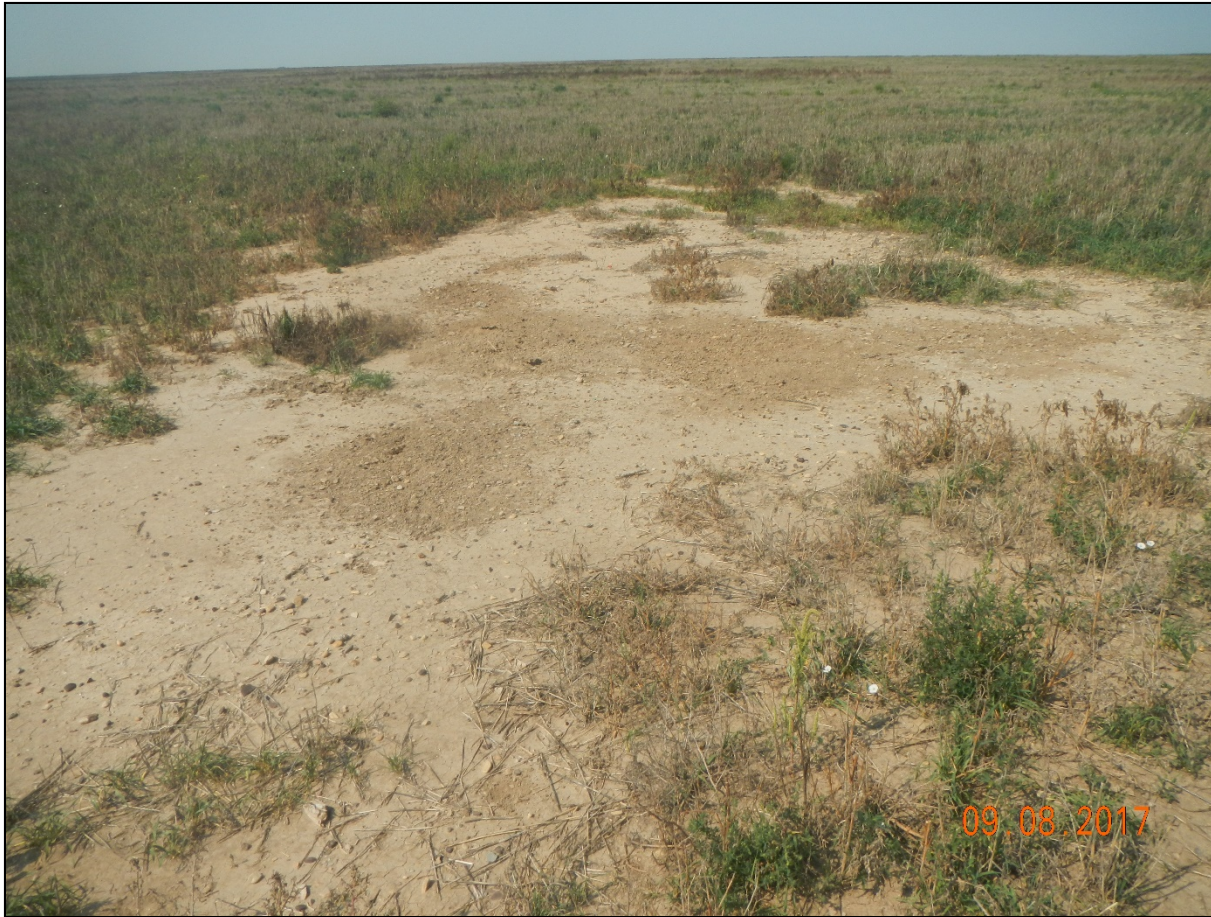
Photo 4. Facing southwest at the location. This area does not have any vegetation growth and could have possible soil issues.

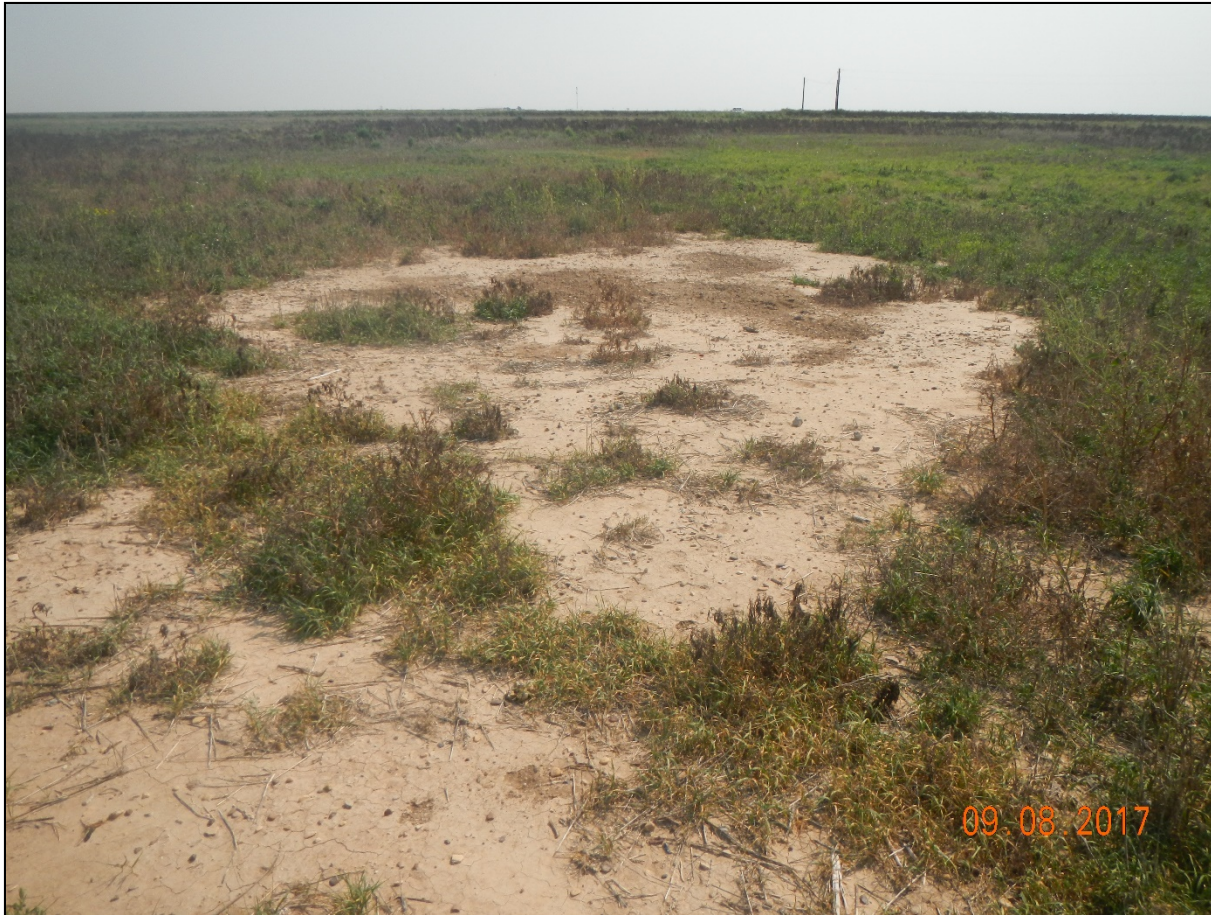
Photo 4. West side of the location facing east. This area does not have any vegetation growth and could have possible soil issues.

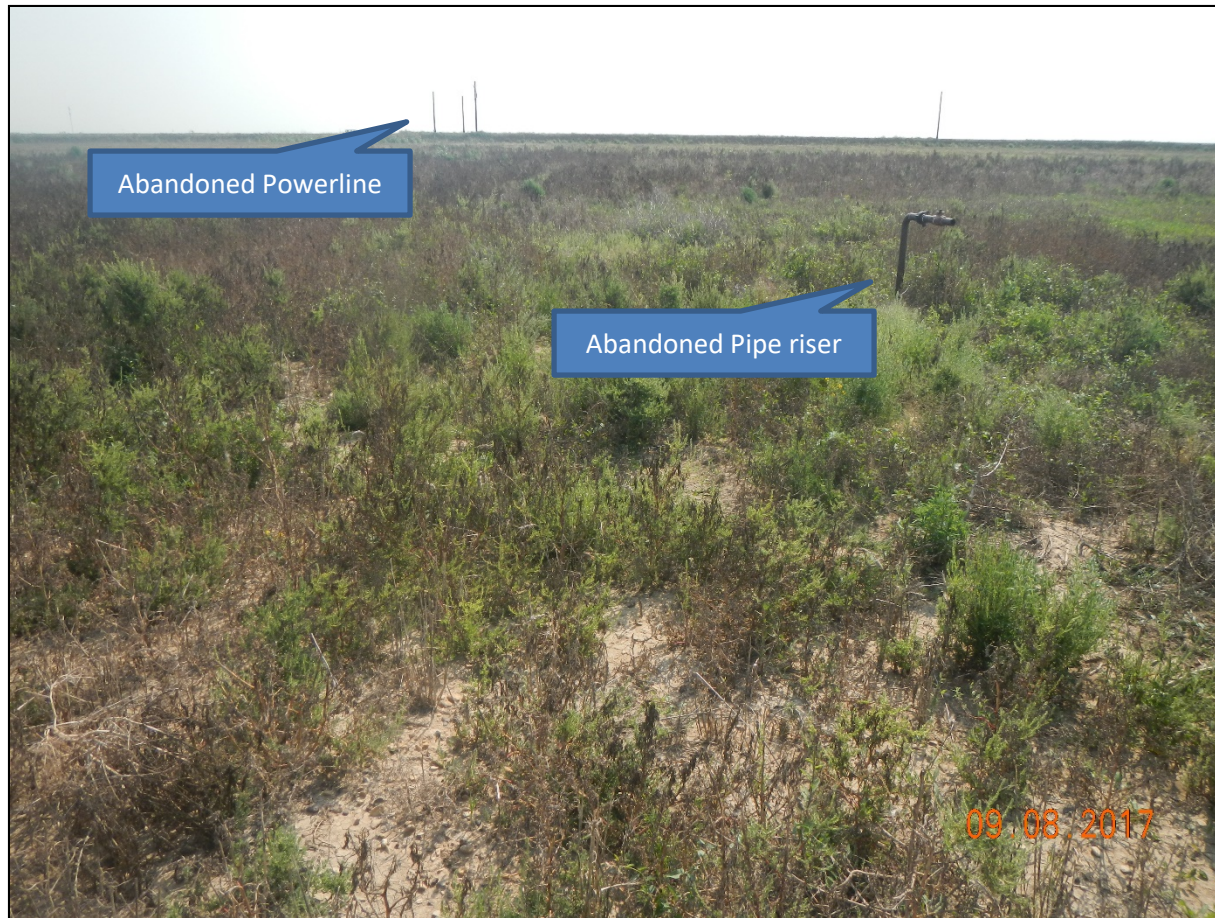
Photo 4. North side of the location facing east.
