Inspection Photos

8/25/2017

Operator: WESTERN OPERATING COMPANY -
95620

Location ID: 312292

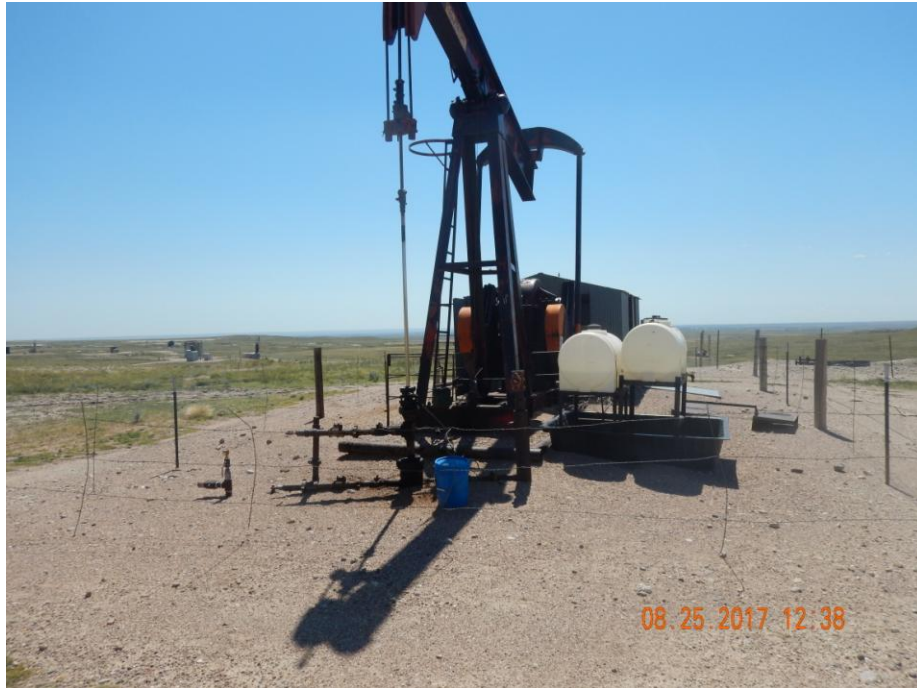
Photo 2: Photo taken at the pump unit, facing south. Photo shows sign missing at well.

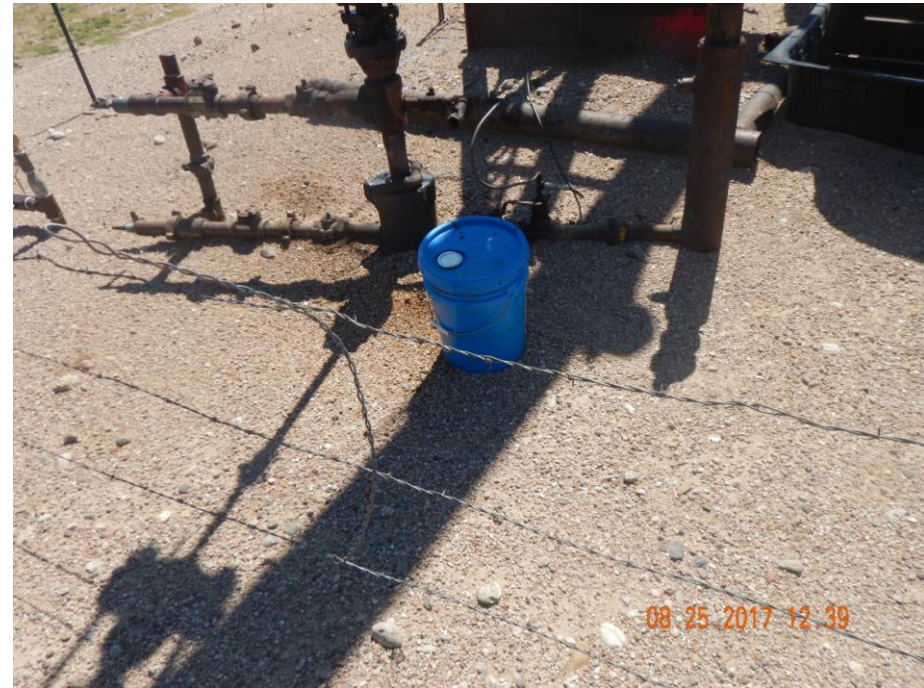
Photo 3: Photo taken at the pumping unit. Photo shows bucket. Bucket needs to be removed and properly stored, or placed into a secondary containment.

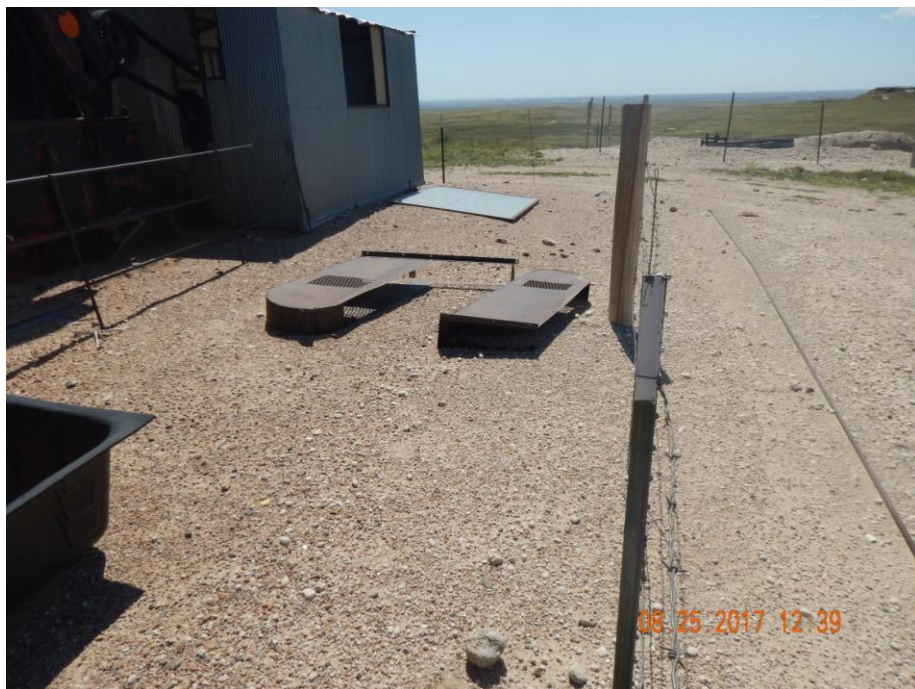
Photo 4: Photo taken on the west side of the pumping unit, facing south. Photo shows equipment being stored on location. This needs to be removed and properly stored.

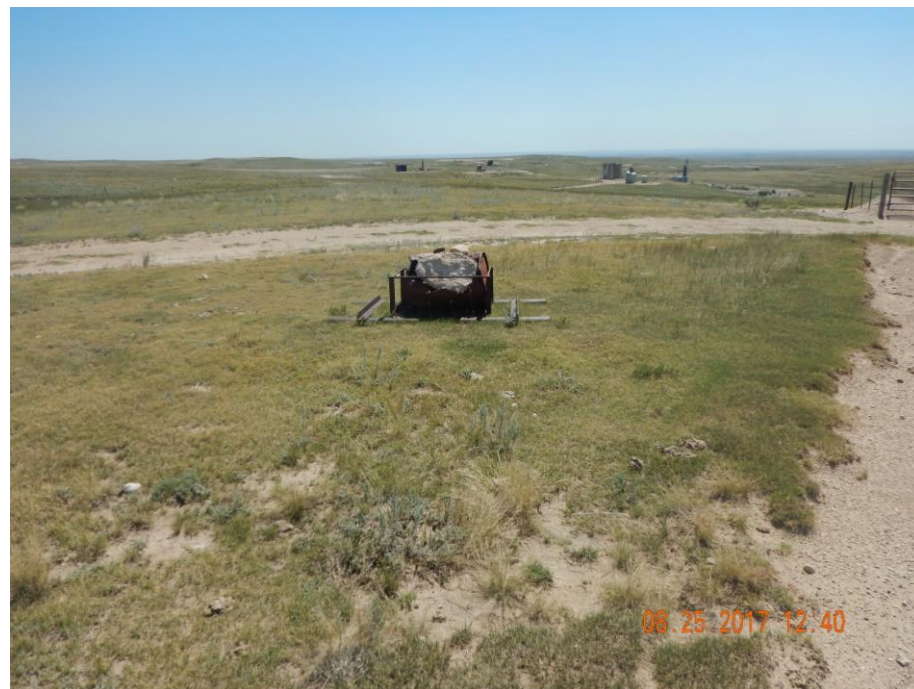
Photo 5: Photo taken east of the pumping unit. Photo shows equipment/debris being stored on location. This needs to be removed and properly stored, or properly disposed of.

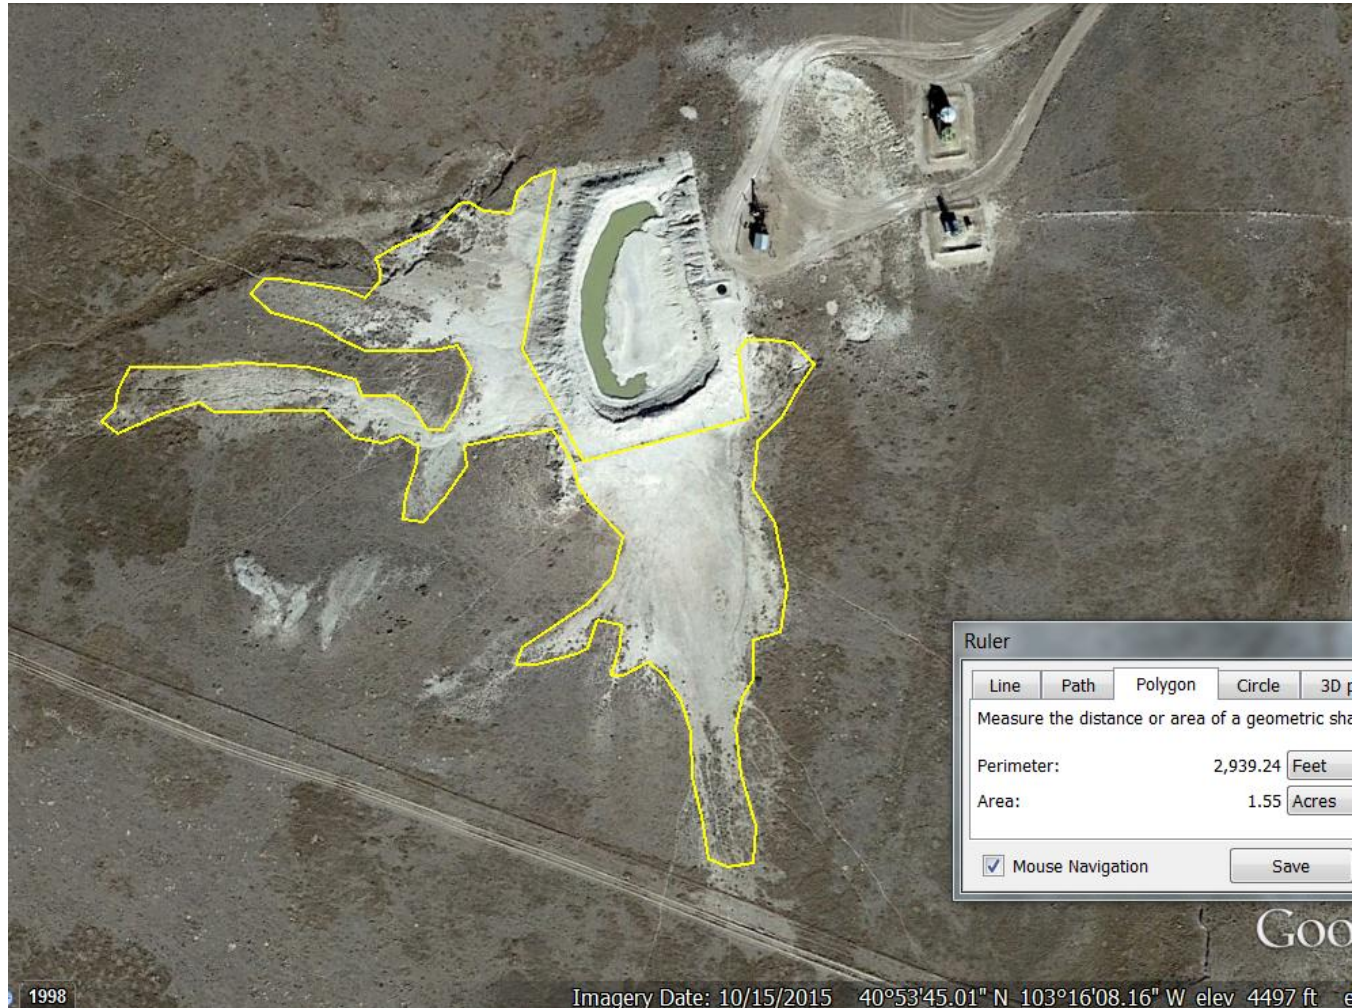
Photo 6a: Current aerial imagery showing the extent of the erosion concerns observed on the location. Photo shows ~1.5 acres of rangeland have been degraded from stormwater runoff from the location.

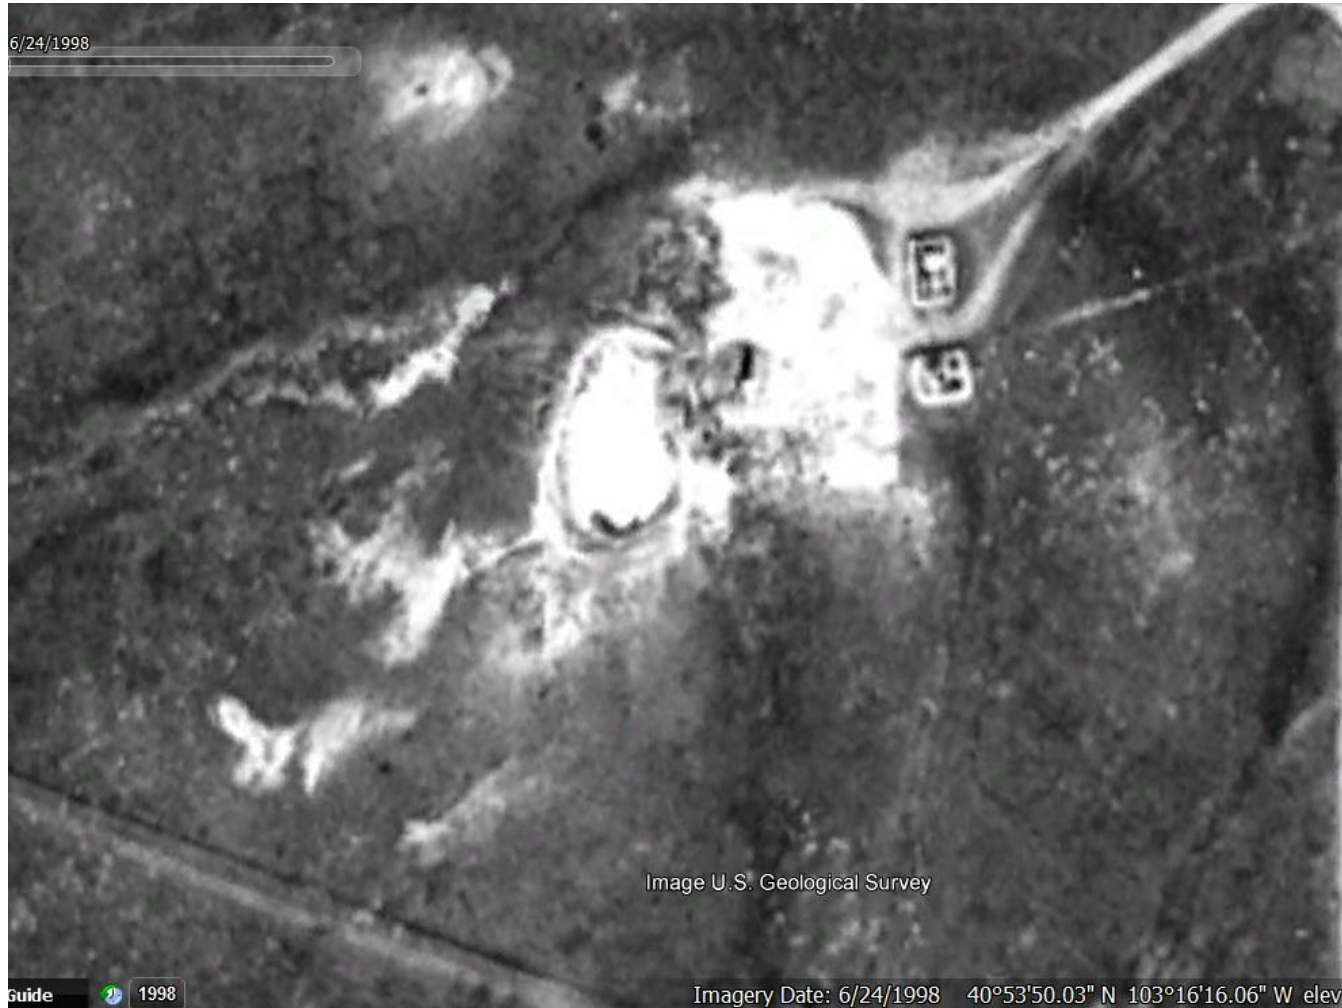
Photo 6b: 1998 historic aerial imagery. Photo shows erosion concerns from the location are evident as far back as (and have likely existed prior to) 1998.

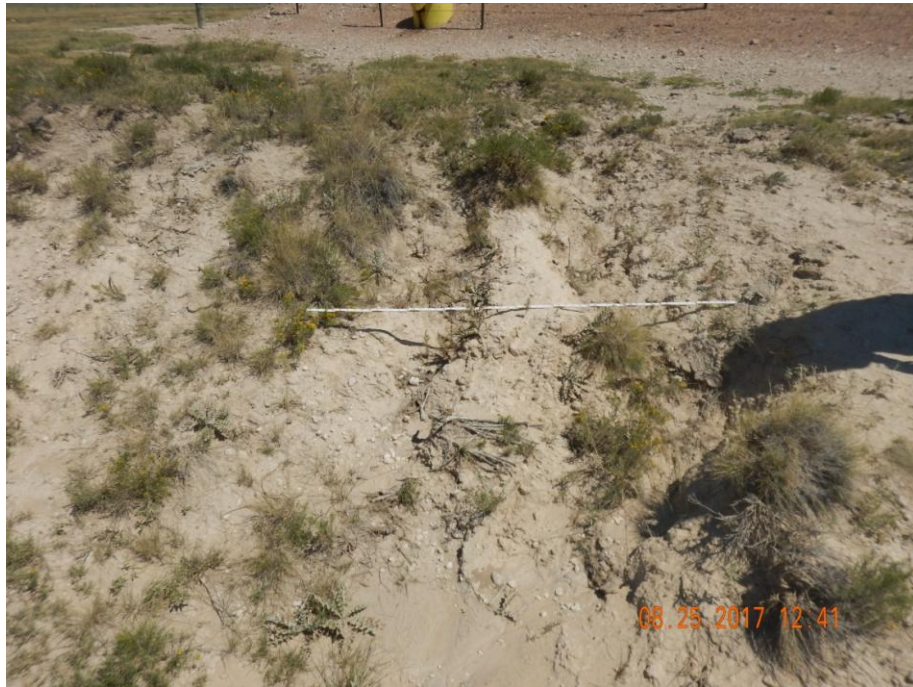
Photo 8: Photo taken on the northern part of the location, just west of the tank battery. Photo shows degradation to the location due to stormwater erosion. Erosion will need to be repaired and stabilized. Required BMPs will need to be installed and maintained in accordance to 1002.f to prevent further degradation. 6 foot measuring stick for reference.

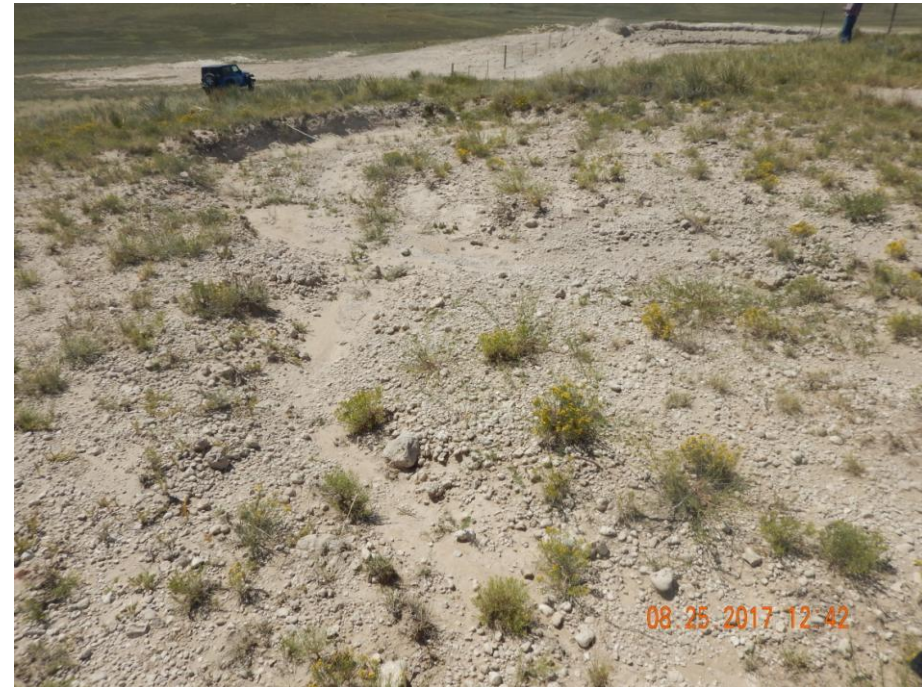
Photo 9: Photo taken on the south end of the location, facing southwest. Photo shows degradation on location due to stormwater erosion. Erosion will need to be repaired and stabilized. Required BMPs will need to be installed and maintained in accordance to 1002.f to prevent further degradation. 6 foot measuring stick for reference.

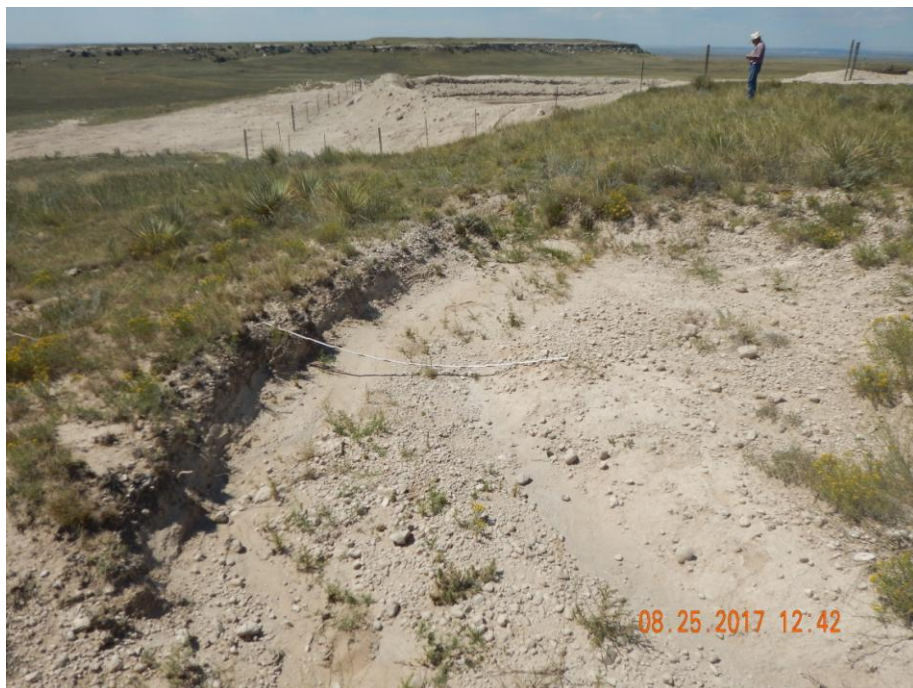
Photo 10: Photo taken on the south end of the location, facing west. Photo shows degradation on location due to stormwater erosion. Erosion will need to be repaired and stabilized. Required BMPs will need to be installed and maintained in accordance to 1002.f to prevent further degradation. 6 foot measuring stick for reference.

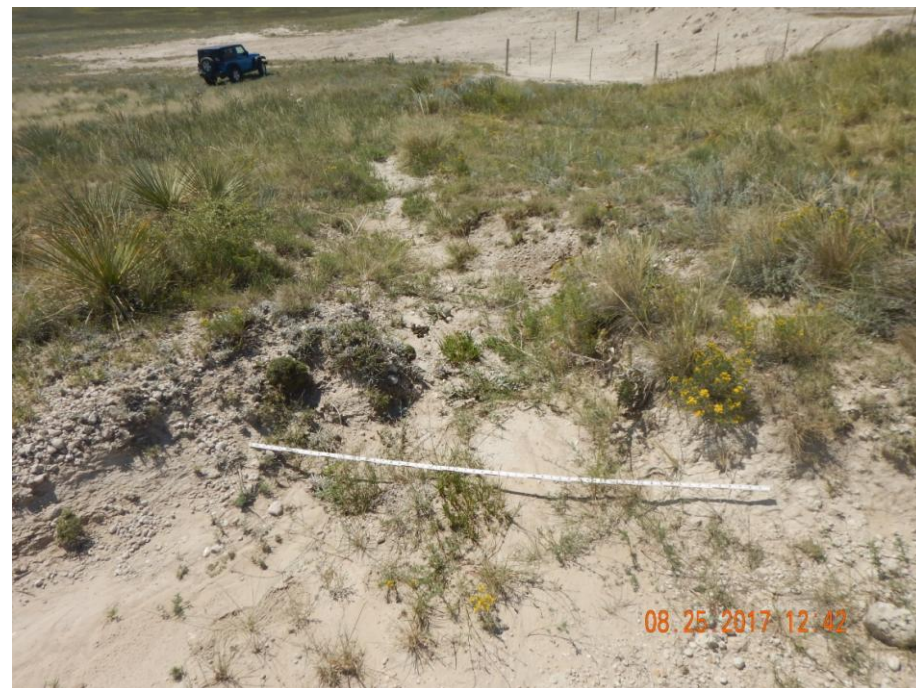
Photo 11: Photo taken on the south end of the location, facing southwest. Photo shows stormwater runoff from the location has caused erosion degradation on the adjacent lands. Erosion will need to be repaired and stabilized. Required BMPs will need to be installed and maintained in accordance to 1002.f to prevent further degradation. 6 foot measuring stick for reference.

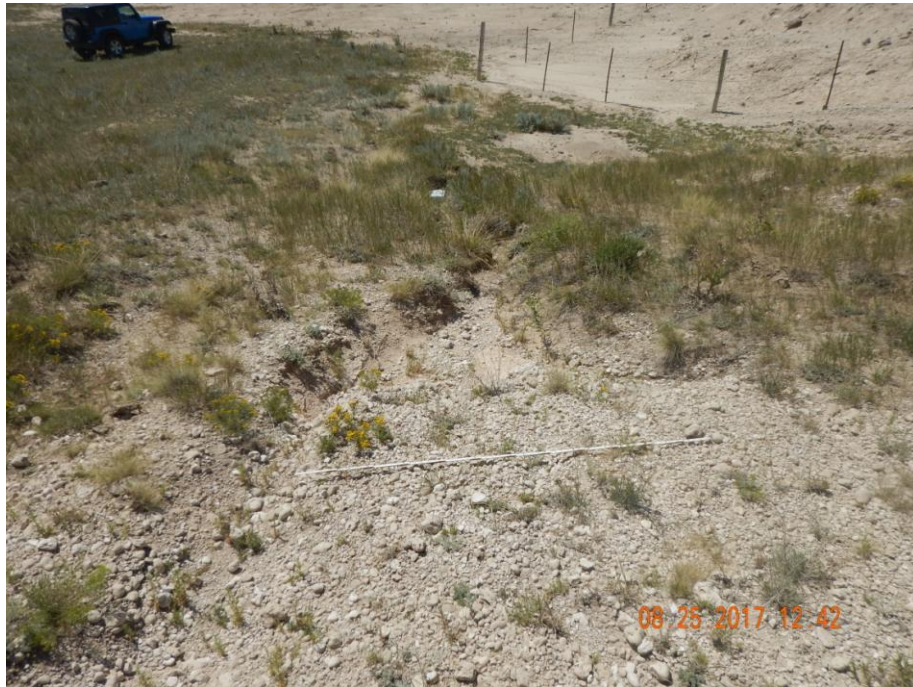
Photo 12: Photo taken on the south end of the location, facing southwest. Photo shows stormwater runoff from the location has caused erosion degradation on the adjacent lands. Erosion will need to be repaired and stabilized. Required BMPs will need to be installed and maintained in accordance to 1002.f to prevent further degradation. 6 foot measuring stick for reference.

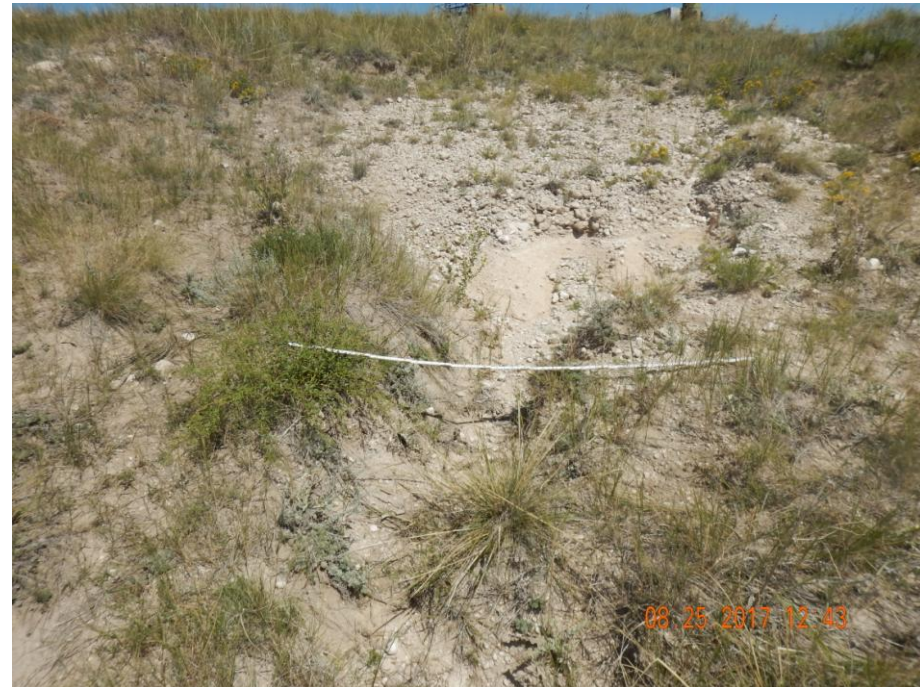
Photo 13: Photo taken on the south end of the location, facing northeast. Photo shows stormwater runoff from the location has caused erosion degradation on the adjacent lands. Erosion will need to be repaired and stabilized. Required BMPs will need to be installed and maintained in accordance to 1002.f to prevent further degradation. 6 foot measuring stick for reference.

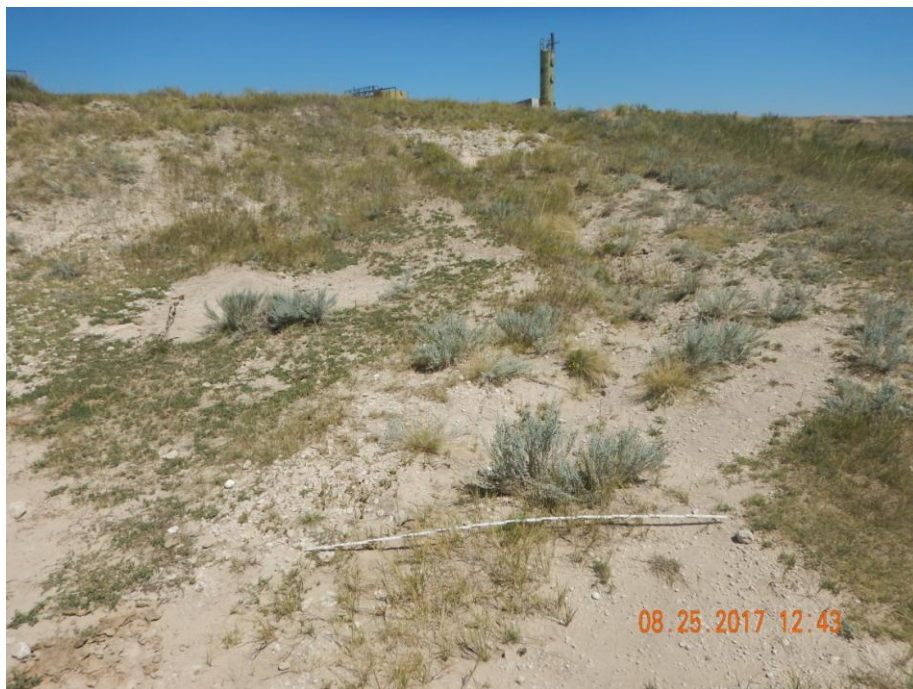
Photo 14: Photo taken on the south end of the location, facing northeast. Photo shows stormwater runoff from the location has caused erosion degradation on the adjacent lands. Erosion will need to be repaired and stabilized. Required BMPs will need to be installed and maintained in accordance to 1002.f to prevent further degradation. 6 foot measuring stick for reference.

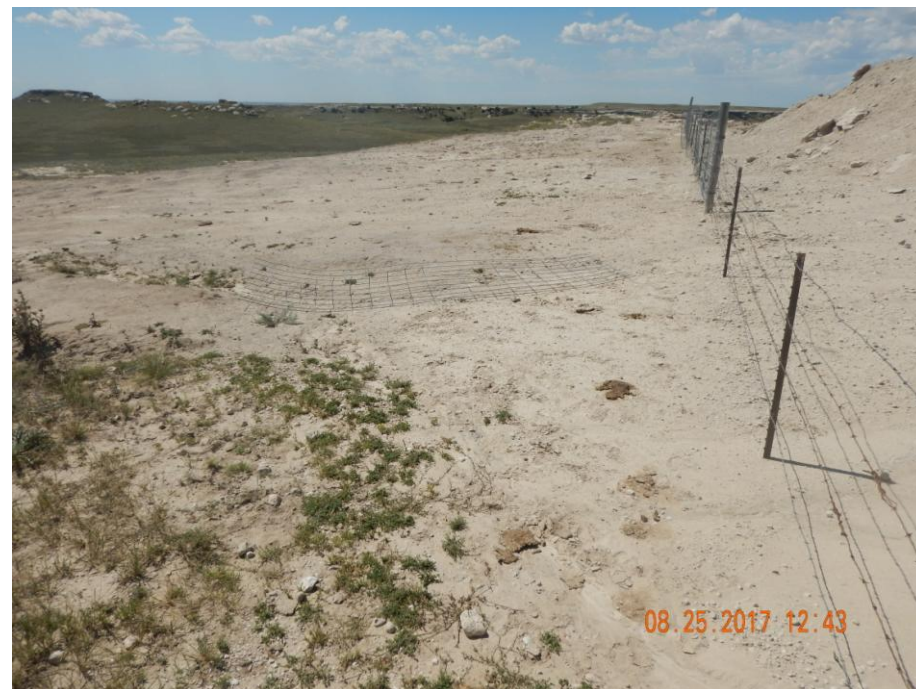
Photo 15: Photo taken on the southeast corner of the pit, facing west. Photo shows stormwater runoff from the location has caused erosion degradation on the adjacent lands. Erosion will need to be repaired and stabilized. Required BMPs will need to be installed and maintained in accordance to 1002.f to prevent further degradation. These areas will need to be re-vegetated/reclaimed. Erosion evident as far back, and likely prior to, 1998 (see photo 6b); soil testing is advised as contaminants may exist preventing vegetation from re-establishing.

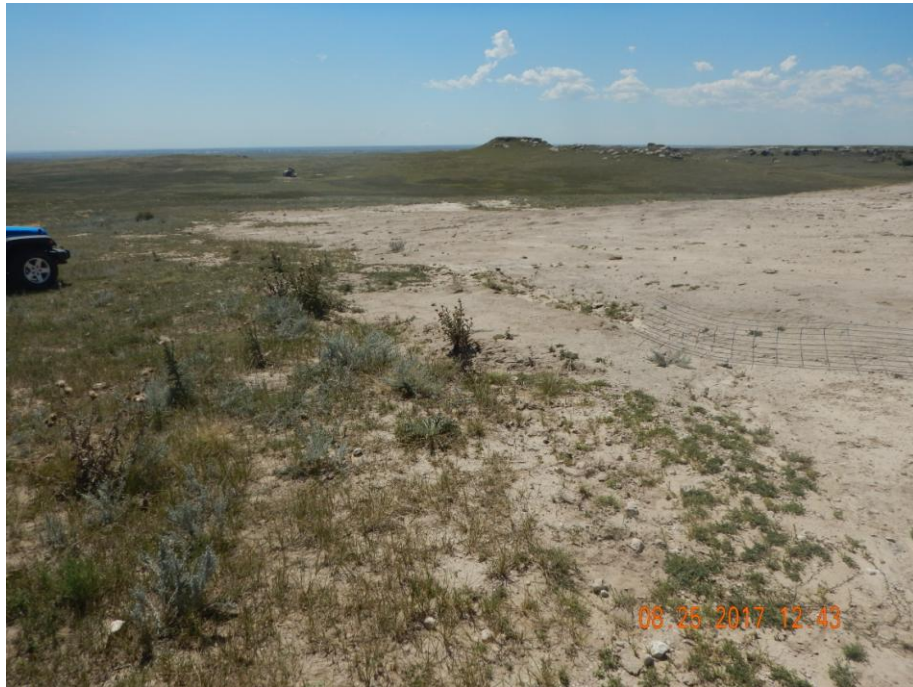
Photo 16: Photo taken on the southeast corner of the pit, facing southwest. Photo shows stormwater runoff from the location has caused erosion degradation on the adjacent lands. Erosion will need to be repaired and stabilized. Required BMPs will need to be installed and maintained in accordance to 1002.f to prevent further degradation. These areas will need to be re-vegetated/reclaimed. Erosion evident as far back, and likely prior to, 1998 (see photo 6b); soil testing is advised as contaminants may exist preventing vegetation from re-establishing.

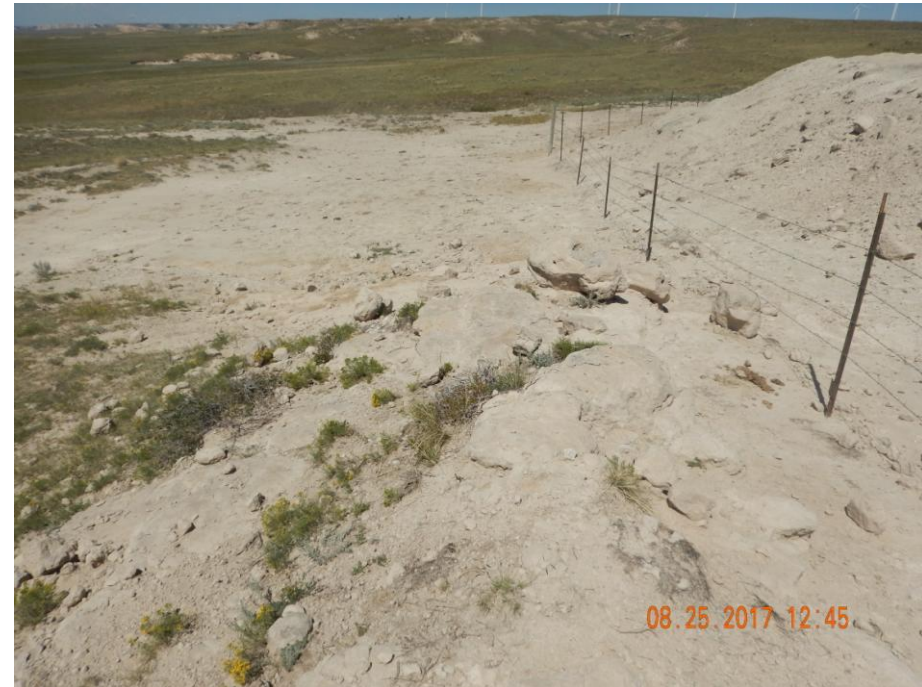
Photo 17: Photo taken on the southwest corner of the pit, facing northwest. Photo shows stormwater runoff from the location has caused erosion degradation on the adjacent lands. Erosion will need to be repaired and stabilized. Required BMPs will need to be installed and maintained in accordance to 1002.f to prevent further degradation. These areas will need to be re-vegetated/reclaimed. Erosion evident as far back, and likely prior to, 1998 (see photo 6b); soil testing is advised as contaminants may exist preventing vegetation from re-establishing.

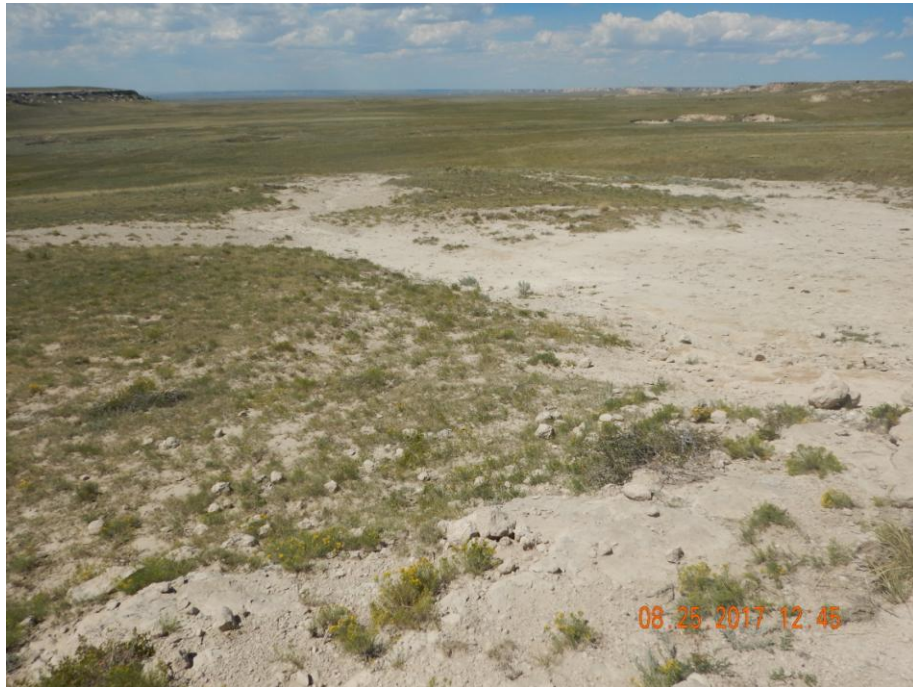
Photo 18: Photo taken on the southwest corner of the pit, facing west. Photo shows stormwater runoff from the location has caused erosion degradation on the adjacent lands. Erosion will need to be repaired and stabilized. Required BMPs will need to be installed and maintained in accordance to 1002.f to prevent further degradation. These areas will need to be re-vegetated/reclaimed. Erosion evident as far back, and likely prior to, 1998 (see photo 6b); soil testing is advised as contaminants may exist preventing vegetation from re-establishing.

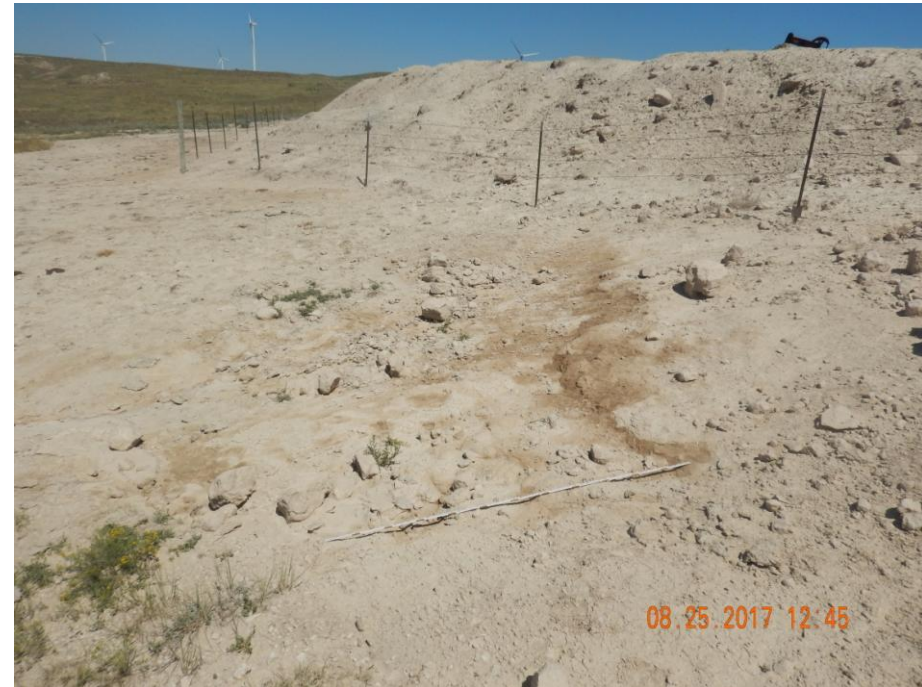
Photo 19: Photo taken on the southwest corner of the pit, facing north. Photo shows stormwater runoff and erosion degradation occurring at the pit. Runoff from the location has caused erosion degradation on the adjacent lands. Erosion will need to be repaired and stabilized. Required BMPs will need to be installed and maintained in accordance to 1002.f to prevent further degradation. These areas will need to be re-vegetated/reclaimed. Erosion evident as far back, and likely prior to, 1998 (see photo 6b); soil testing is advised as contaminants may exist preventing vegetation from re-establishing. 6 foot measuring stick for reference.

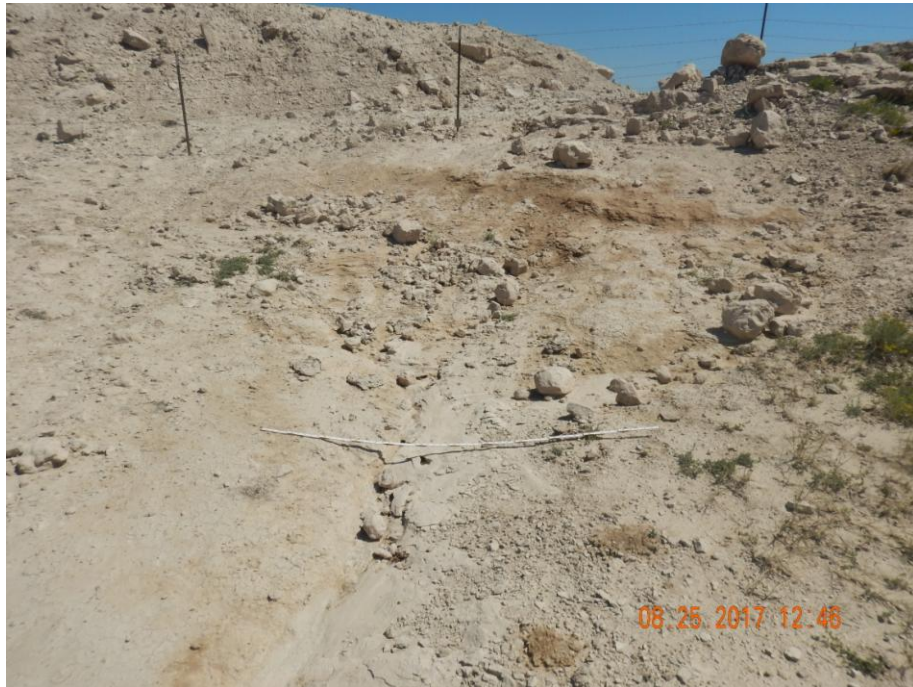
Photo 20: Photo taken on the southwest corner of the pit, facing northeast. Photo shows stormwater runoff and erosion degradation occurring at the pit. Runoff from the location has caused erosion degradation on the adjacent lands. Erosion will need to be repaired and stabilized. Required BMPs will need to be installed and maintained in accordance to 1002.f to prevent further degradation. These areas will need to be re-vegetated/reclaimed. Erosion evident as far back, and likely prior to, 1998 (see photo 6b); soil testing is advised as contaminants may exist preventing vegetation from re-establishing. 6 foot measuring stick for reference.

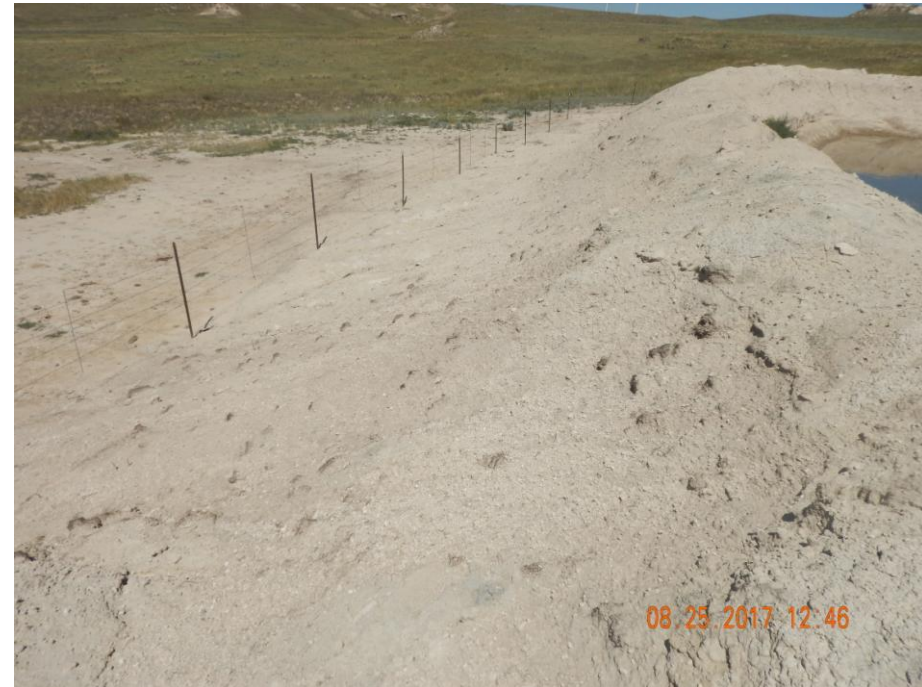
Photo 21: Photo taken on the west end of the pit, facing north. Photo shows stormwater runoff from the location has caused erosion degradation on the adjacent lands. Erosion will need to be repaired and stabilized. Required BMPs will need to be installed and maintained in accordance to 1002.f to prevent further degradation. These areas will need to be re-vegetated/reclaimed. Erosion evident as far back, and likely prior to, 1998 (see photo 6b); soil testing is advised as contaminants may exist preventing vegetation from re-establishing.

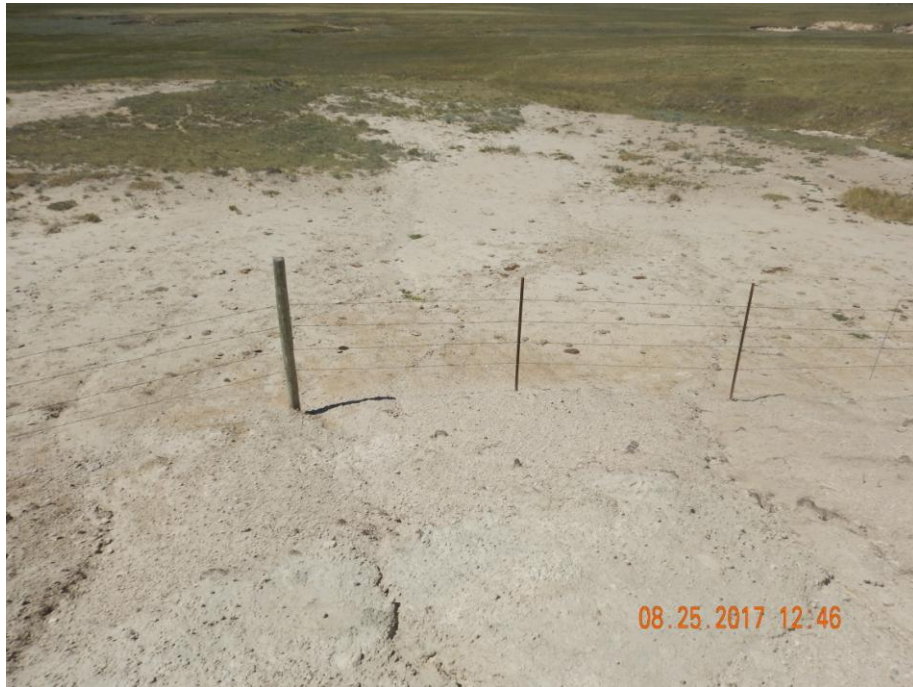
Photo 22: Photo taken on the west end of the pit, facing west. Photo shows stormwater runoff from the location has caused erosion degradation on the adjacent lands. Erosion will need to be repaired and stabilized. Required BMPs will need to be installed and maintained in accordance to 1002.f to prevent further degradation. These areas will need to be re-vegetated/reclaimed. Erosion evident as far back, and likely prior to, 1998 (see photo 6b); soil testing is advised as contaminants may exist preventing vegetation from re-establishing.

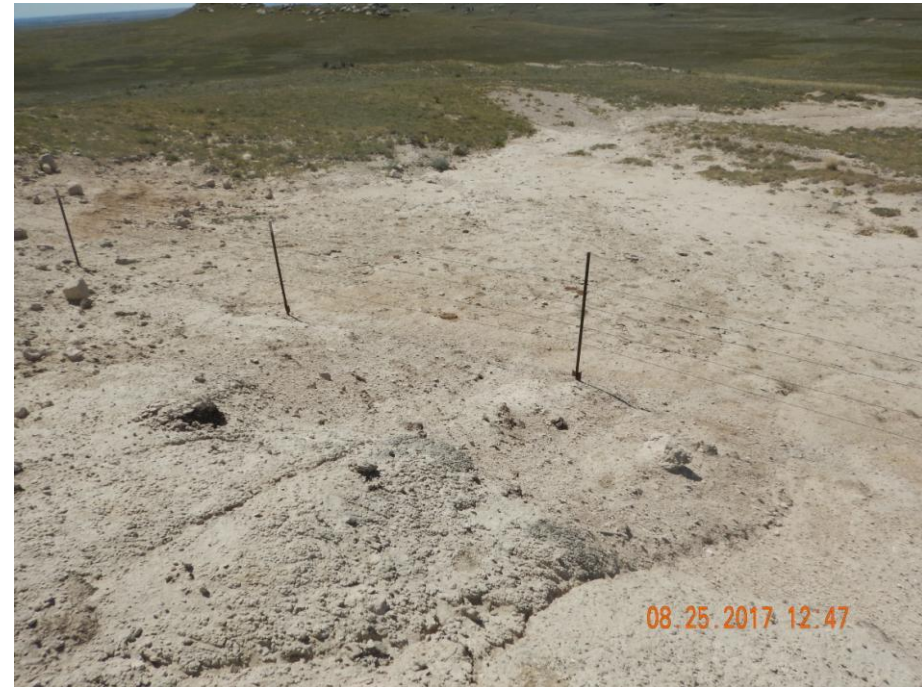
Photo 23: Photo taken on the west end of the pit, facing southwest. Photo shows stormwater runoff from the location has caused erosion degradation on the adjacent lands. Erosion will need to be repaired and stabilized. Required BMPs will need to be installed and maintained in accordance to 1002.f to prevent further degradation. These areas will need to be re-vegetated/reclaimed. Erosion evident as far back, and likely prior to, 1998 (see photo 6b); soil testing is advised as contaminants may exist preventing vegetation from re-establishing.

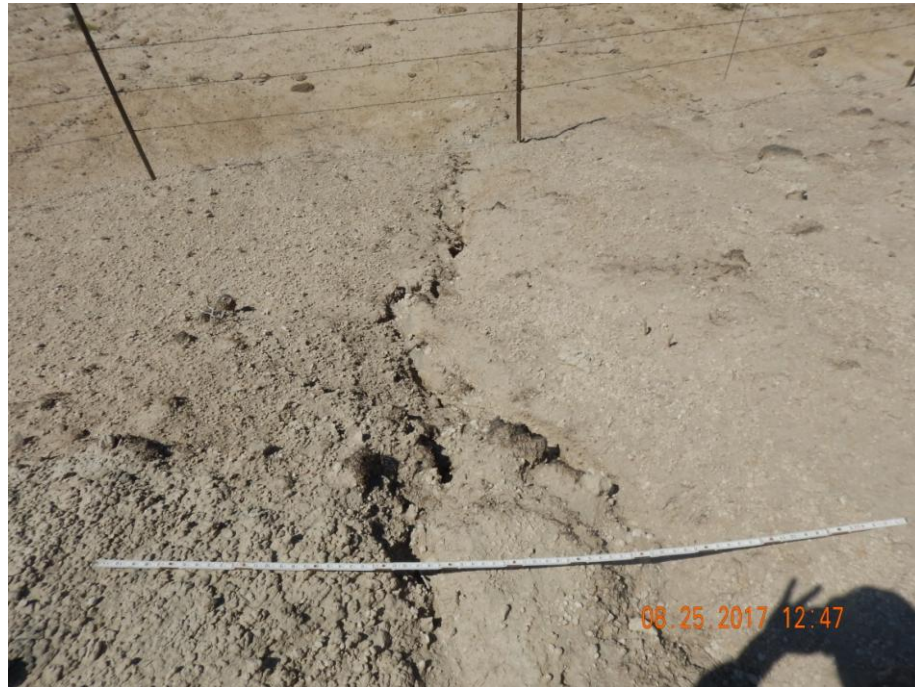
Photo 24: Photo taken from the west end of the pit. Photo shows stormwater runoff and erosion degradation occurring at the pit. Runoff from the location has caused erosion degradation on the adjacent lands. Erosion will need to be repaired and stabilized. Required BMPs will need to be installed and maintained in accordance to 1002.f to prevent further degradation. 6 foot measuring stick for reference.

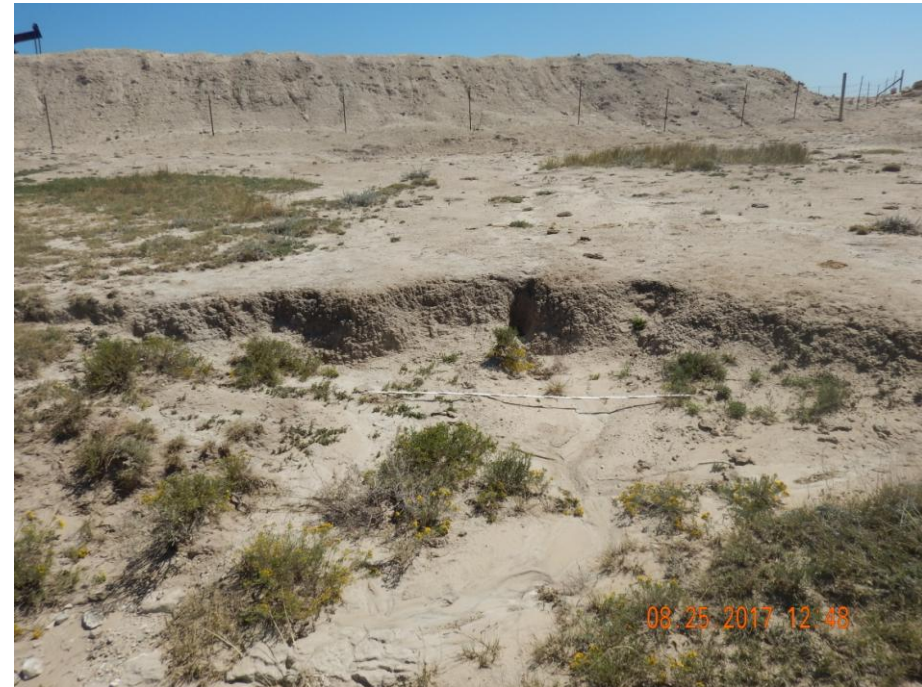
Photo 25: Photo taken from the west of the pit, facing east. Photo shows large headcuts have formed due to stormwater erosion from the location. Erosion will need to be repaired and stabilized. Required BMPs will need to be installed and maintained in accordance to 1002.f to prevent further degradation. These areas will need to be re-vegetated/reclaimed. Erosion evident as far back, and likely prior to, 1998 (see photo 6b); soil testing is advised as contaminants may exist preventing vegetation from re-establishing. 6 foot measuring stick for reference.

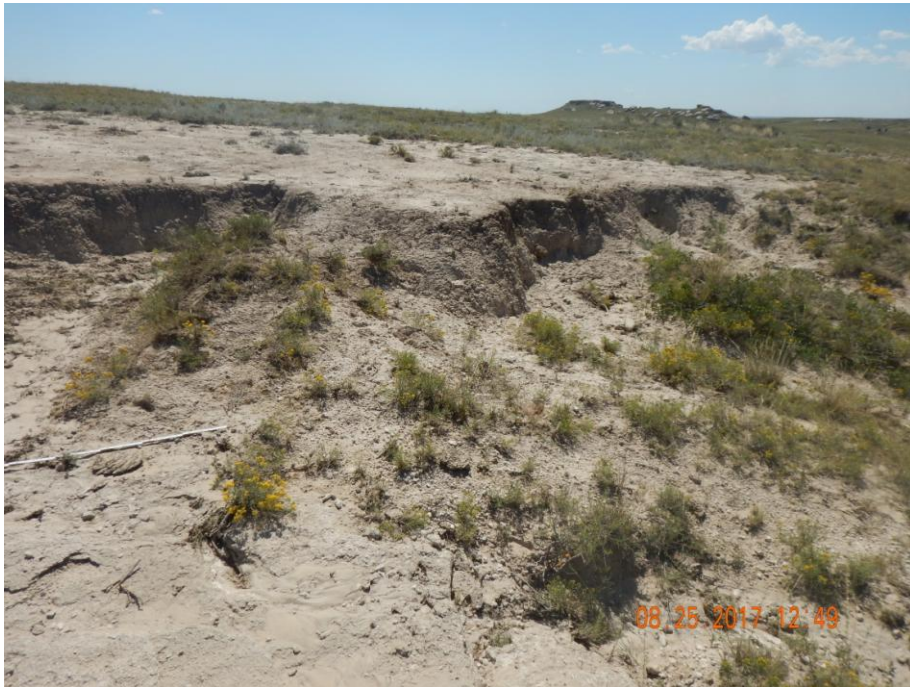
Photo 26: Photo taken from the west of the pit, facing south. Photo shows large headcuts have formed due to stormwater erosion from the location. Erosion will need to be repaired and stabilized. Required BMPs will need to be installed and maintained in accordance to 1002.f to prevent further degradation. These areas will need to be re-vegetated/reclaimed. Erosion evident as far back, and likely prior to, 1998 (see photo 6b); soil testing is advised as contaminants may exist preventing vegetation from re-establishing. 6 foot measuring stick for reference.

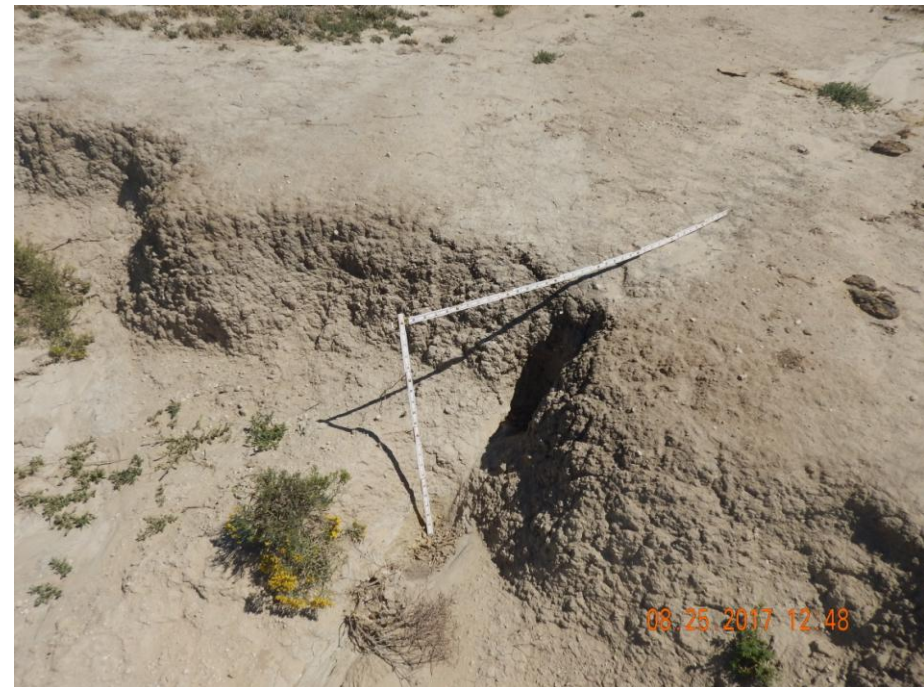
Photo 27: Photo taken from the degraded areas west of the pit. Photo shows large headcuts have formed due to stormwater erosion from the location. Headcut seen here is ~2 feet in height. There are other headcuts in the area that appear to be larger in size.

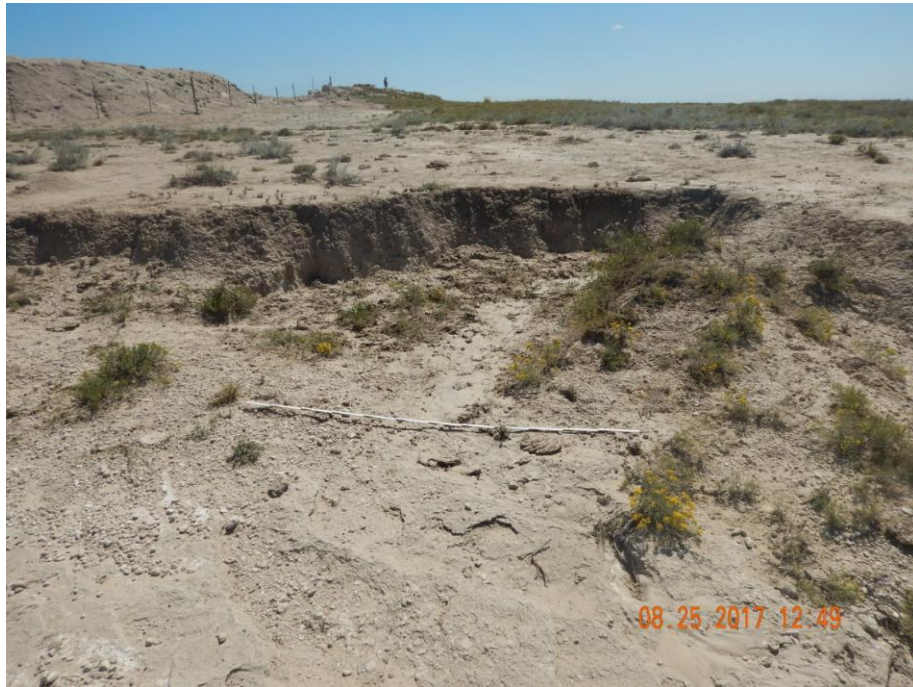
Photo 28: Photo taken from the west of the pit, facing southeast. Photo shows large headcuts have formed due to stormwater erosion from the location. Erosion will need to be repaired and stabilized. Required BMPs will need to be installed and maintained in accordance to 1002.f to prevent further degradation. These areas will need to be re-vegetated/reclaimed. Erosion evident as far back, and likely prior to, 1998 (see photo 6b); soil testing is advised as contaminants may exist preventing vegetation from re-establishing. 6 foot measuring stick for reference.

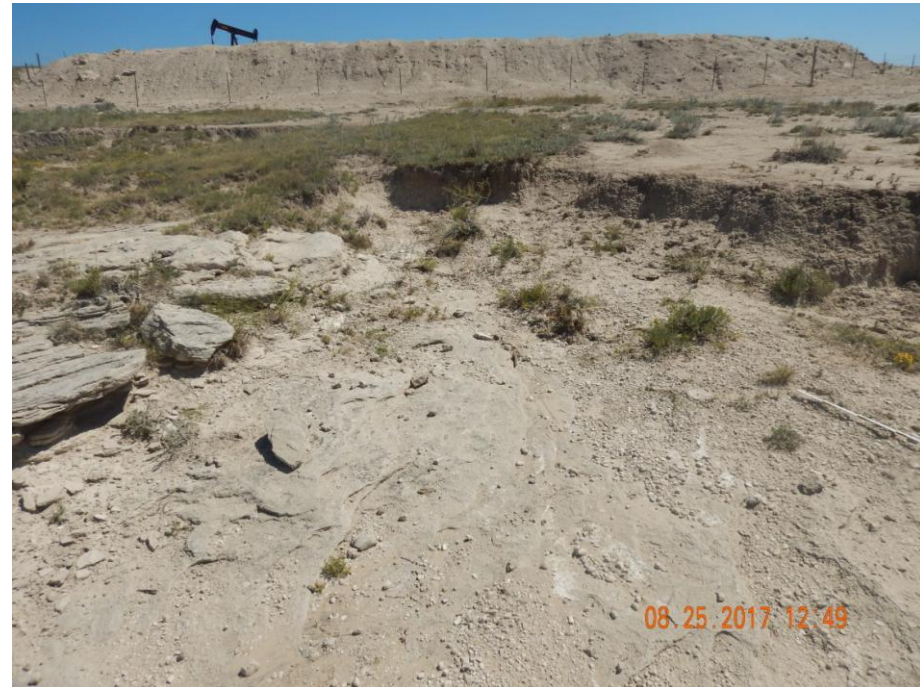
Photo 29: Photo taken from the west of the pit, facing east. Photo shows large headcuts have formed due to stormwater erosion from the location. Erosion will need to be repaired and stabilized. Required BMPs will need to be installed and maintained in accordance to 1002.f to prevent further degradation. These areas will need to be re-vegetated/reclaimed. Erosion evident as far back, and likely prior to, 1998 (see photo 6b); soil testing is advised as contaminants may exist preventing vegetation from re-establishing. 6 foot measuring stick for reference.

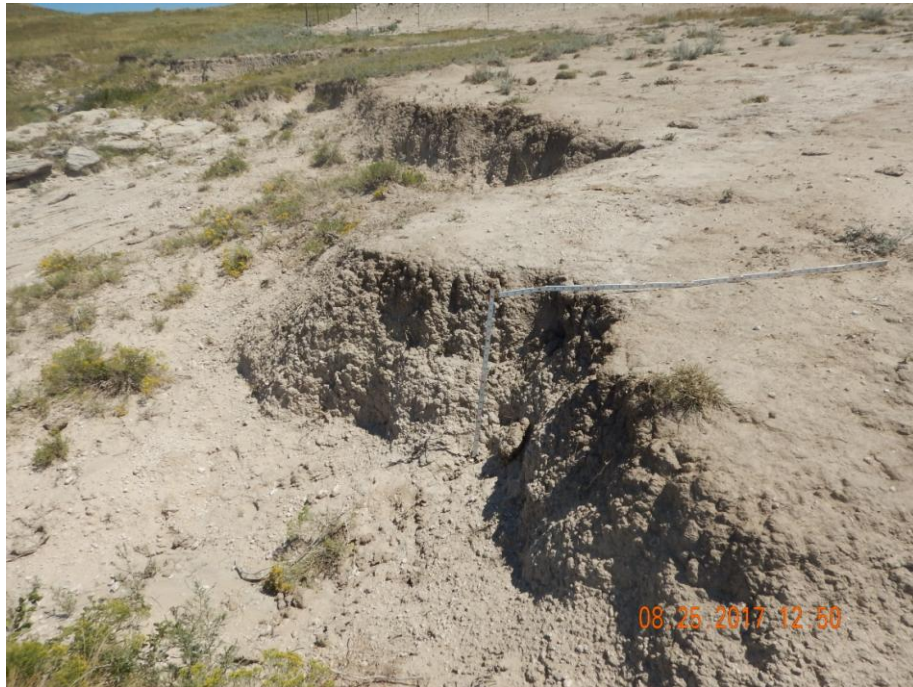
Photo 30: Photo taken from the west of the pit, facing north. Photo shows large headcuts have formed due to stormwater erosion from the location. Headcut seen here is ~2 feet in height. There are other headcuts in the area that appear to be larger in size.
