Inspection Photos

8/25/2017

Operator: WESTERN OPERATING COMPANY -
95620

Location ID: 312292

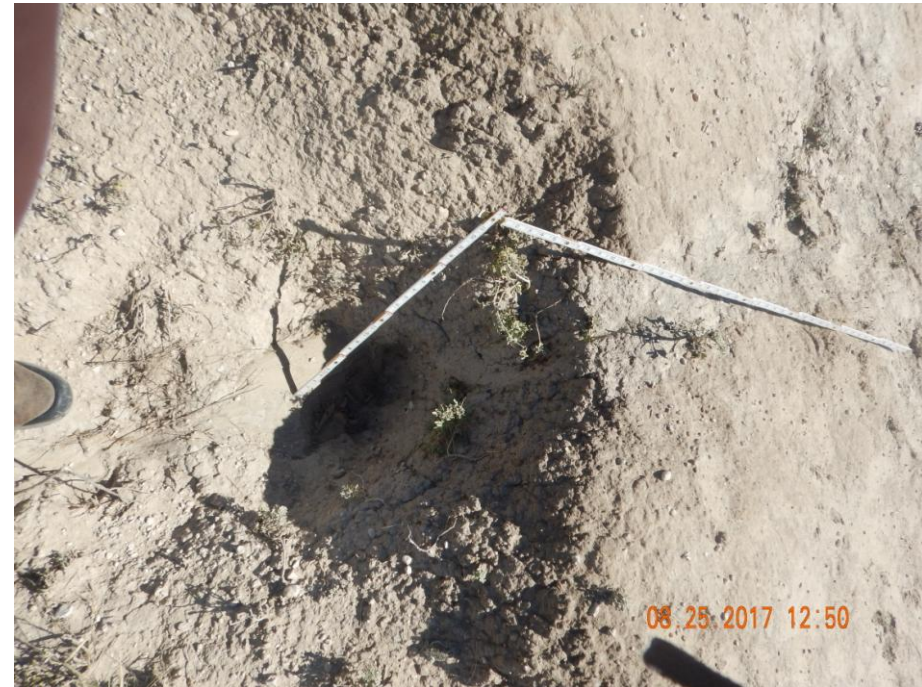
Photo 31: Photo taken from the west of the pit. Photo shows large headcuts have formed due to stormwater erosion from the location. Headcut seen here is ~2 feet in height. There are other headcuts in the area that appear to be larger in size.

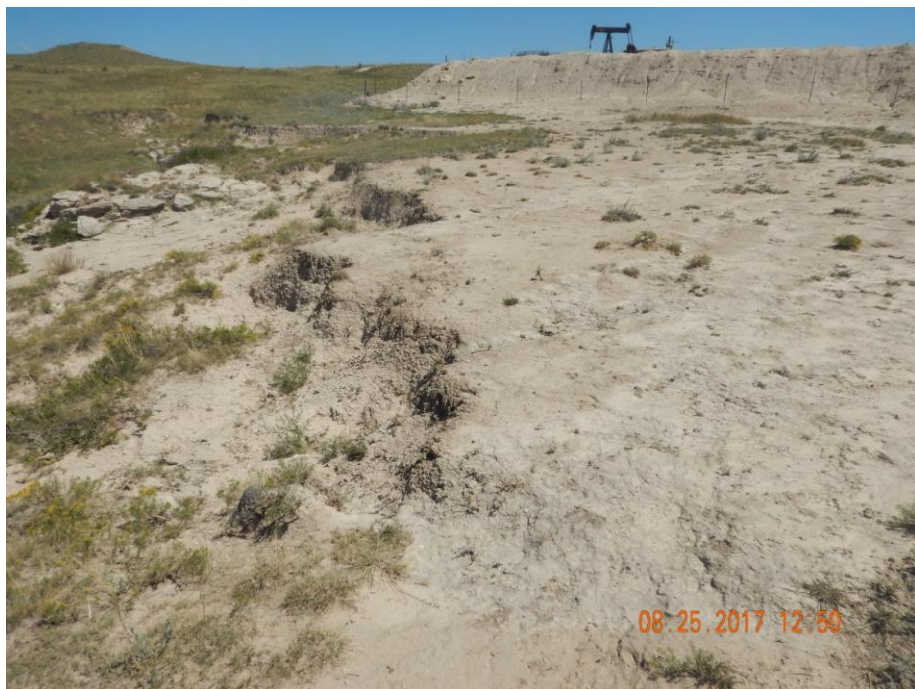
Photo 32: Photo taken from the southwest of the pit, facing north. Photo shows stormwater runoff from the location has caused erosion degradation on the adjacent lands. Erosion will need to be repaired and stabilized. Required BMPs will need to be installed and maintained in accordance to 1002.f to prevent further degradation. These areas will need to be re-vegetated/reclaimed. Soil testing is advised as contaminants may exist preventing vegetation from re-establishing.

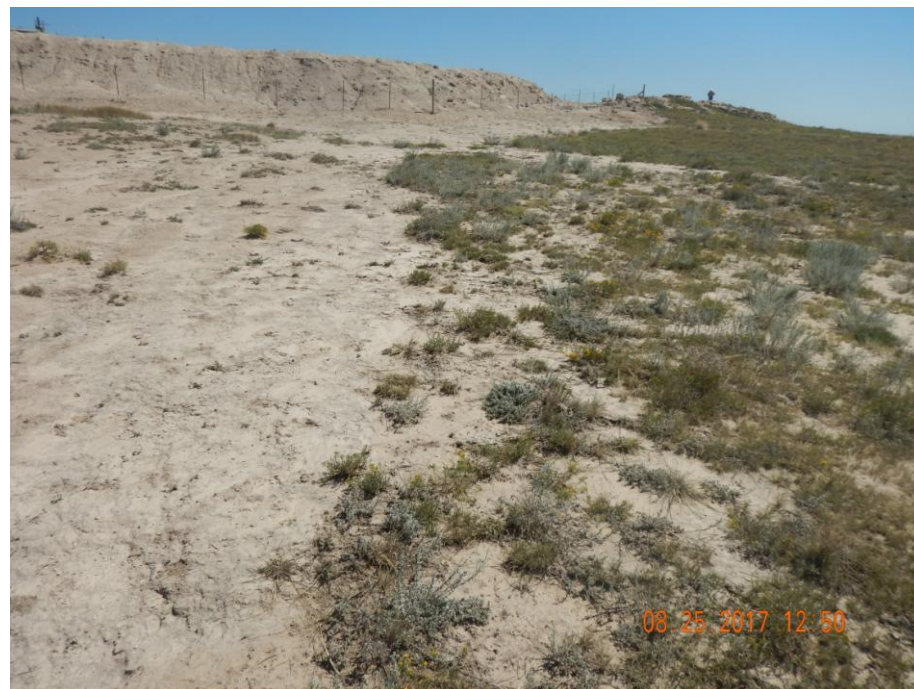
Photo 33: Photo taken from the southwest of the pit, facing east. Photo shows stormwater runoff from the location has caused erosion degradation on the adjacent lands. Erosion will need to be repaired and stabilized. Required BMPs will need to be installed and maintained in accordance to 1002.f to prevent further degradation. These areas will need to be re-vegetated/reclaimed. Soil testing is advised as contaminants may exist preventing vegetation from re-establishing.

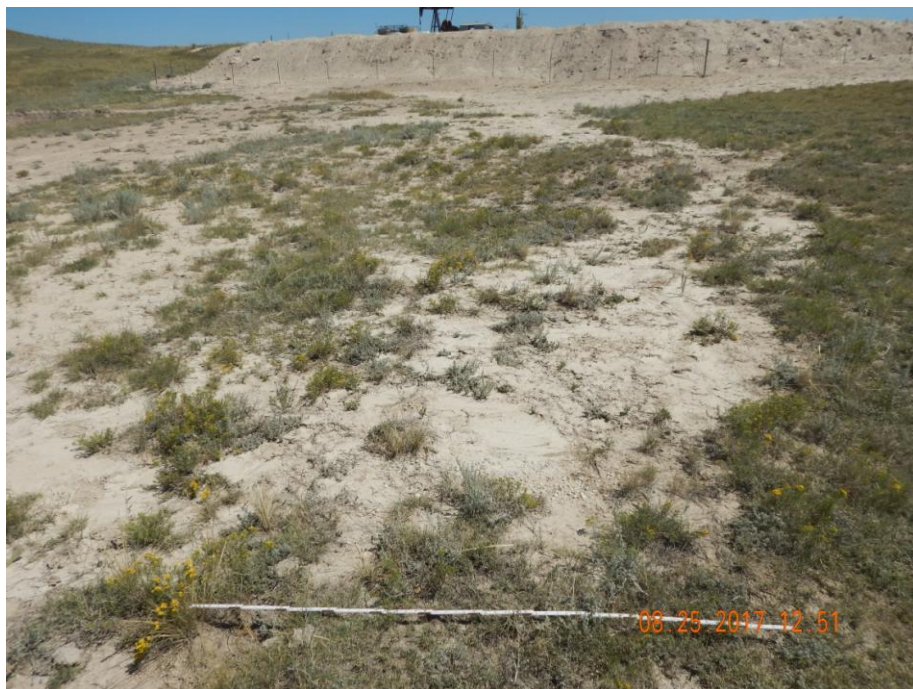
Photo 34: Photo taken from the southwest of the pit, facing north. Photo shows stormwater runoff from the location has caused erosion degradation on the adjacent lands. Erosion will need to be repaired and stabilized. Required BMPs will need to be installed and maintained in accordance to 1002.f to prevent further degradation. These areas will need to be re-vegetated/reclaimed. Soil testing is advised as contaminants may exist preventing vegetation from re-establishing. 6 foot measuring stick for reference.

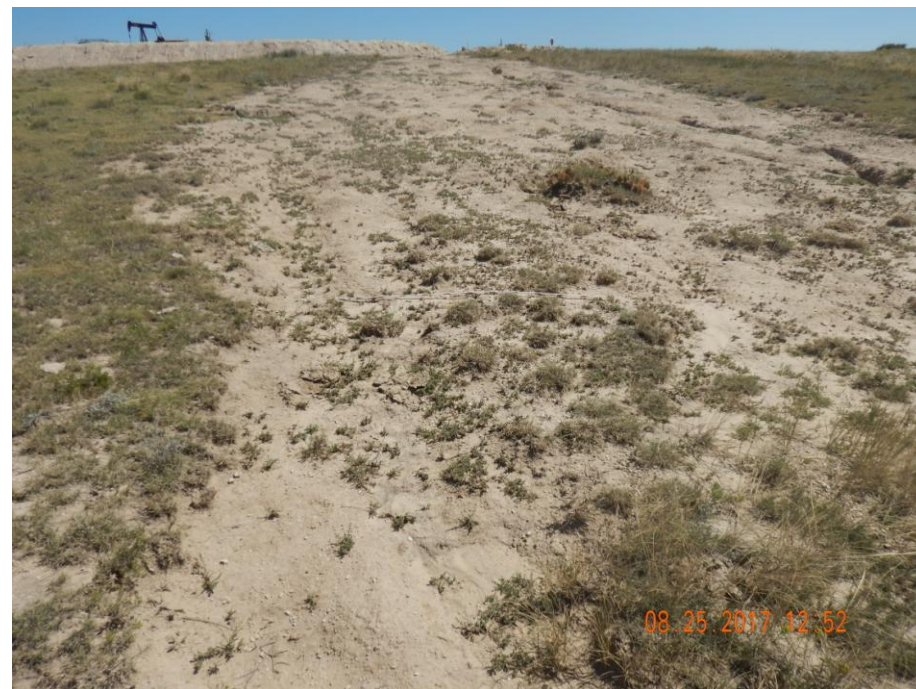
Photo 35: Photo taken from the southwest of the pit, facing north. Photo shows stormwater runoff from the location has caused erosion degradation on the adjacent lands. Erosion will need to be repaired and stabilized. Required BMPs will need to be installed and maintained in accordance to 1002.f to prevent further degradation. These areas will need to be re-vegetated/reclaimed. Soil testing is advised as contaminants may exist preventing vegetation from re-establishing.

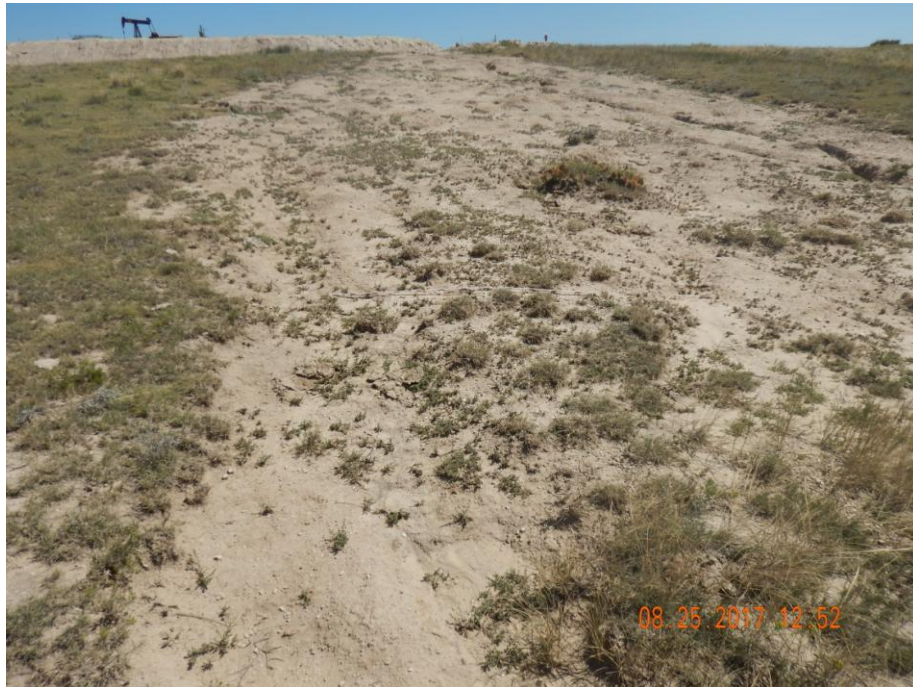
Photo 36: Photo taken from the southwest of the pit, facing north. Photo shows stormwater runoff from the location has caused erosion degradation on the adjacent lands. Erosion will need to be repaired and stabilized. Required BMPs will need to be installed and maintained in accordance to 1002.f to prevent further degradation. These areas will need to be re-vegetated/reclaimed. Soil testing is advised as contaminants may exist preventing vegetation from re-establishing. 6 foot measuring stick for reference.

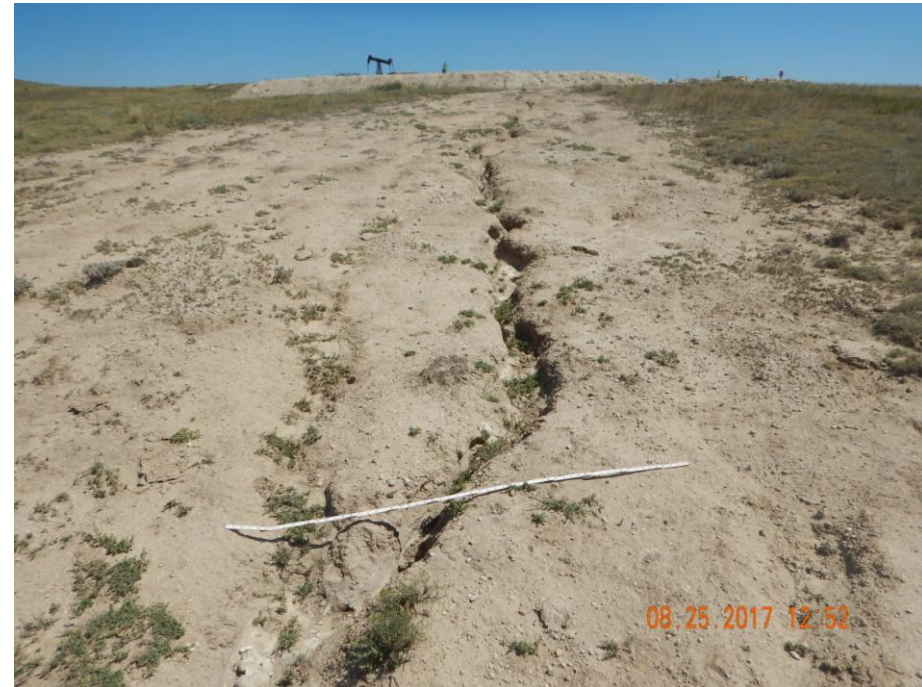
Photo 37: Photo taken from the southwest of the pit, facing north. Photo shows stormwater runoff from the location has caused erosion degradation on the adjacent lands. Erosion will need to be repaired and stabilized. Required BMPs will need to be installed and maintained in accordance to 1002.f to prevent further degradation. These areas will need to be re-vegetated/reclaimed. Soil testing is advised as contaminants may exist preventing vegetation from re-establishing.

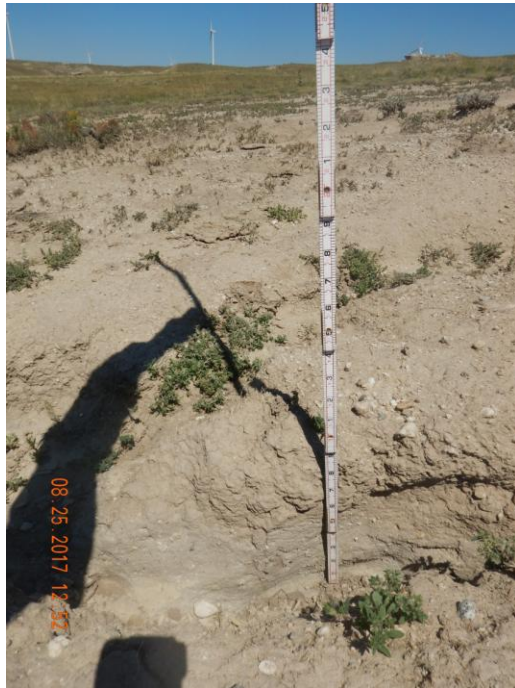
Photo 38: Photo taken from the southwest of the pit. Photo shows gulley erosion due to stormwater runoff from the location. Gulley seen here is ~1.5 feet in depth.

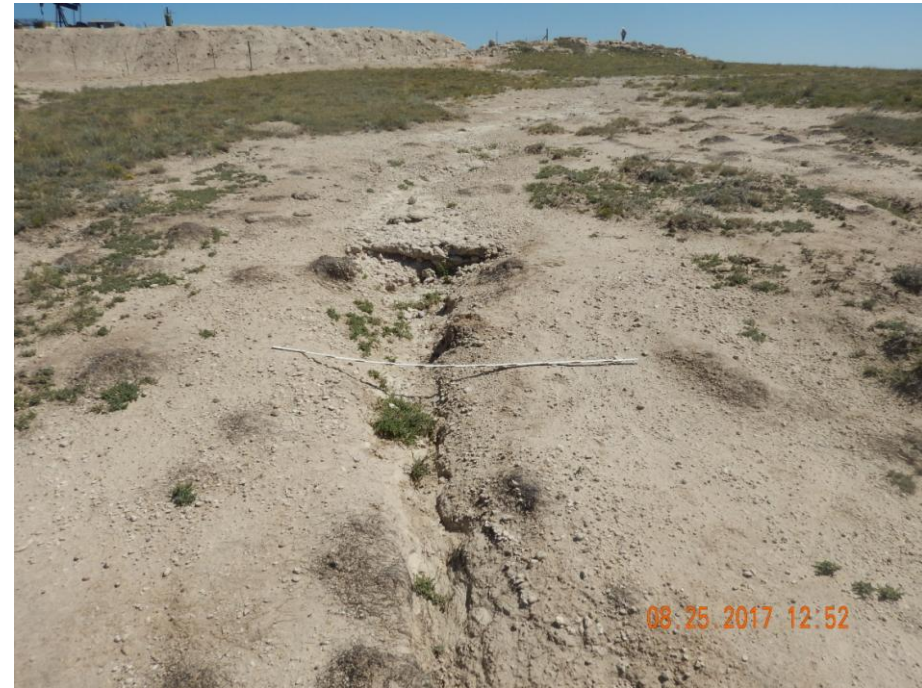
Photo 39: Photo taken from the southwest of the pit, facing east. Photo shows stormwater runoff from the location has caused erosion degradation on the adjacent lands. Erosion will need to be repaired and stabilized. Required BMPs will need to be installed and maintained in accordance to 1002.f to prevent further degradation. These areas will need to be re-vegetated/reclaimed. Soil testing is advised as contaminants may exist preventing vegetation from re-establishing.

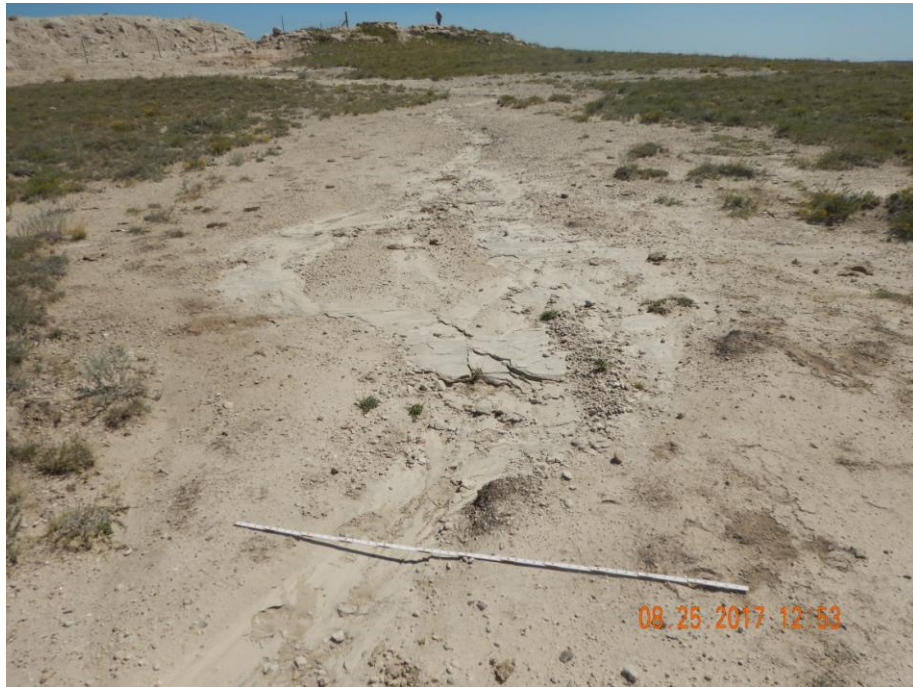
Photo 40: Photo taken from the southwest of the pit, facing east. Photo shows stormwater runoff from the location has caused erosion degradation on the adjacent lands. Erosion will need to be repaired and stabilized. Required BMPs will need to be installed and maintained in accordance to 1002.f to prevent further degradation. These areas will need to be re-vegetated/reclaimed. Soil testing is advised as contaminants may exist preventing vegetation from re-establishing. 6 foot measuring stick for reference.

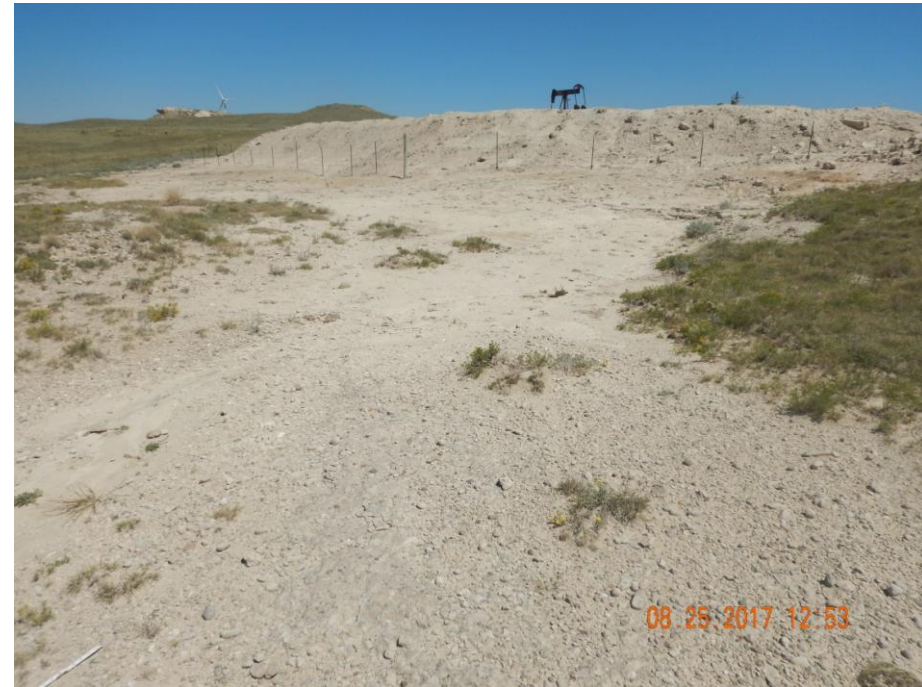
Photo 41: Photo taken from the southwest of the pit, facing northeast. Photo shows stormwater runoff from the location has caused erosion degradation on the adjacent lands. Erosion will need to be repaired and stabilized. Required BMPs will need to be installed and maintained in accordance to 1002.f to prevent further degradation. These areas will need to be re-vegetated/reclaimed. Soil testing is advised as contaminants may exist preventing vegetation from re-establishing.

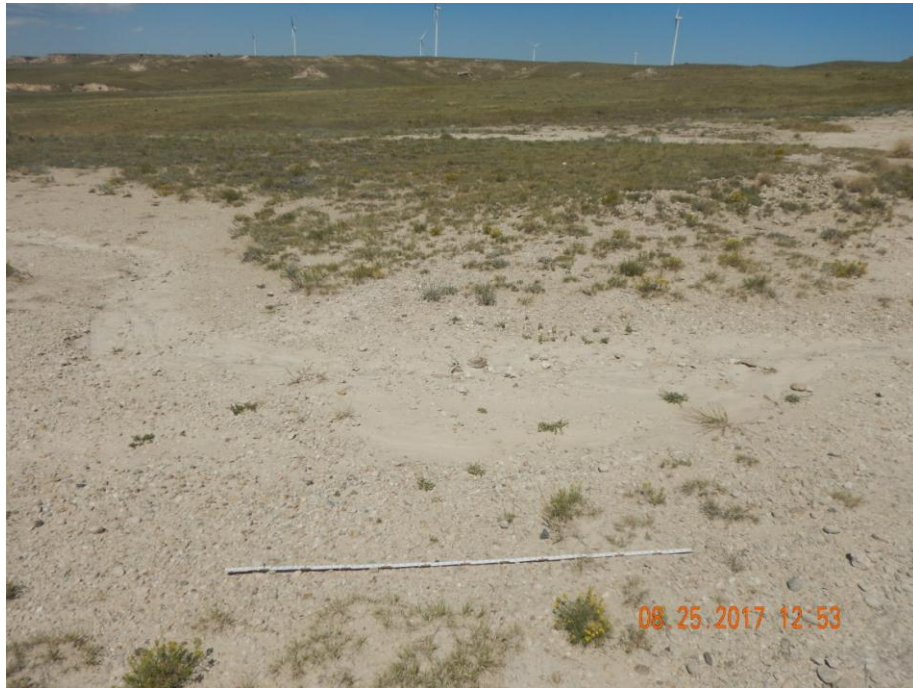
Photo 42: Photo taken from the southwest end of the pit, facing north. Photo shows stormwater runoff from the location has caused erosion degradation on the adjacent lands. Erosion will need to be repaired and stabilized. Required BMPs will need to be installed and maintained in accordance to 1002.f to prevent further degradation. These areas will need to be re-vegetated/reclaimed. Soil testing is advised as contaminants may exist preventing vegetation from re-establishing. 6 foot measuring stick for reference.

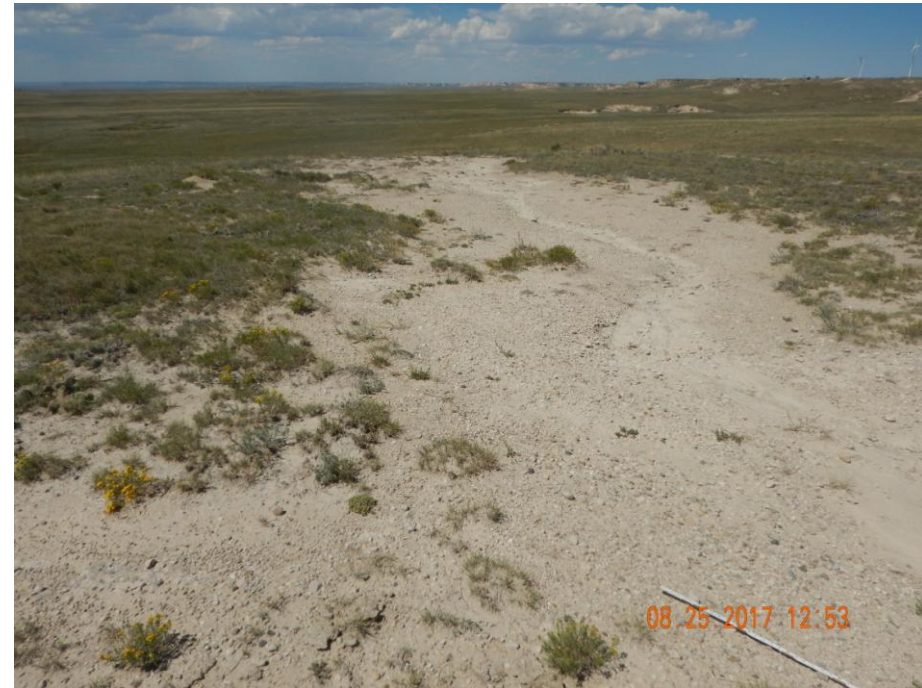
Photo 43: Photo taken from the southwest end of the pit, facing west. Photo shows stormwater runoff from the location has caused erosion degradation on the adjacent lands. Erosion will need to be repaired and stabilized. Required BMPs will need to be installed and maintained in accordance to 1002.f to prevent further degradation. These areas will need to be re-vegetated/reclaimed. Soil testing is advised as contaminants may exist preventing vegetation from re-establishing. 6 foot measuring stick for reference.

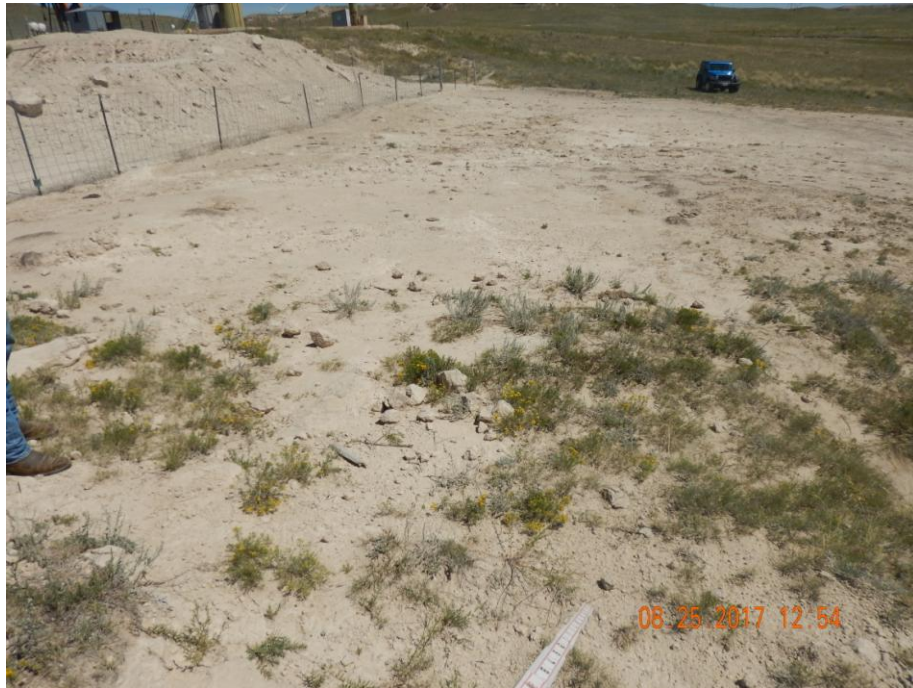
Photo 44: Photo taken from the south end of the pit, facing east. Photo shows stormwater runoff from the location has caused erosion degradation on the adjacent lands. Erosion will need to be repaired and stabilized. Required BMPs will need to be installed and maintained in accordance to 1002.f to prevent further degradation. These areas will need to be re-vegetated/reclaimed. Soil testing is advised as contaminants may exist preventing vegetation from re-establishing.

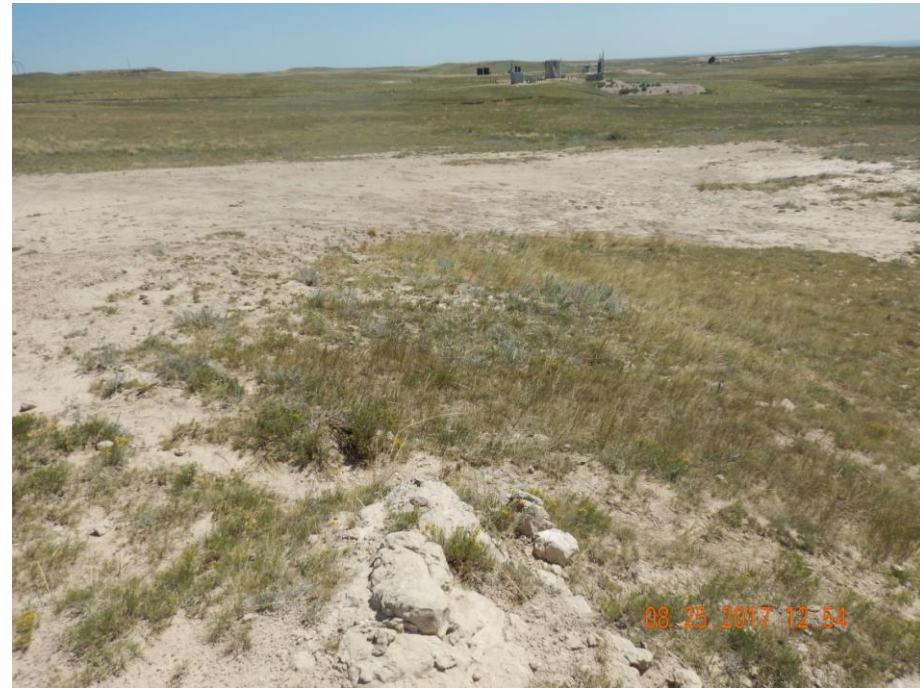
Photo 45: Photo taken from the south end of the pit, facing southeast. Photo shows stormwater runoff from the location has caused erosion degradation on the adjacent lands. Erosion will need to be repaired and stabilized. Required BMPs will need to be installed and maintained in accordance to 1002.f to prevent further degradation. These areas will need to be re-vegetated/reclaimed. Soil testing is advised as contaminants may exist preventing vegetation from re-establishing.

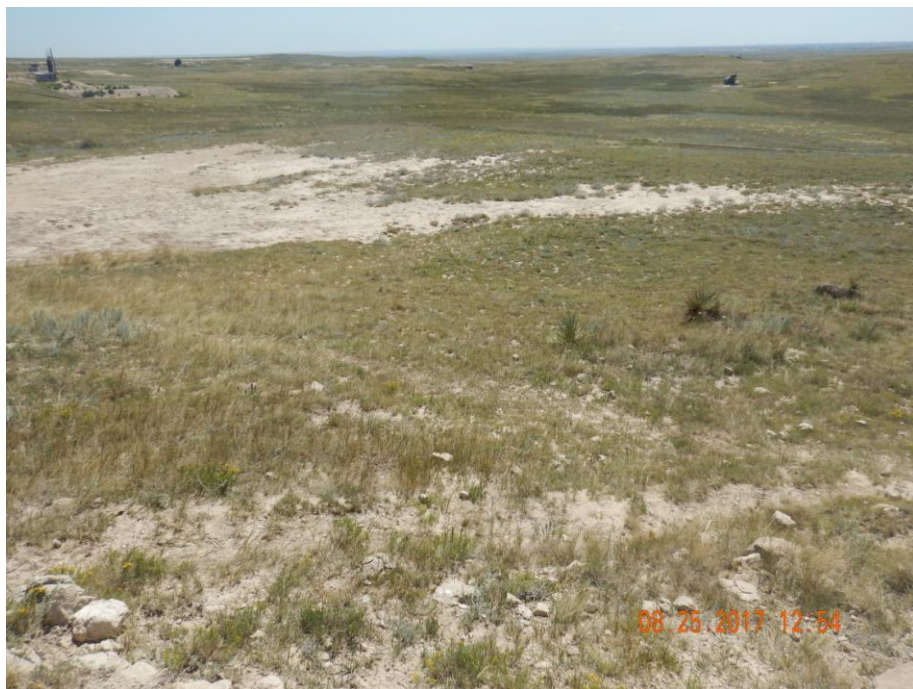
Photo 46: Photo taken from the south end of the pit, facing south. Photo shows stormwater runoff from the location has caused erosion degradation on the adjacent lands. Erosion will need to be repaired and stabilized. Required BMPs will need to be installed and maintained in accordance to 1002.f to prevent further degradation. These areas will need to be re-vegetated/reclaimed. Soil testing is advised as contaminants may exist preventing vegetation from re-establishing.

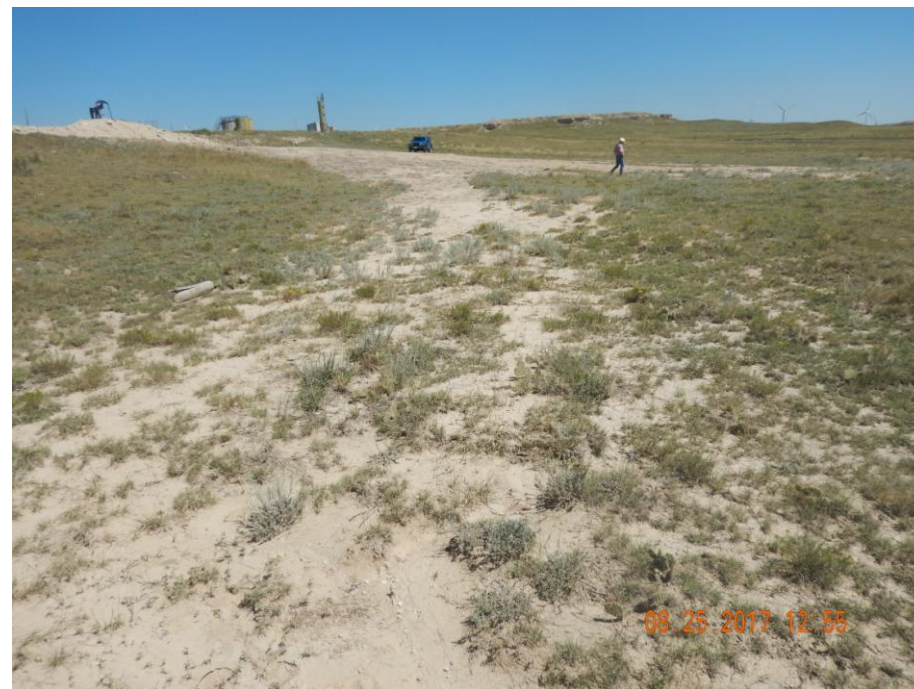
Photo 47: Photo taken from the south and west end of the pit, facing northeast. Photo shows stormwater runoff from the location has caused erosion degradation on the adjacent lands. Erosion will need to be repaired and stabilized. Required BMPs will need to be installed and maintained in accordance to 1002.f to prevent further degradation. These areas will need to be re-vegetated/reclaimed. Soil testing is advised as contaminants may exist preventing vegetation from re-establishing.

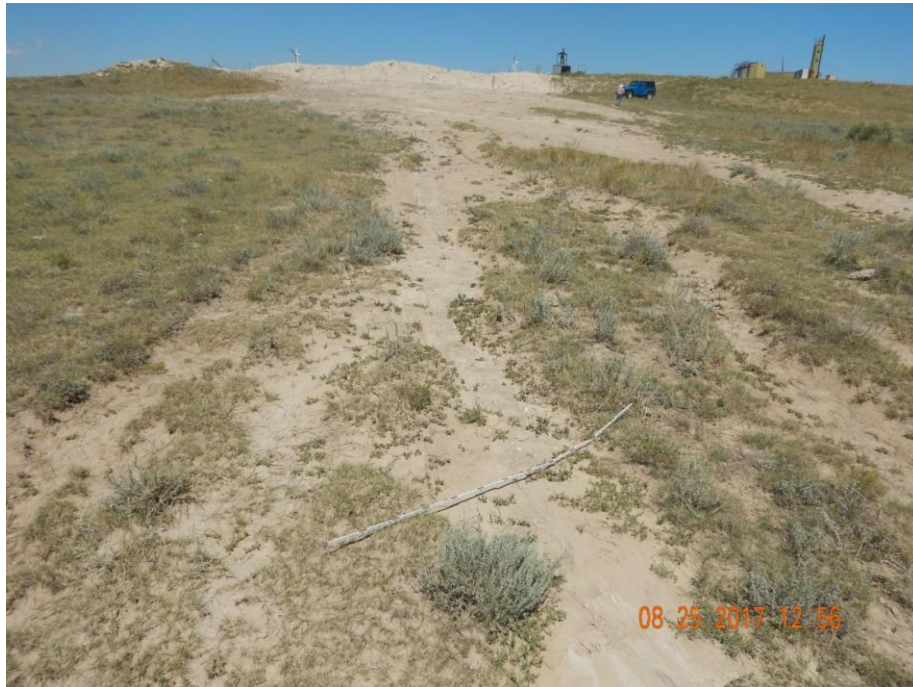
Photo 48: Photo taken from the south of the pit, facing north. Photo shows stormwater runoff from the location has caused erosion degradation on the adjacent lands. Erosion will need to be repaired and stabilized. Required BMPs will need to be installed and maintained in accordance to 1002.f to prevent further degradation. These areas will need to be re-vegetated/reclaimed. Soil testing is advised as contaminants may exist preventing vegetation from re-establishing. 6 foot measuring stick for reference.

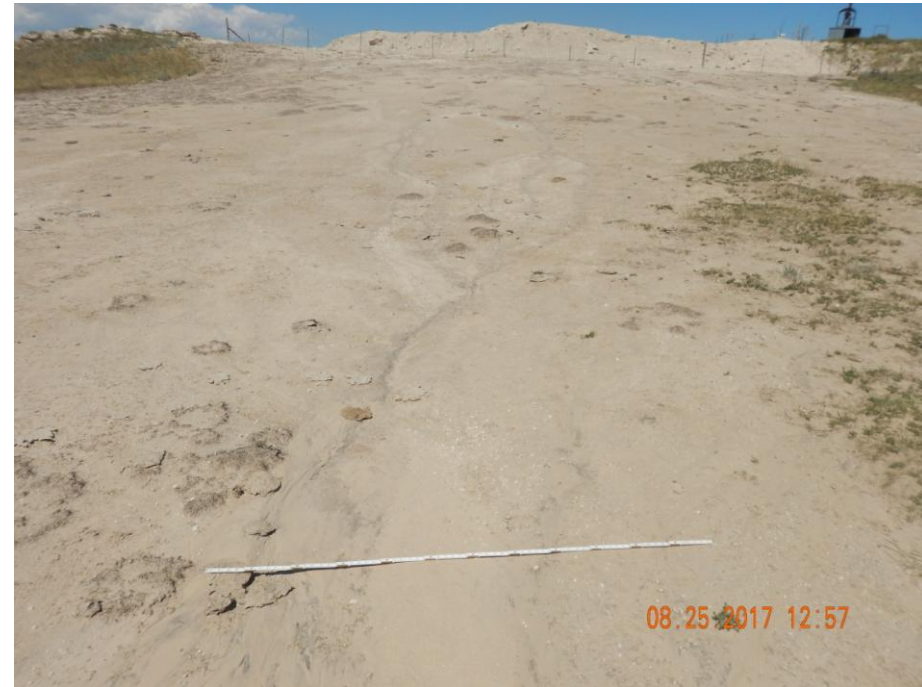
Photo 49: Photo taken from the south of the pit, facing north. Photo shows stormwater runoff from the location has caused erosion degradation on the adjacent lands. Erosion will need to be repaired and stabilized. Required BMPs will need to be installed and maintained in accordance to 1002.f to prevent further degradation. These areas will need to be re-vegetated/reclaimed. Soil testing is advised as contaminants may exist preventing vegetation from re-establishing. 6 foot measuring stick for reference.

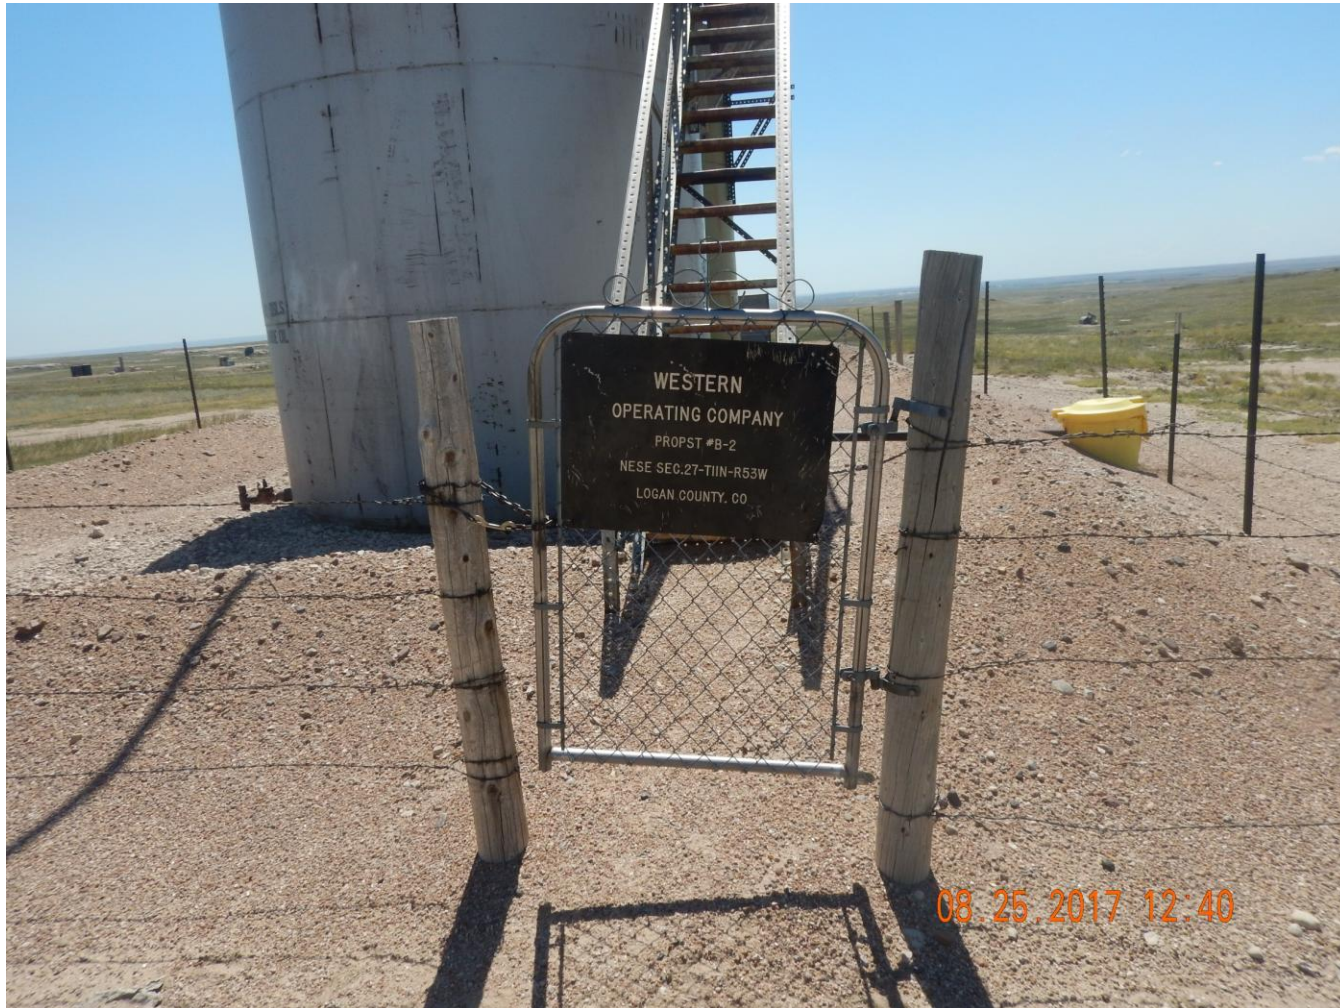
Photo 50: Photo of sign at the battery on the east end of the location. No sign at the well. Emergency contact information missing from location.
