Inspection Photos

Operator: WESTERN OPERATING COMPANY -
95620

Location ID: 312291

Inspection Doc. Number: 675103910

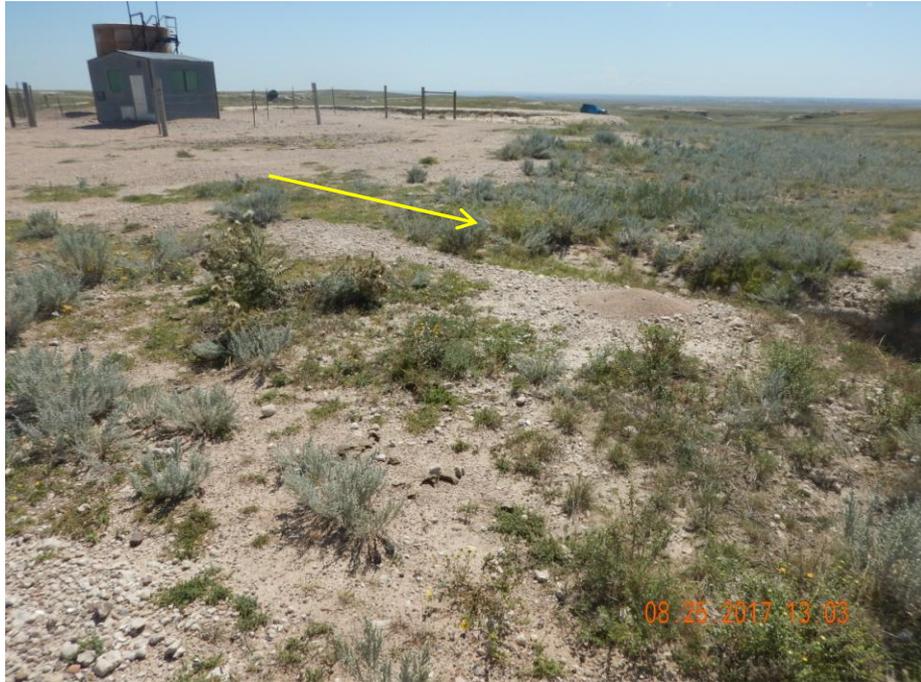
Photo 2: Photo taken from the west end of the location, facing south. Photo shows gully formation on the west end of the location.

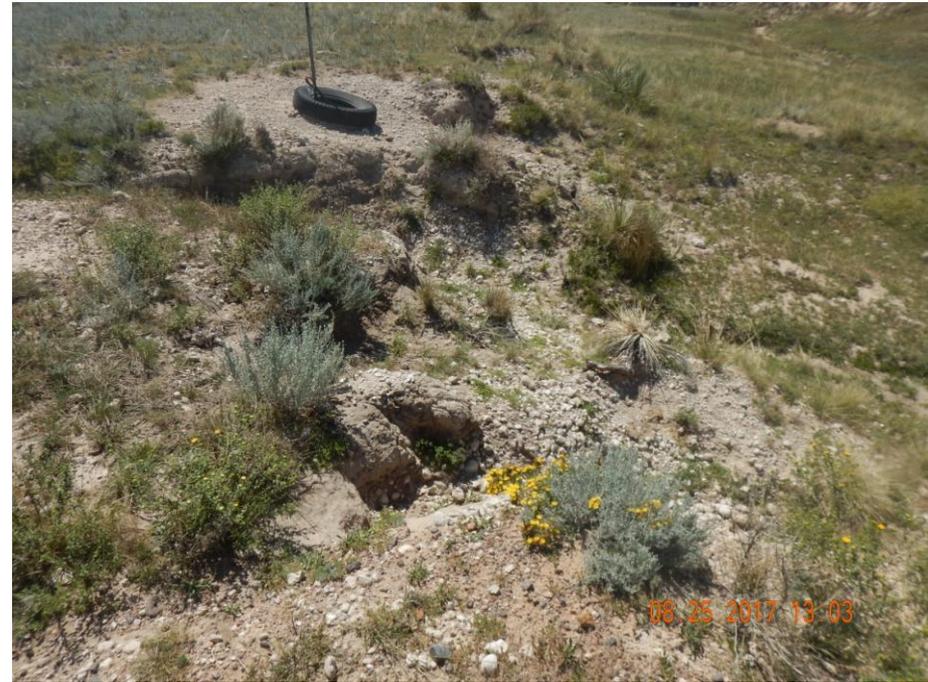
Photo 3: Photo taken from the west end of the location, facing south. Photo shows gully formation on the west end of the location.

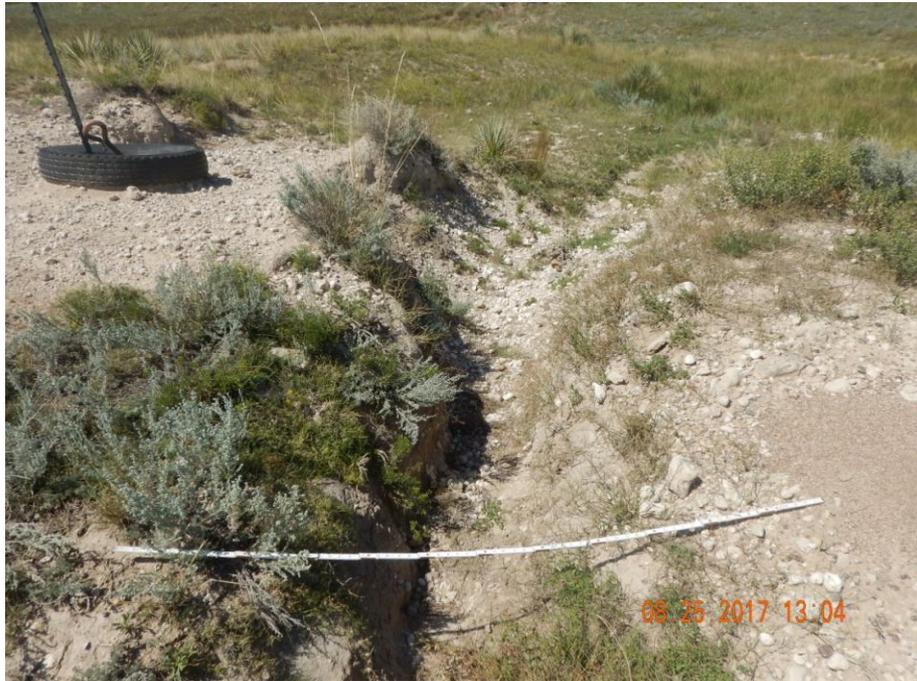
Photo 4: Photo taken from the west end of the location, facing west. Photo shows gully formation due to stormwater erosion from the location. Erosion will need to be repaired and stabilized. Required BMPs will need to be installed and maintained in accordance to 1002.f to prevent further degradation. 6 foot measuring stick for reference.

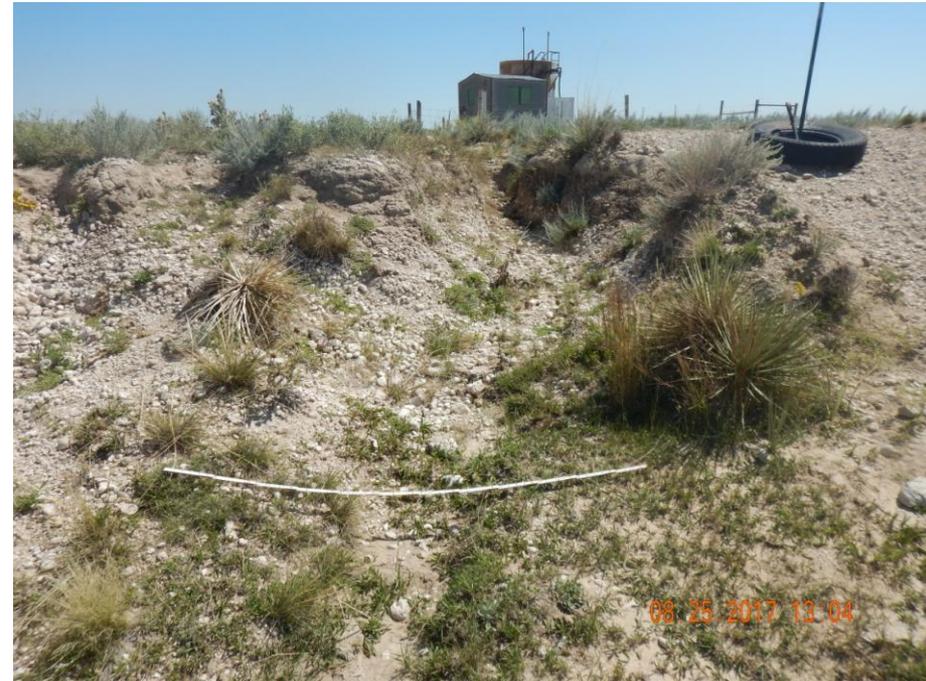
Photo 5: Photo taken from the west end of the location, facing east. Photo shows gully formation due to stormwater erosion from the location. Erosion will need to be repaired and stabilized. Required BMPs will need to be installed and maintained in accordance to 1002.f to prevent further degradation. 6 foot measuring stick for reference.

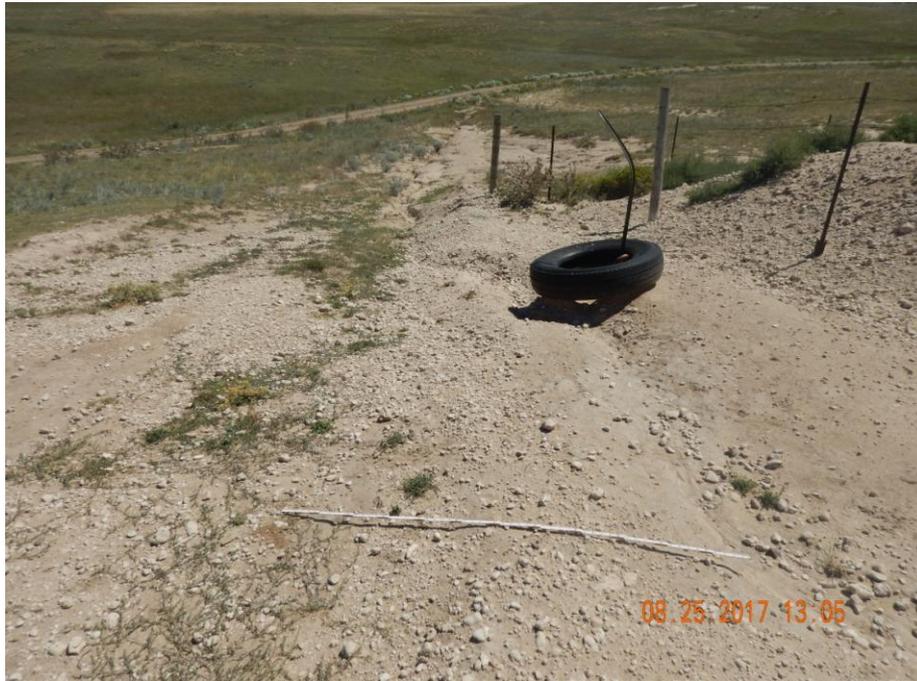
Photo 6: Photo taken on the east end of the location, facing east. Photo shows degradation on location due to stormwater erosion. Erosion will need to be repaired and stabilized. Required BMPs will need to be installed and maintained in accordance to 1002.f to prevent further degradation. These areas will need to be re-vegetated/reclaimed. Soil testing is advised as contaminants may exist preventing vegetation from re-establishing. 6 foot measuring stick for reference.

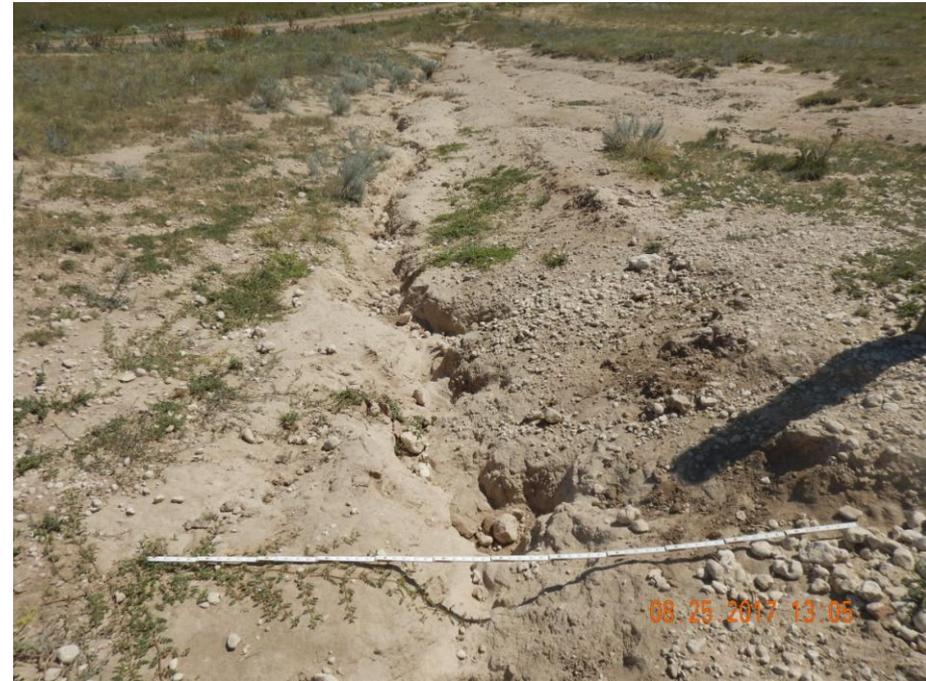
Photo 7: Photo taken from the northeast of pit/location, facing east. Photo shows stormwater runoff from the location has caused erosion degradation on the adjacent lands. Erosion will need to be repaired and stabilized. Required BMPs will need to be installed and maintained in accordance to 1002.f to prevent further degradation. These areas will need to be re-vegetated/reclaimed. Soil testing is advised as contaminants may exist preventing vegetation from re-establishing.

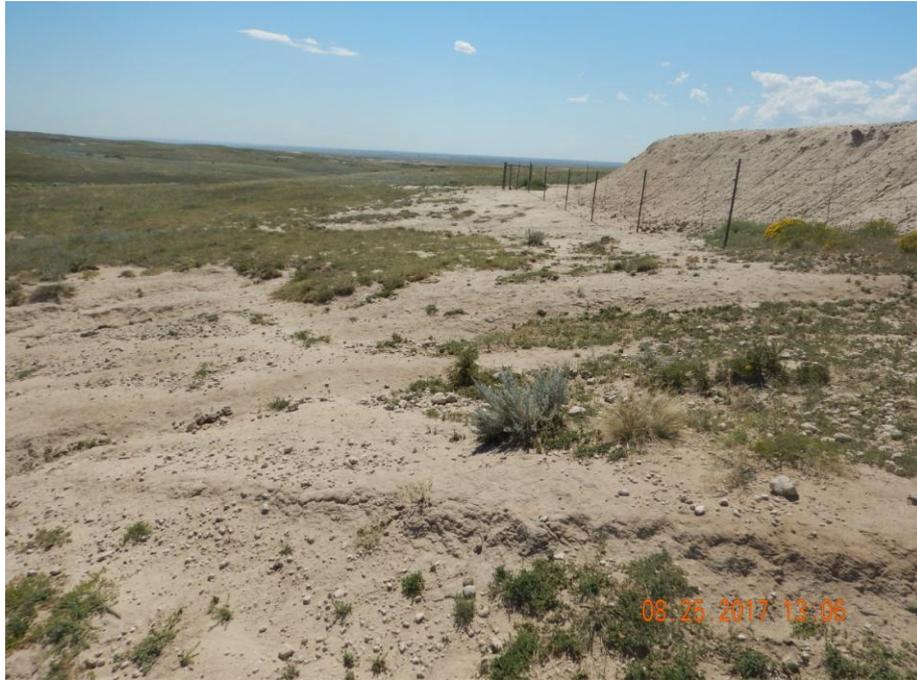
Photo 8: Photo taken on the east end of the location, facing south. Photo shows stormwater runoff from the location has caused erosion degradation on the adjacent lands. Erosion will need to be repaired and stabilized. Required BMPs will need to be installed and maintained in accordance to 1002.f to prevent further degradation. These areas will need to be re-vegetated/reclaimed. Soil testing is advised as contaminants may exist preventing vegetation from re-establishing.

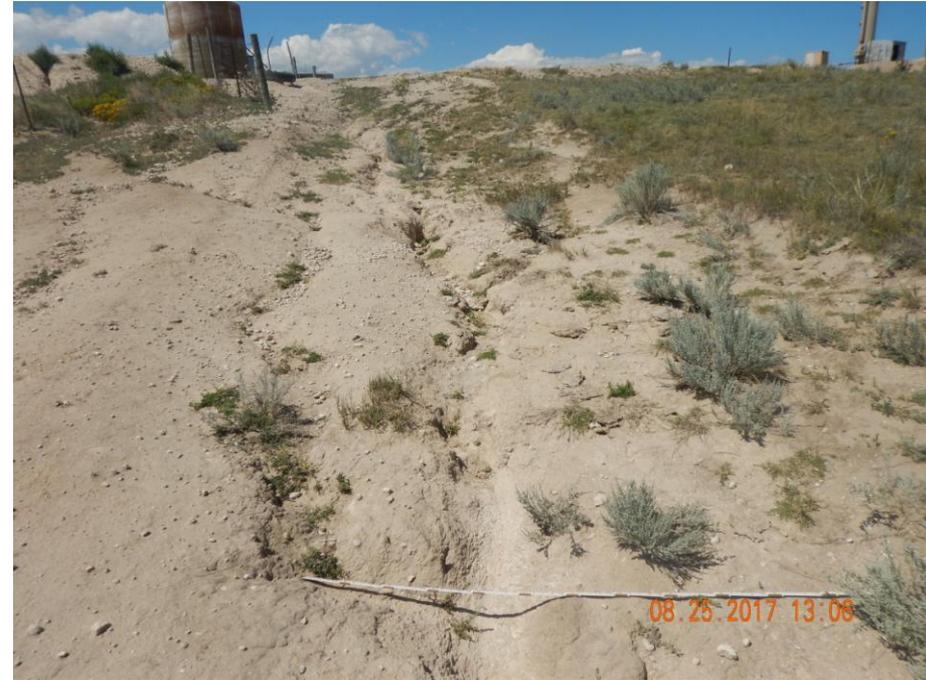
Photo 9: Photo taken east of the location, facing west. Photo shows stormwater runoff from the location has caused erosion degradation on the adjacent lands. Erosion will need to be repaired and stabilized. Required BMPs will need to be installed and maintained in accordance to 1002.f to prevent further degradation. These areas will need to be re-vegetated/reclaimed. Soil testing is advised as contaminants may exist preventing vegetation from re-establishing.

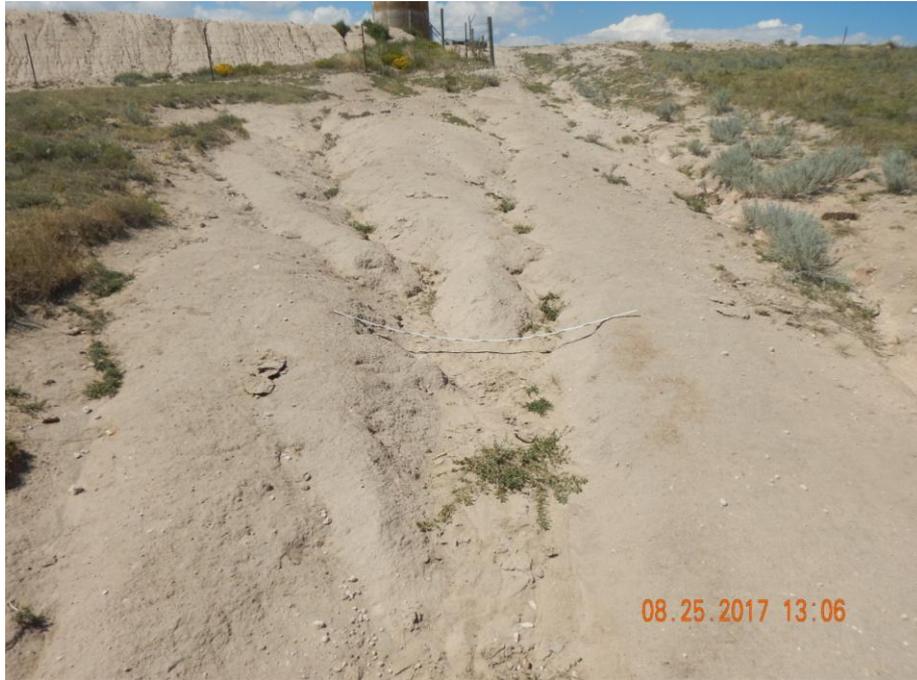
Photo 10: Photo taken east of the location, facing west. Photo shows stormwater runoff from the location has caused erosion degradation on the adjacent lands. Erosion will need to be repaired and stabilized. Required BMPs will need to be installed and maintained in accordance to 1002.f to prevent further degradation. These areas will need to be re-vegetated/reclaimed. Soil testing is advised as contaminants may exist preventing vegetation from re-establishing.

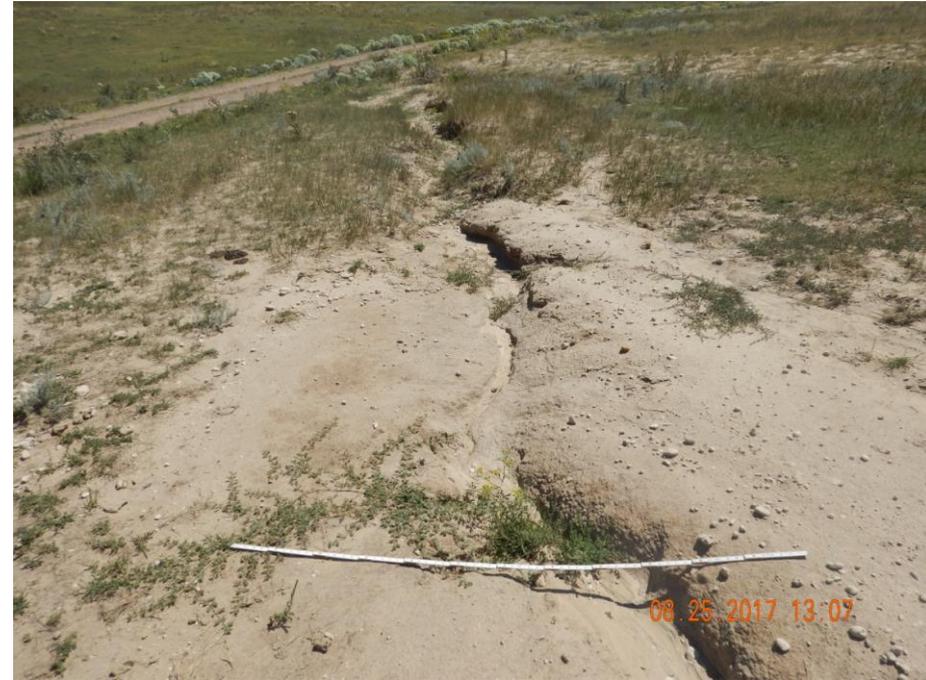
Photo 11: Photo taken east of the location, facing east. Photo shows stormwater runoff from the location has caused erosion degradation on the adjacent lands. Erosion will need to be repaired and stabilized. Required BMPs will need to be installed and maintained in accordance to 1002.f to prevent further degradation. These areas will need to be re-vegetated/reclaimed. Soil testing is advised as contaminants may exist preventing vegetation from re-establishing.

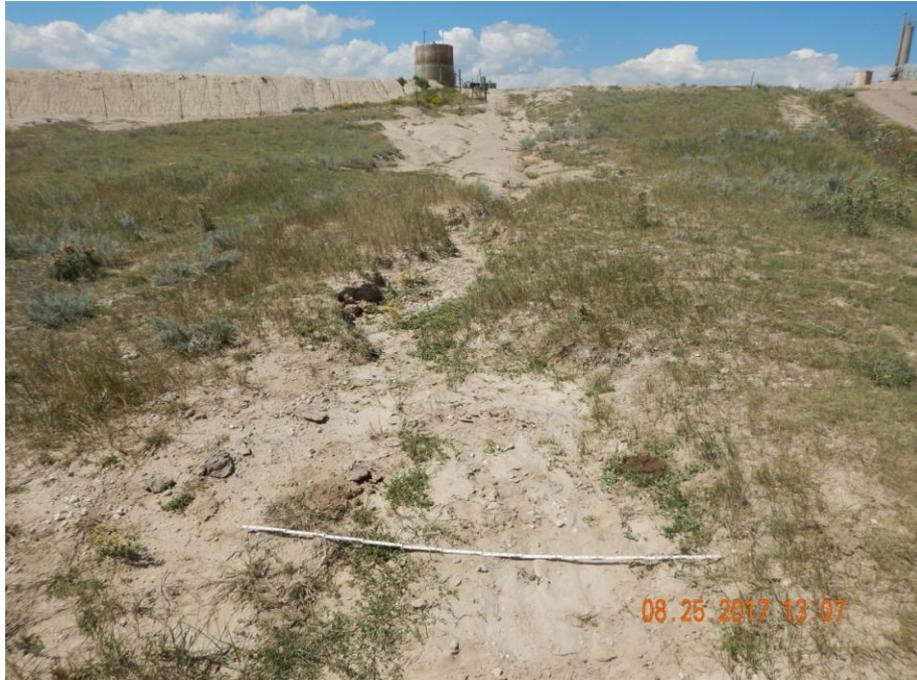
Photo 12: Photo taken east of the location, facing east. Photo shows stormwater runoff from the location has caused erosion degradation on the adjacent lands. Erosion will need to be repaired and stabilized. Required BMPs will need to be installed and maintained in accordance to 1002.f to prevent further degradation. These areas will need to be re-vegetated/reclaimed. Soil testing is advised as contaminants may exist preventing vegetation from re-establishing.

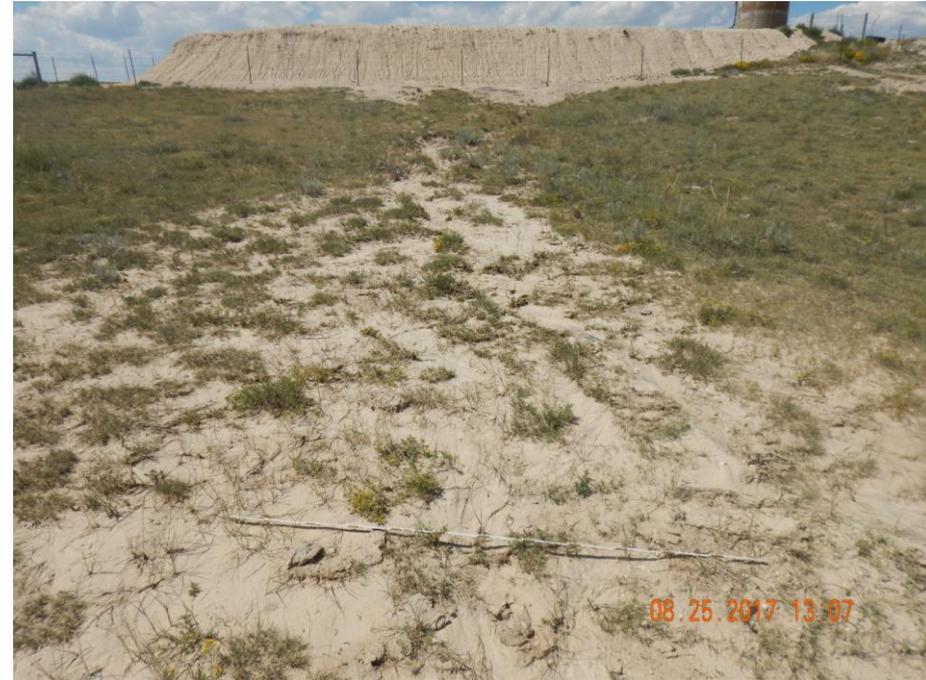
Photo 13: Photo taken east of the location, facing east. Photo shows stormwater runoff from the location has caused erosion degradation on the adjacent lands. Erosion will need to be repaired and stabilized. Required BMPs will need to be installed and maintained in accordance to 1002.f to prevent further degradation. These areas will need to be re-vegetated/reclaimed. Soil testing is advised as contaminants may exist preventing vegetation from re-establishing.

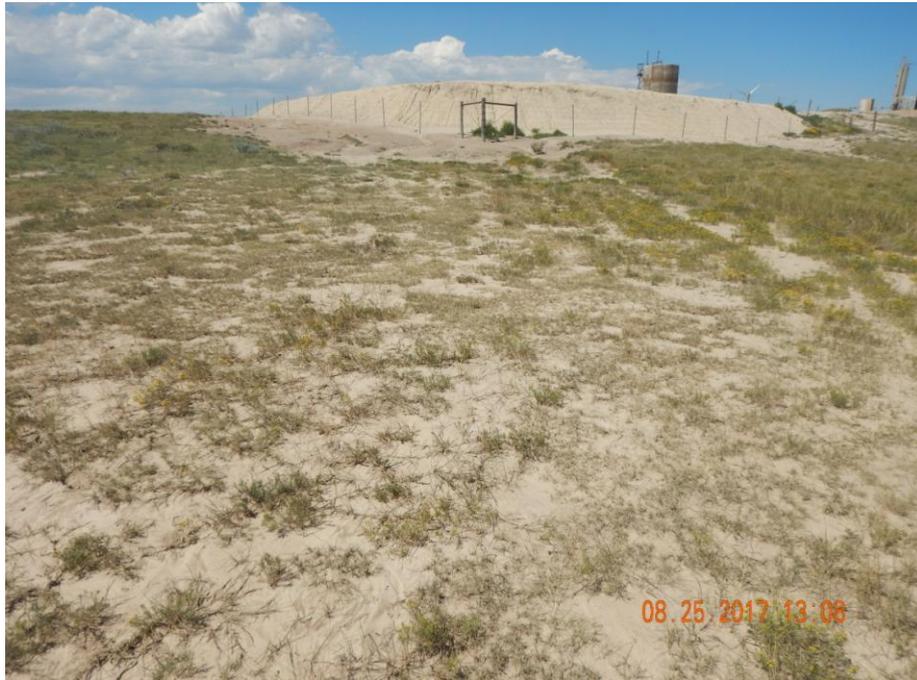
Photo 14: Photo taken southeast of the location, facing northwest. Photo shows stormwater runoff from the location has caused erosion degradation on the adjacent lands. Erosion will need to be repaired and stabilized. Required BMPs will need to be installed and maintained in accordance to 1002.f to prevent further degradation. These areas will need to be re-vegetated/reclaimed. Soil testing is advised as contaminants may exist preventing vegetation from re-establishing.

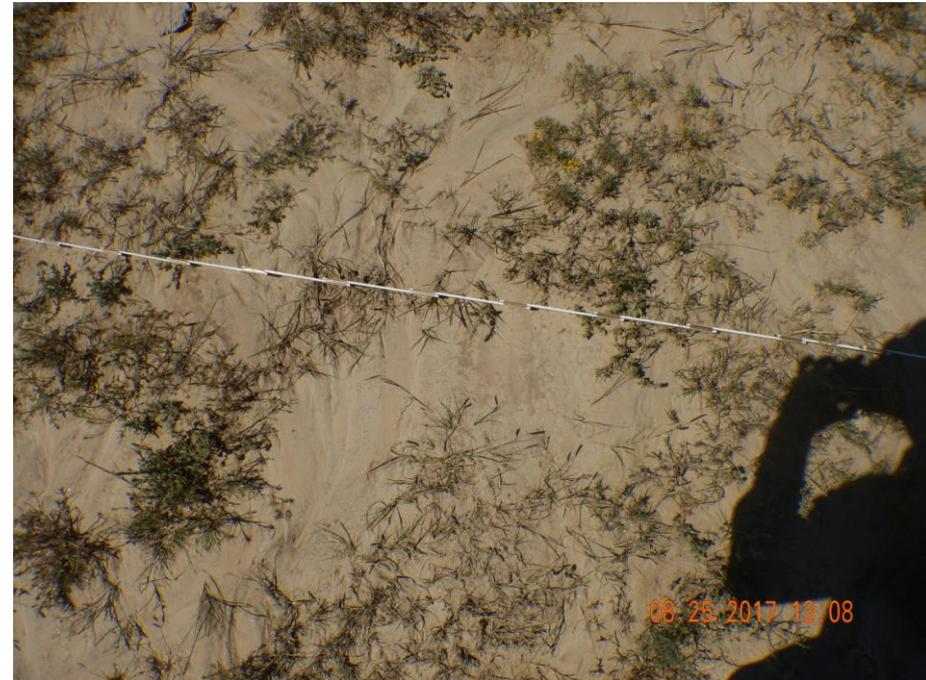
Photo 15: Photo taken from the southeast of the location. Photo shows sediment deposition from sediment laden stormwater runoff coming from the location. Deposition has degraded the vegetation in the adjacent areas. 6 foot measuring stick for reference.

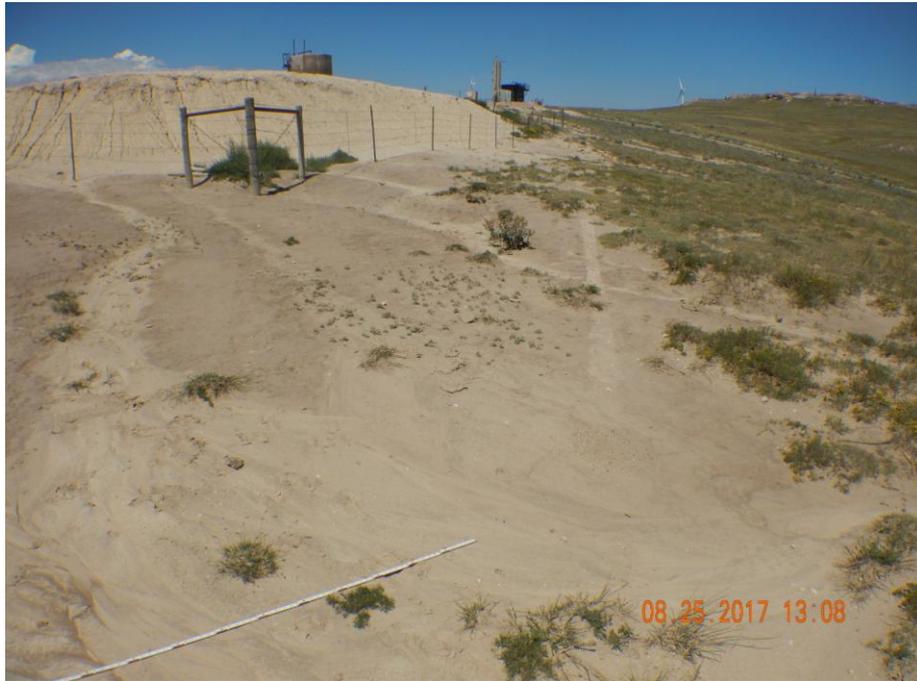
Photo 16: Photo taken from the southeast end of the pit, facing north. Photo shows stormwater runoff from the location has caused erosion degradation on the adjacent lands. Erosion will need to be repaired and stabilized. Required BMPs will need to be installed and maintained in accordance to 1002.f to prevent further degradation. These areas will need to be re-vegetated/reclaimed. Soil testing is advised as contaminants may exist preventing vegetation from re-establishing.

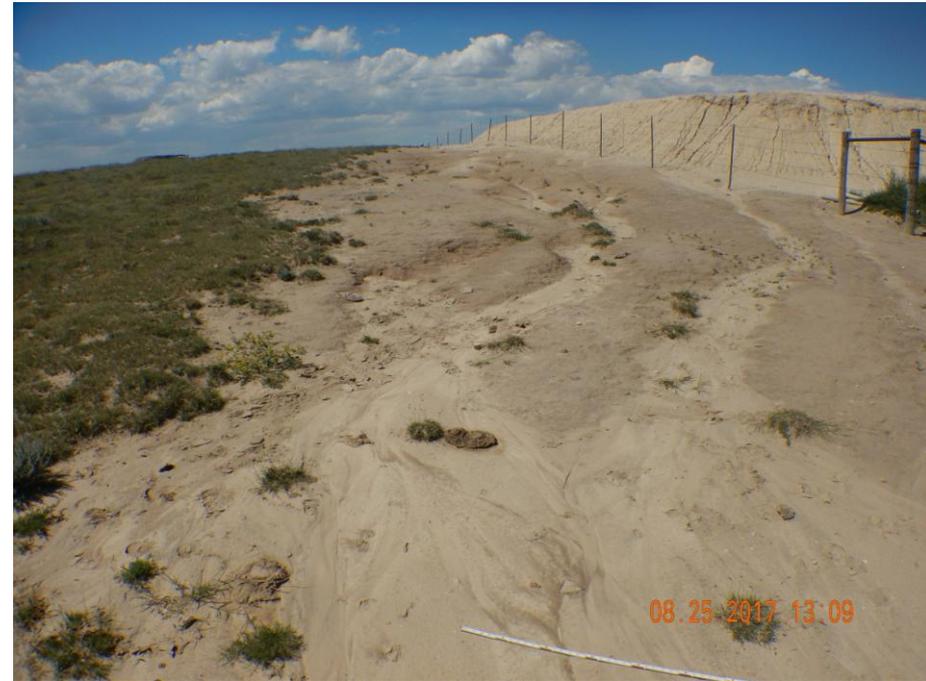
Photo 17: Photo taken from the southeast end of the pit, facing north. Photo shows stormwater runoff from the location has caused erosion degradation on the adjacent lands. Erosion will need to be repaired and stabilized. Required BMPs will need to be installed and maintained in accordance to 1002.f to prevent further degradation. These areas will need to be re-vegetated/reclaimed. Soil testing is advised as contaminants may exist preventing vegetation from re-establishing.

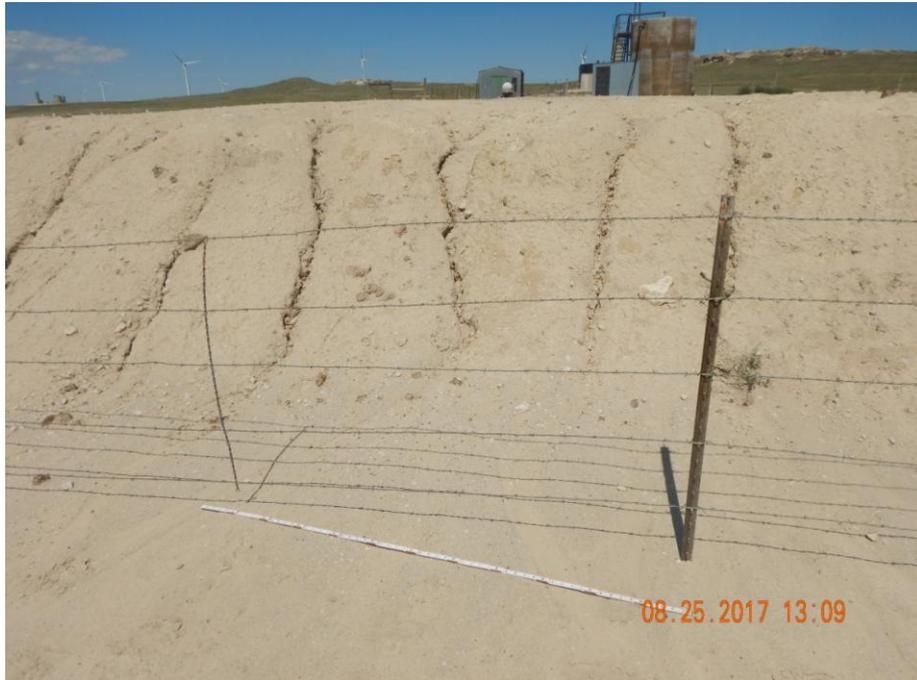
Photo 18: Photo taken on the south end of the pit. Photo shows rill erosion formations on the berms of the pit caused by stormwater.

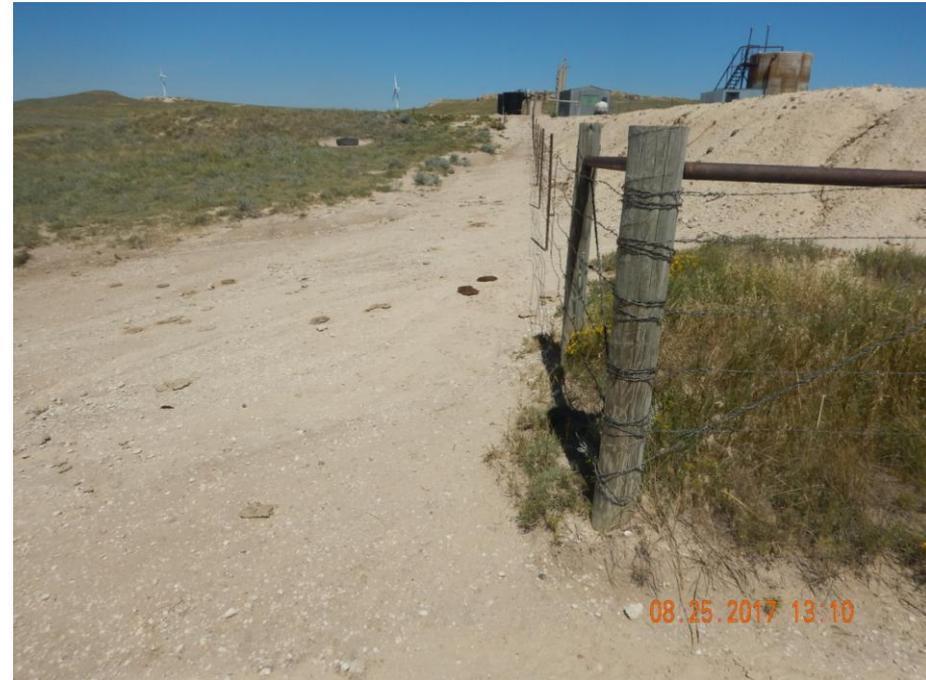
Photo 19: Photo taken on the south end of the location, facing northeast. Photo shows stormwater runoff from the location has caused erosion degradation on the adjacent lands. Erosion will need to be repaired and stabilized. Required BMPs will need to be installed and maintained in accordance to 1002.f to prevent further degradation. These areas will need to be re-vegetated/reclaimed. Soil testing is advised as contaminants may exist preventing vegetation from re-establishing.

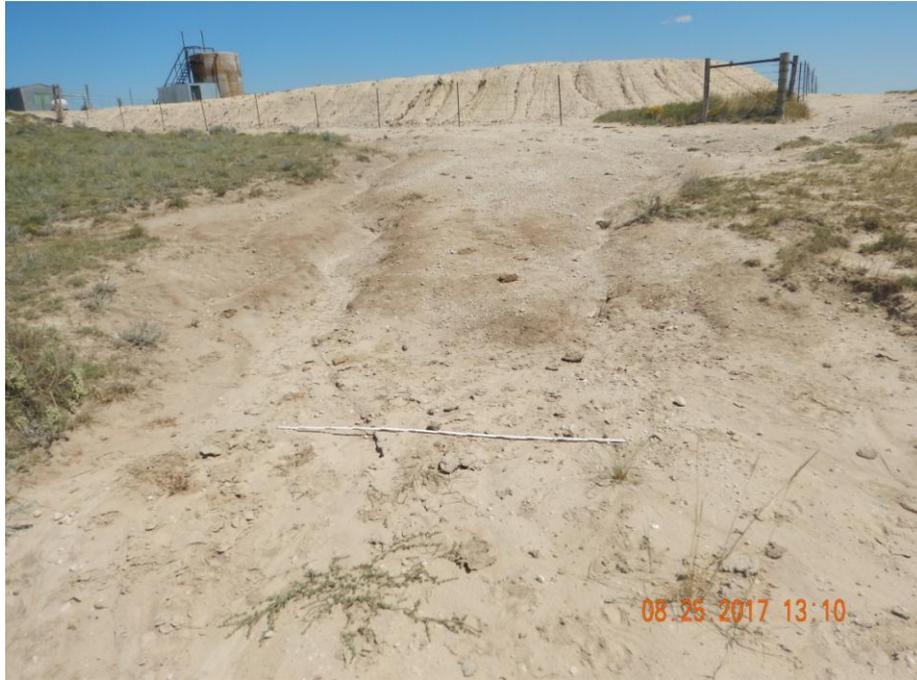
Photo 20: Photo taken from the southwest of the pit, facing northeast. Photo shows stormwater runoff from the location has caused erosion degradation on the adjacent lands. Erosion will need to be repaired and stabilized. Required BMPs will need to be installed and maintained in accordance to 1002.f to prevent further degradation. These areas will need to be re-vegetated/reclaimed. Soil testing is advised as contaminants may exist preventing vegetation from re-establishing.

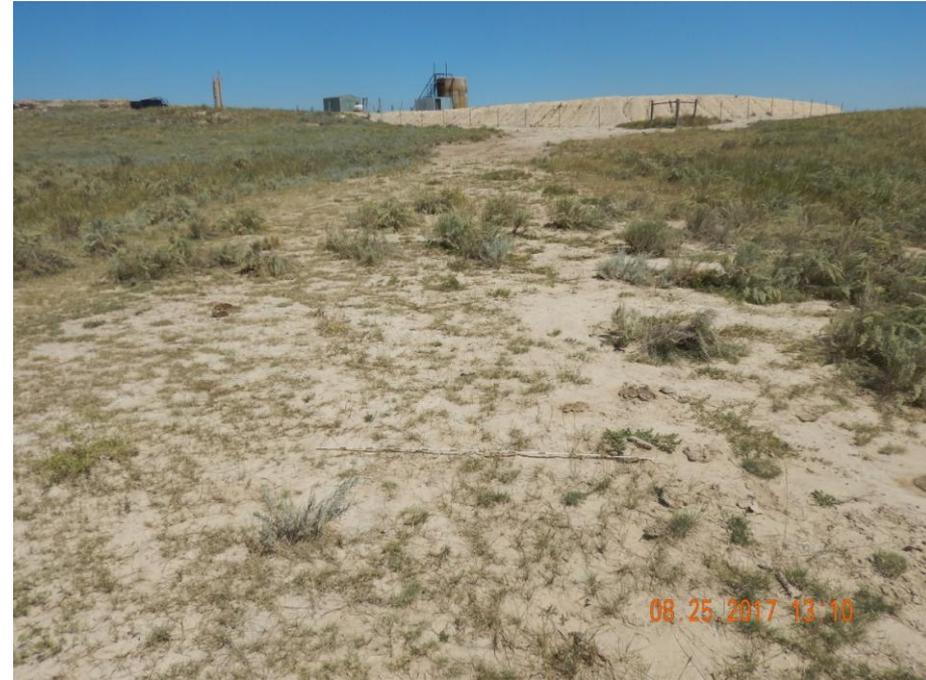
Photo 21: Photo taken from the southwest of the pit, facing northeast. Photo shows stormwater runoff from the location has caused erosion degradation on the adjacent lands. Erosion will need to be repaired and stabilized. Required BMPs will need to be installed and maintained in accordance to 1002.f to prevent further degradation. These areas will need to be re-vegetated/reclaimed. Soil testing is advised as contaminants may exist preventing vegetation from re-establishing.
