# Inspection Photos

Operator: NIGHTHAWK PRODUCTION LLC -  
10399

Location ID: 437624

Inspection Doc. Number: 675103920  
Lincoln County, CO

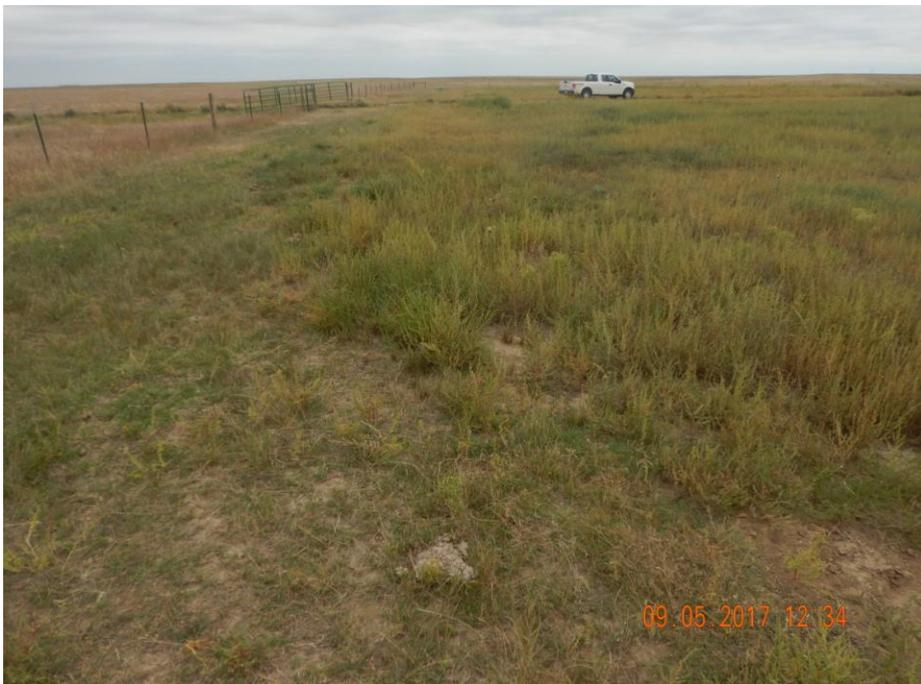
**Photo 1:** Photo taken from the northwest corner of the location, facing east. Photo shows vegetation over the reclamation area is predominantly undesirable weedy plant species and not reflective of the adjacent reference area. Well was PA'd 2014, at least three growing seasons have passed.

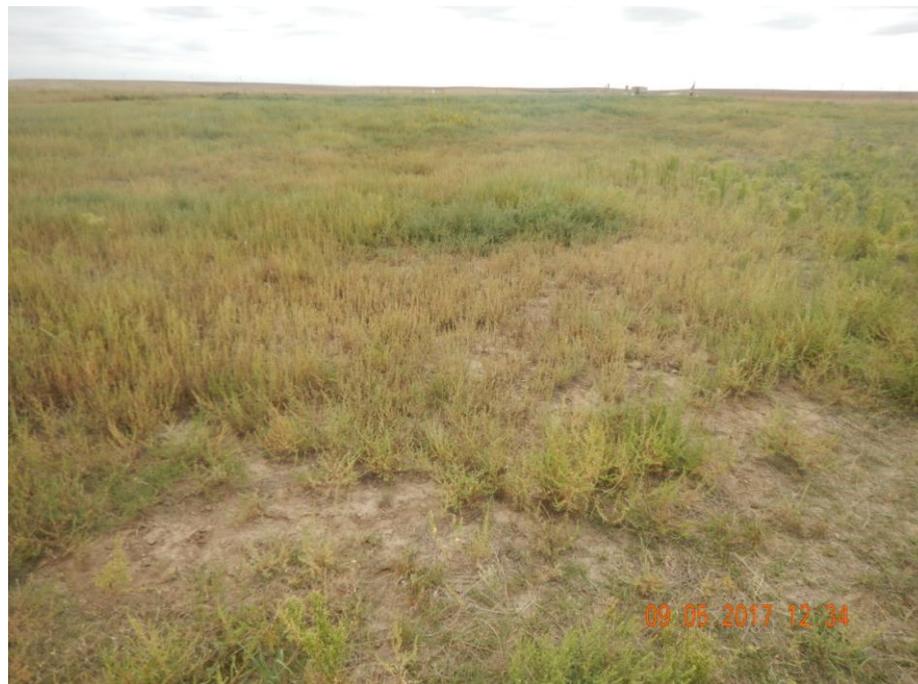
**Photo 2:** Photo taken from the northwest corner of the location, facing southeast. Photo shows vegetation over the reclamation area is predominantly undesirable weedy plant species and not reflective of the adjacent reference area. Well was PA'd 2014, at least three growing seasons have passed.

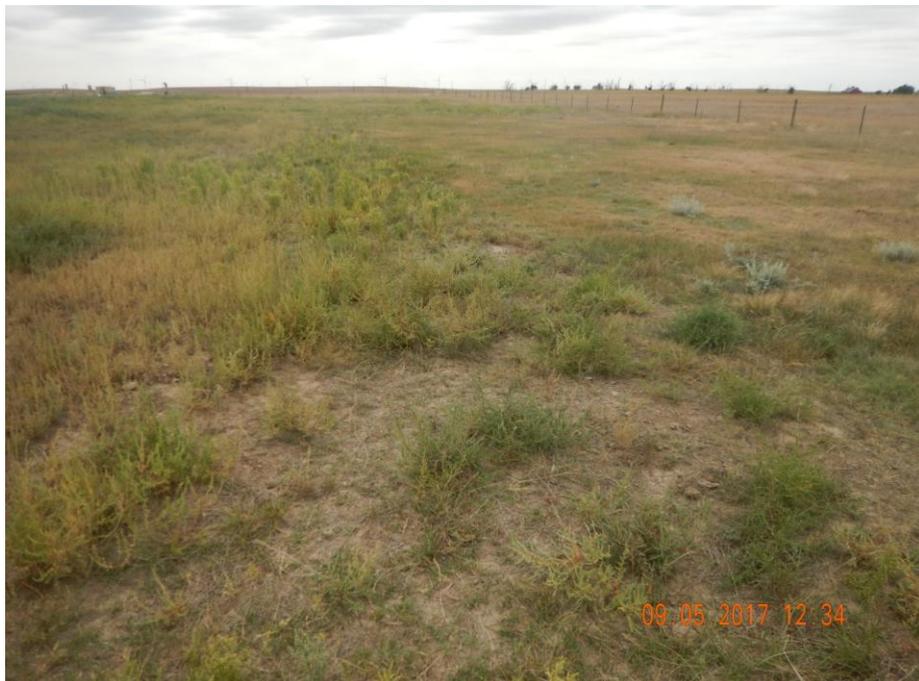
**Photo 3:** Photo taken from the northwest corner of the location, facing south. Photo shows vegetation over the reclamation area is predominantly undesirable weedy plant species and not reflective of the adjacent reference area. Well was PA'd 2014, at least three growing seasons have passed

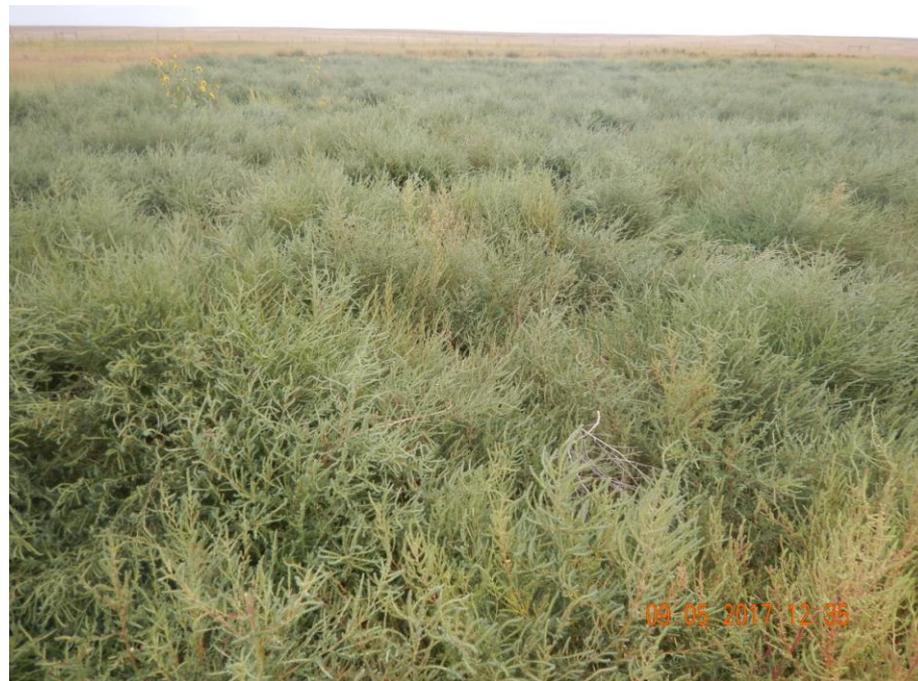
**Photo 4:** Photo taken from the central portion of the location, facing south. Photo shows vegetation over the reclamation area is predominantly undesirable weedy plant species and not reflective of the adjacent reference area. Well was PA'd 2014, at least three growing seasons have passed

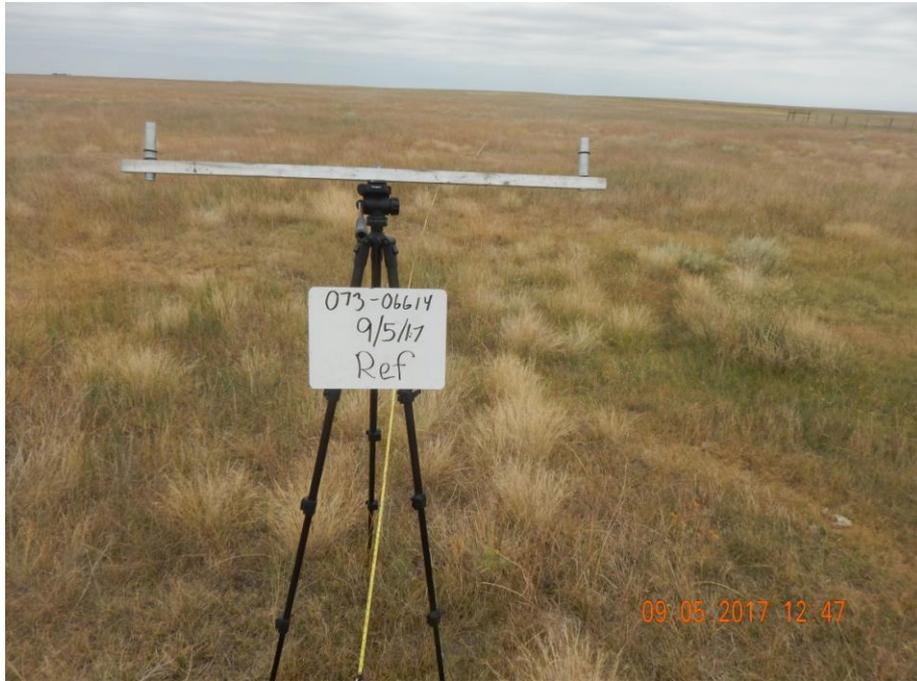
**Photo 5:** Photo taken from the adjacent reference area, facing east. Photo shows the start point for the reference area transect.

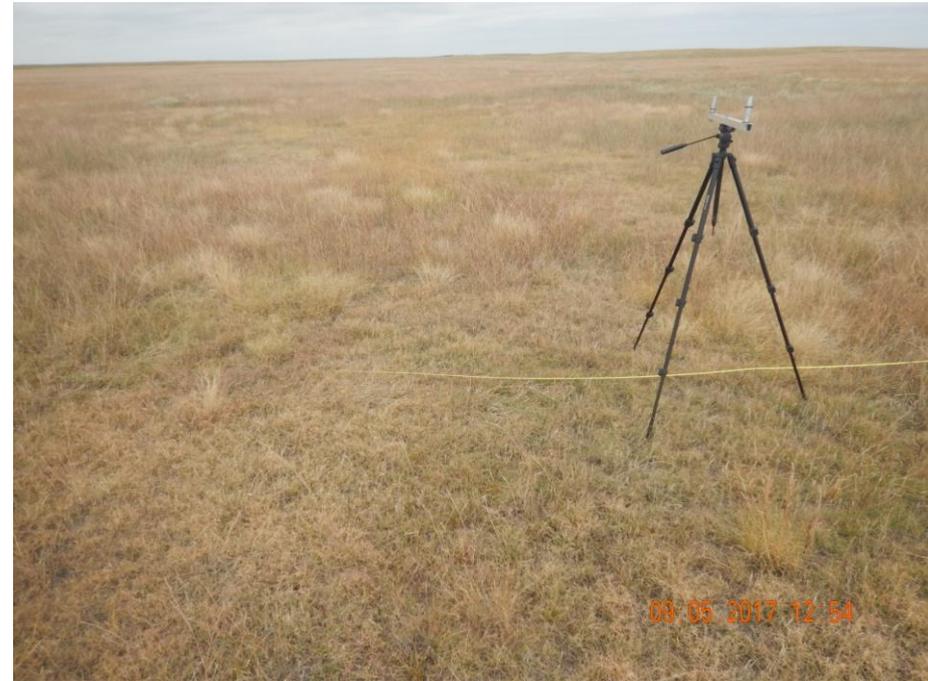
**Photo 6:** Photo shows vegetation at the 50th point of the reference area transect, facing north.

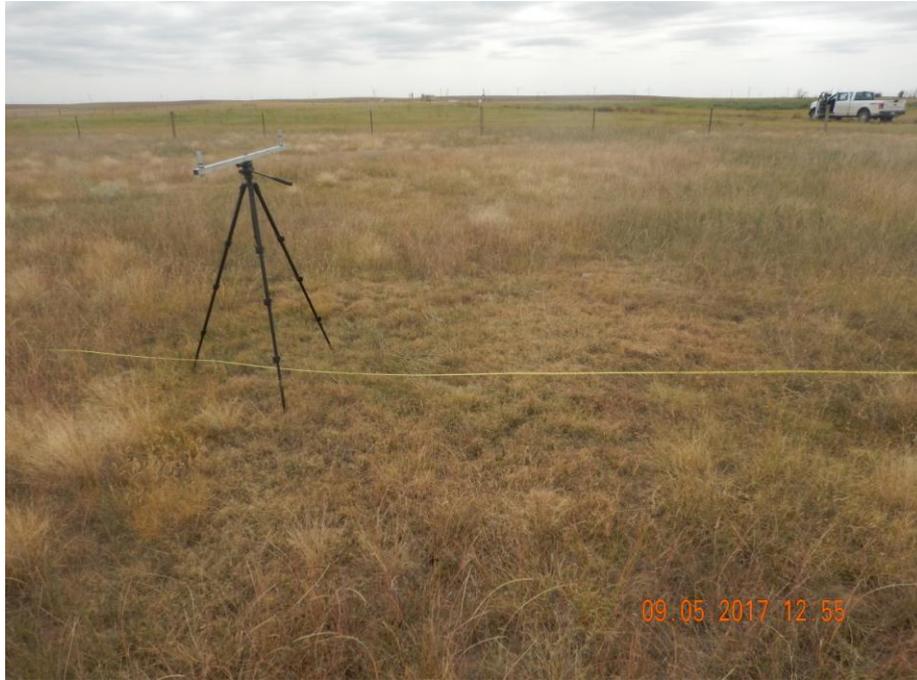
**Photo 7:** Photo shows vegetation at the 50th point of the reference area transect, facing south.

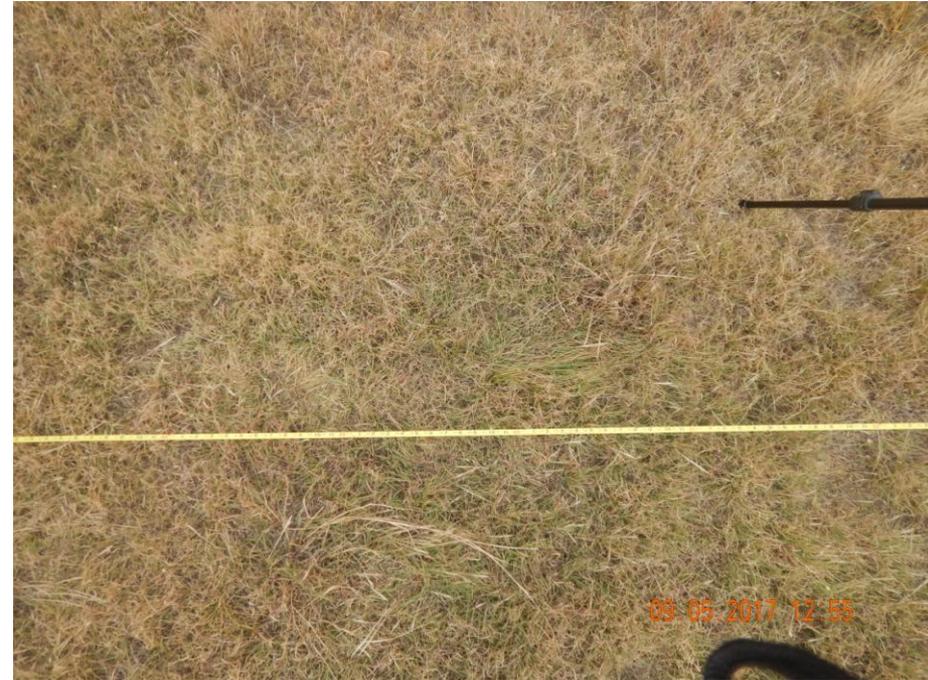
**Photo 8:** Photo shows vegetation at the 50th point of the reference area transect.

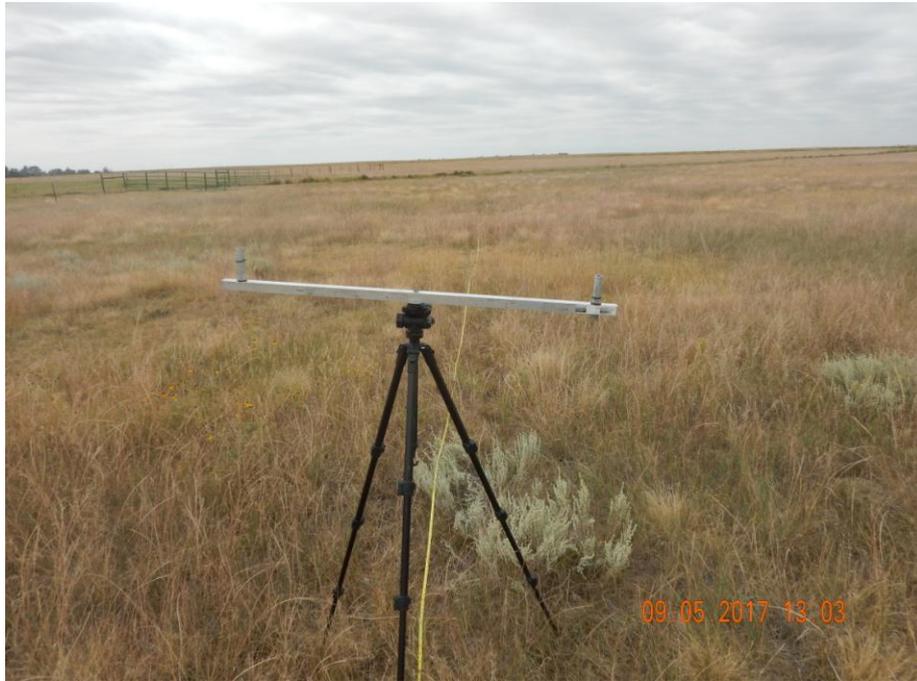
**Photo 9:** Photo taken from the adjacent reference area, facing west. Photo shows the end point for the reference area transect.

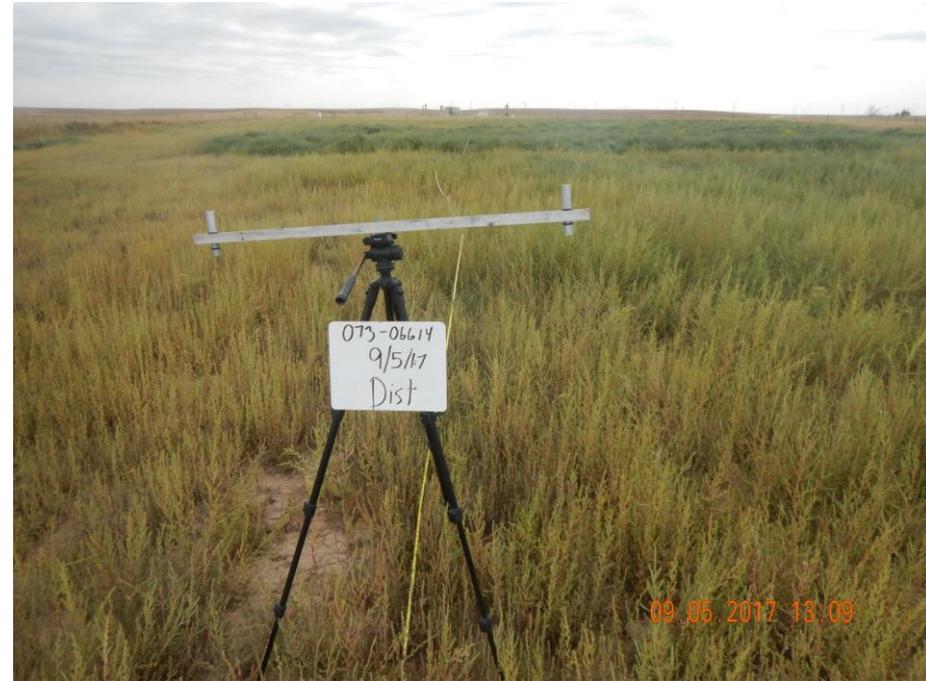
**Photo 10:** Photo taken from the location, facing south. Photo shows the start point for the disturbance area transect.

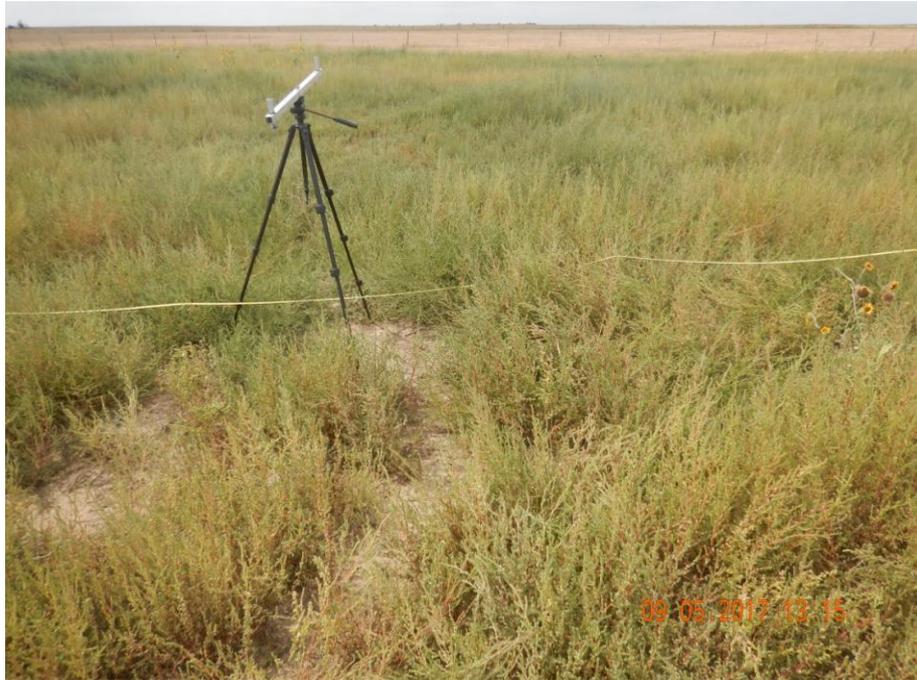
**Photo 11:** Photo shows vegetation at the 50th point of the disturbance area transect, facing west.

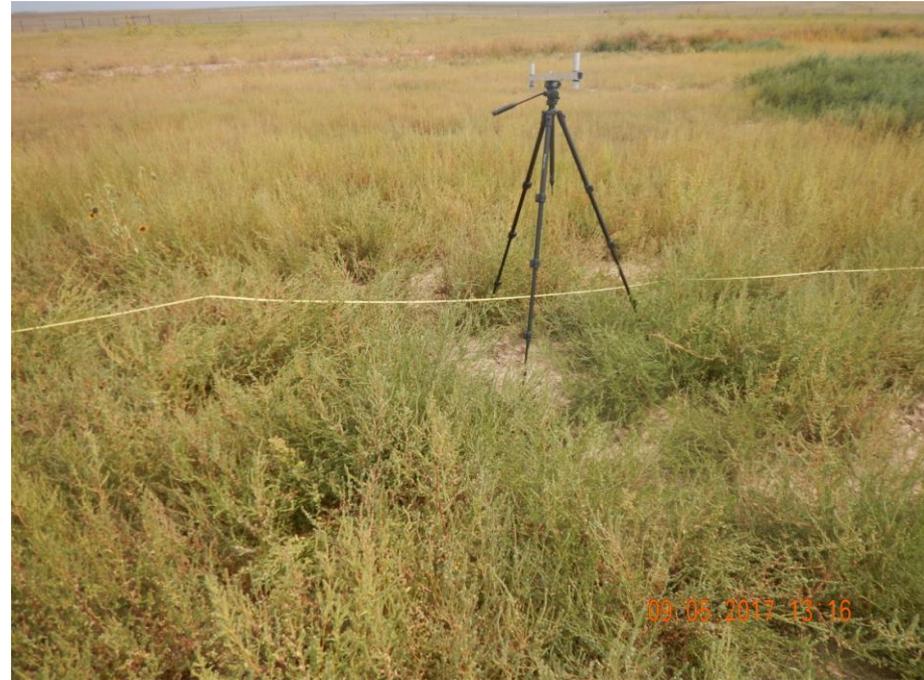
**Photo 12:** Photo shows vegetation at the 50th point of the disturbance area transect, facing east.

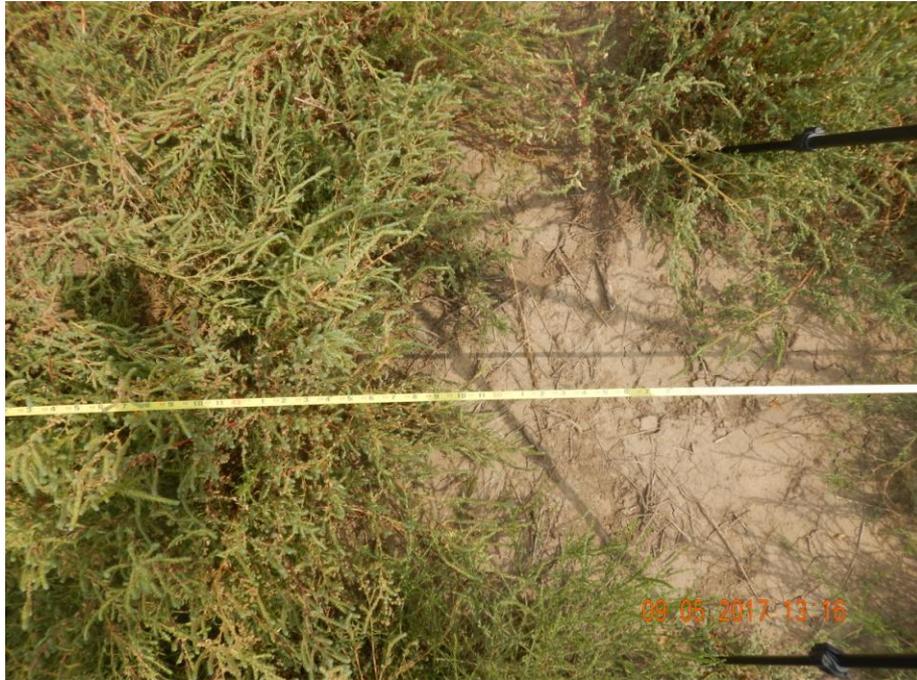
**Photo 13:** Photo shows vegetation at the 50th point of the disturbance area transect.

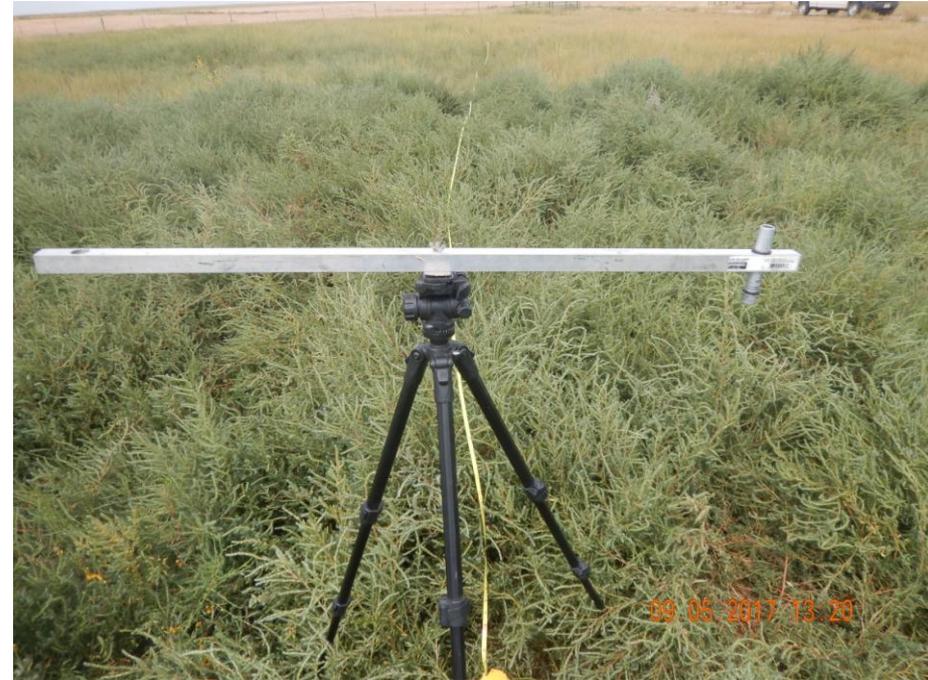
**Photo 14:** Photo taken from the disturbance area, facing north. Photo shows the end point for the disturbance area transect.
