Inspection Photos

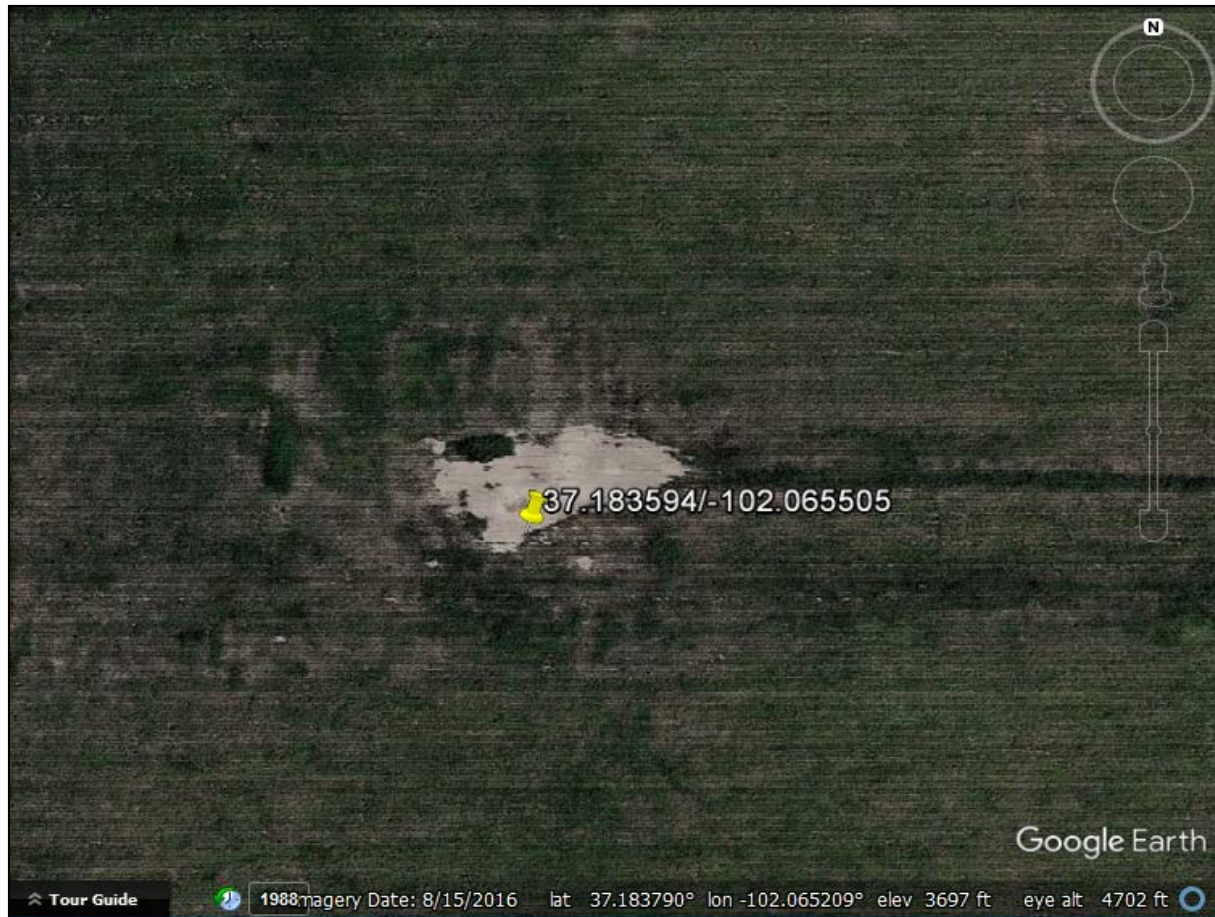
Photo 1. 2016 aerial imagery shows location of well site. There is no crop growth shown in an area approximately 250' x 100'.

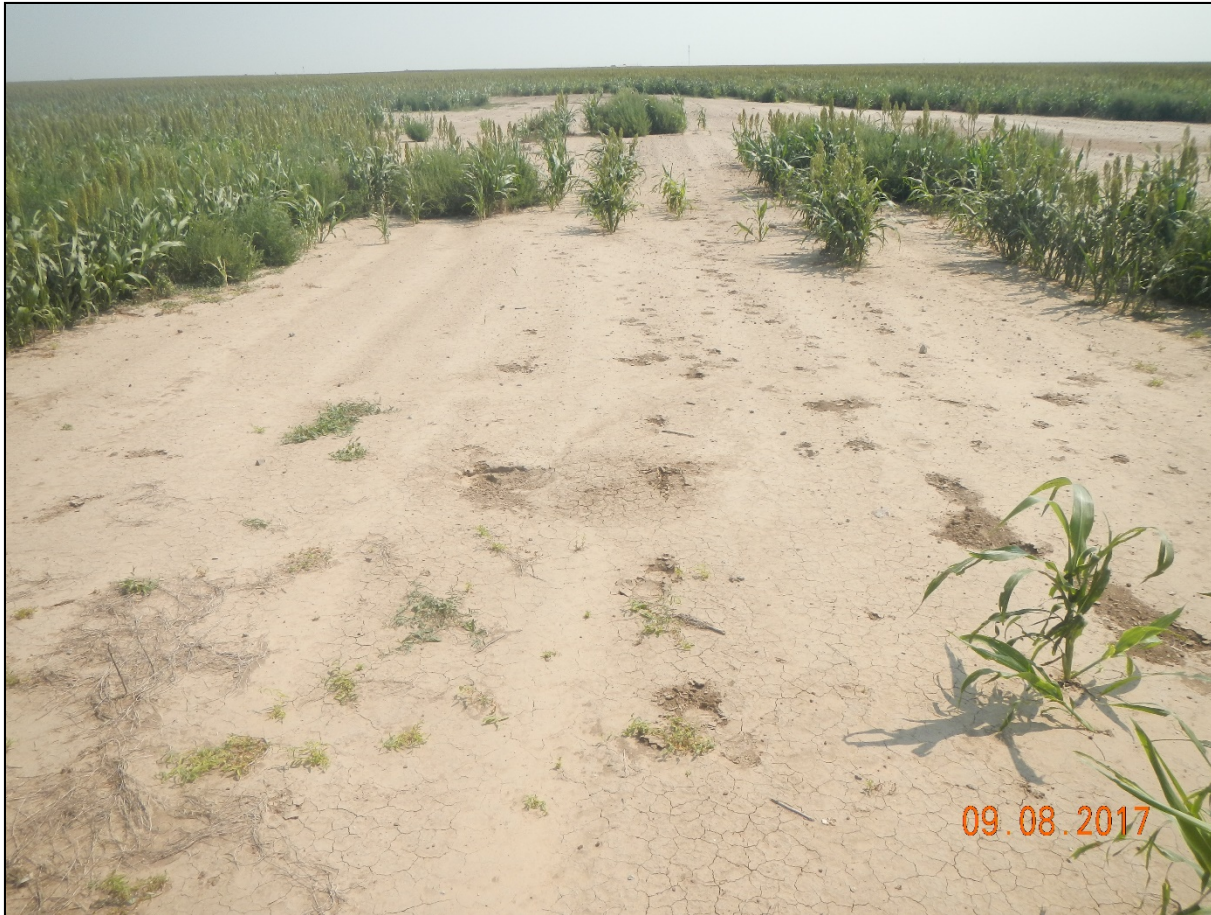
Photo 2. West side of the location facing east. There is a lack of crop growth at the location.

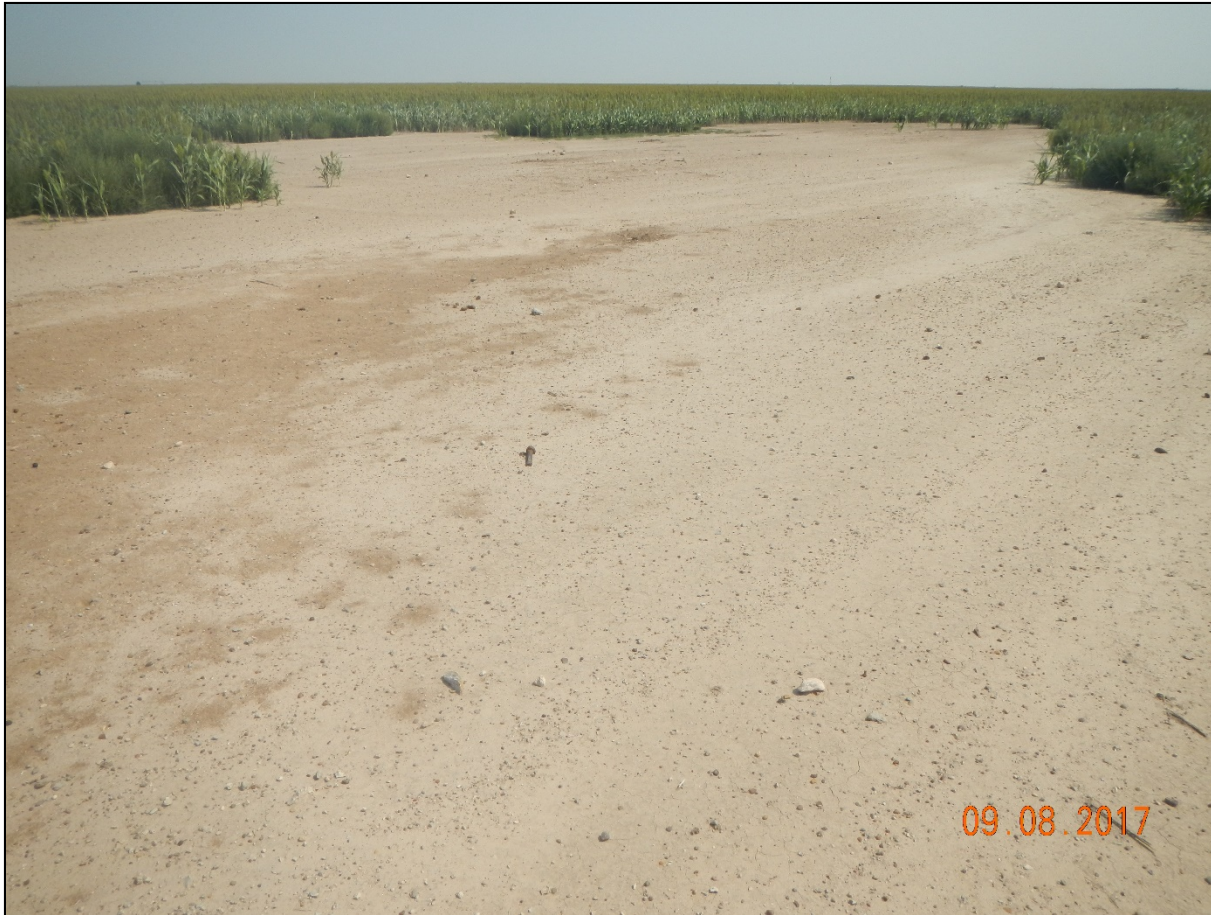
Photo 3. South side of the location facing northeast. There appears to be soil issues affecting crop growth.

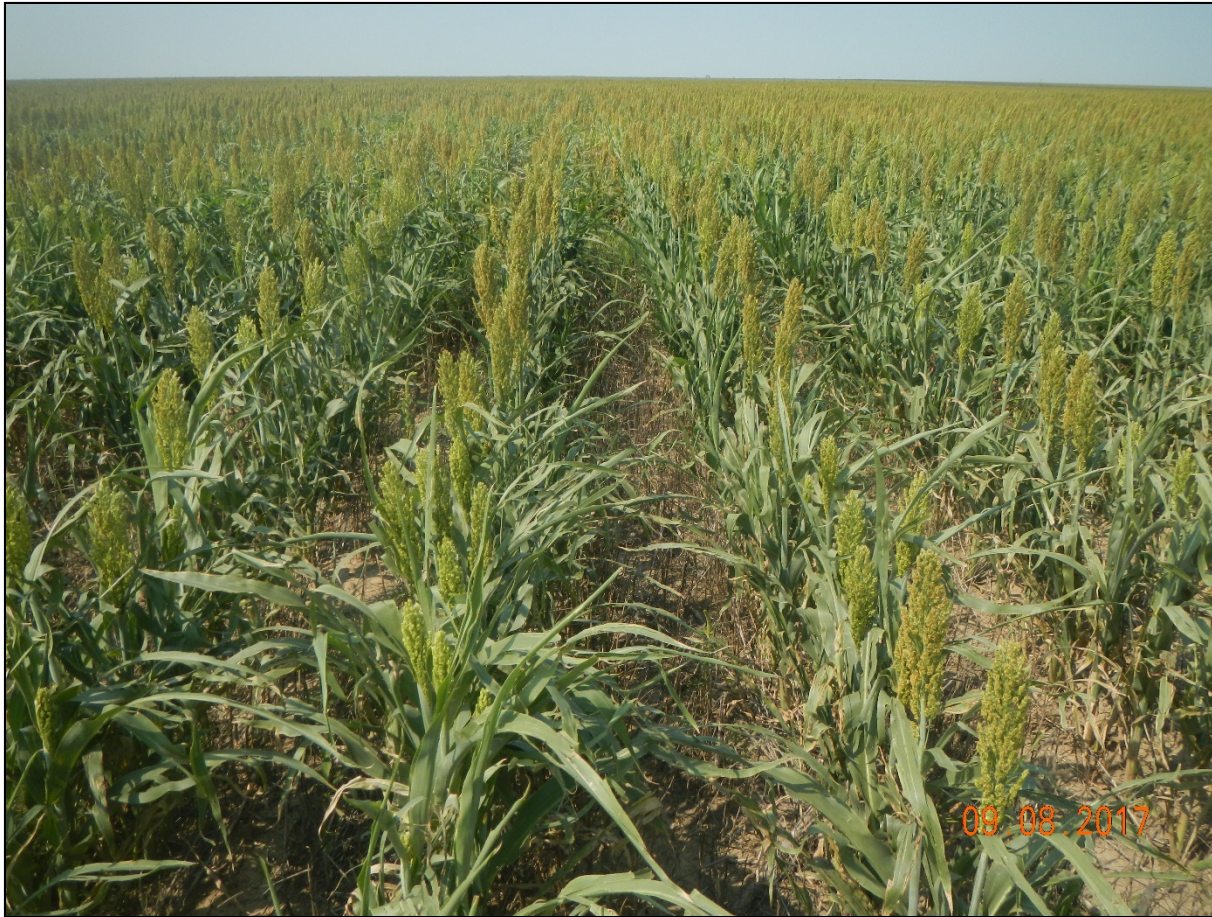
Photo 5. Facing west toward the surrounding crop growth off the location.
