Inspection Photos

Location Name: Wells Ranch USX AA 23-67HN Pad

API: 05-123-35338

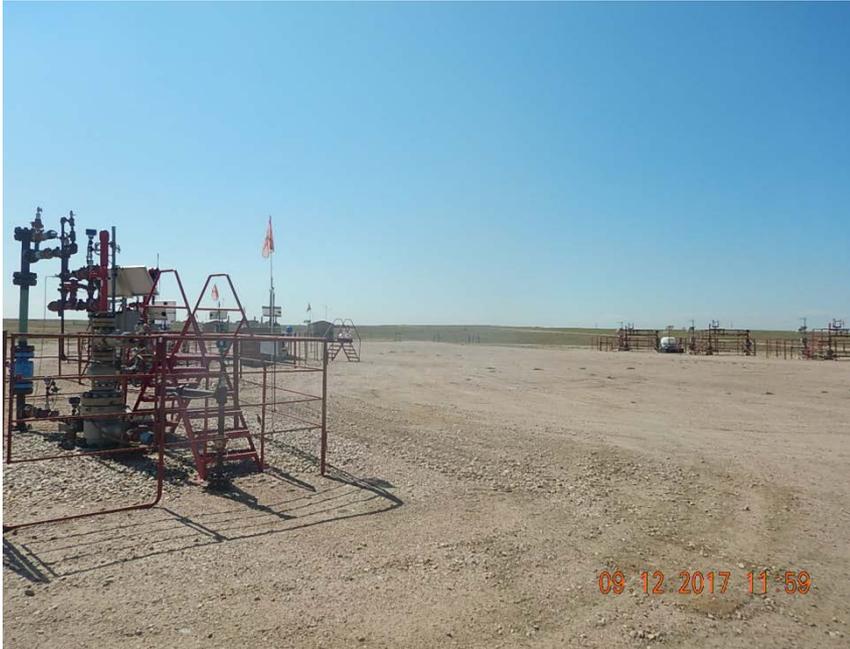
Photo 1: Wellheads, looking SE

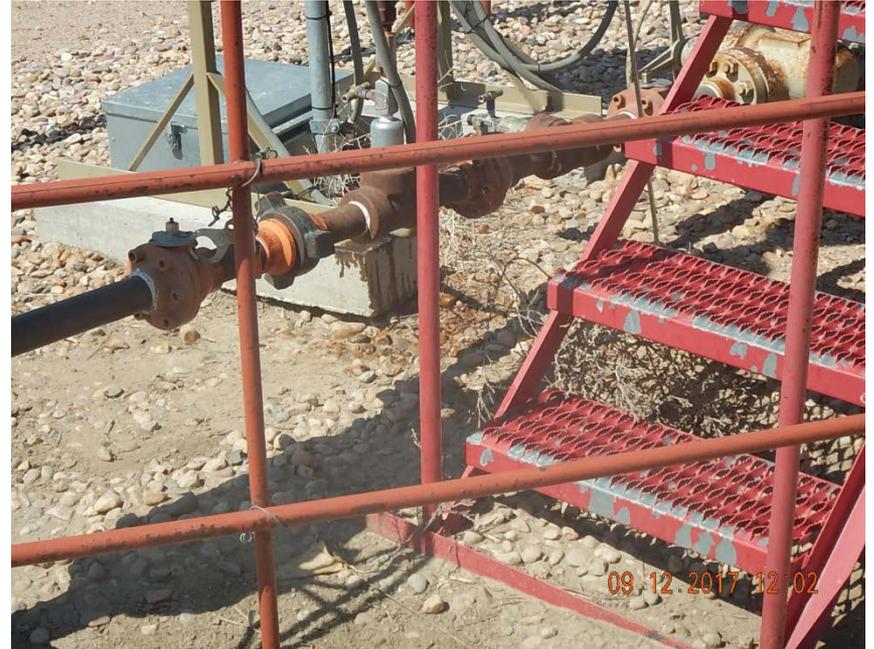
Photo 2: Stained soil at wellhead

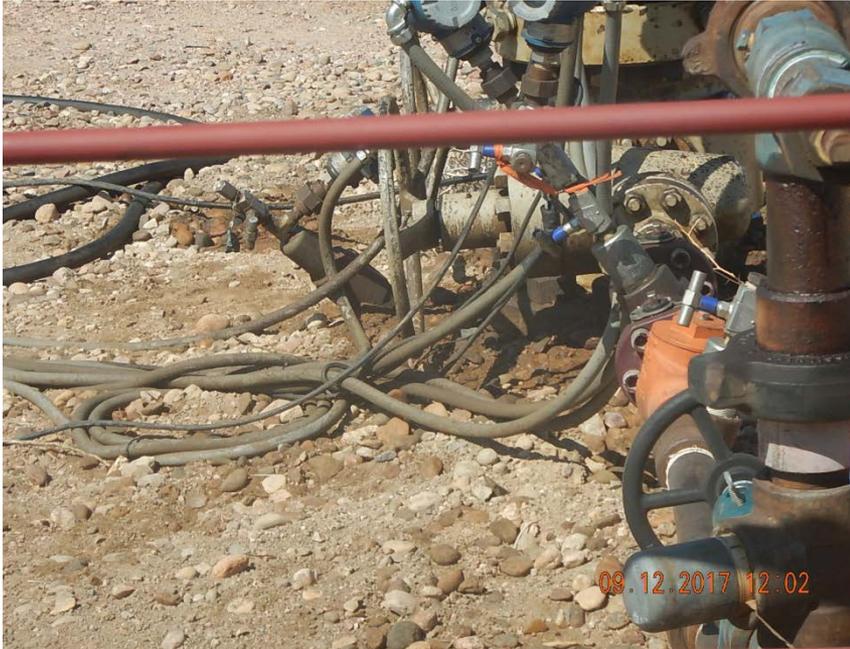
Photo 3: Stained soil at pumping unit wellhead

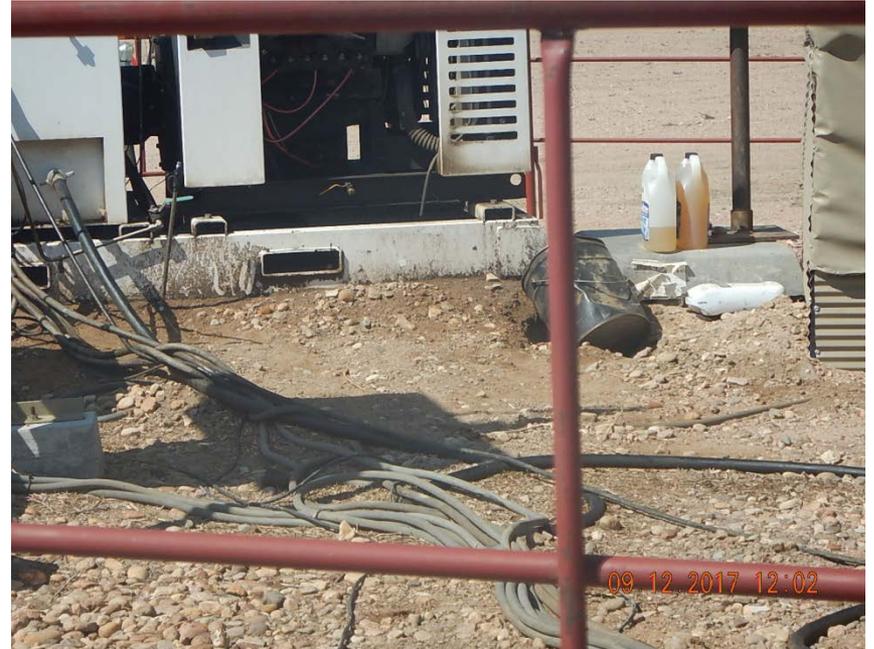
Photo 4: Stained soil at generator
