Inspection Photos
Location Name: Wells Ranch USX AE #19-14
API: 05-123-25739

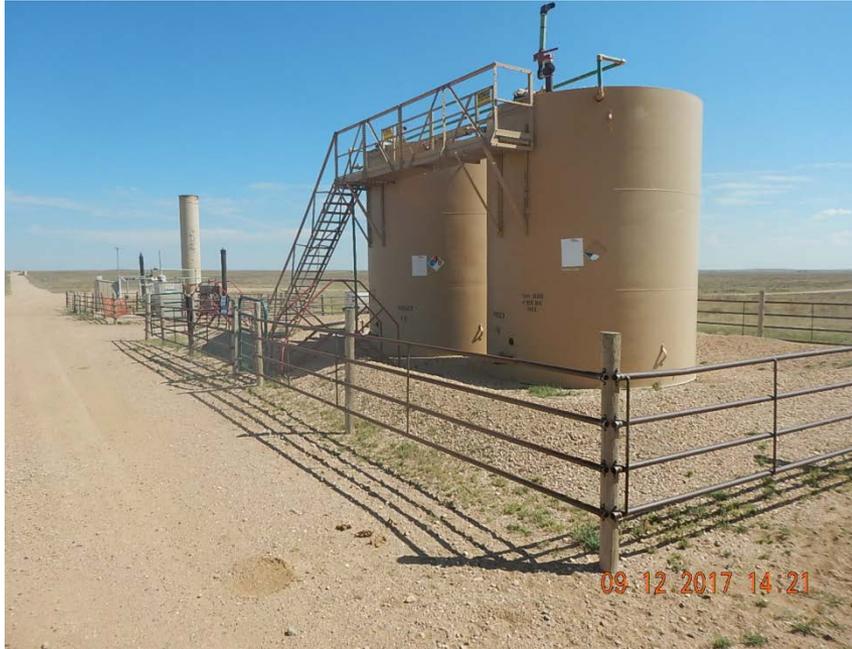
Photo 1: Location, looking SE

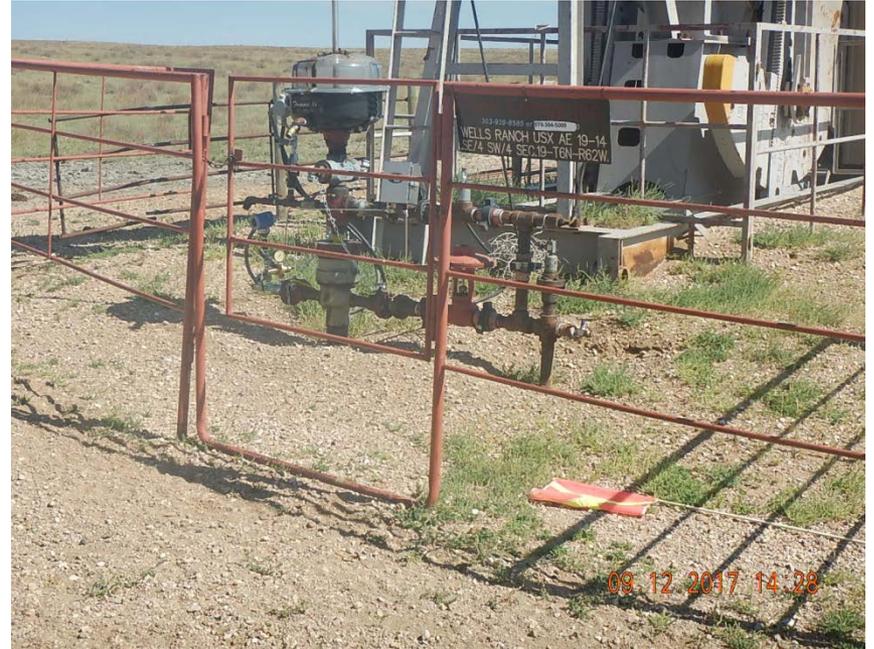
Photo 2: Wellhead, looking SE

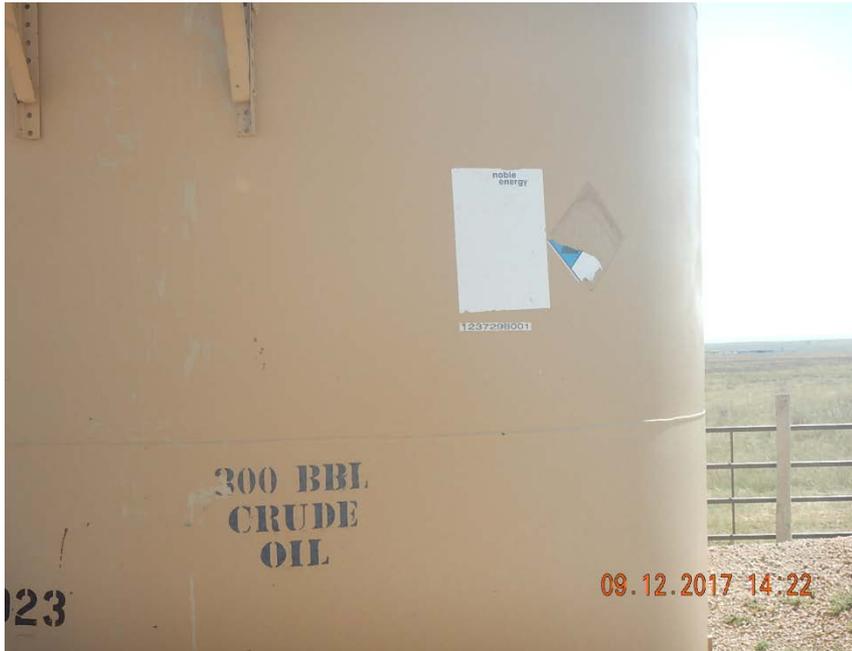
Photo 3: Damaged placard

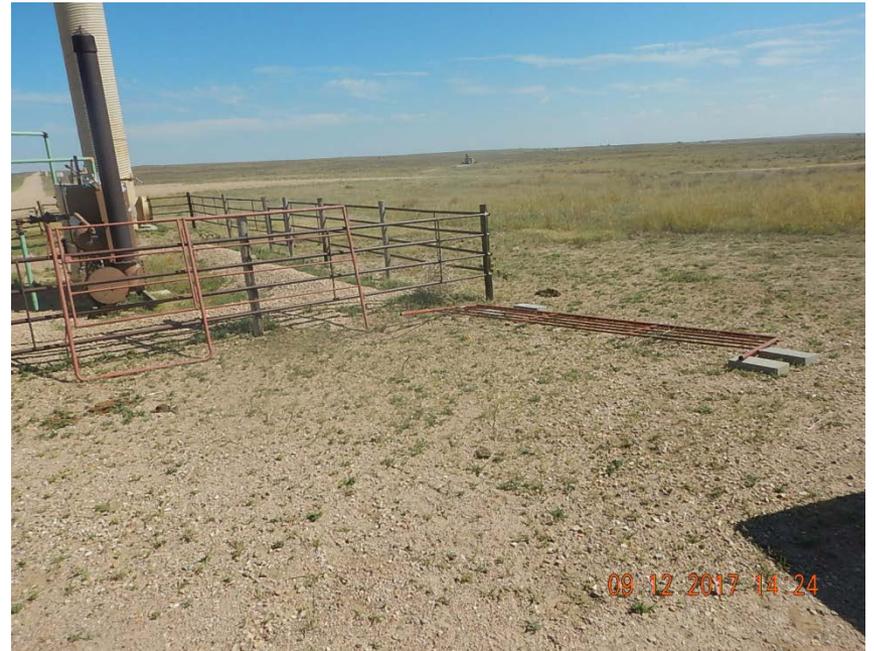
Photo 4: Unused fencing

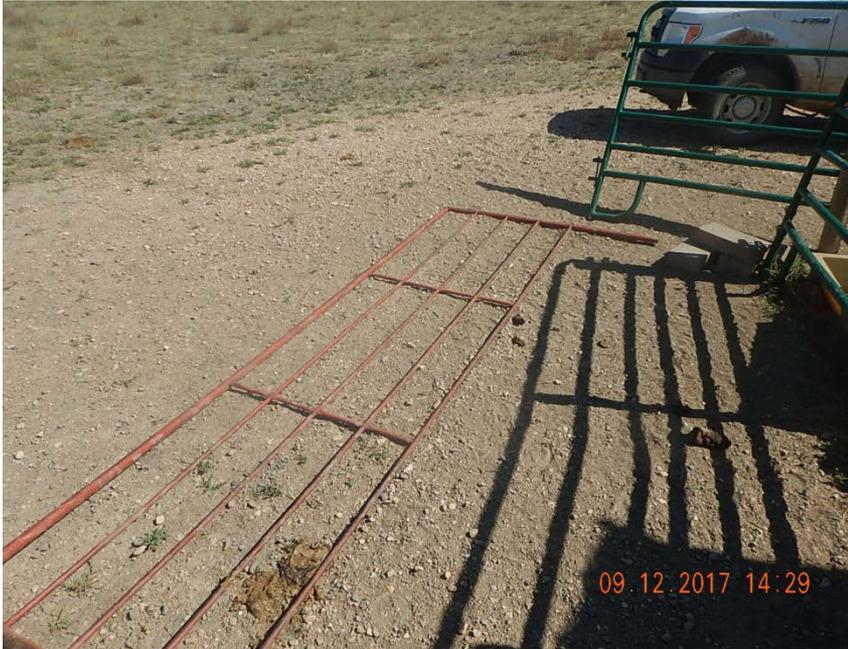
Photo 5: Unused fencing

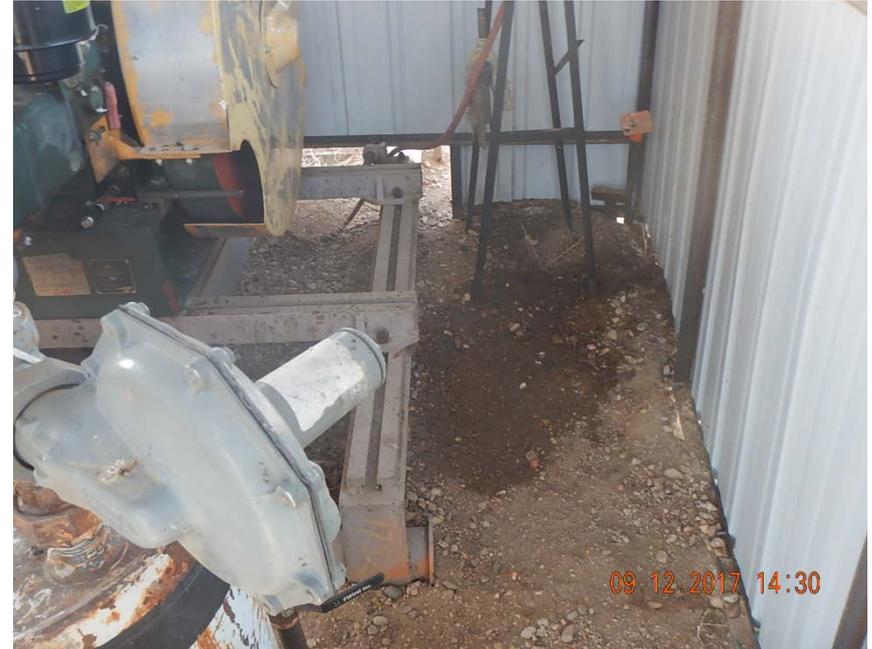
Photo 6: Stained soil at engine
