Inspection Photos
Location Name: E. Johnson 2-21
API: 05-123-21260

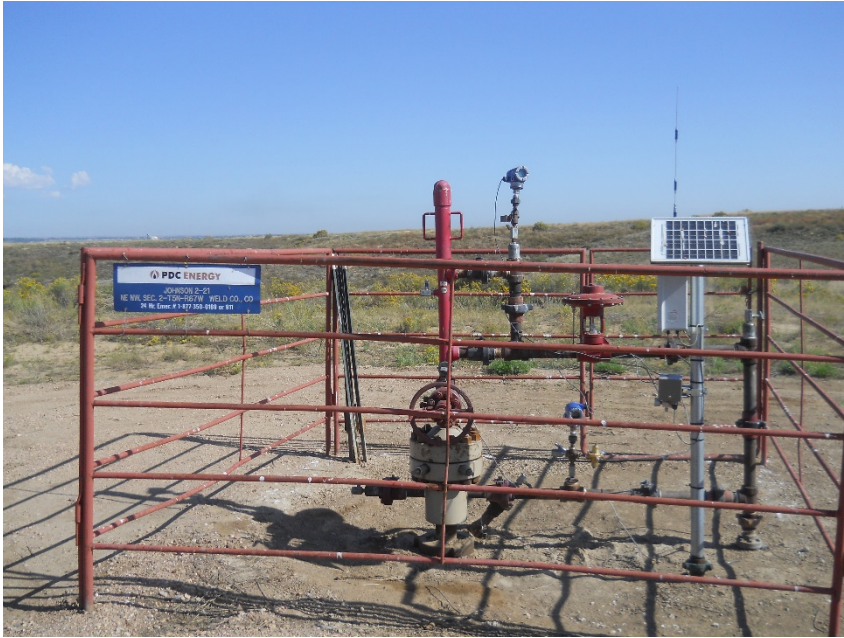
Wellhead looking north

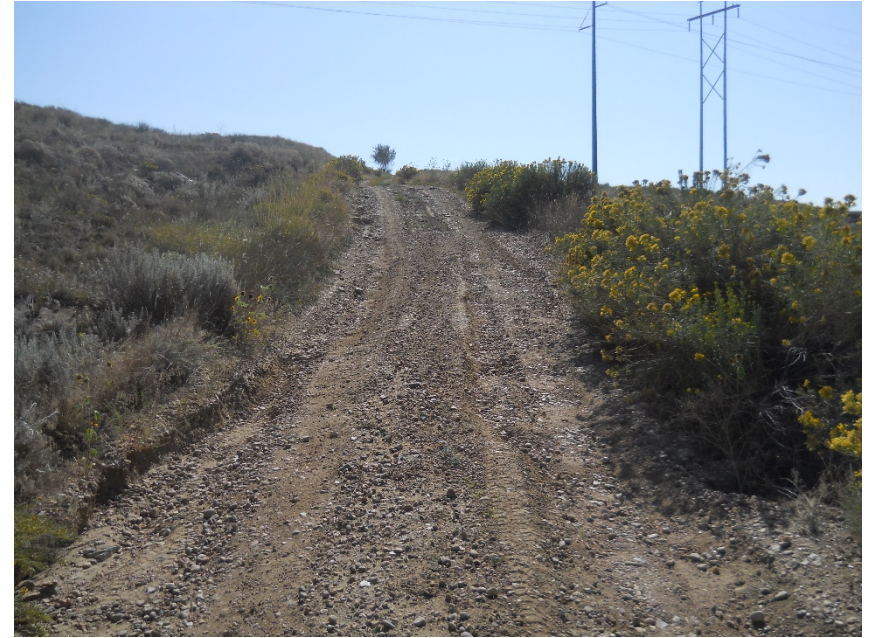
**Access road to wellhead from battery looking southeast.
Road is washing out on both sides**

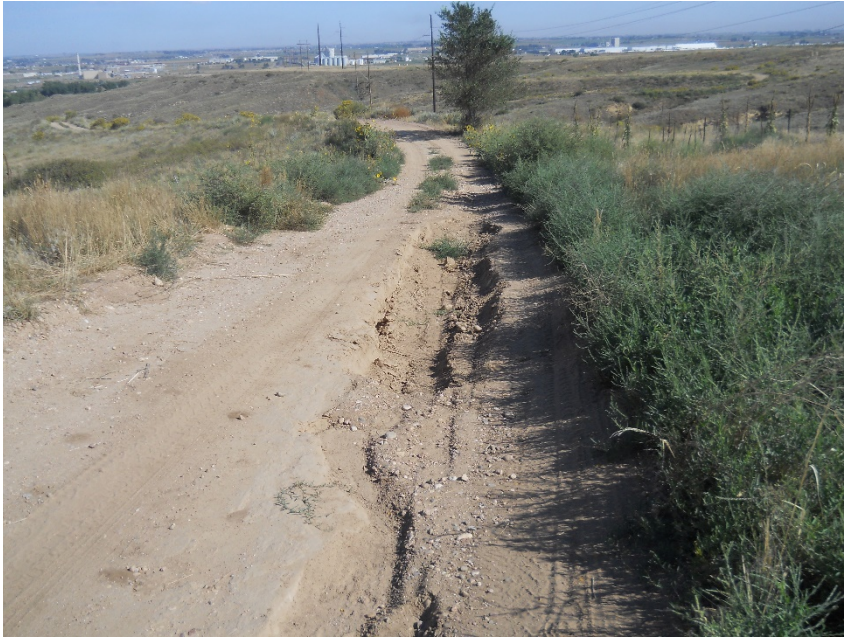
Lease road to battery is washing out, looking north

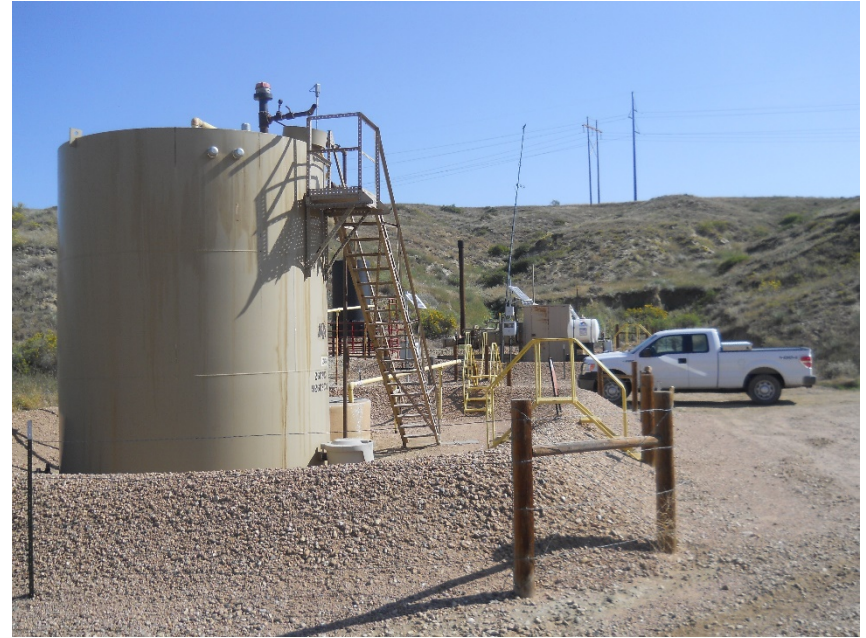
Battery looking east from southwest edge of location

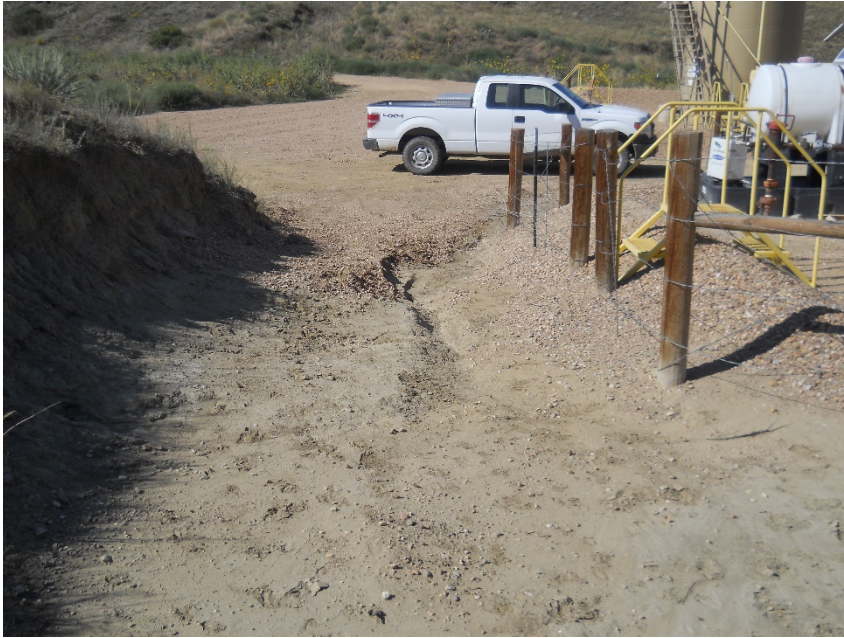
Location washing out south side of separator

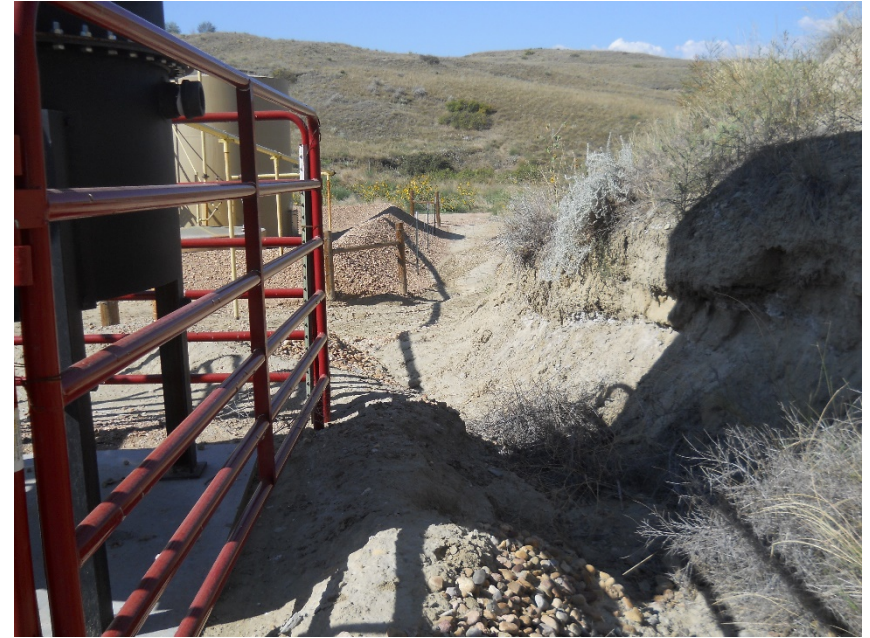
Location washing out north side of location, discharging northwest of tank battery with sediment carrying off into field

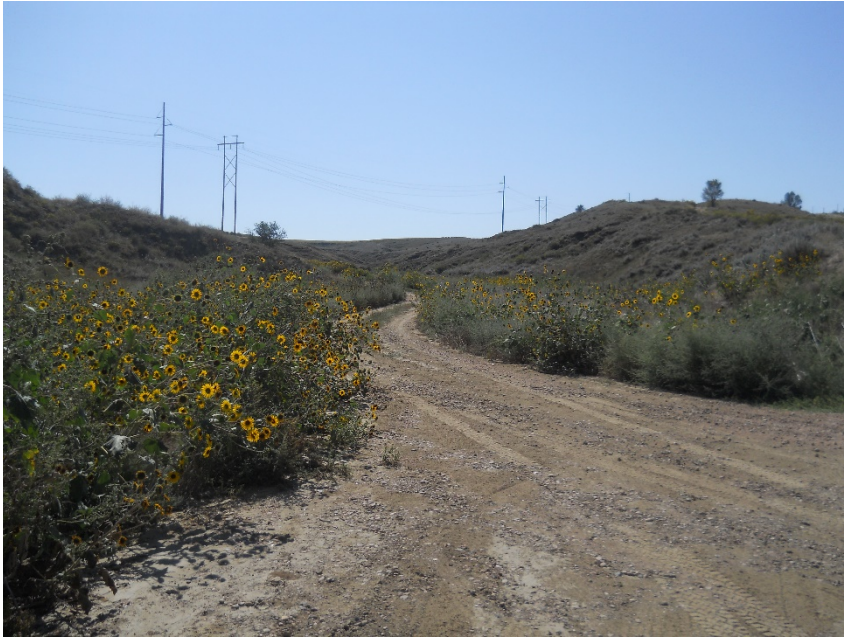
Access road to wellhead looking south from battery. Actively growing weeds need to be controlled.
