Inspection Photos  
Location Name: Fuqua 19-02-10-1H  
API: 05-057-06483

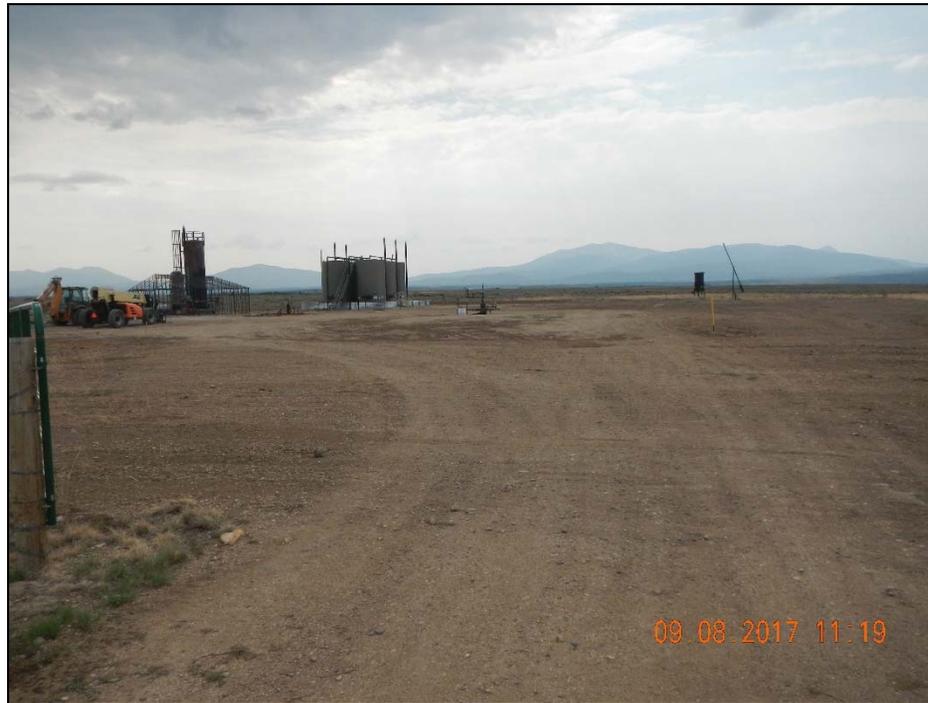
**Photo 1. Overview of location taken at entrance facing southeast.**

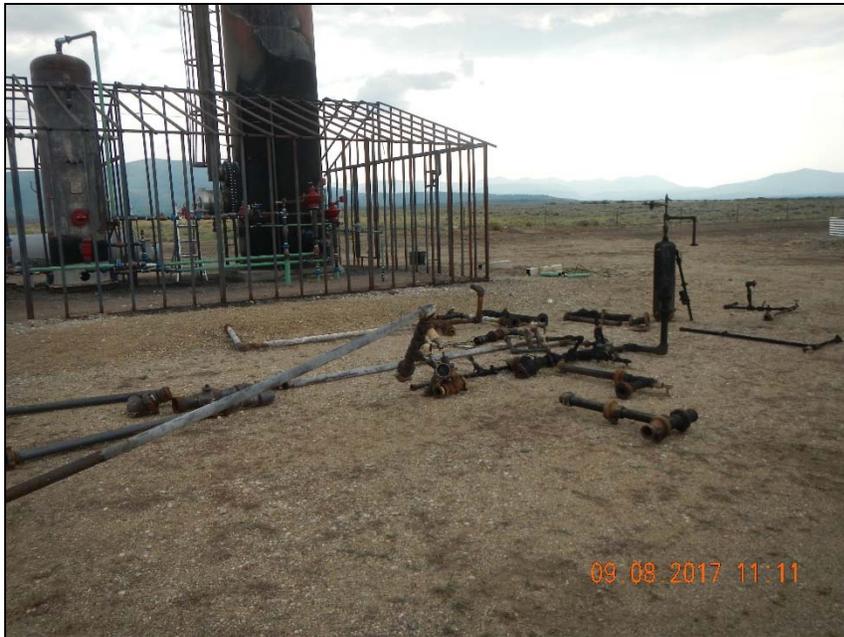
Photo 2. Equipment storage/evidence of recent fire.

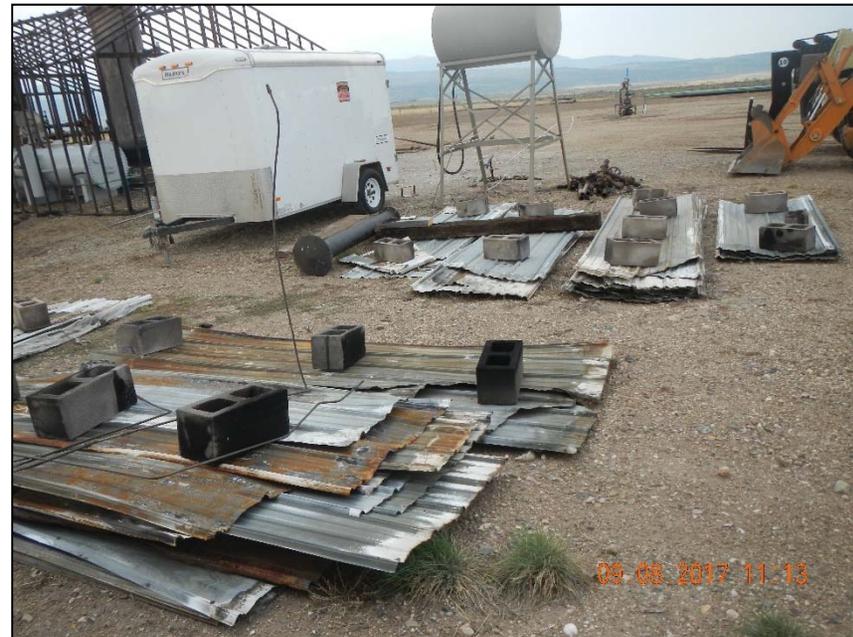
Photo 3. Equipment storage/evidence of recent fire.

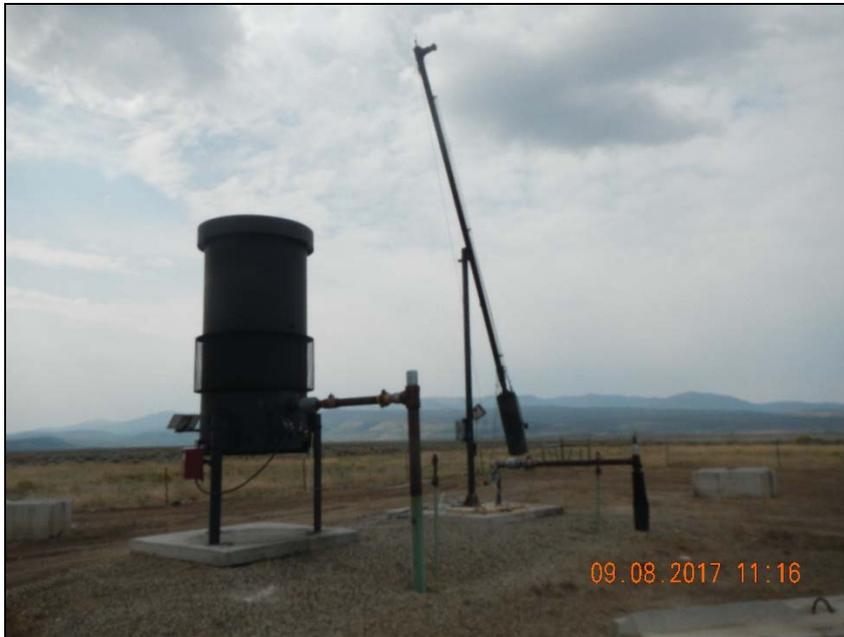
**Photo 4. Flare knocked over. 1 – 1” and 1 – 2” steel risers.**

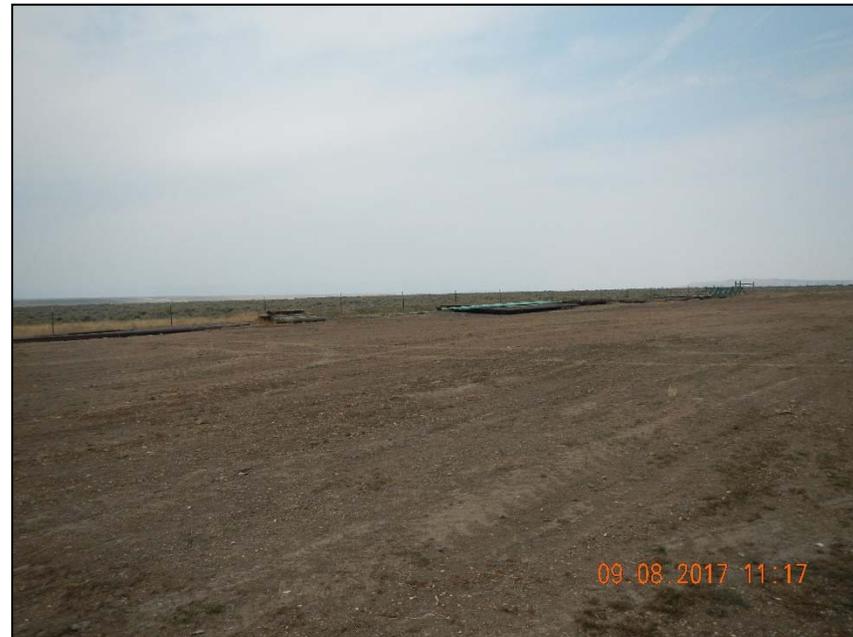
**Photo 5. Equipment storage.**

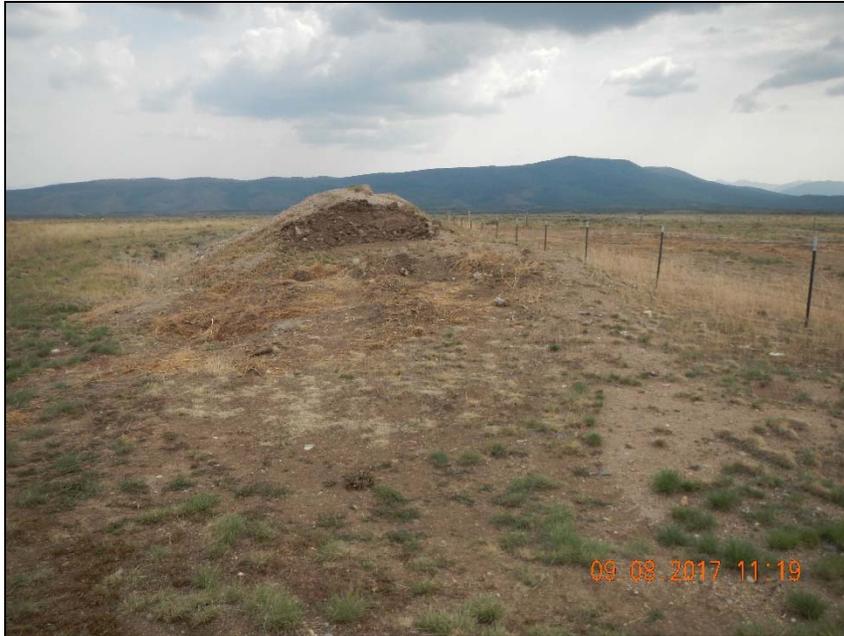
Photo 6. Topsoil pile with recent soil removal and dried annual weeds.

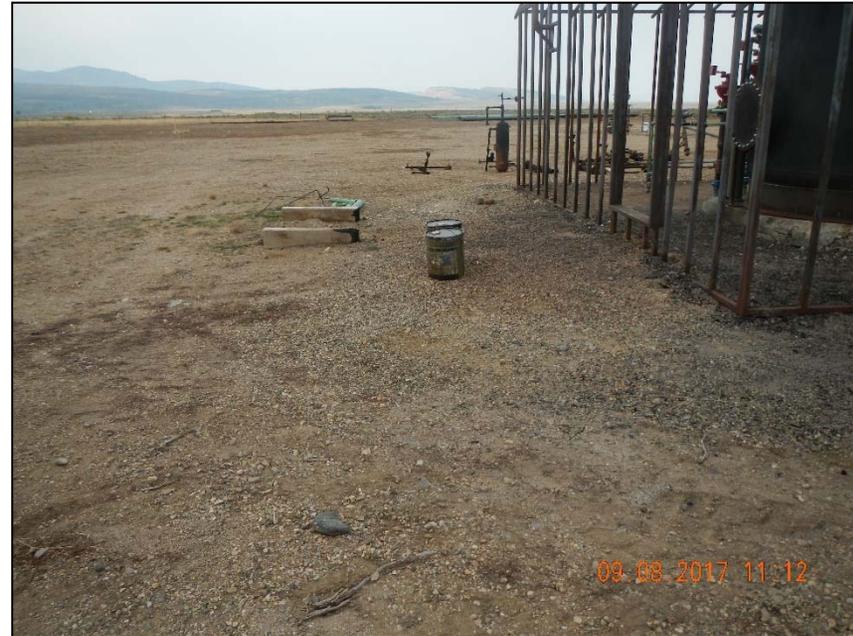
Photo 7. Equipment storage/evidence of recent fire.
