Inspection Photos
Location Name: Silver Spur Minerals 35-2H
API: 05-057-06490

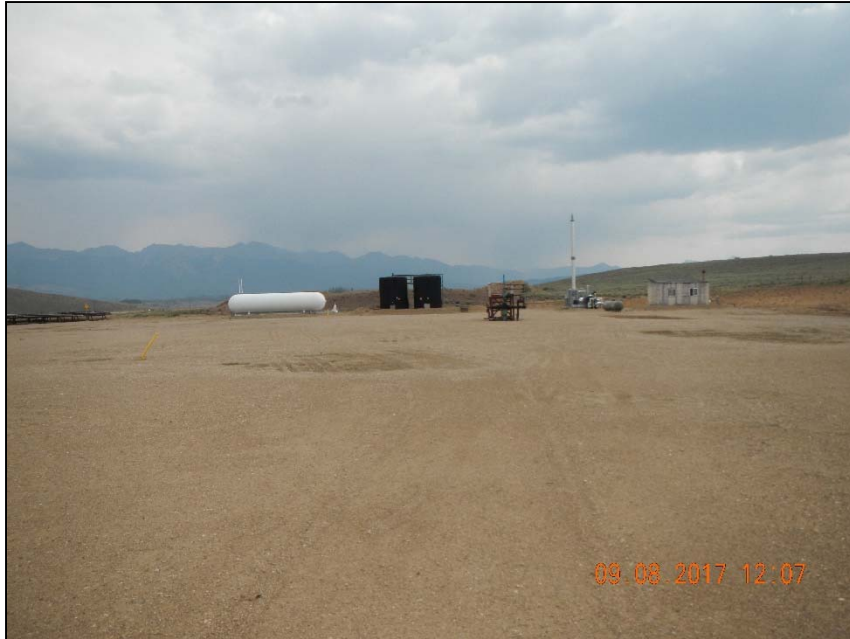
Photo 1. Overview of location taken at entrance facing south.

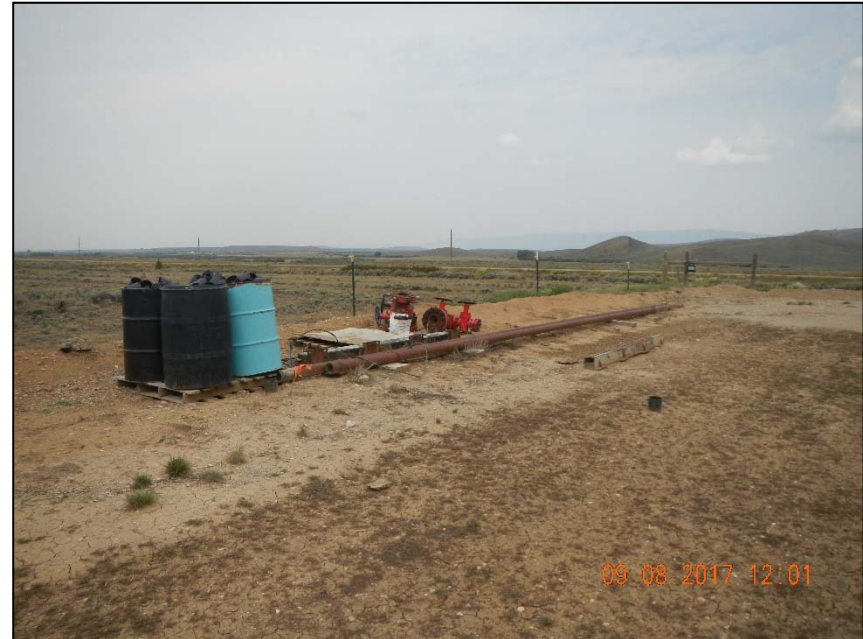
Photo 2. Equipment stored on location.

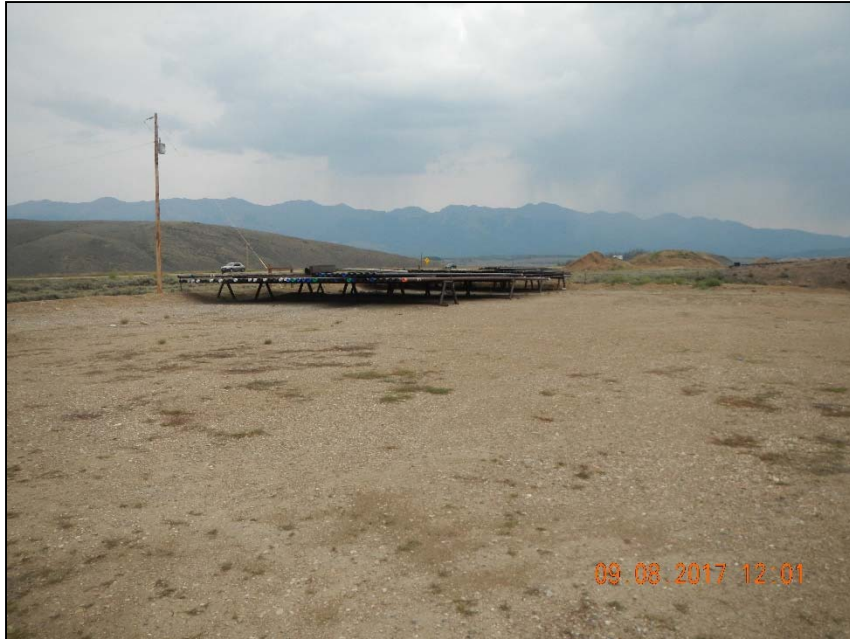
Photo 3. Equipment stored on location.

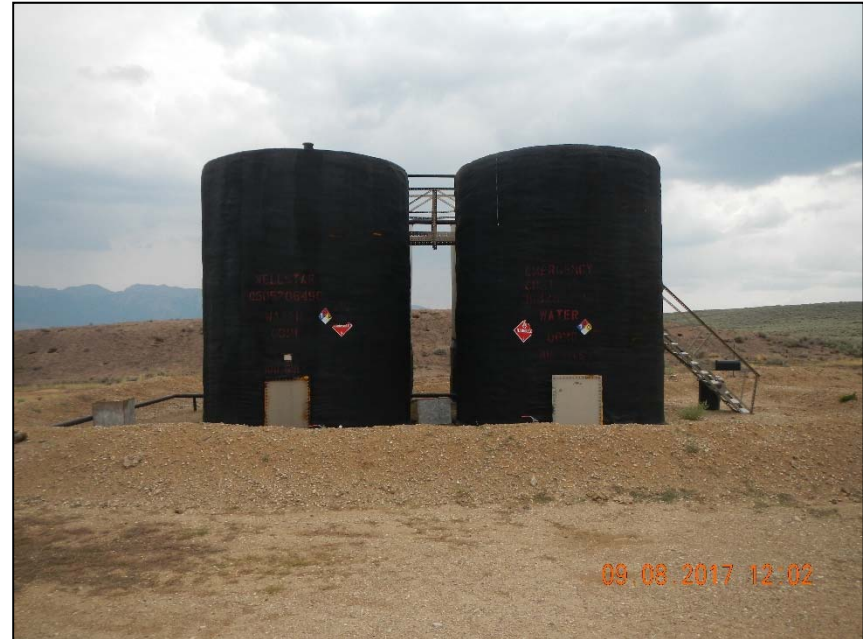
Photo 4. Unconsolidated berm.

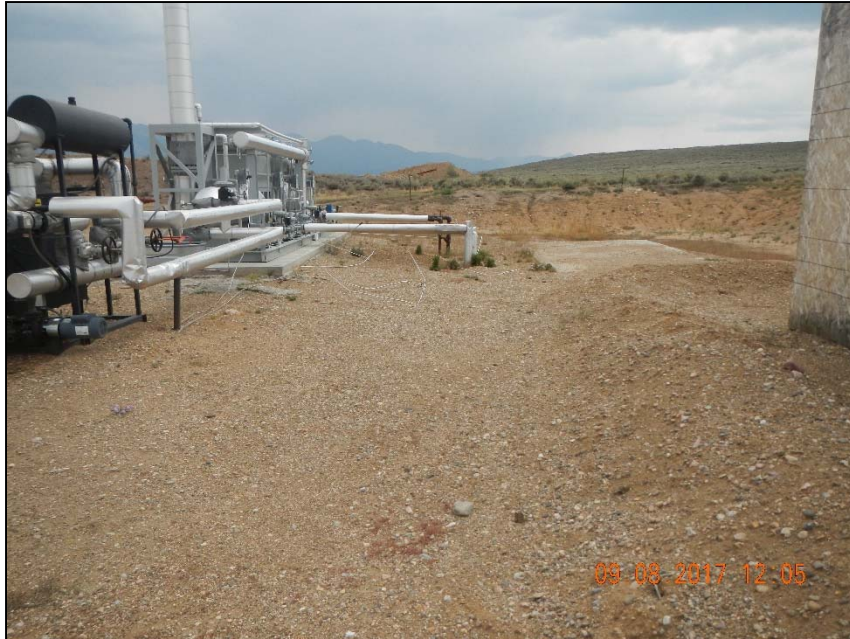
Photo 5. Erosion rills coming onto location.

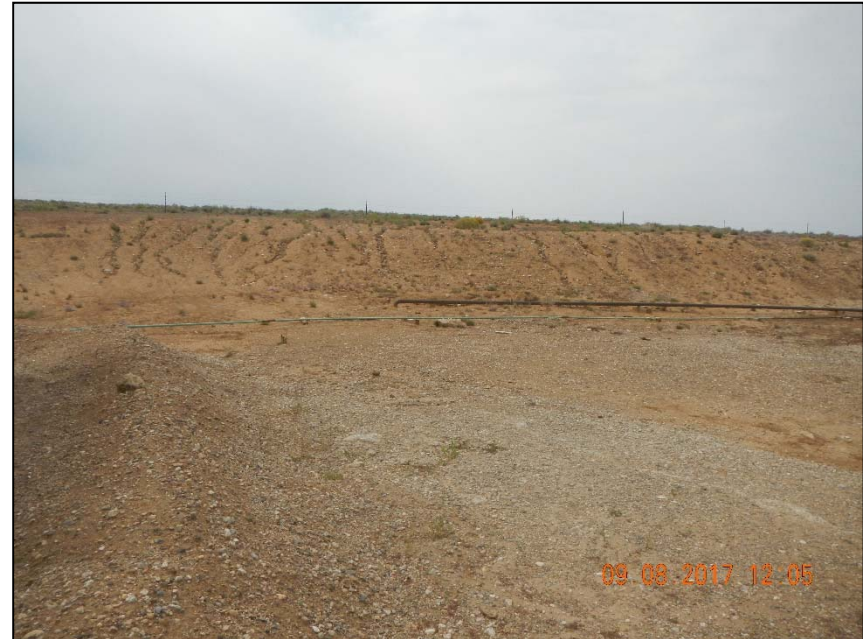
Photo 6. Erosion rills coming onto location.
