## Inspection Photos

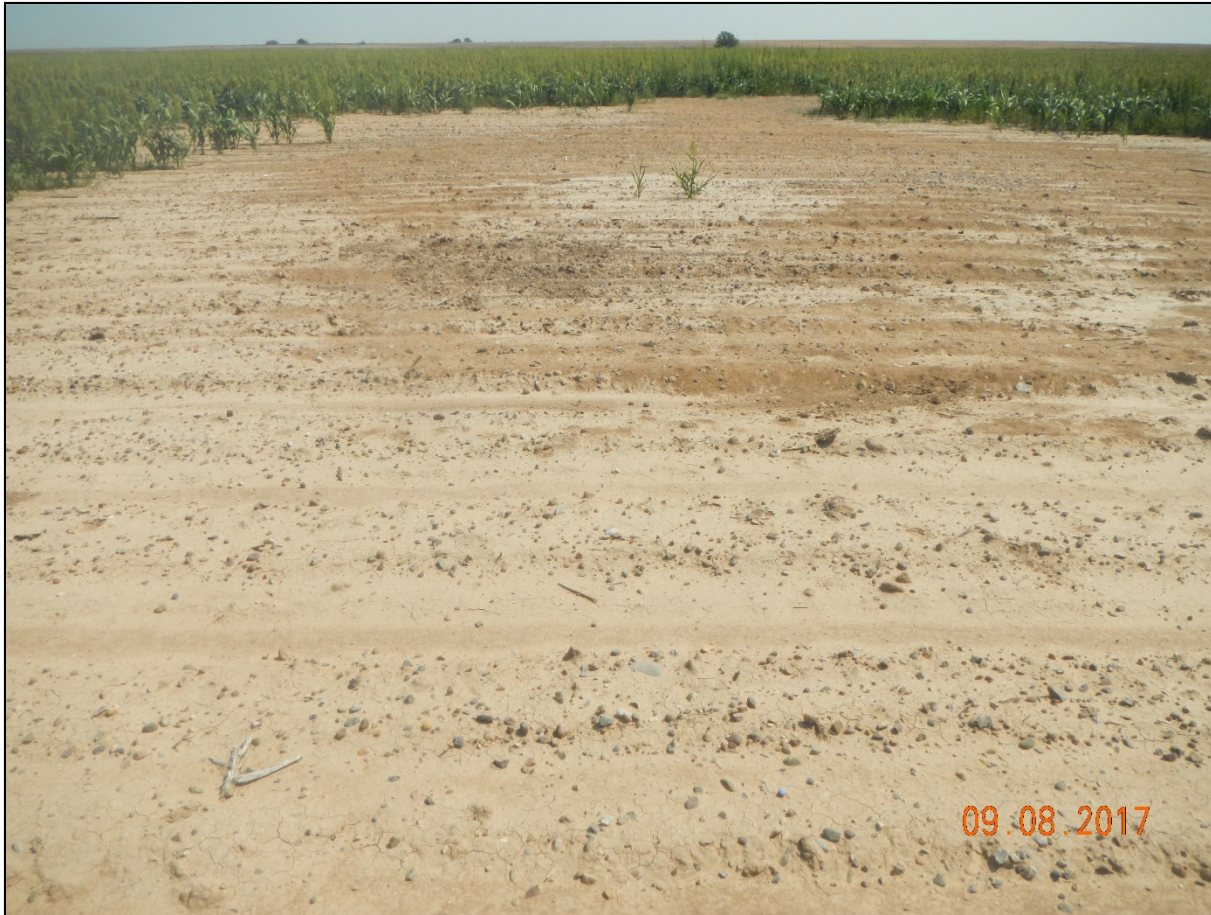
**Photo 2.** West side of the location facing east. There is a lack of crop growth at the location.

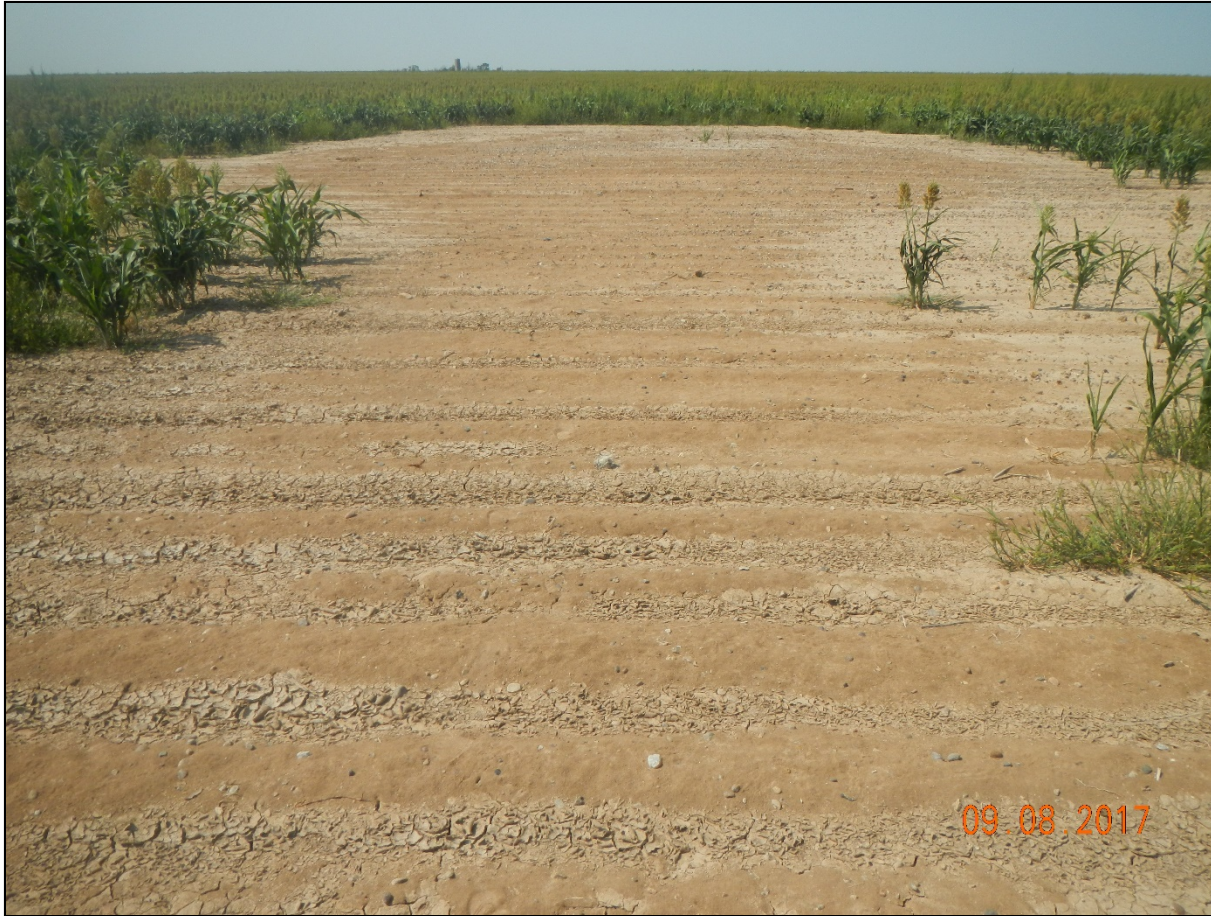
**Photo 3.** East side of the location facing west. There appears to be soil issues affecting crop growth.

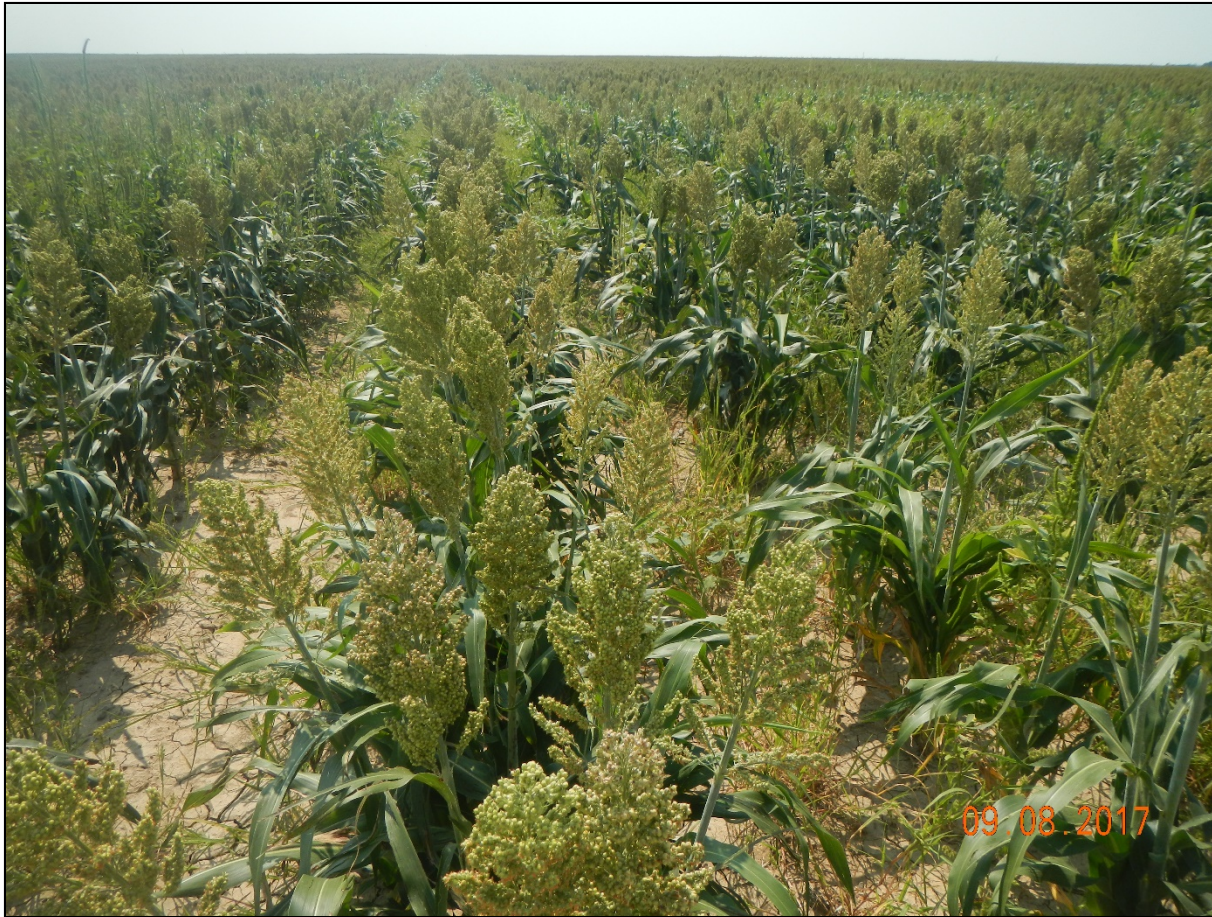
**Photo 5.** Facing south toward the surrounding crop growth off the location.
