Inspection Photos

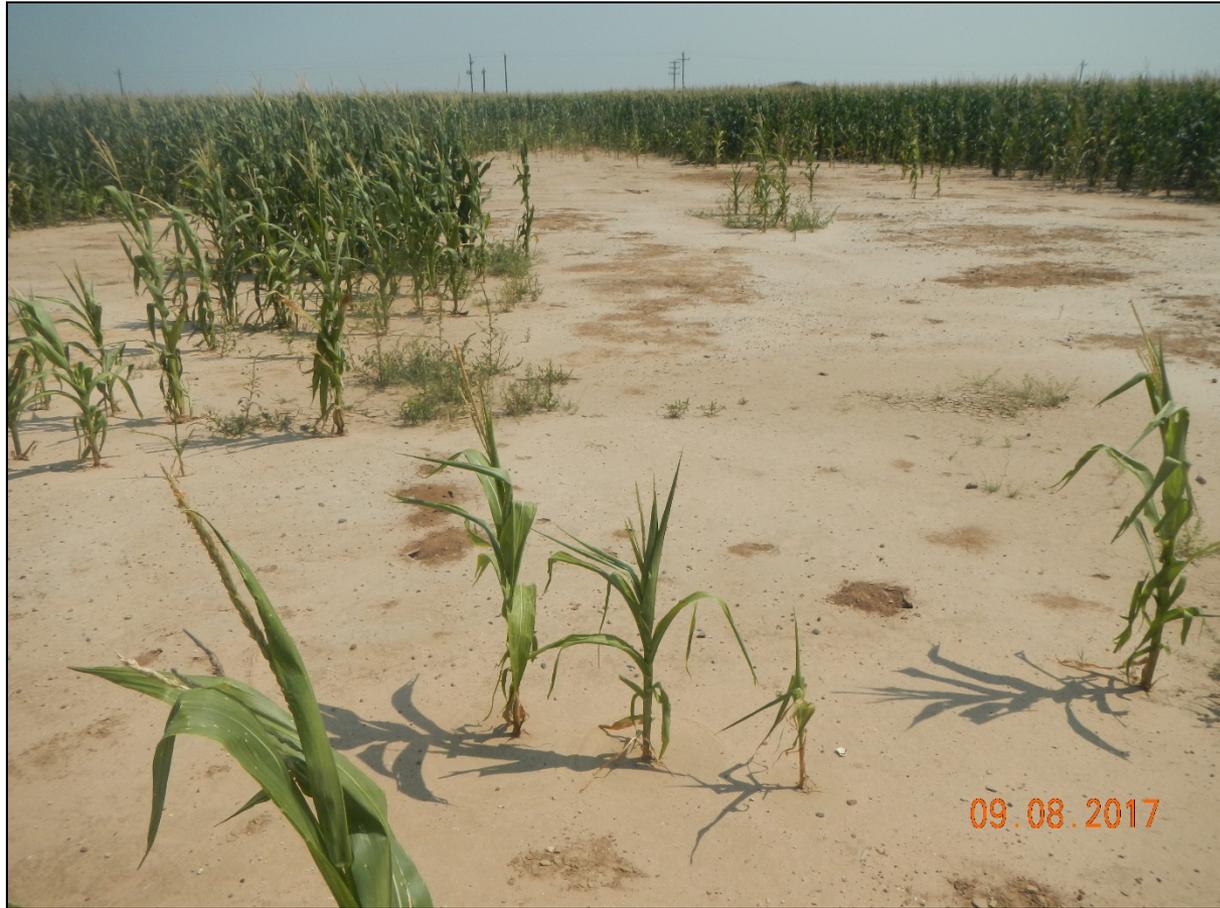
Photo 2. West side of the location facing east. There is a lack of crop growth at the location.

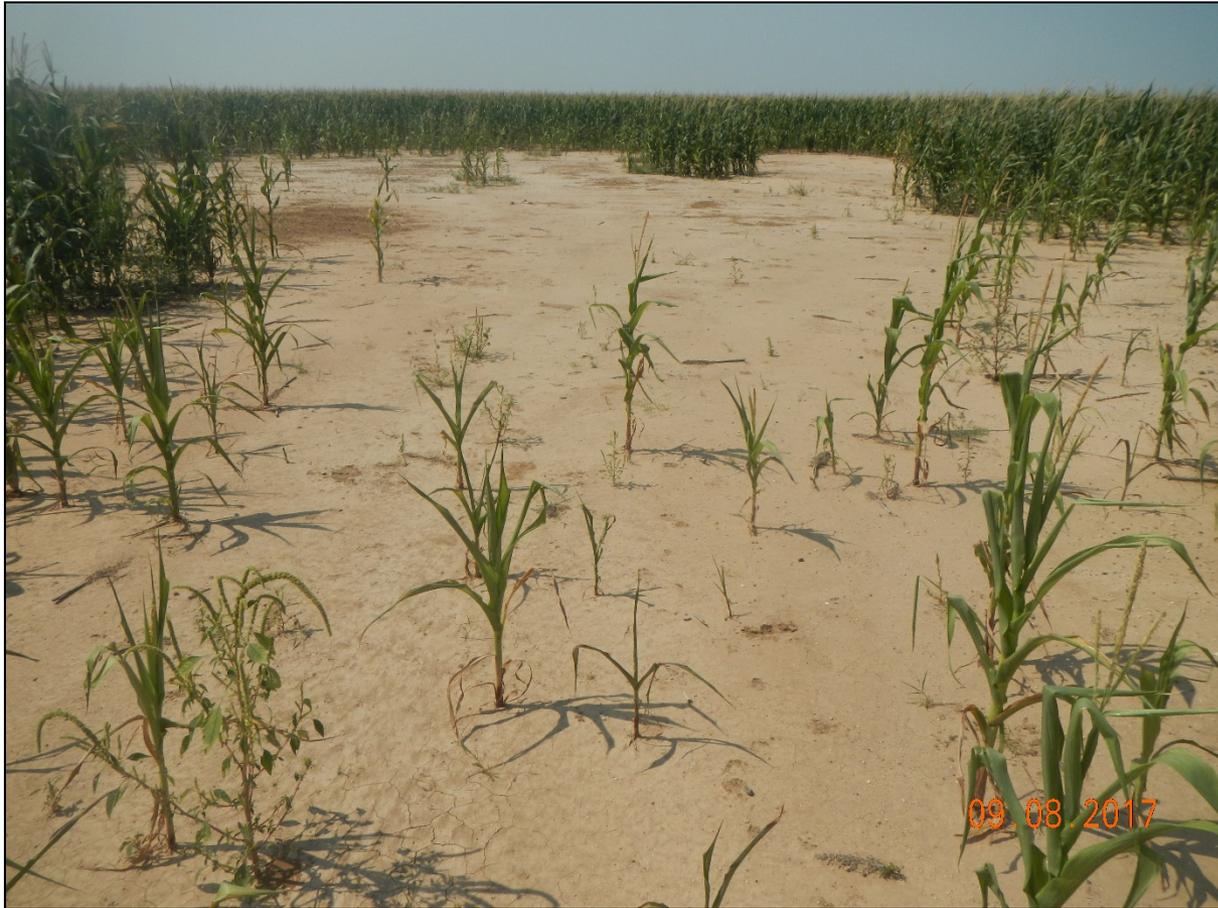
Photo 3. East side of the location facing west. There appears to be soil issues affecting crop growth.

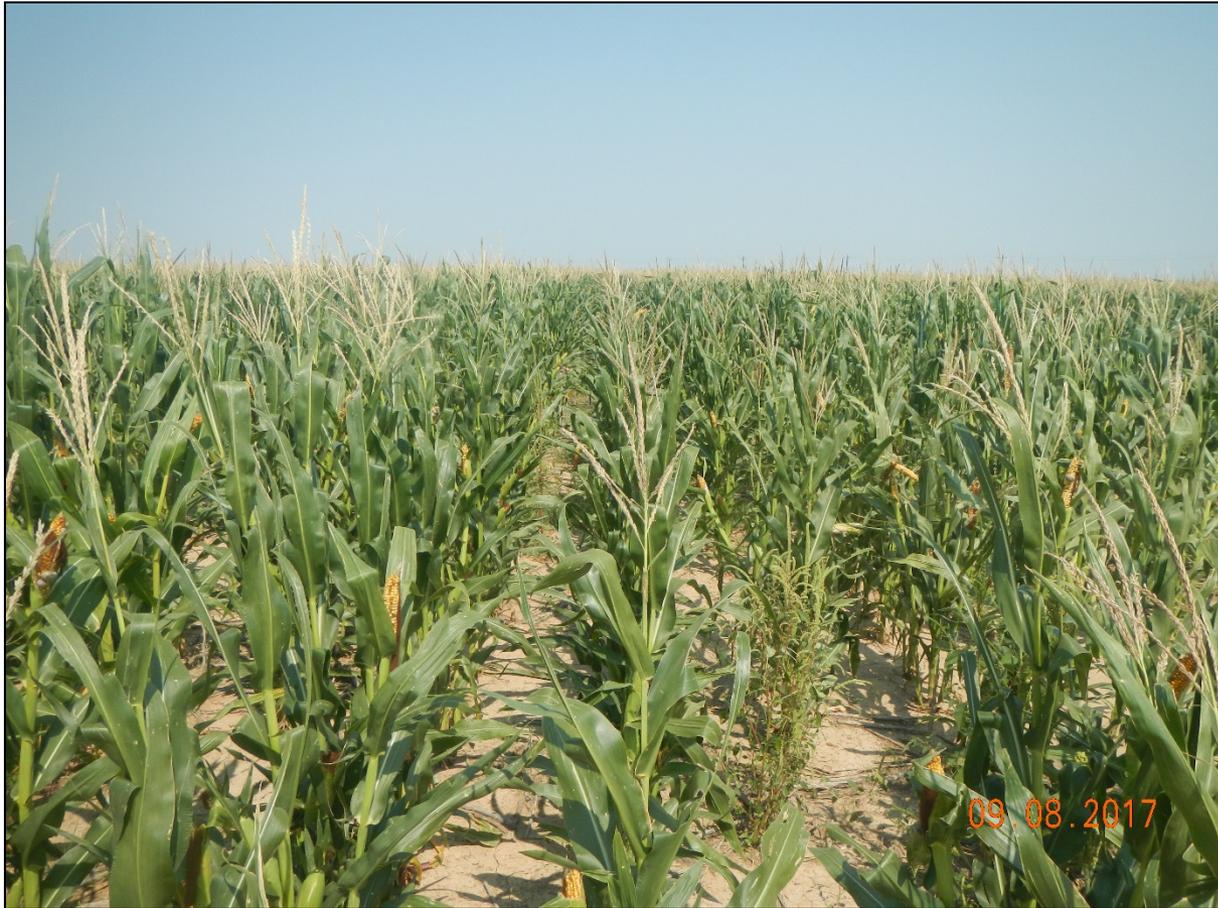
Photo 5. Facing north toward the surrounding crop growth off the location.
