Inspection Photos

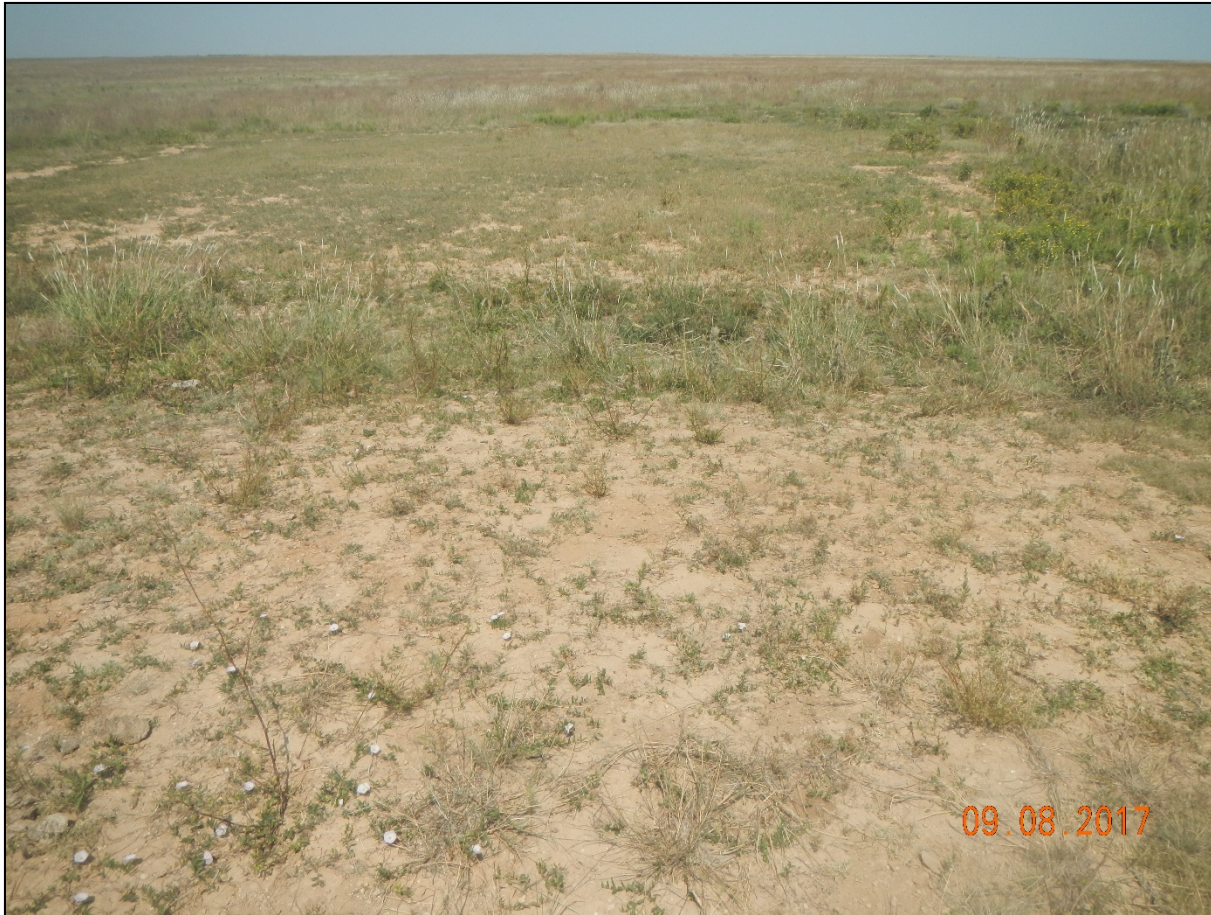
Photo 1. Facing north toward the location. The desirable vegetation has not adequately established at the location.

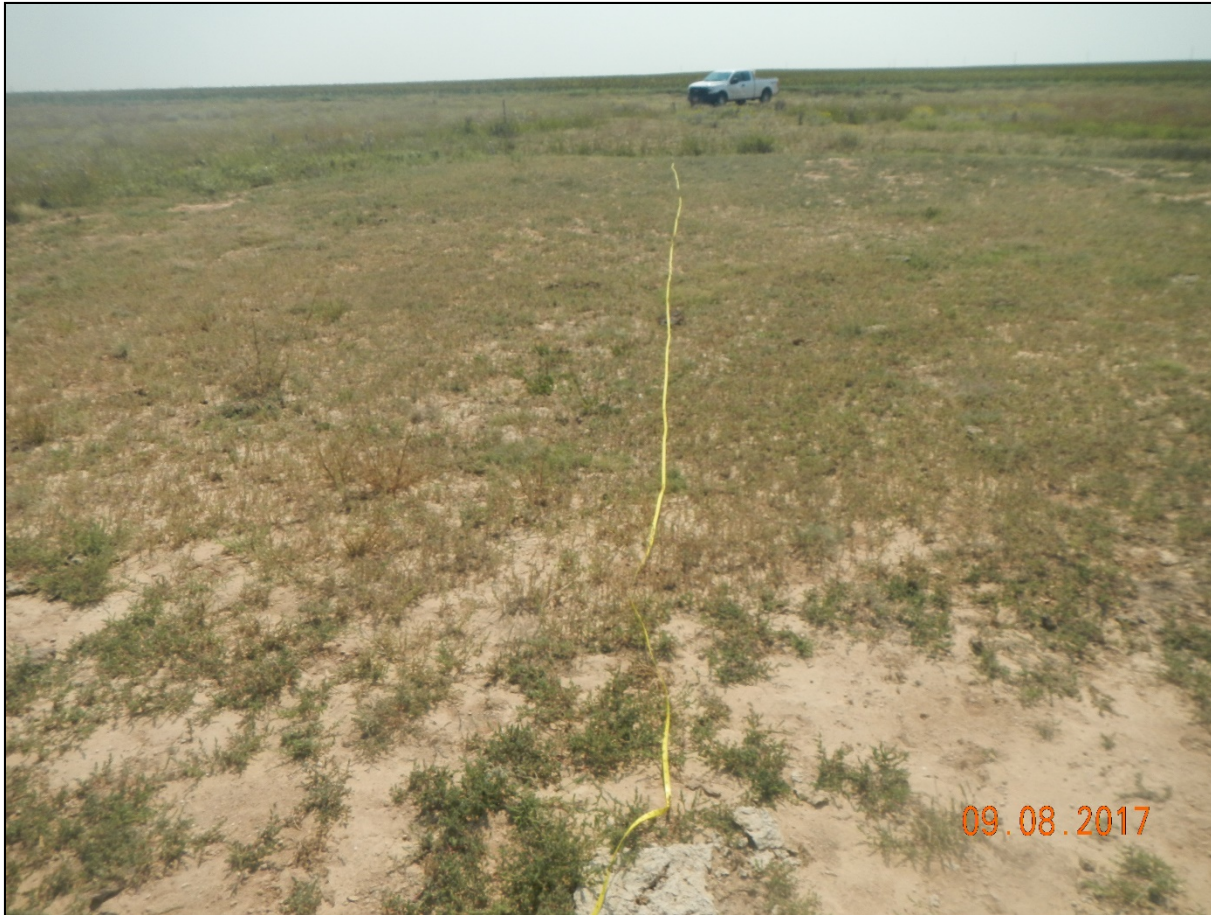
Photo 2. Northern side of the location facing south. A 100ft tape measure is laid out at the location. There is predominately undesirable weeds in this area.

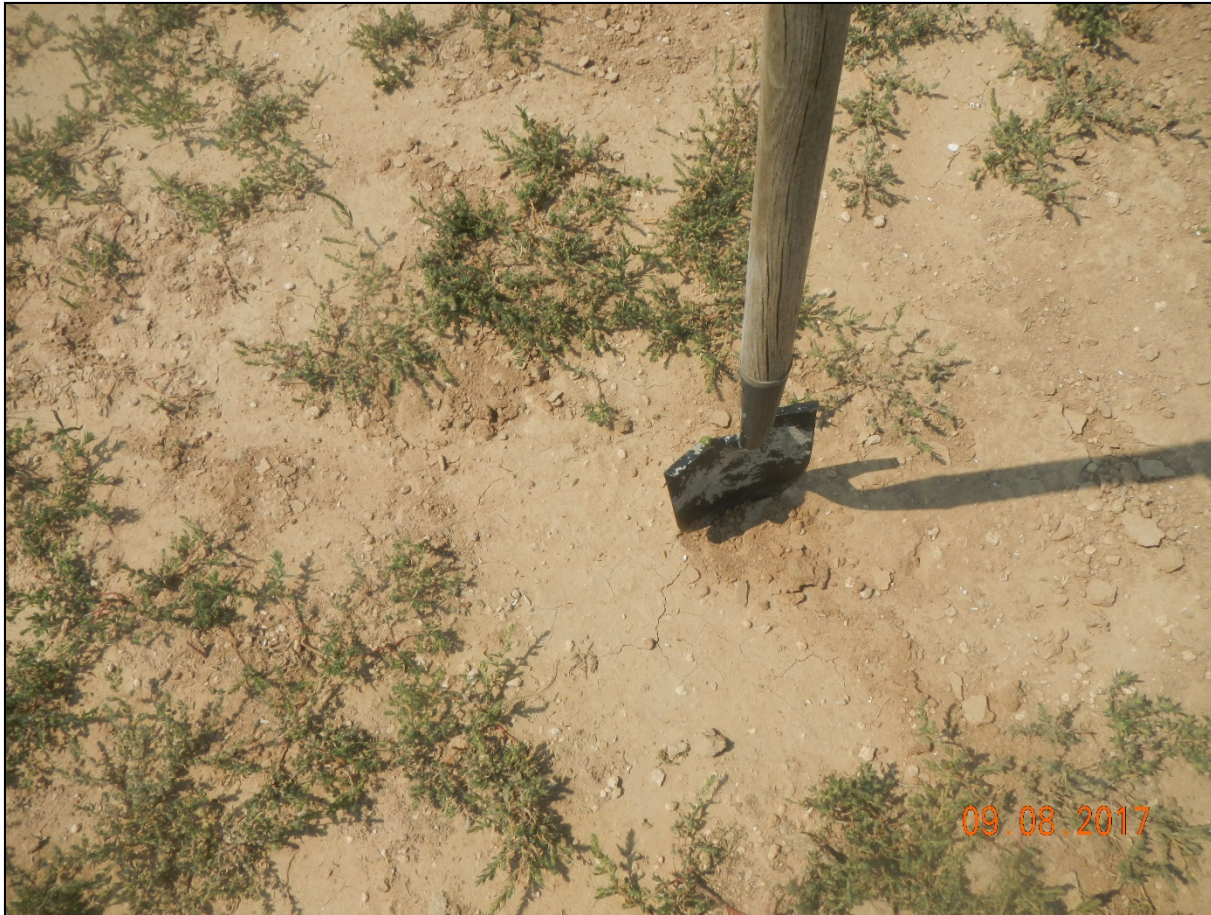
Photo 4. The soils at the location appear to be compacted. The shovel shown in the photo was unable to penetrate into the soil.

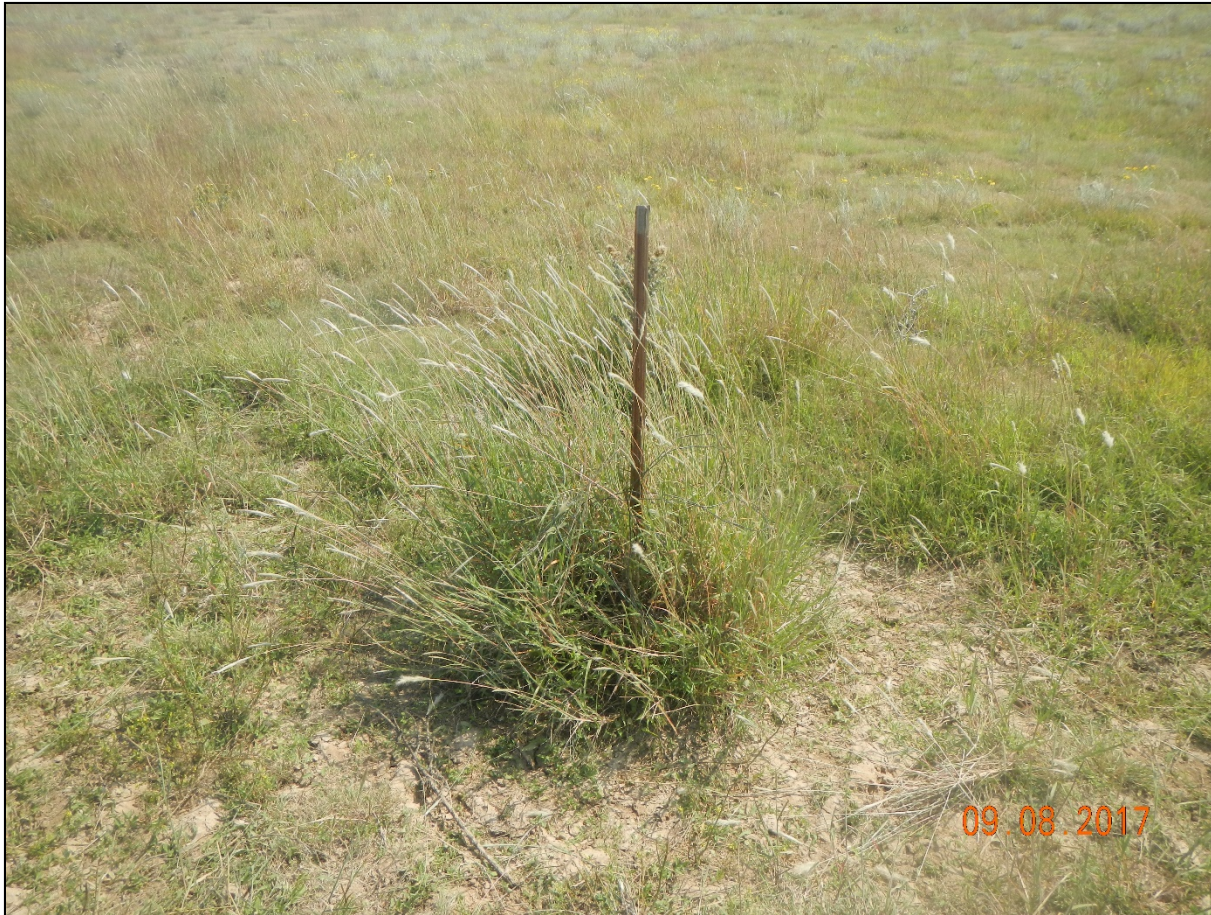
Photo 5. There is a t-post and wire that remains at the southeast side of the location.
