**Inspection Photos**  
**Location Name: Hill #31-15-8**  
**API: 05-123-19368**

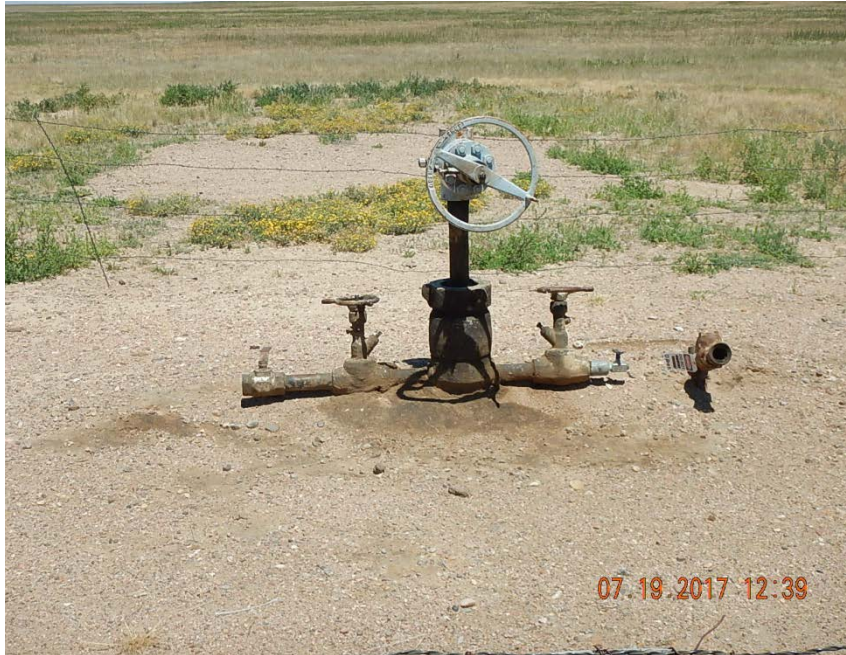
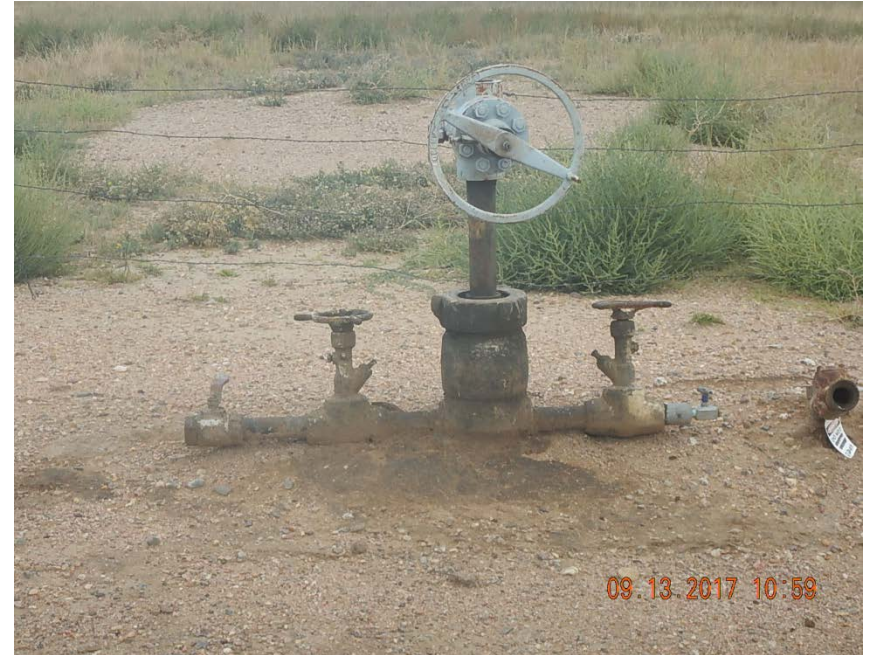
**Photo 1: Stained soil at wellhead**

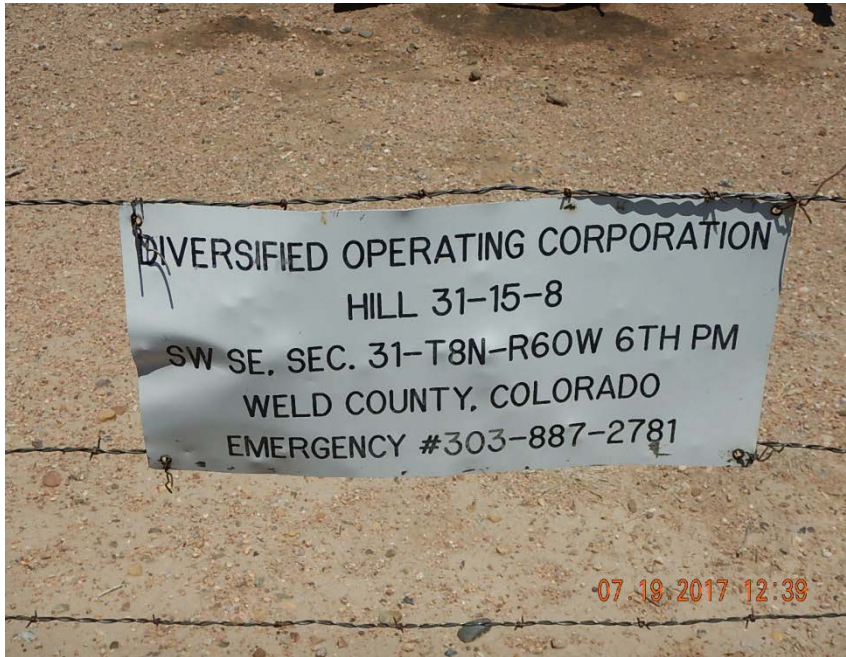
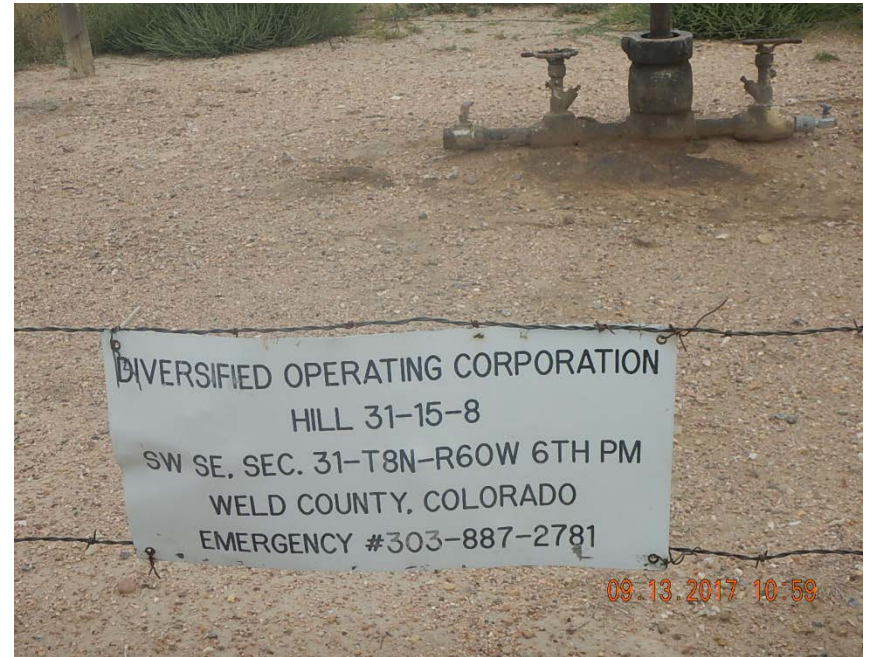
**Photo 2: Wellhead sign is for prior operator**

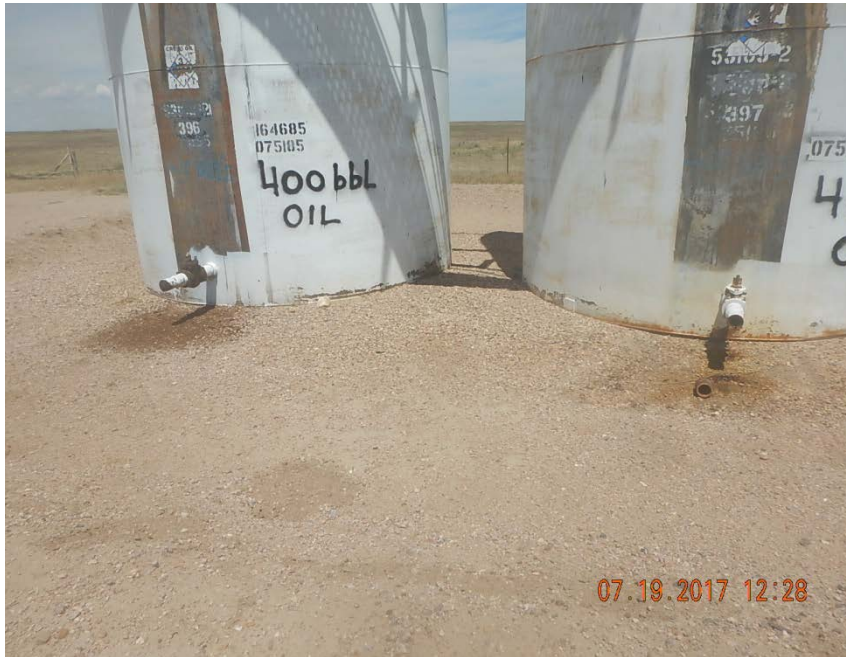
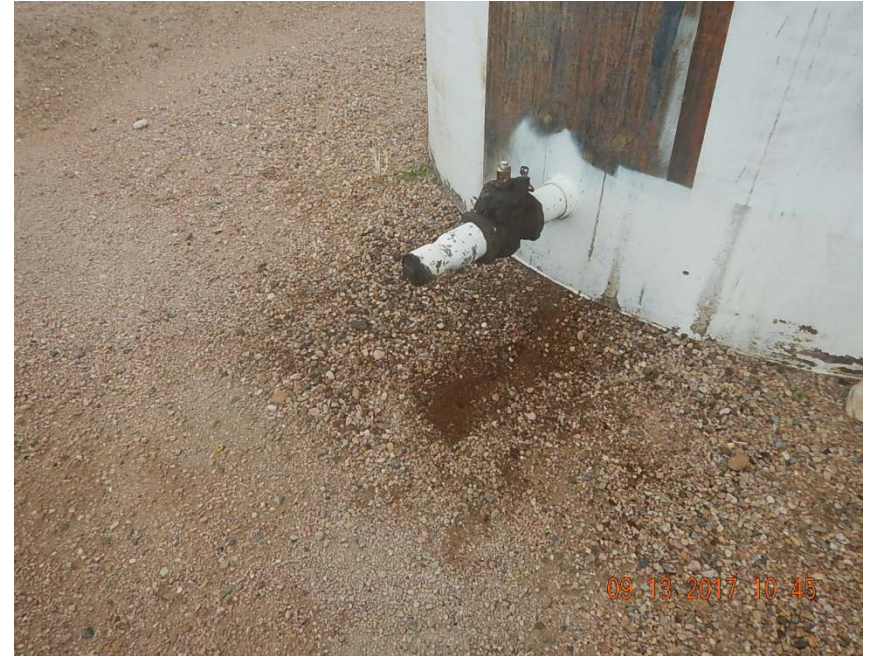
**Photo 3: Stained soil at crude oil loadouts removed or remediated. Leaking stopped.**

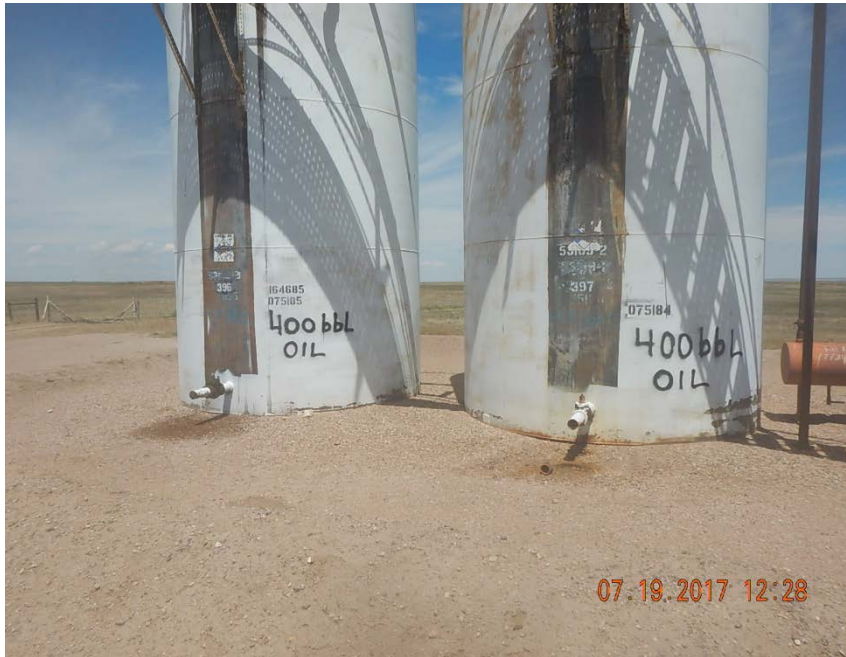
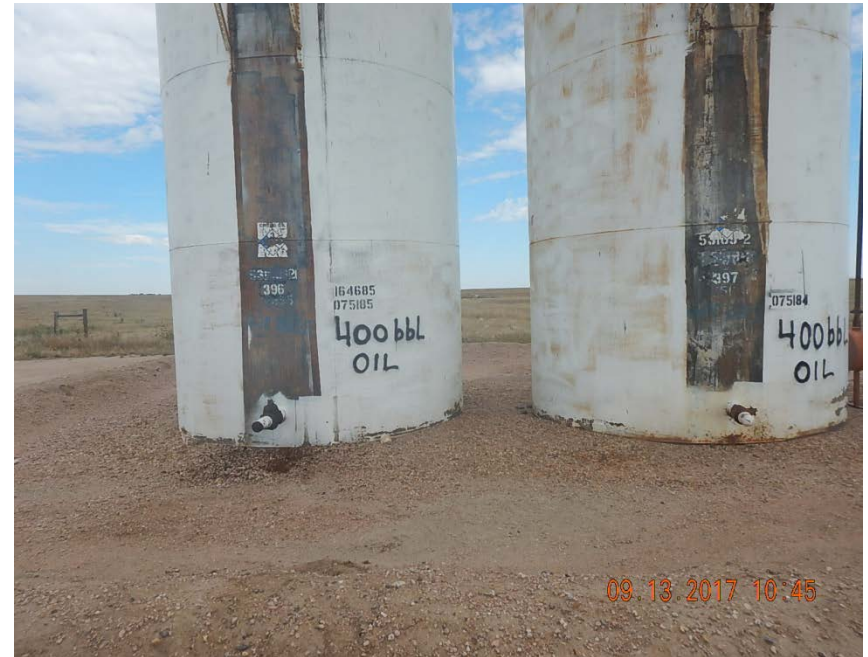
**Photo 4: Damaged placards on crude oil tanks**

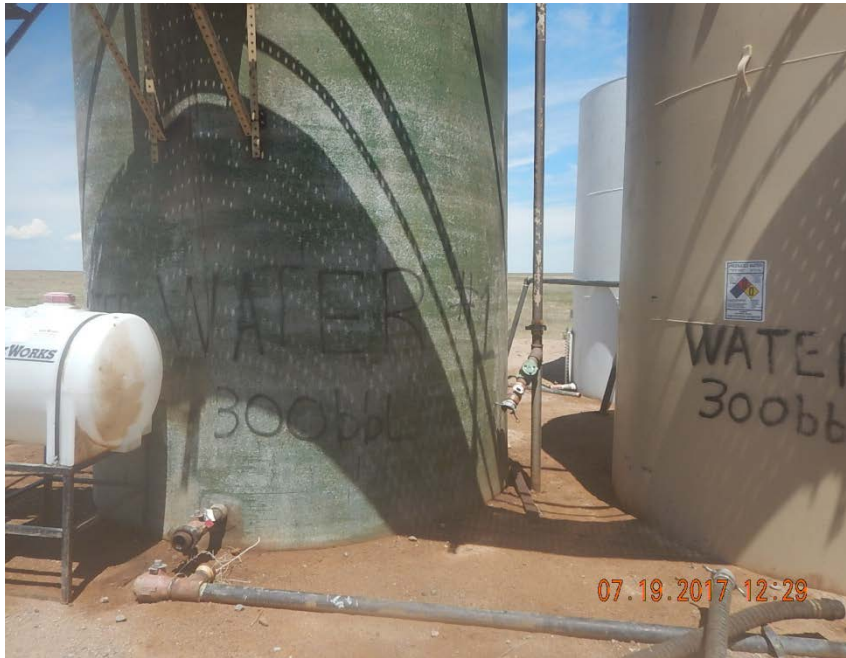
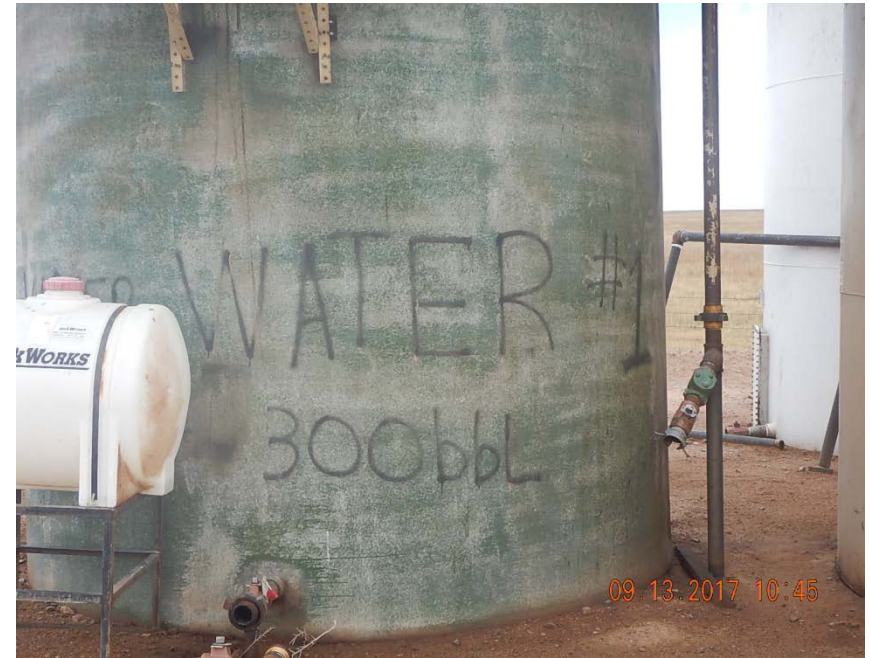
**Photo 5: Production tank lacking placarding**

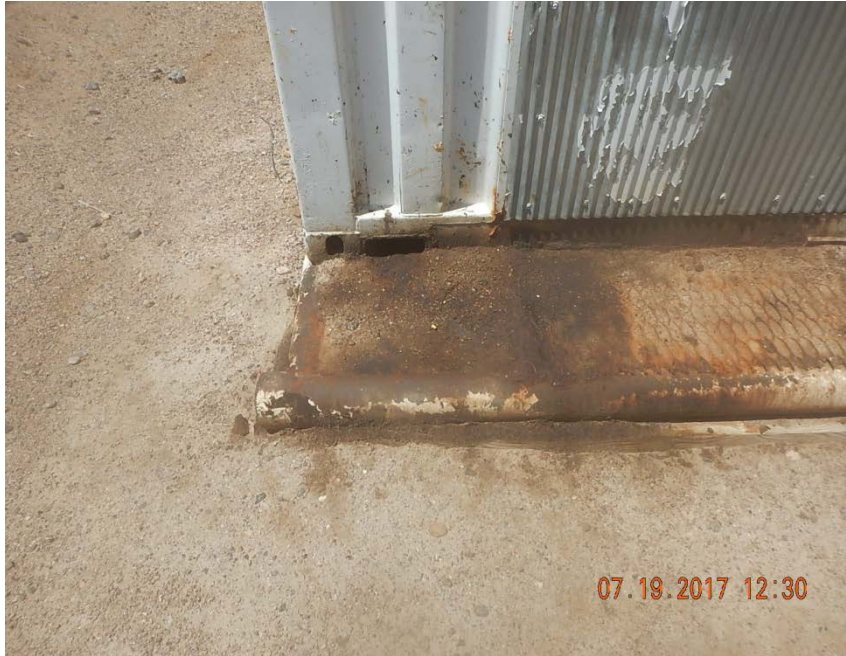
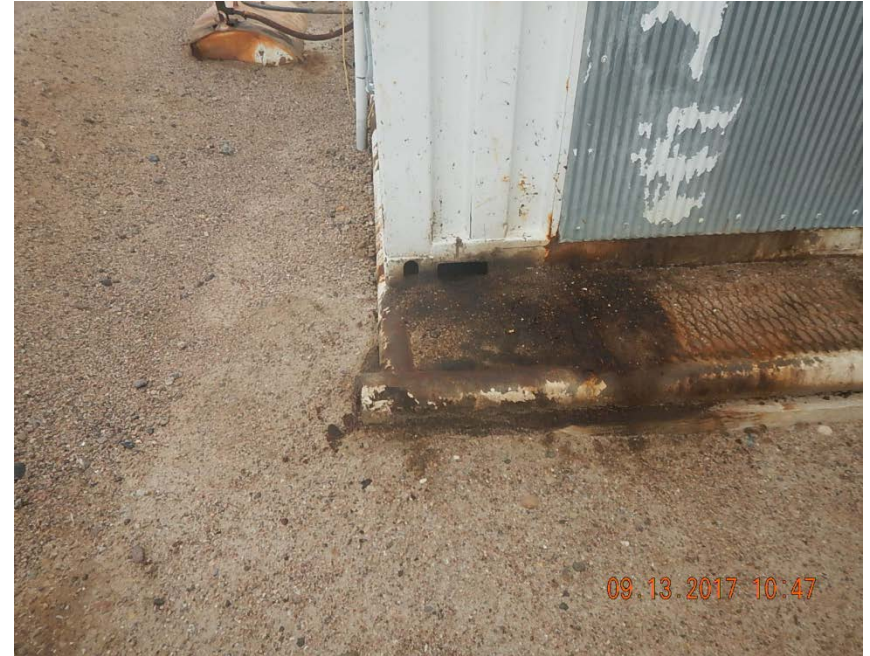
**Photo 6: Stained soil at SE corner of pumphouse**

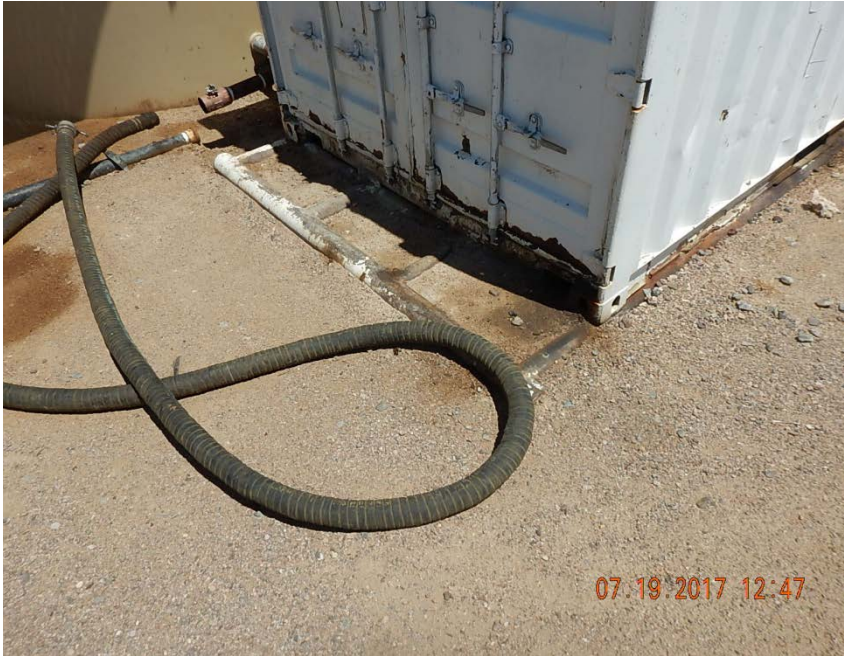
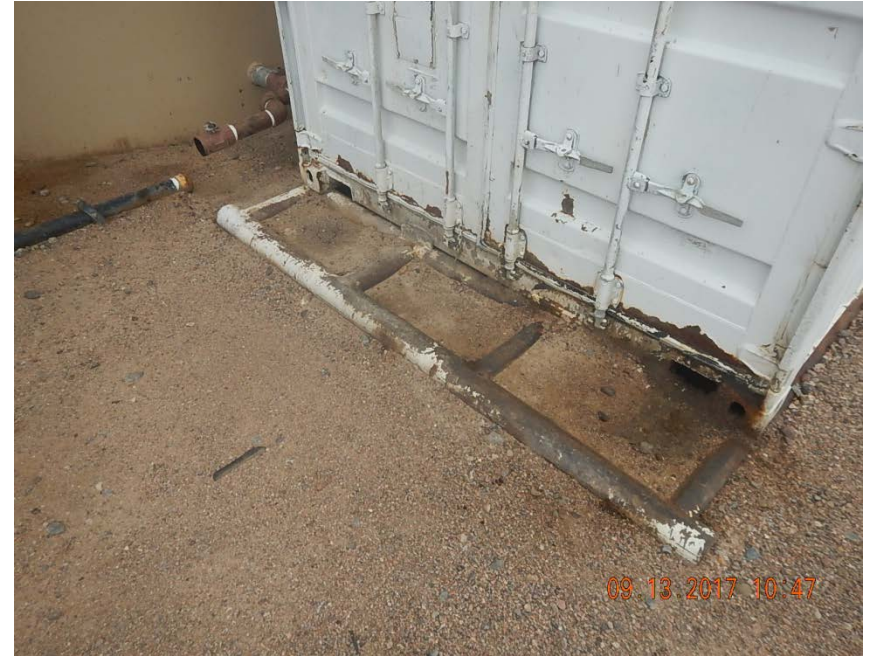
**Photo 7: Stained soil at SW corner of pumphouse, unused equipment removed.**

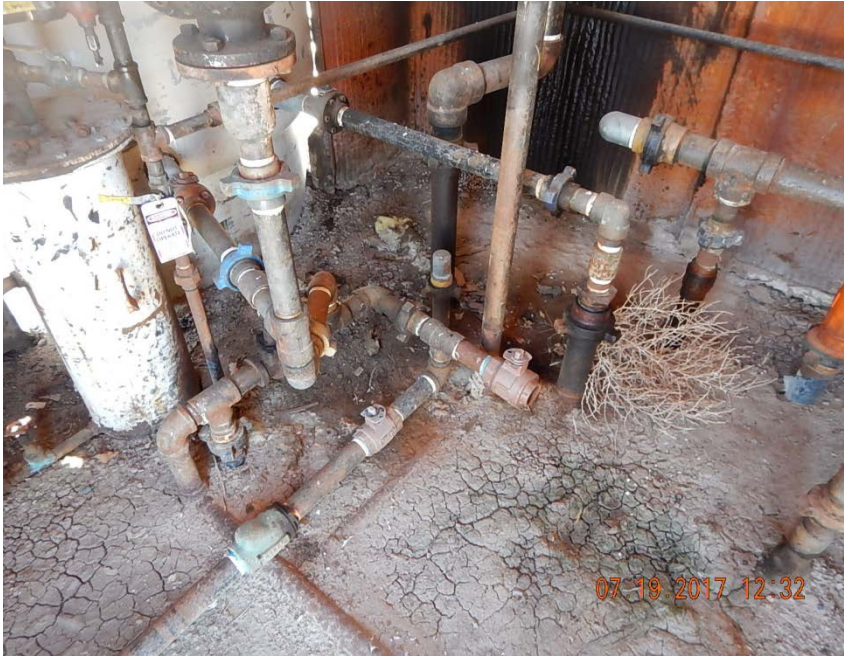
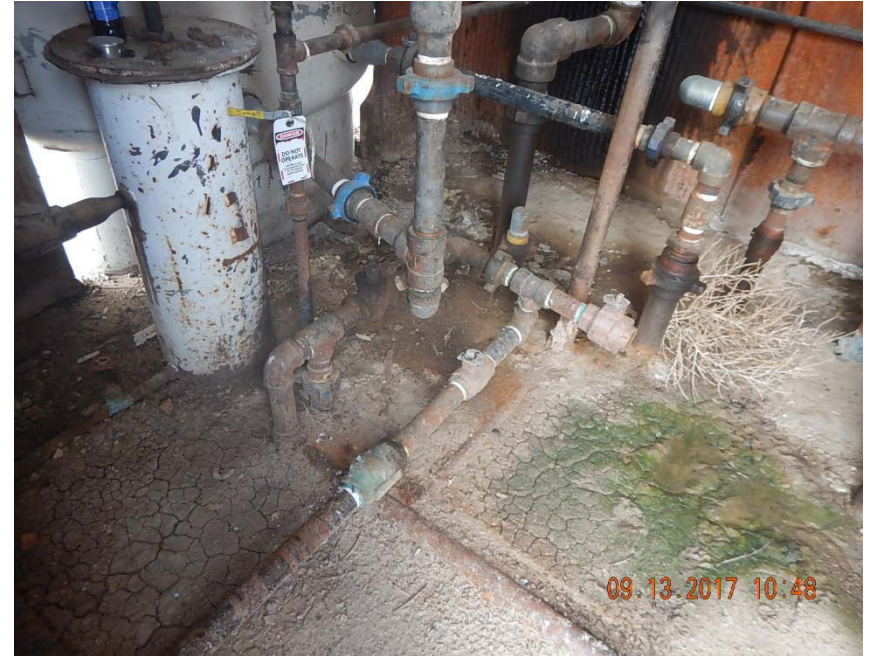
**Photo 8: Stained soil in treater house**

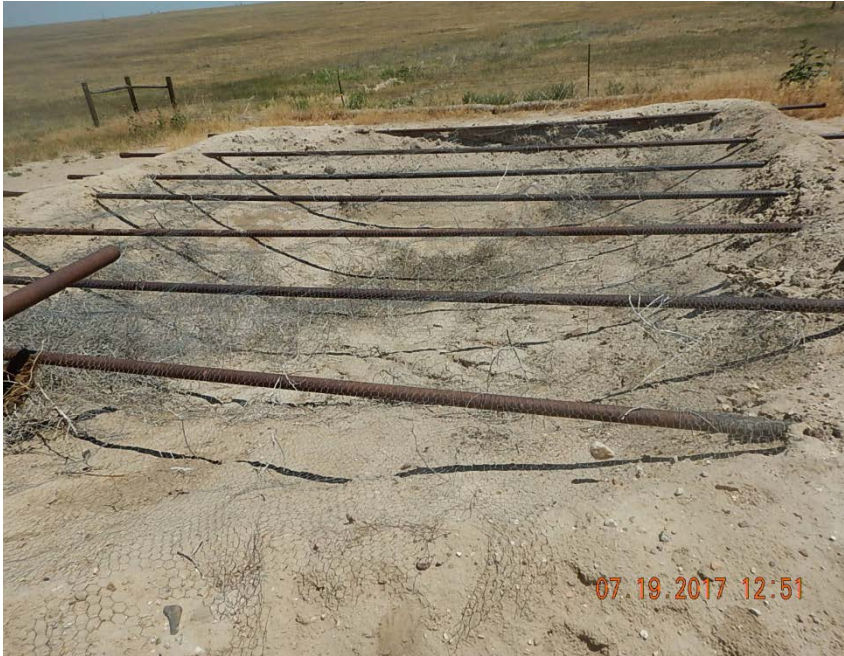
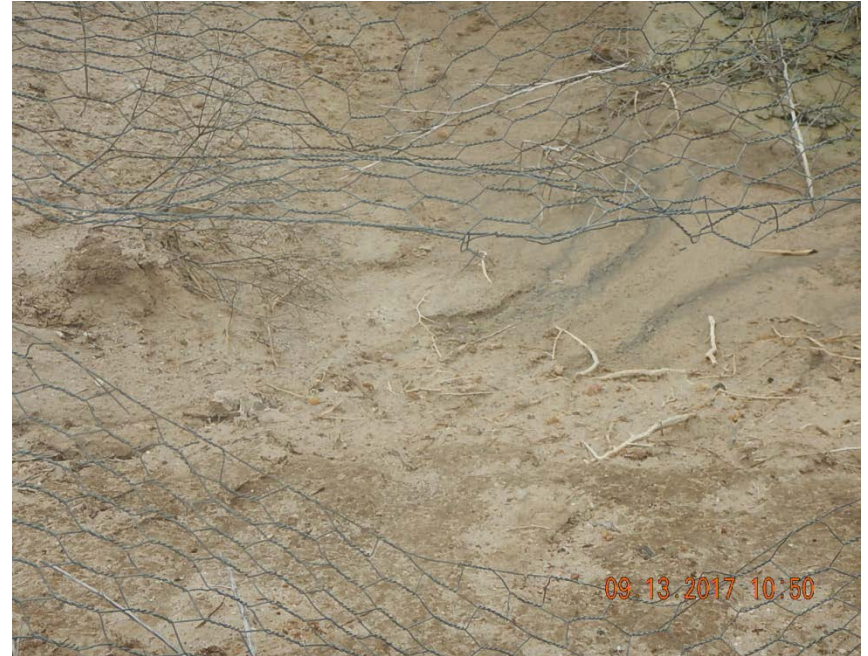
**Photo 9: Gaps in netting on pit**

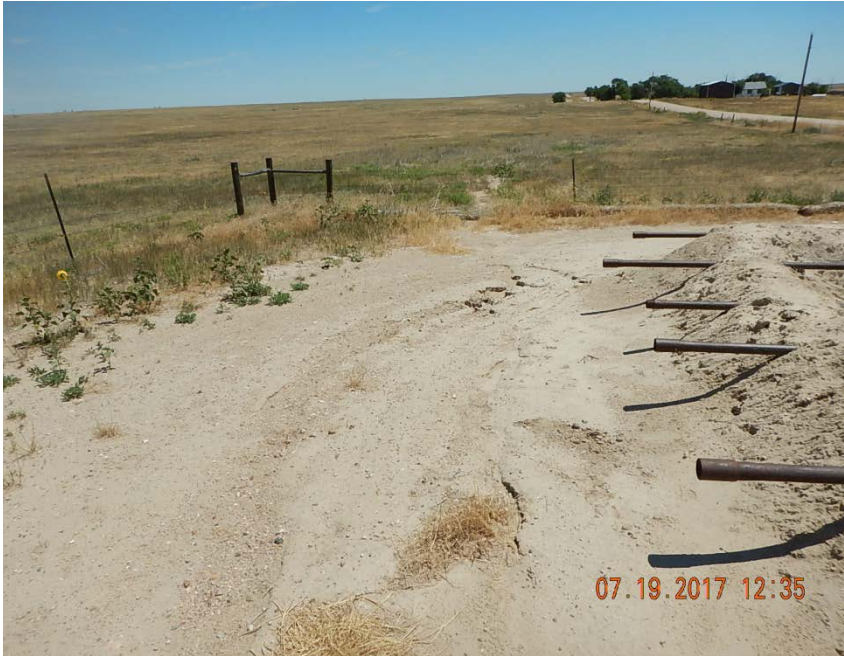
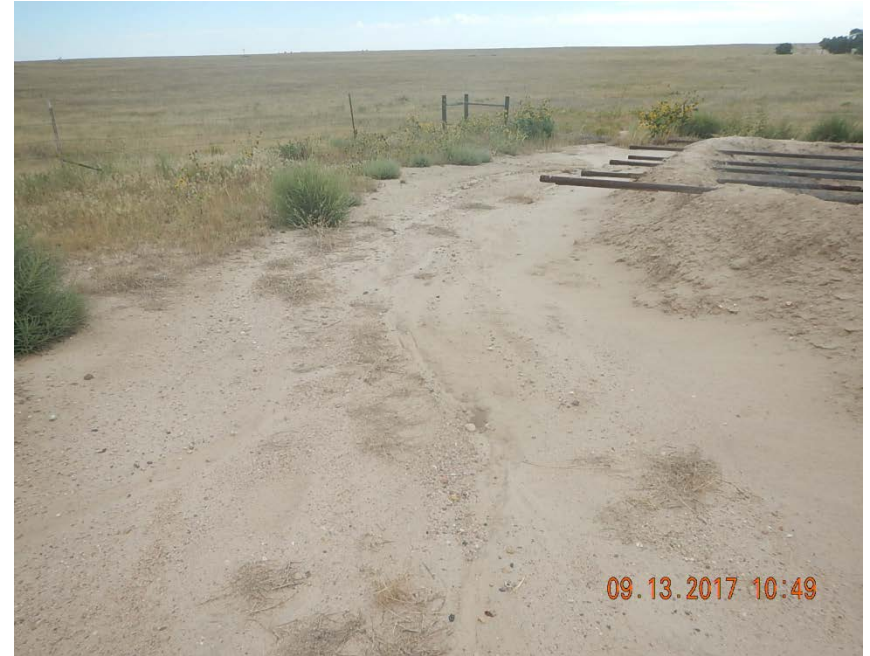
**Photo 10: Stormwater erosion on N side of pit.**

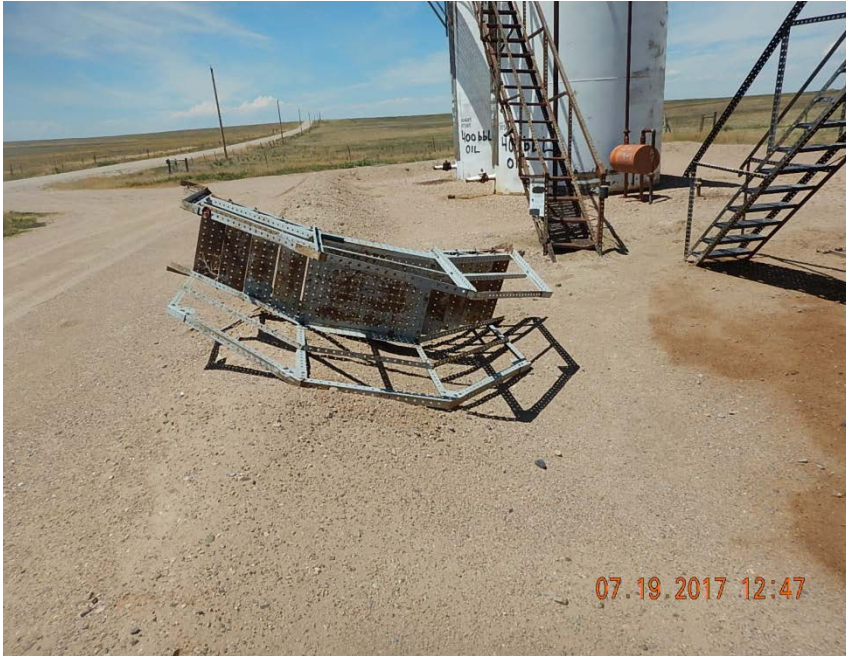
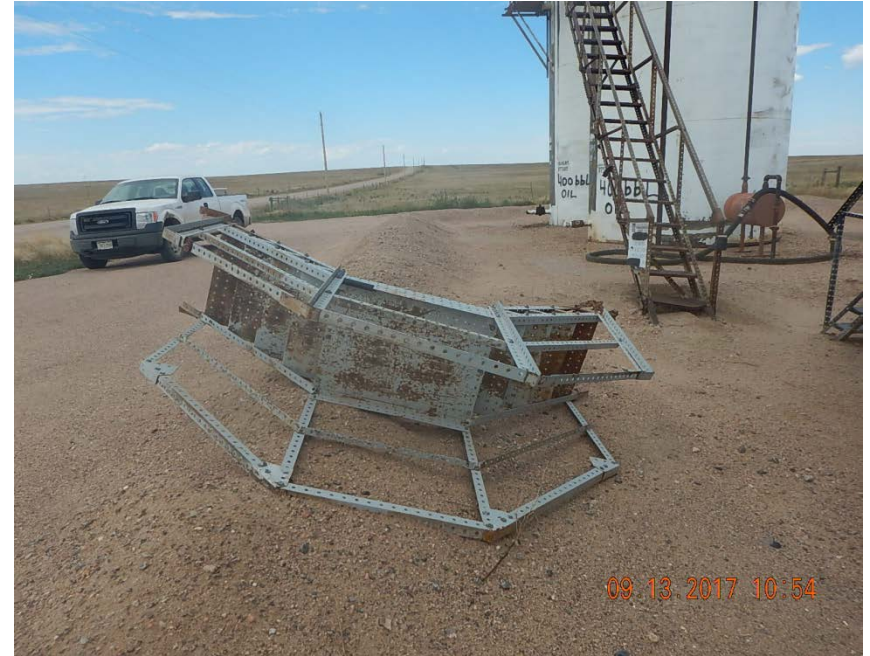
**Photo 11: Unused equipment at battery**

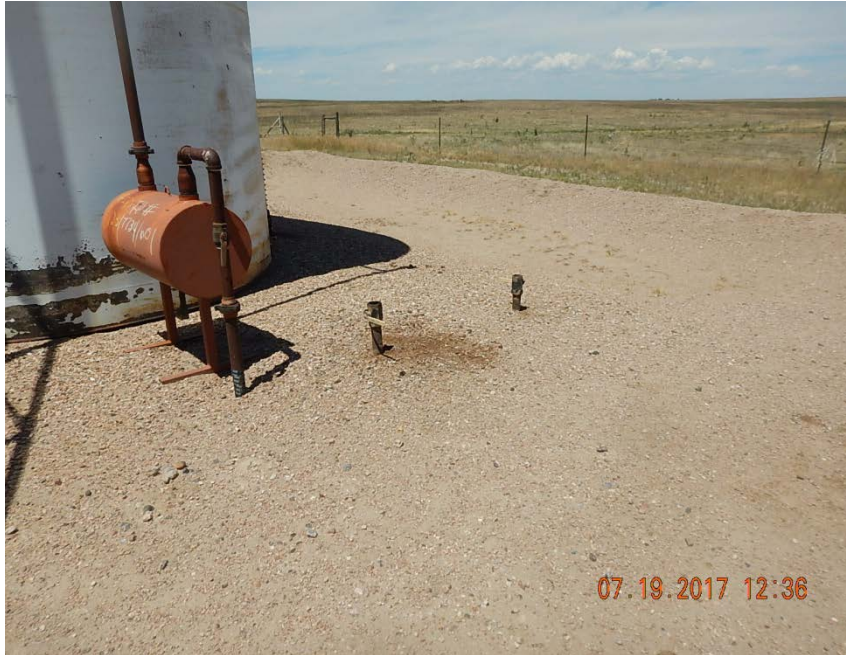
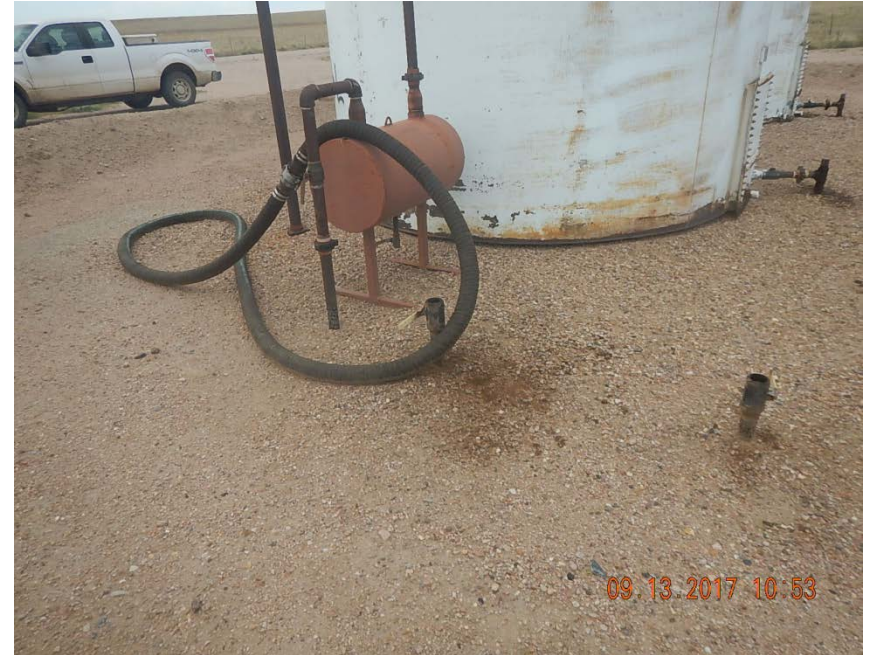
**Photo 12: Unmarked unused risers at location.**

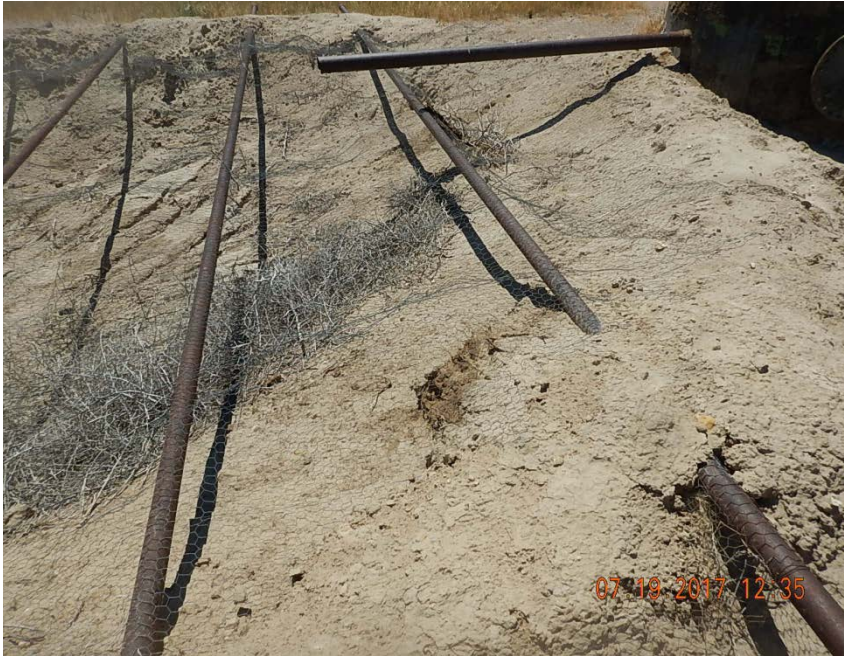
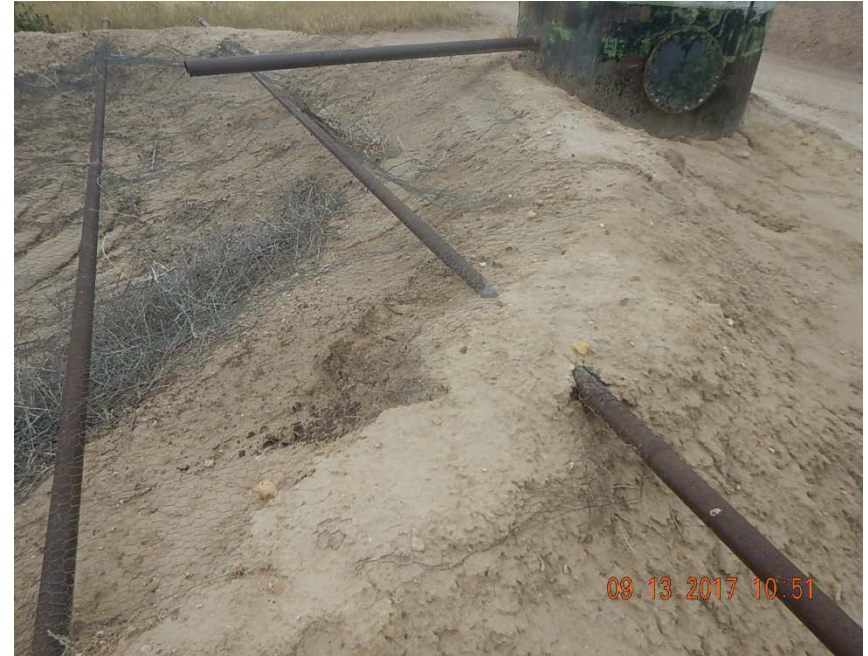
**Photo 13: Stained soil at NW corner of pit**

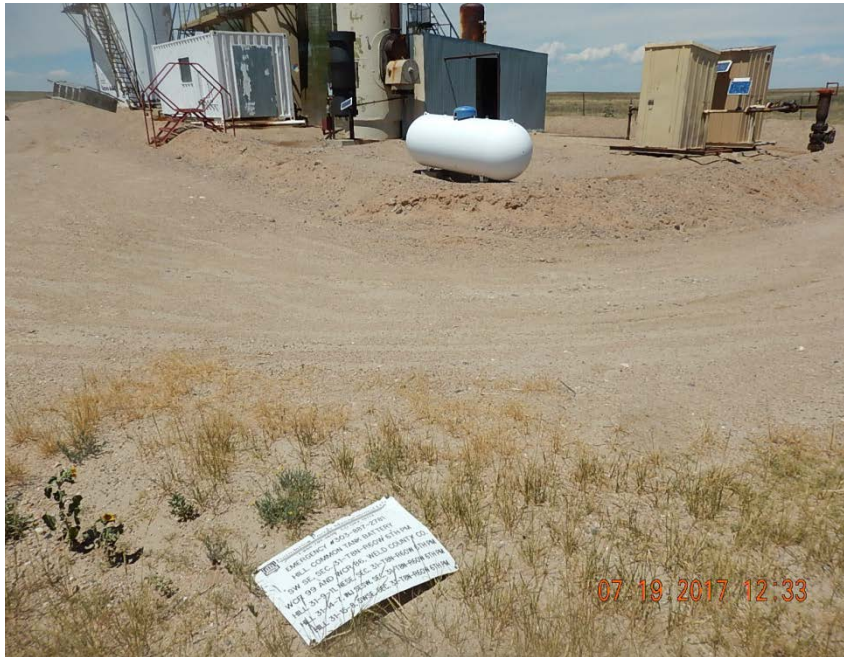
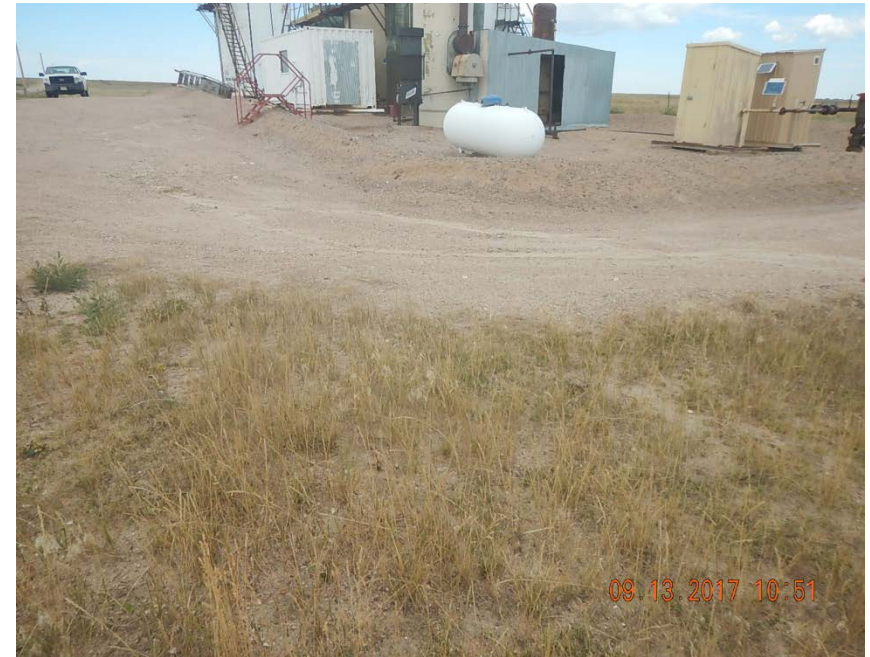
**Photo 14: Battery sign reattached**

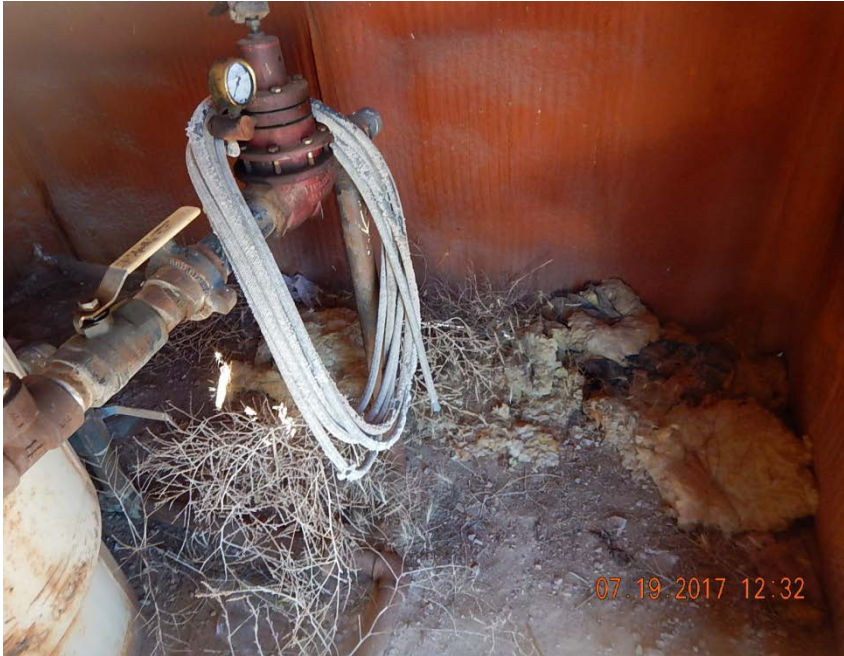
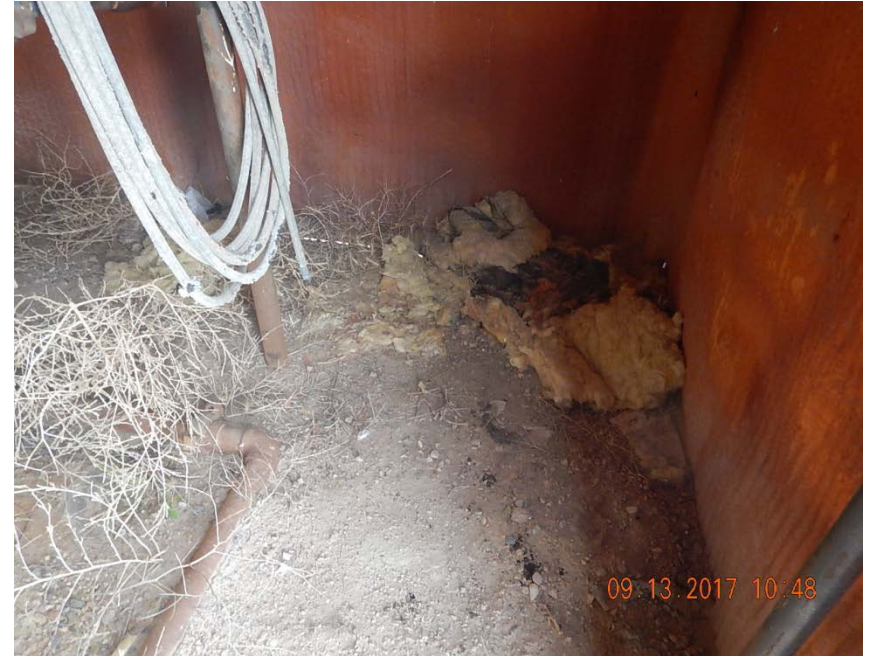
**Photo 15: Debris in treater house**

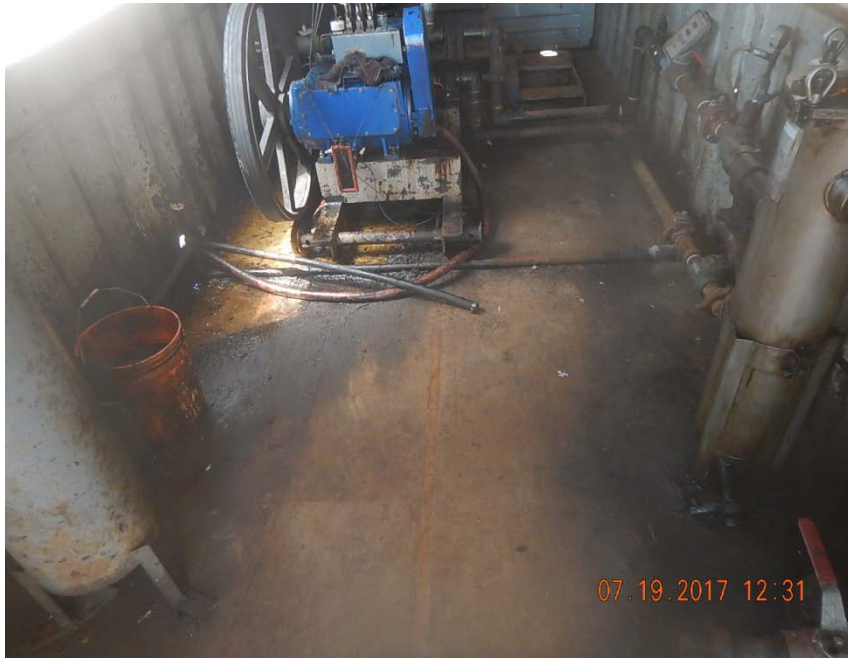
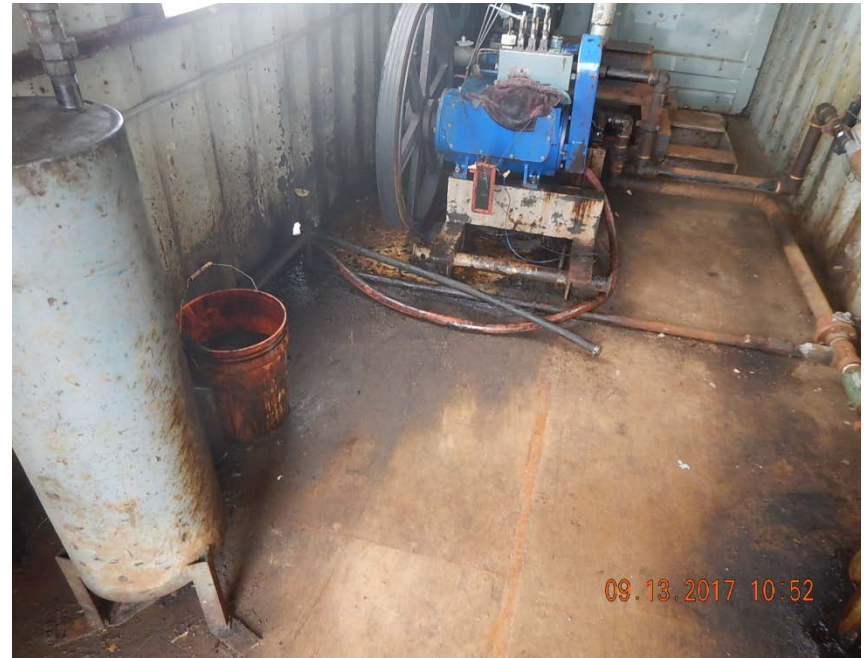
**Photo 16: Oily residue in pump house**

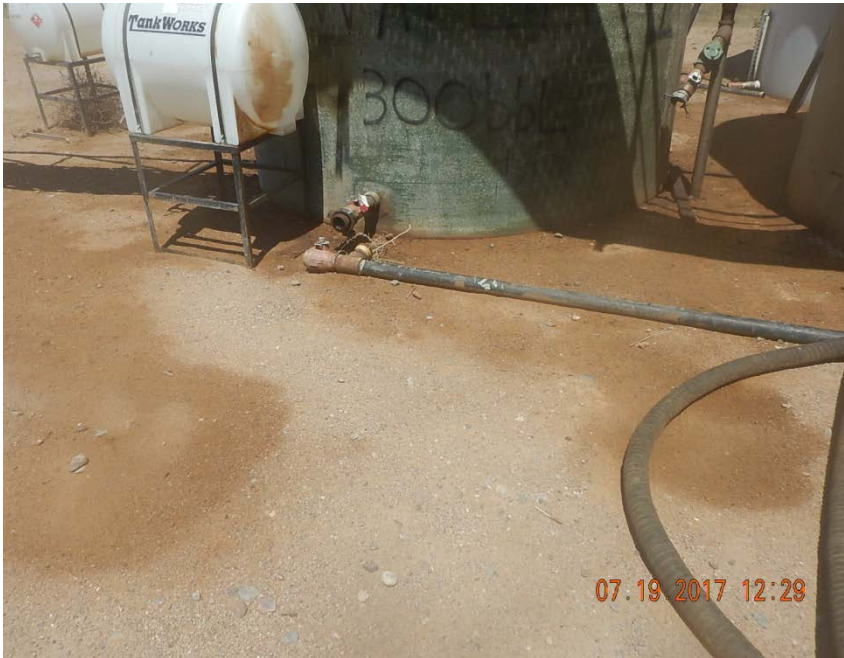
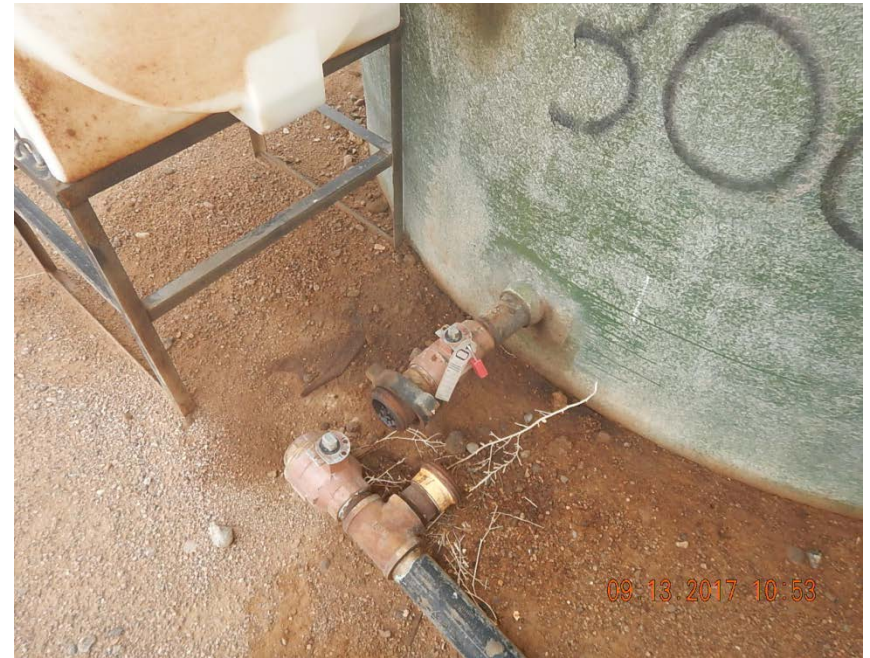
**Photo 17: Stained soil at produced water**

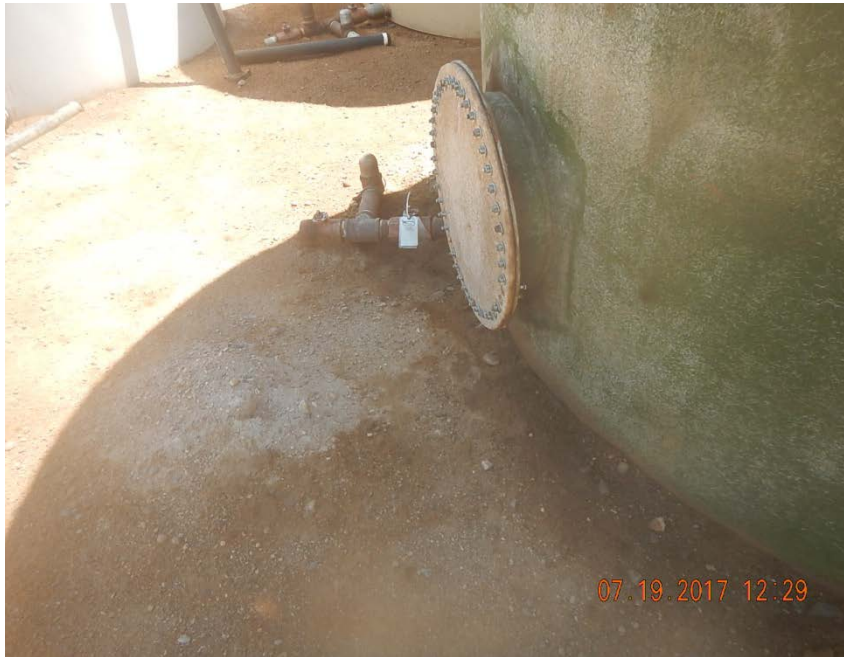
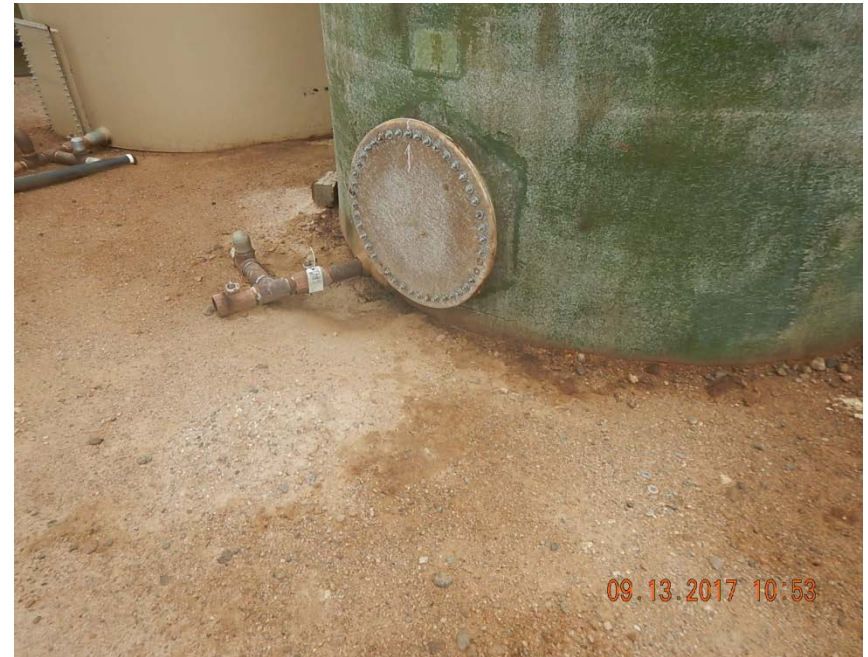
**Photo 18: Stained soil at produced water tank**

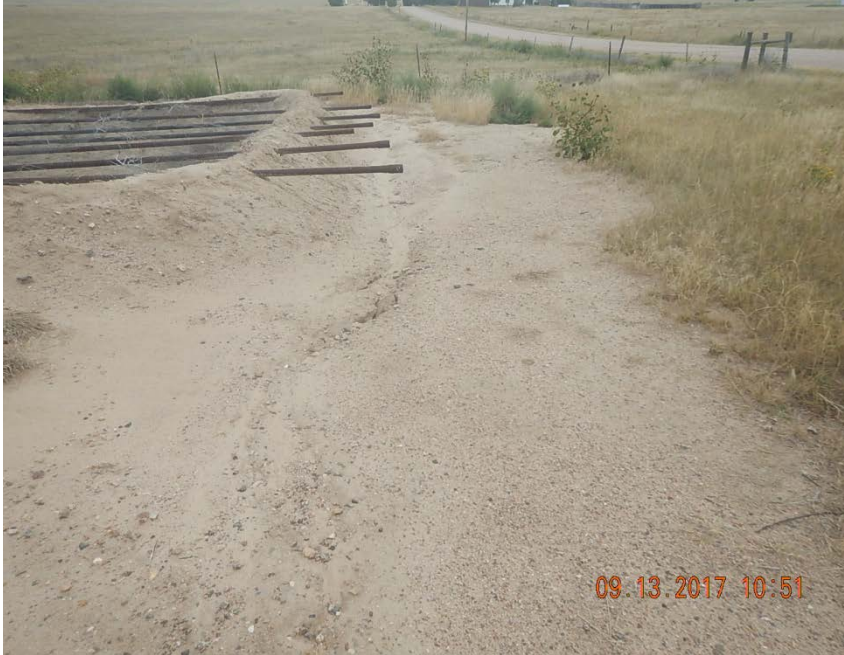
**Photo 19: Stormwater runoff on S side of pit**
