**Inspection Photos**  
**Location Name: Hill #31-9-11**  
**API: 05-123-19627**

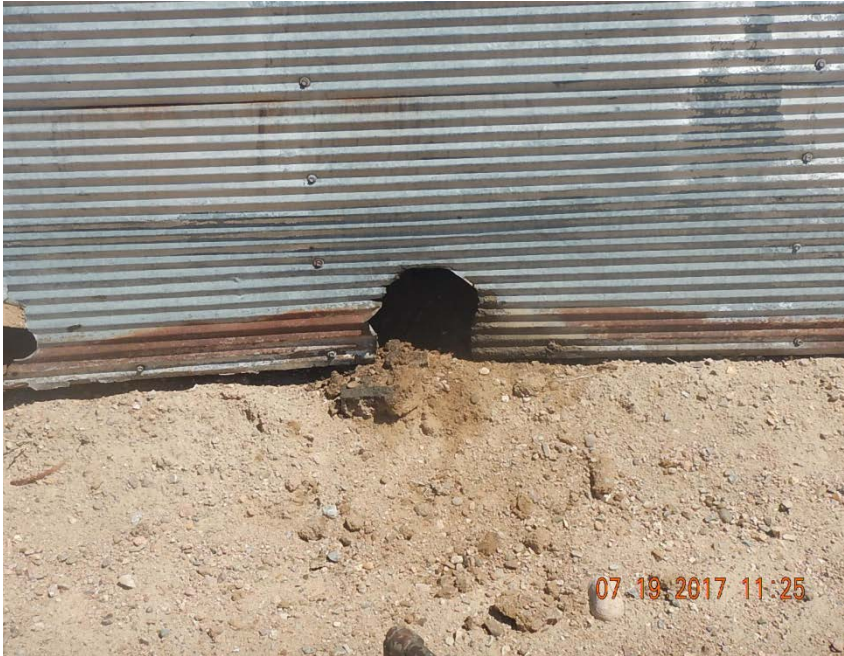
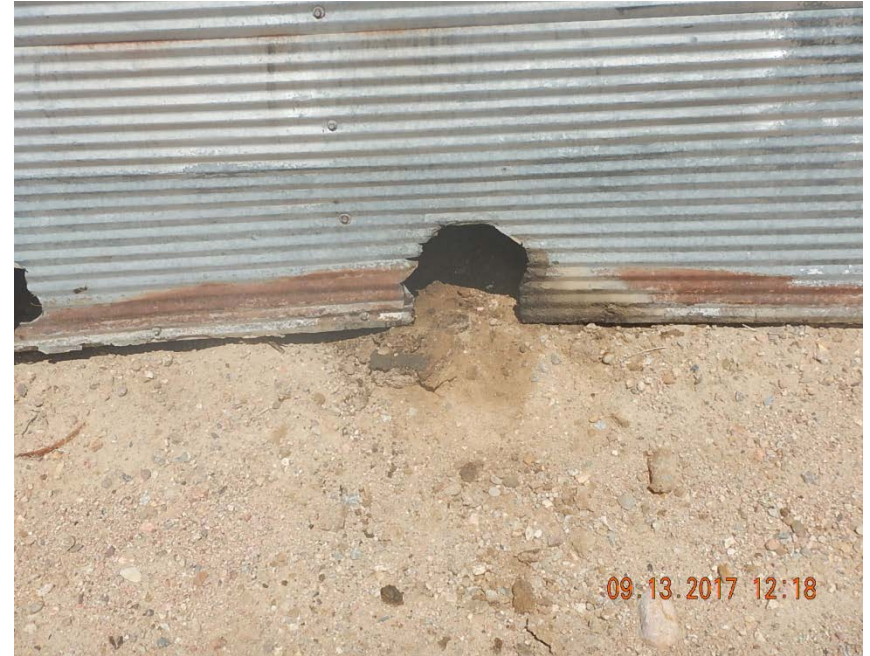
**Photo from prior inspection for comparison**

**Photo 1: Stained soil at engine house**

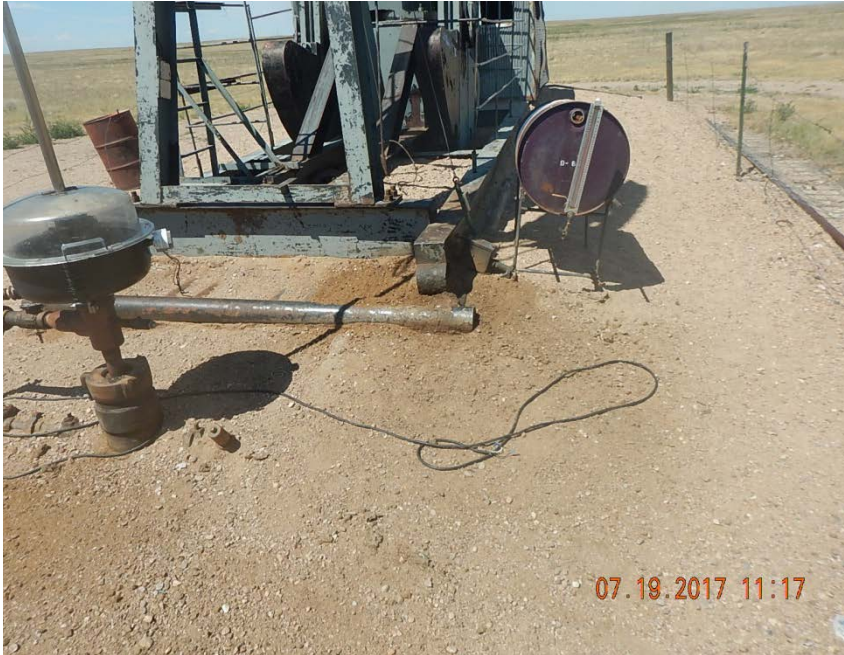
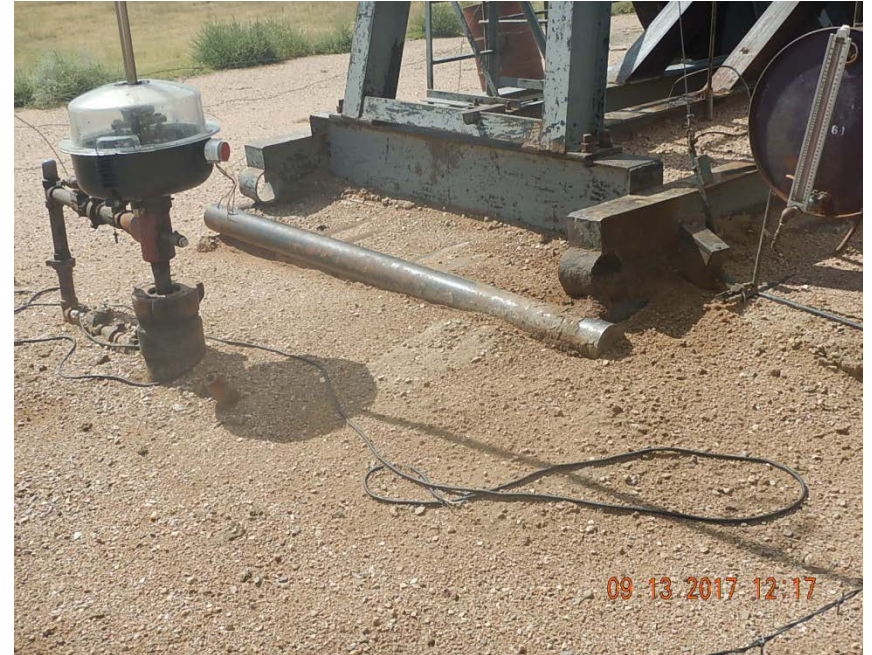
**Photo from prior inspection for comparison**

**Photo 2: Stained soil at pump jack**

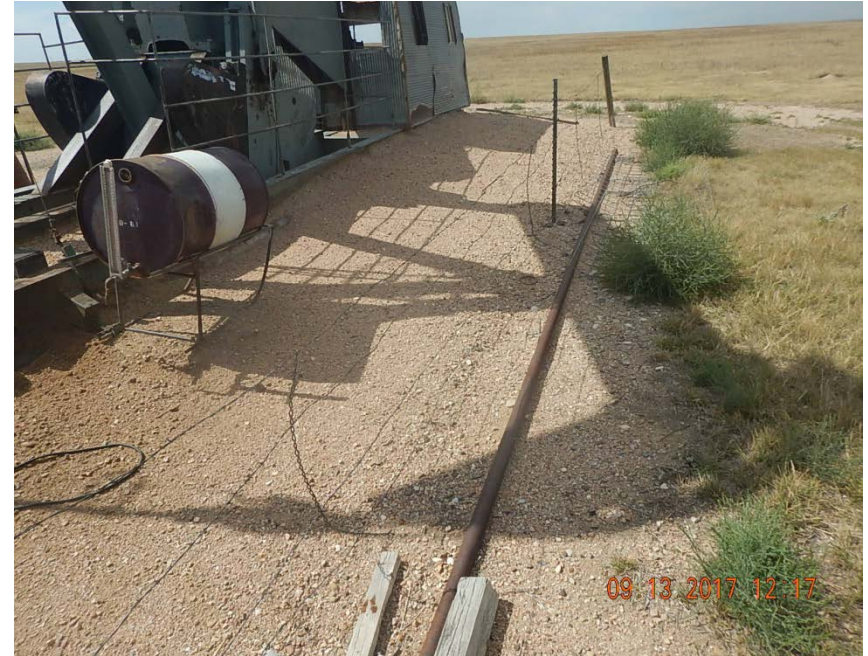
**Photo from prior inspection for comparison**

**Photo 3: Unused equipment by pump jack.**

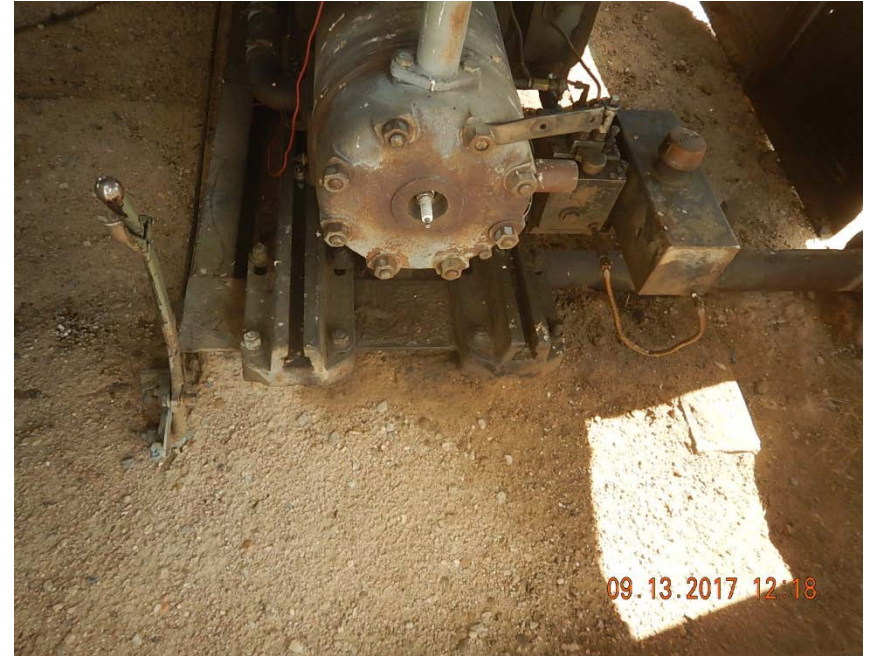
**Photo from prior inspection for comparison**

**Photo 4: Stained soil at engine**
