Inspection Photos
Location Name: Dinner E 14-5
API #: 05-123-25471

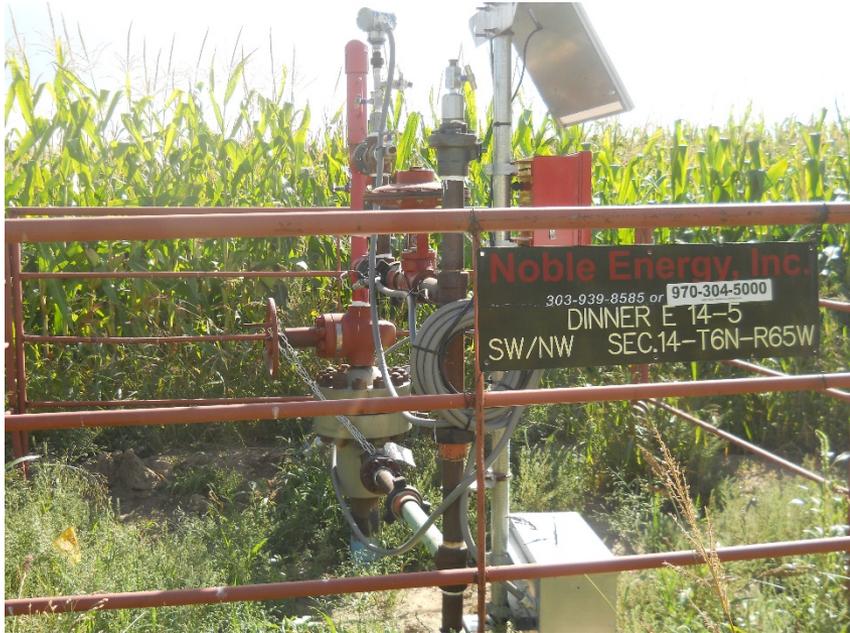
Wellhead looking east. Well is in active crops

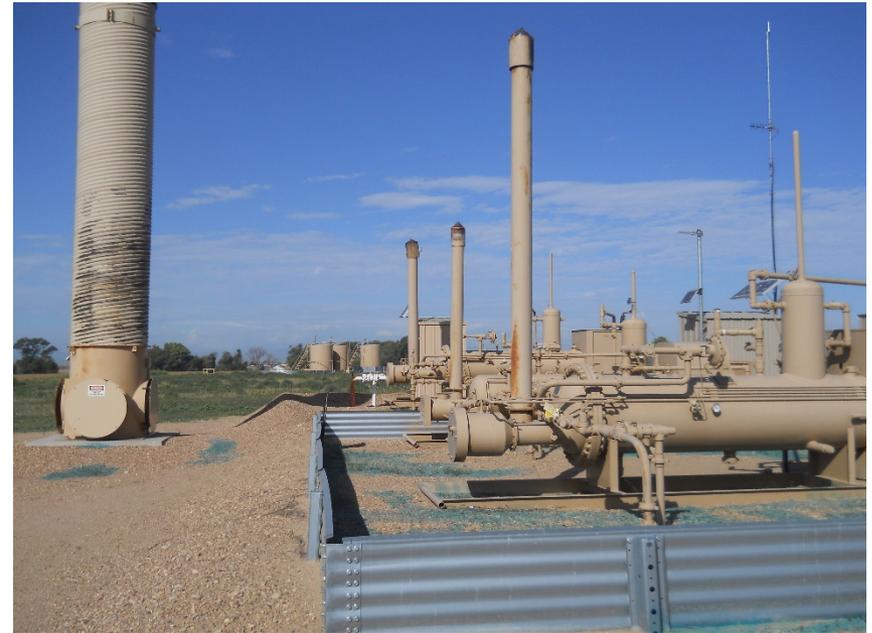
Battery looking west

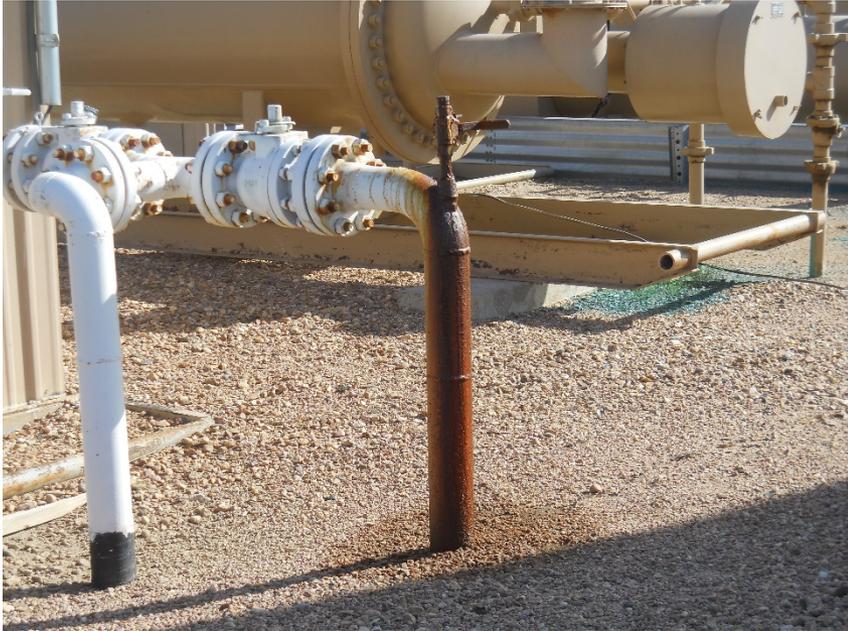
Leaking valve at gas meter run that is staining soil.

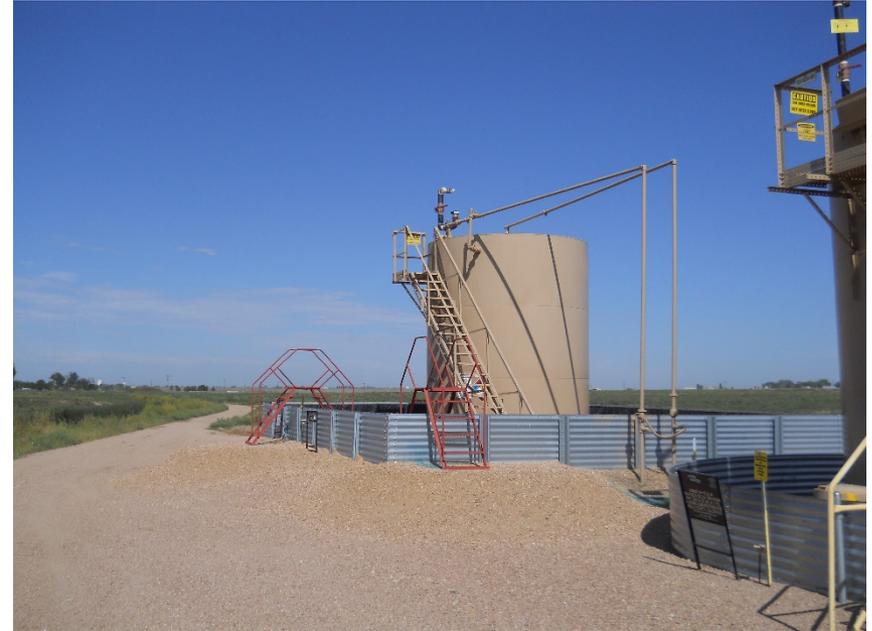
Tank battery looking west
