Inspection Photos
Location Name: Merrion Oil & Gas
API 05-103-10024
9/13/2017

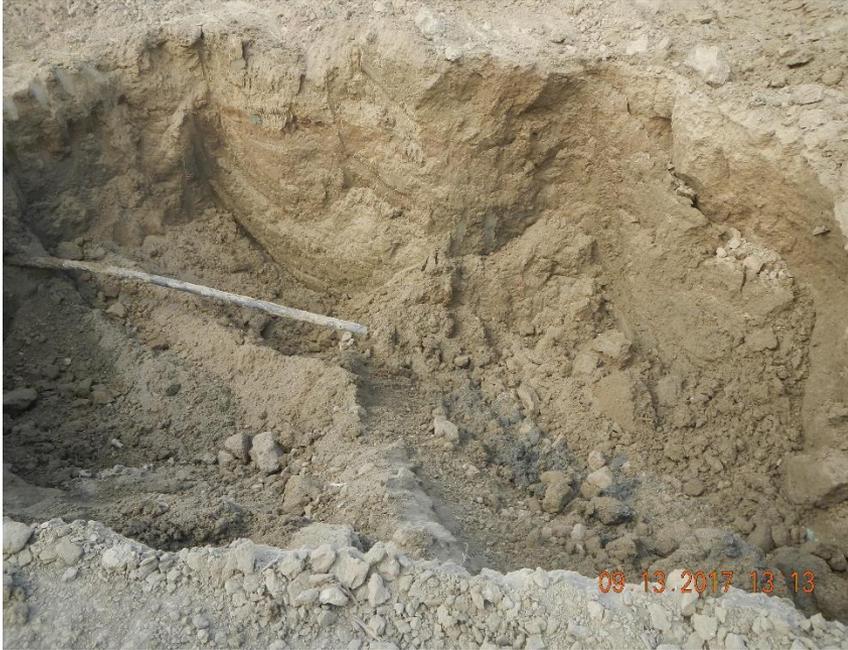
Looking north at dump line spill point into former pit

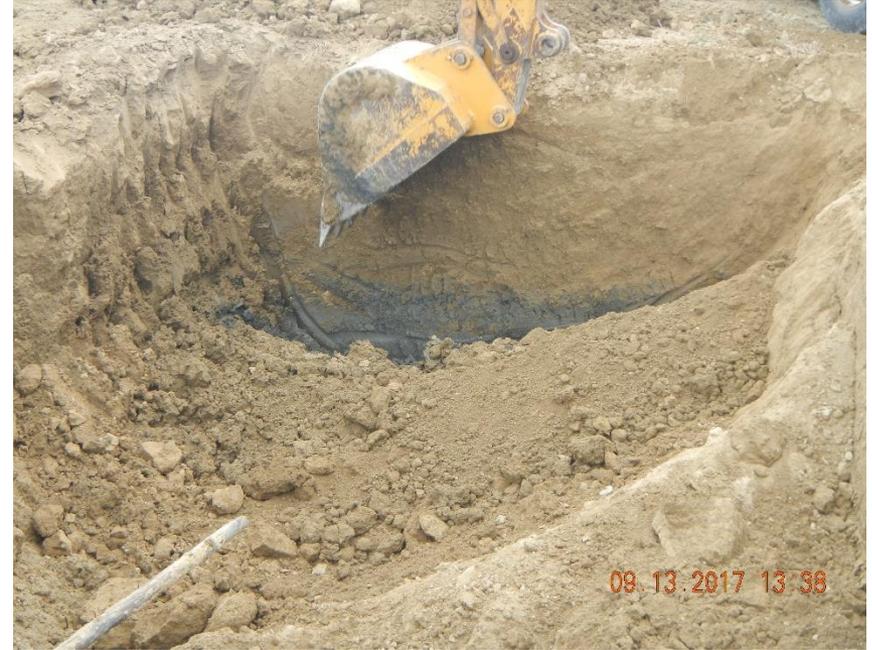
Historic contamination east end of former pit

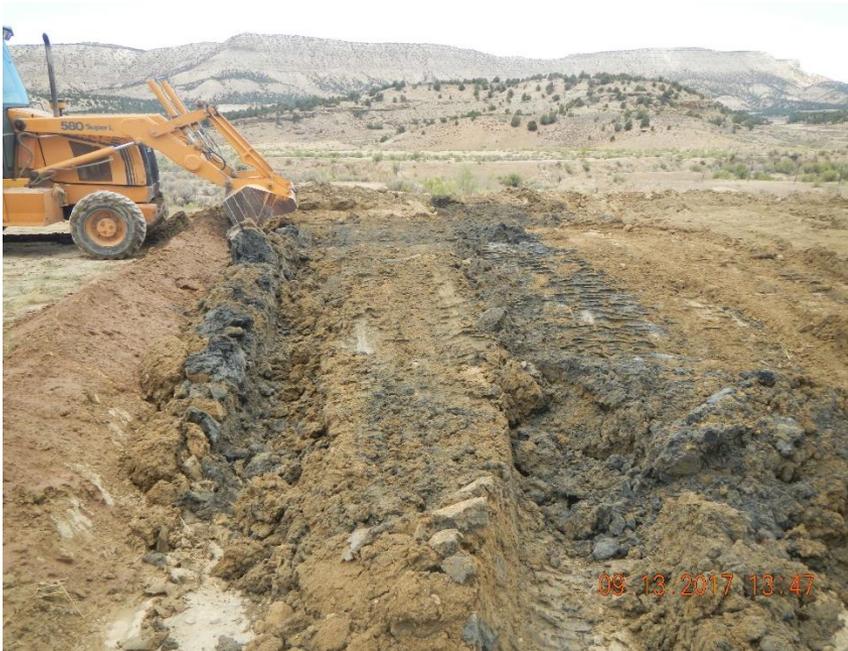
Looking north at landfarm under construction

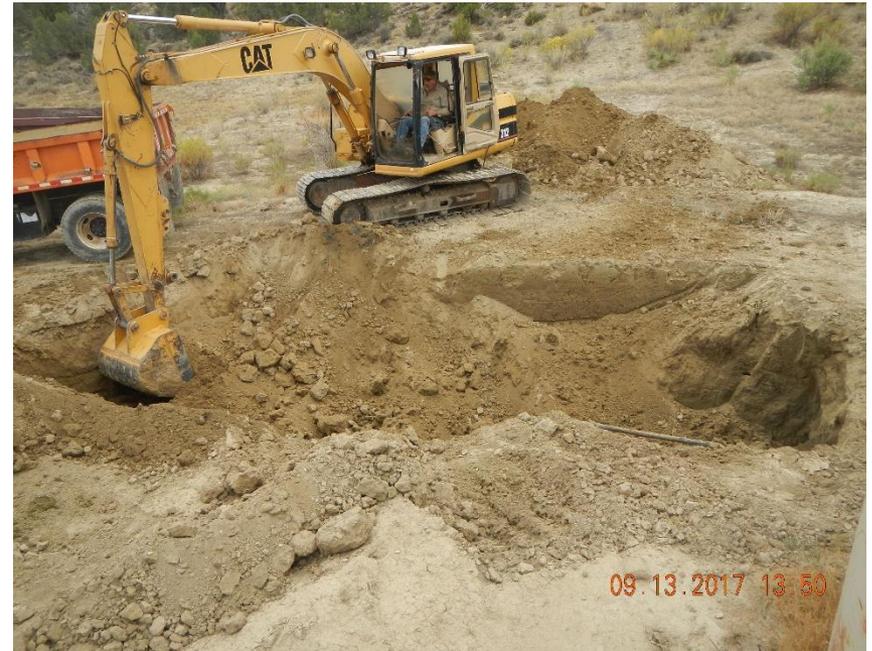
Looking southeast at excavation from AST
