COGCC conducted an inspection of the Wells Ranch USX BB 11-06 location (Location ID 310656) on August 24, 2017 (Document 684904162). During that inspection, COGCC made the following observations:

Name: Wells Ranch USX BB 11-06

Location ID: 310656

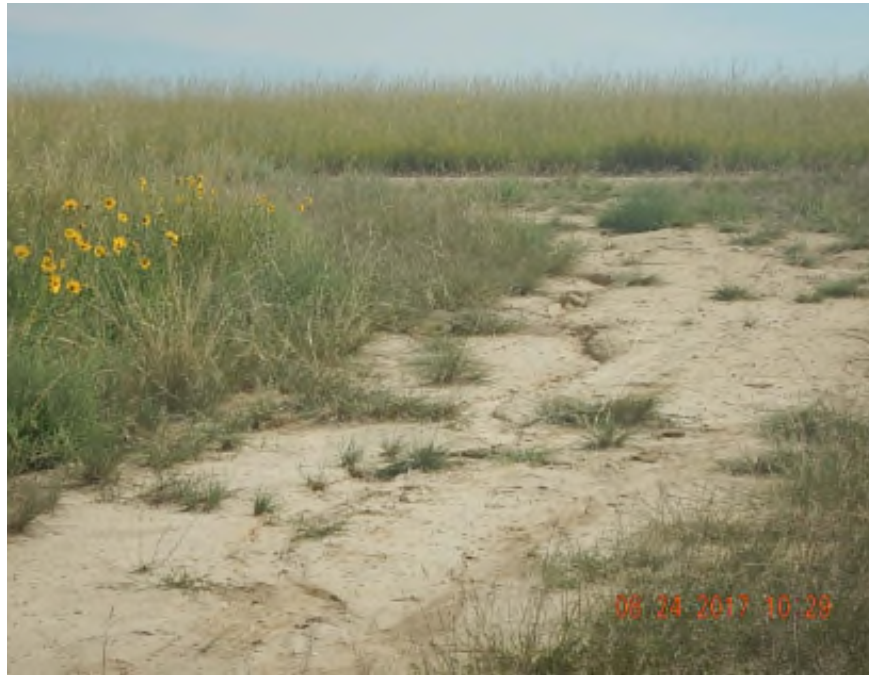
COGCC – 8/24/17

1. Storm Water: Stormwater erosion along lease road. Install or repair required BMPs per Rule 1002.f. Refer to the 1002.f guidance document for further details.

Photo 2: Stormwater erosion on lease road, looking E

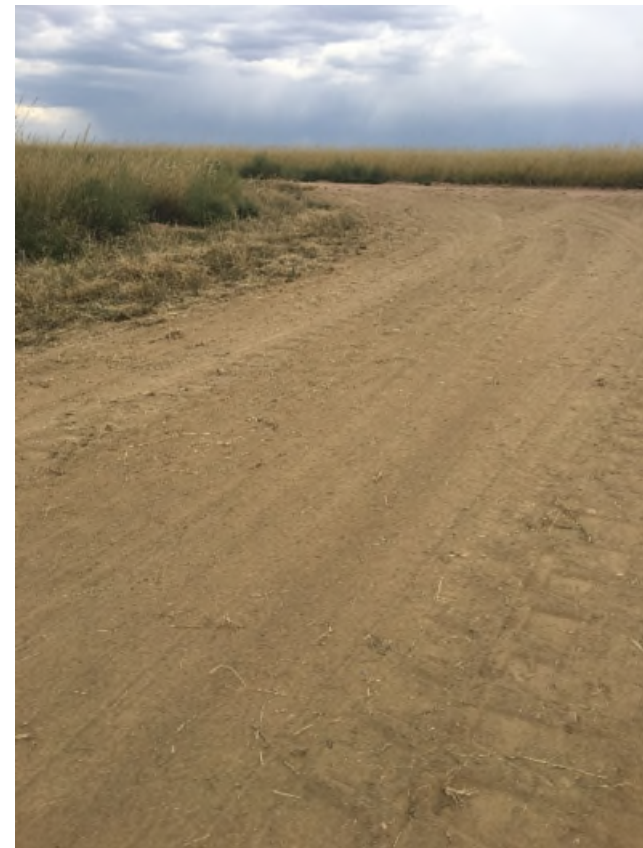
Noble Energy – 9/13/17

Photo NBL1. Noble has repaired erosion on the lease road and mowed vegetation.

Response: Noble has repaired the erosion on the lease road. The vegetation has also been mowed.
