Inspection Photos

Operator: GRAND MESA OPERATING CO - 35080

Location ID: 438955

Inspection Doc. Number: 682502554

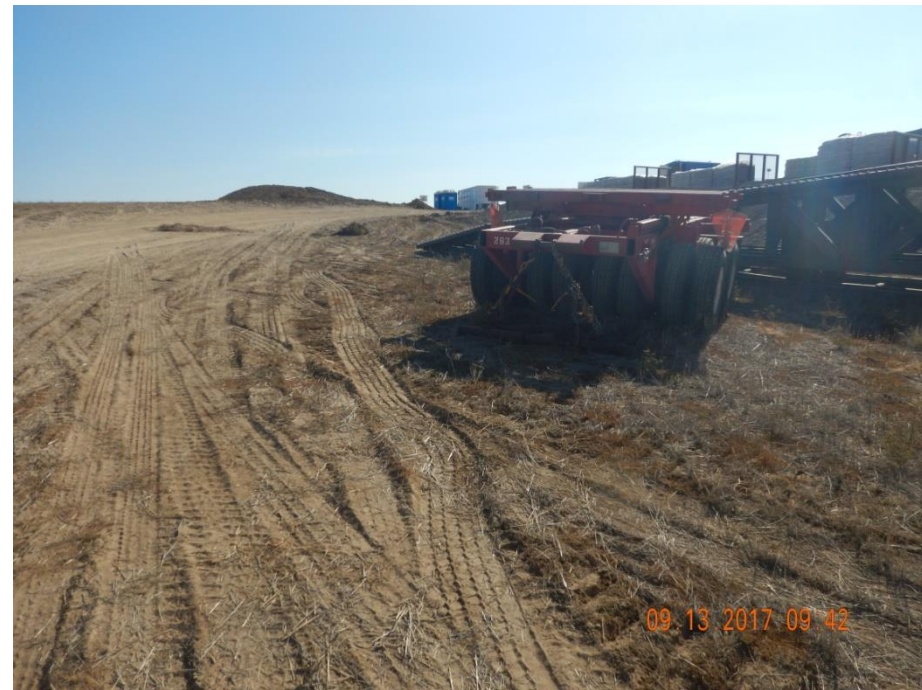
Photo 2: Photo taken from the northeast end of the location, facing east. North and south ends of location along slope of hill. Areas of the access road and north end of the location at risk to stormwater degradation. Advise incorporating additional BMPs in these areas.

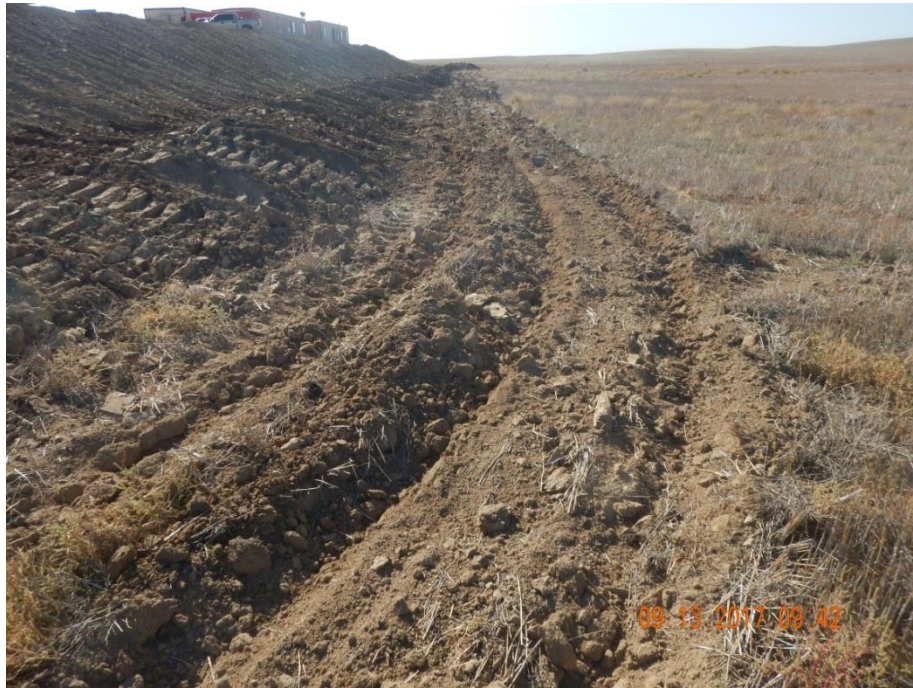
Photo 3: Photo taken from the west end of the location, facing south. Photo shows surface roughening has been implemented along the perimeter of the location.

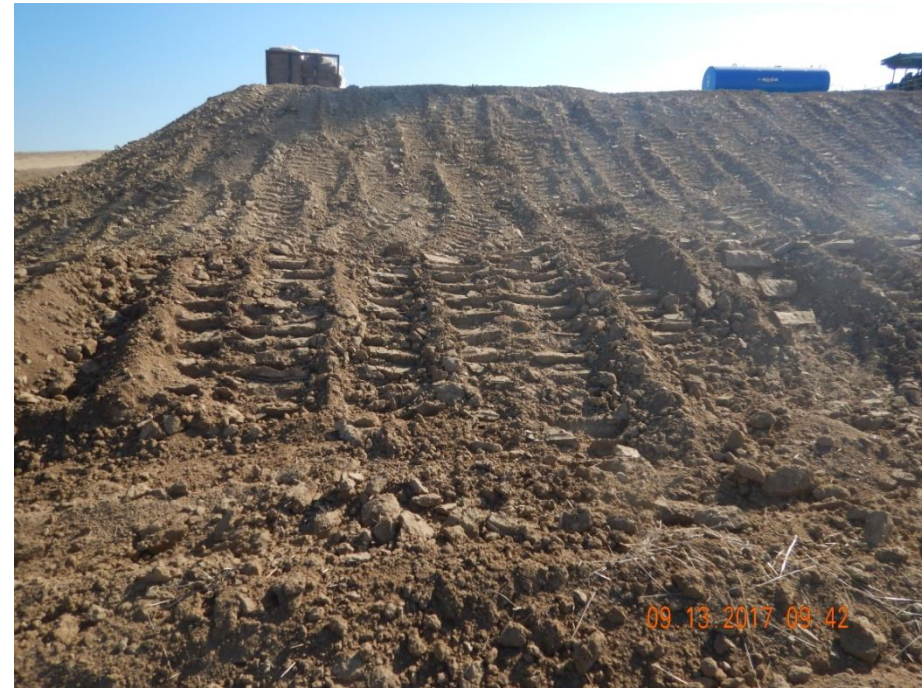
Photo 4: Photo taken from the west end of the location, facing east. Photo shows slopes of the pad and berms have been tracked, but remain largely unconsolidated. In their current condition BMPs are sufficient on a temporary basis, however slopes and berms will require additional consolidation once more permanent BMPs are required.

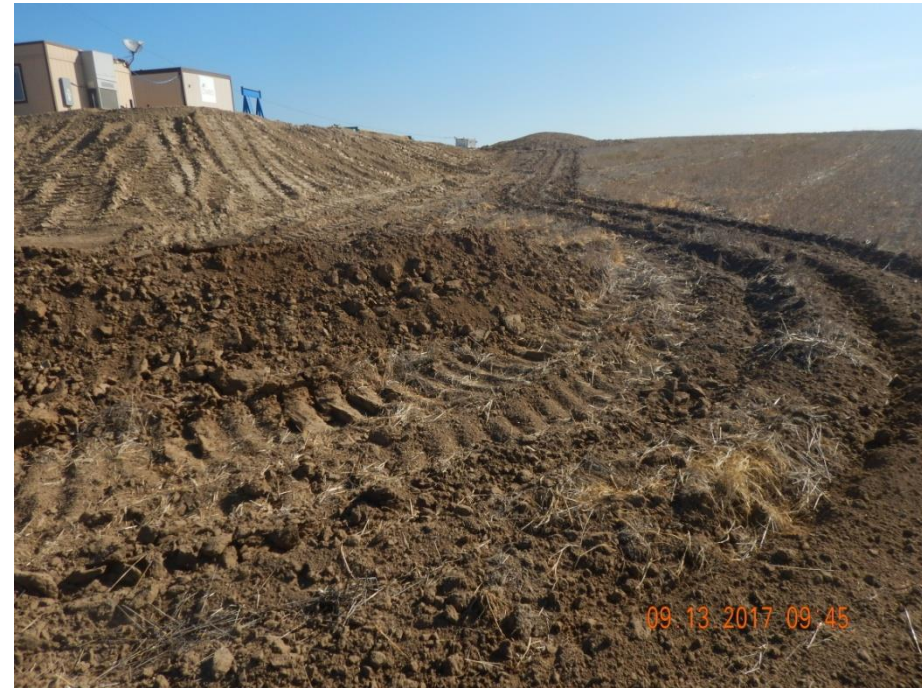
Photo 6: Photo taken from the southwest end of the location, facing east. Please note that surface roughening surface had been implemented up the slope, rather than along the contour per good engineering practices. This will likely contribute to erosion and degradation during a stormwater event. Advise implementing additional BMPs to be used in conjunction to surface roughening on the slopes.

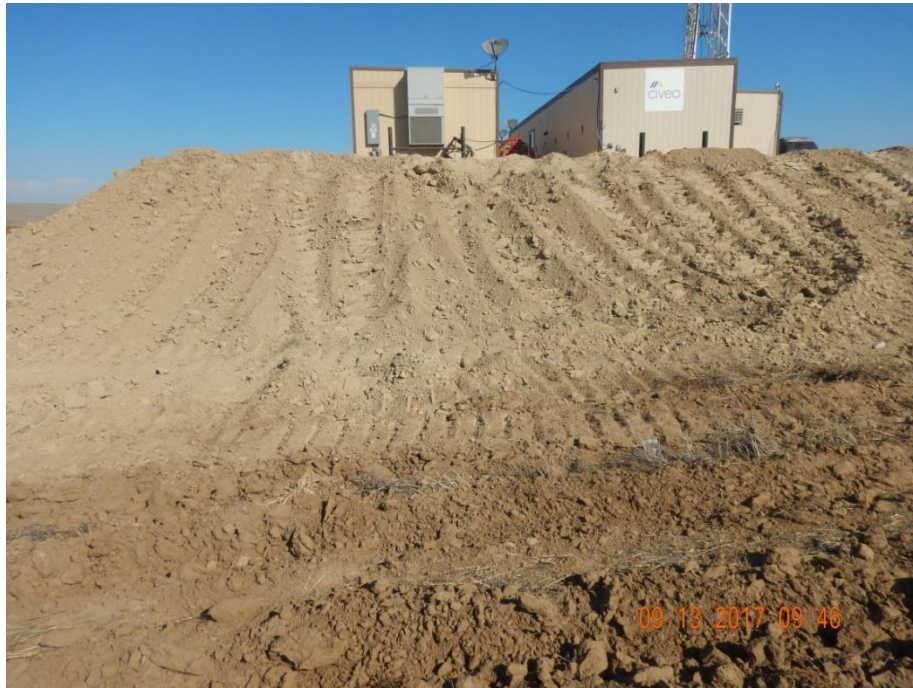
Photo 7: Photo taken from the south end of the location, facing north. Photo shows tracking had been attempted on the slopes, however slopes remain largely un-consolidated.

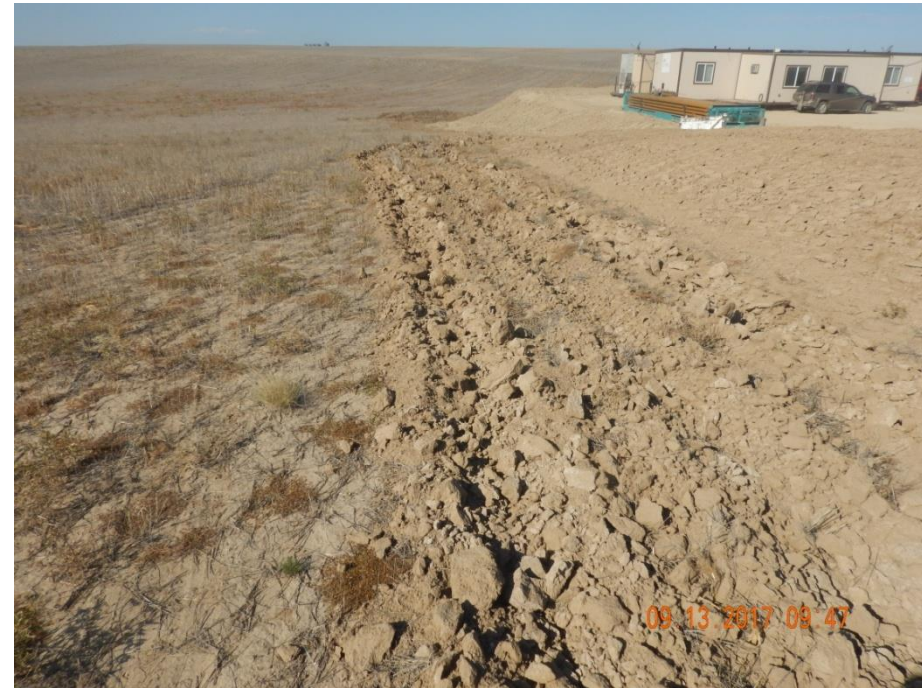
Photo 8: Photo taken from the south end of the location, facing west. Photo shows surface roughening surface had been implemented up the slope, rather than along the contour per good engineering practices. This will likely contribute to erosion and degradation during a stormwater event. Advise implementing additional BMPs to be used in conjunction to surface roughening on the slopes.

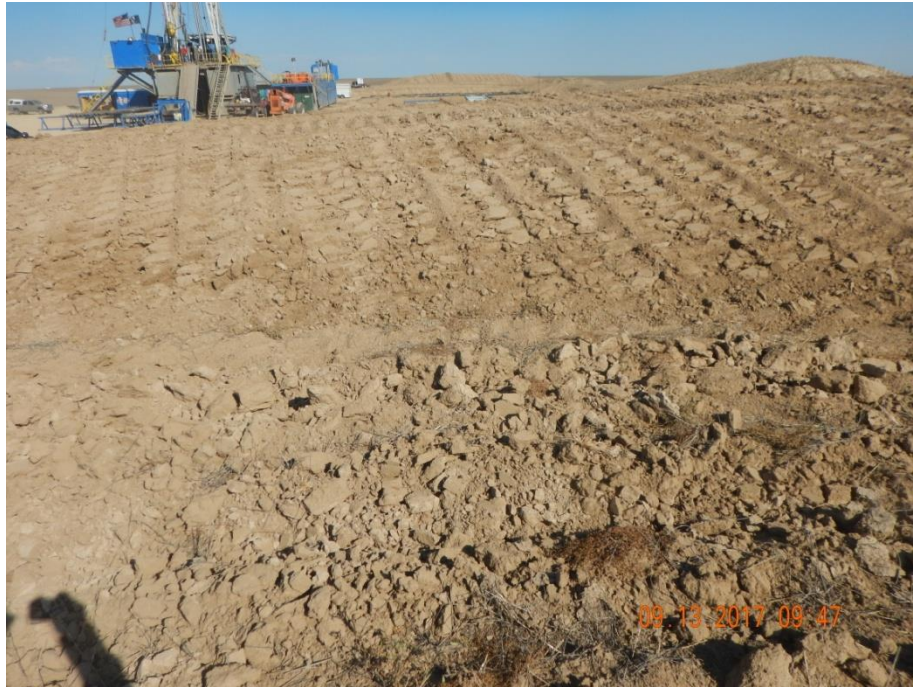
Photo 9: Photo taken from the south end of the location, facing north. Photo shows tracking along soil stockpile.

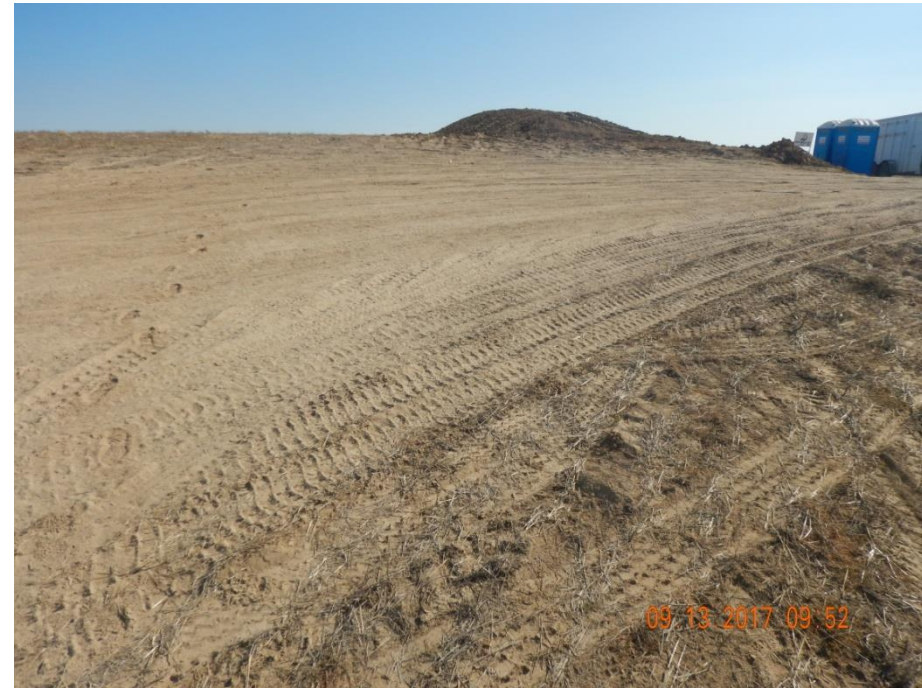
Photo 14: Photo taken from the north end of the location, facing east. Photo shows areas of the access road and north end of the location at risk to stormwater degradation. Advise incorporating additional BMPs in these areas.
