# Construction and Stormwater Inspection

September 19, 2017

Operator: GREAT WESTERN OPERATING COMPANY LLC- #10110

Location ID: 451100

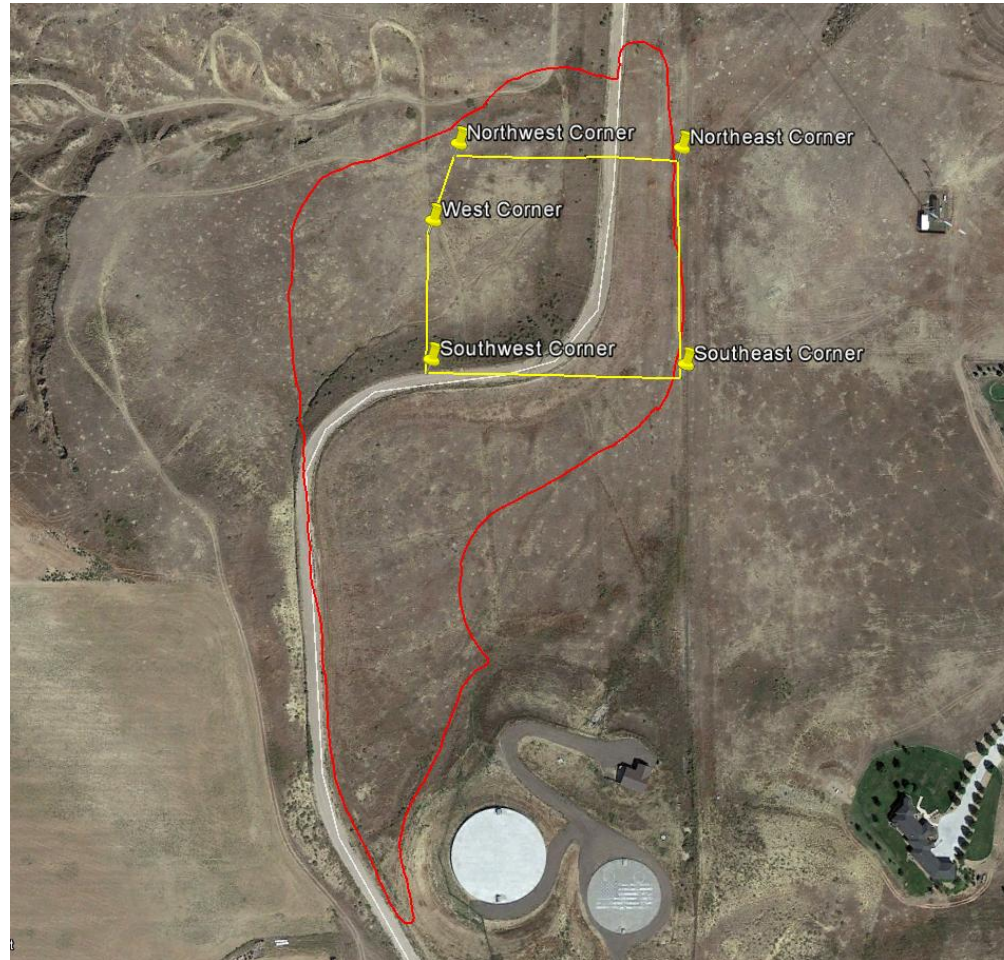
Google Earth aerial imagery taken September 7, 2016 overlaid with field collected data from September 19, 2017 using a Trimble Juno 3B handheld device (red line). Total disturbance of 12.48 acres was mapped on September 19, 2017 (84% over permitted construction disturbance). Form 2A Document #401154132 was permitted for 6.77 acres of construction disturbance. Based on the Facility Layout Drawing (Document #401159161), the proposed pad corners have been overlaid with the field collected data to illustrate where the Operator exceeded the construction disturbance.

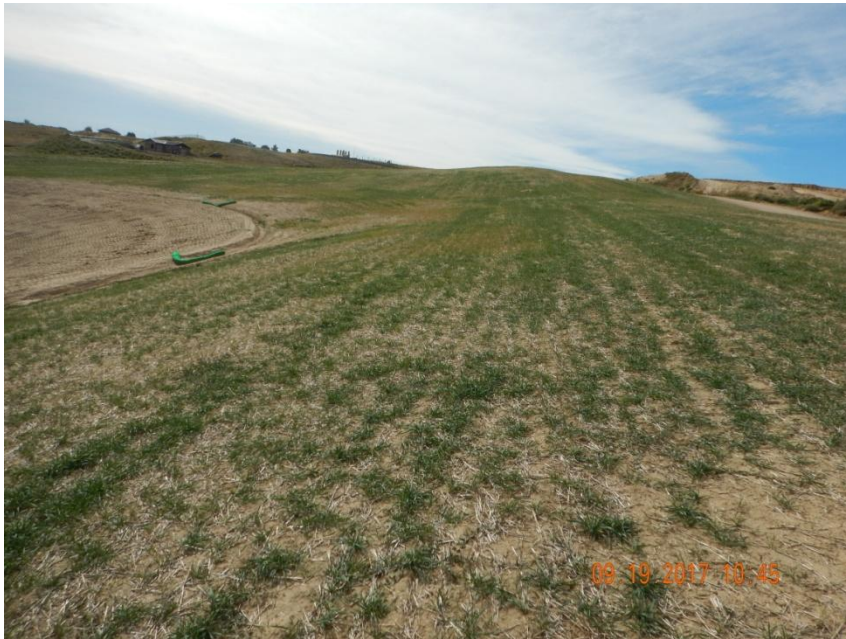
**Photo 2.** Photo taken from the western location, facing South. The topsoil stockpile has been stored along a portion of the western location. Both the topsoil stockpile and other areas constructed to be a berm have been seeded and mulched. Operator indicated that a “TOPSOIL” sign would be placed to indicate the location of the topsoil.

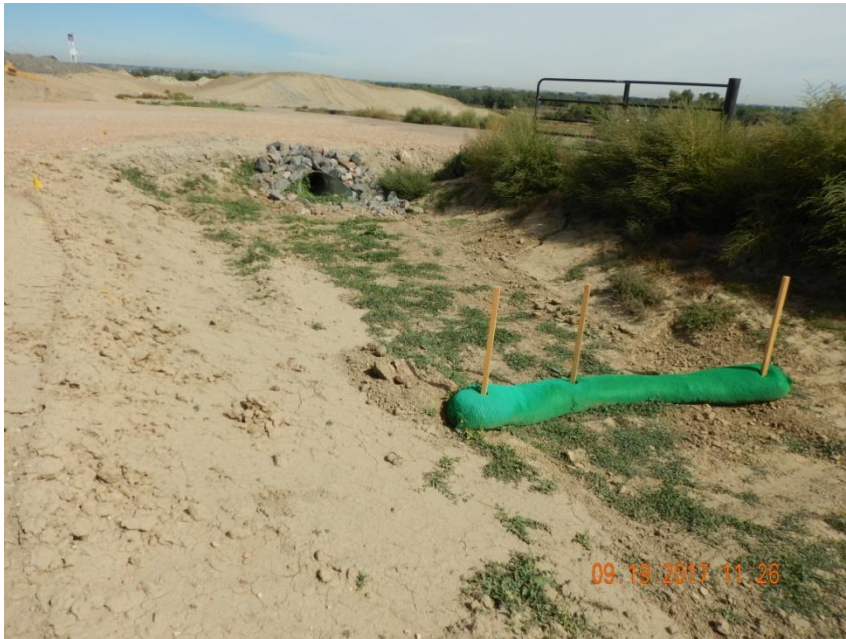
**Photo 4.** Photo taken from the northeastern pad location, facing North. A perimeter ditch has been installed around the toe of the cut slope in conjunction with filter wattle which is directed to a sediment basin along the northeastern location. Russian thistle and Kochia were observed along the perimeter of the location which needs to be controlled and managed per Rule 603.f.

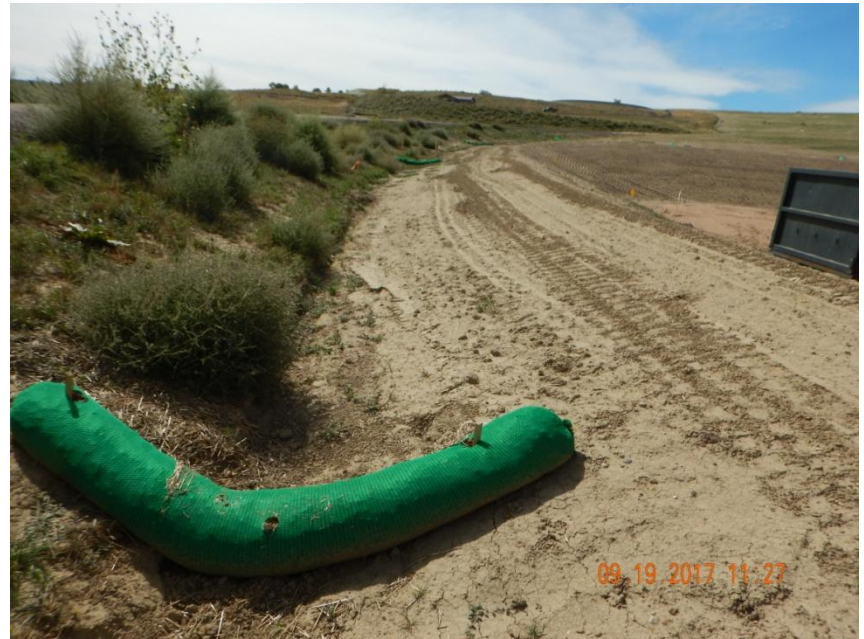
**Photo 5.** Photo taken from the northeastern pad location, facing South. A perimeter ditch has been installed around the toe of the cut slope in conjunction with filter wattle which is directed to a sediment basin along the northeastern location. Russian thistle and Kochia were observed along the perimeter of the location which needs to be controlled and managed per Rule 603.f.

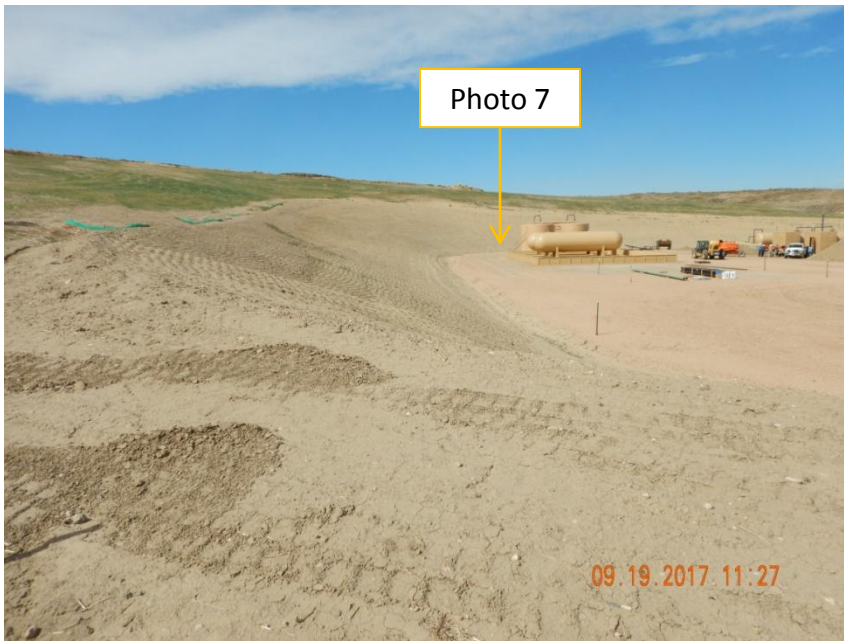
**Photo 6.** Photo taken from the eastern location, facing West. A perimeter ditch has been installed around the top of the cut slope in conjunction with filtrex wattles to control stormwater run-on. Cut slopes have been temporarily tracked with equipment. Rill erosion was observed along portions of the cut slope- see Photo 7.

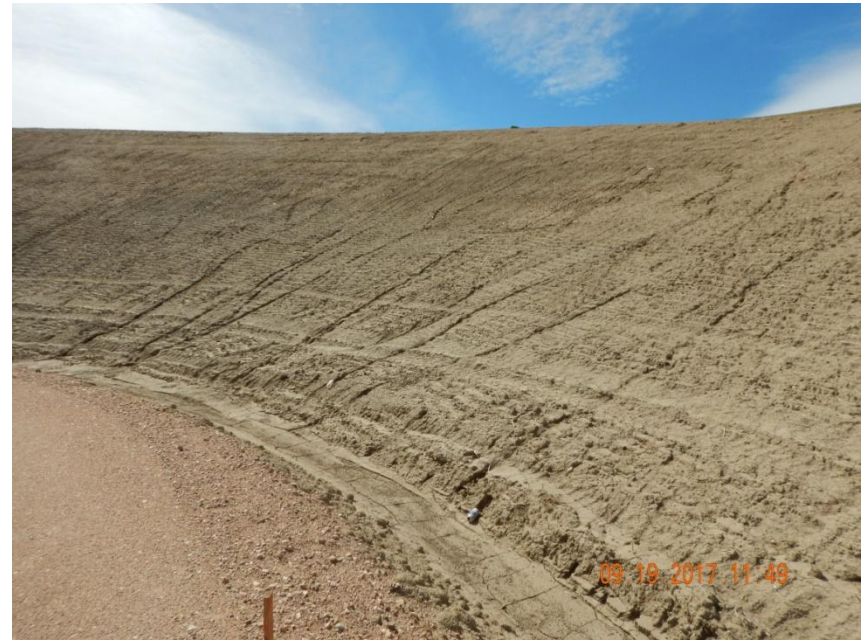
**Photo 7.** Photo taken from the southwestern pad location, facing South. Rill erosion observed along the western, southwestern and southern cut slope areas. Operator needs to stabilize cut slopes per Rule 1002.f.(2)C.

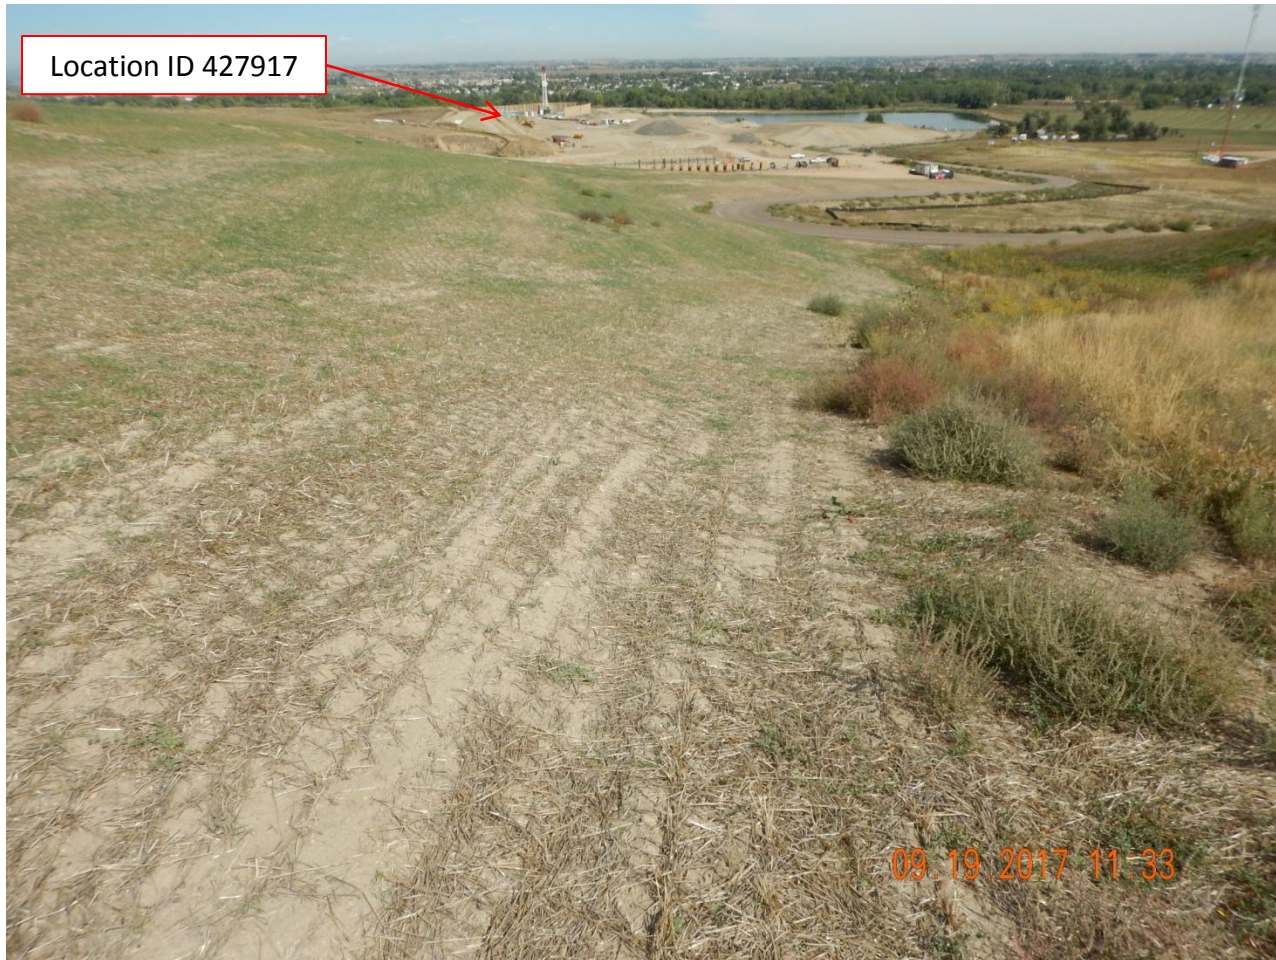
**Photo 8.** Photo taken from the southern location, facing North. The well pad (Location ID 427917) can be seen in the above photo. Areas constructed to be a berm, as mentioned in Photo 2, do not have uniform germination but appear to be temporarily stabilized with mulch. May need additional reclamation activities for long-term self-sustaining stabilization.

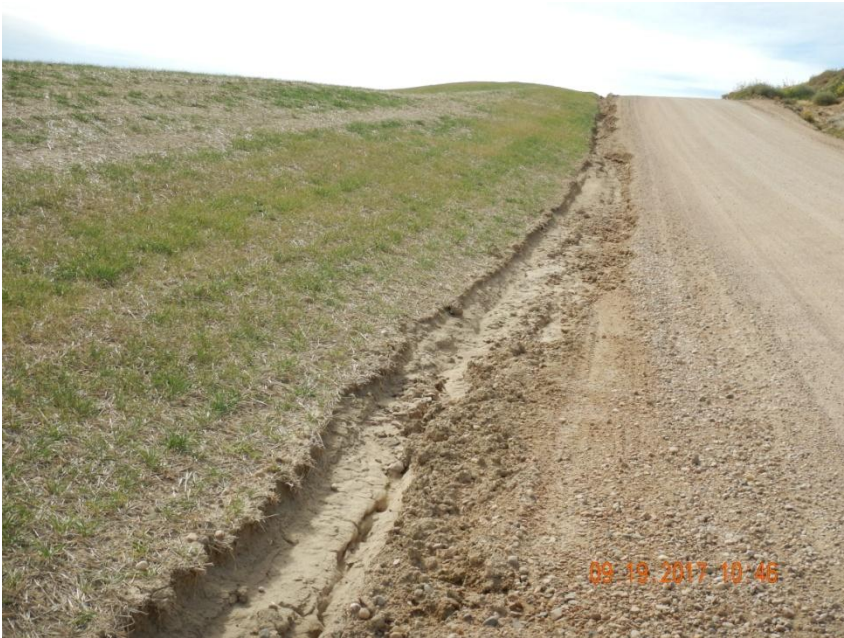
**Photo 9.** Photo taken from the western location, facing South. Stormwater appears to be travel along the western fill slope and lease road which then runs onto the northwestern location- see Photos 11 & 12.

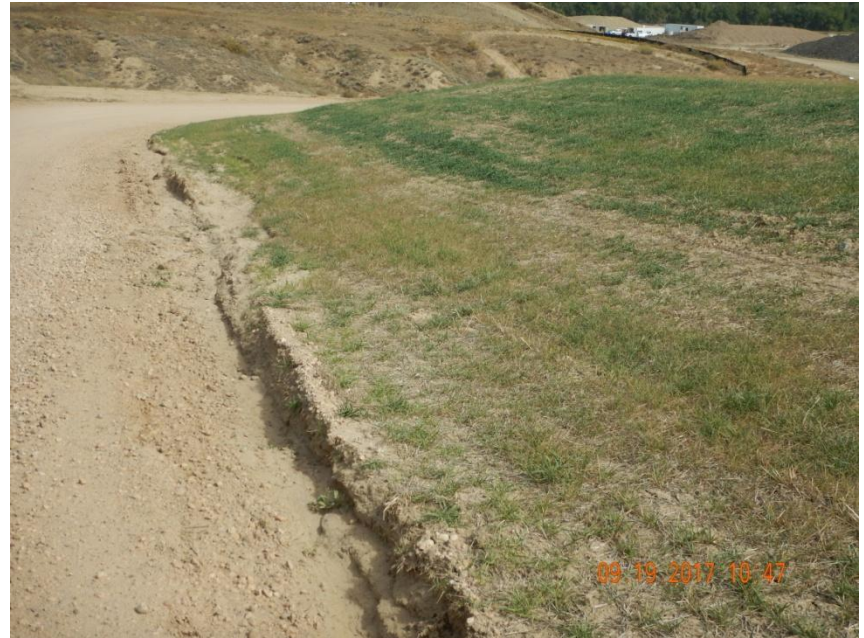
**Photo 10.** Photo taken from the western location, facing North. Stormwater appears to be travel along the western fill slope and lease road which then runs onto the northwestern location- see Photos 11 & 12.

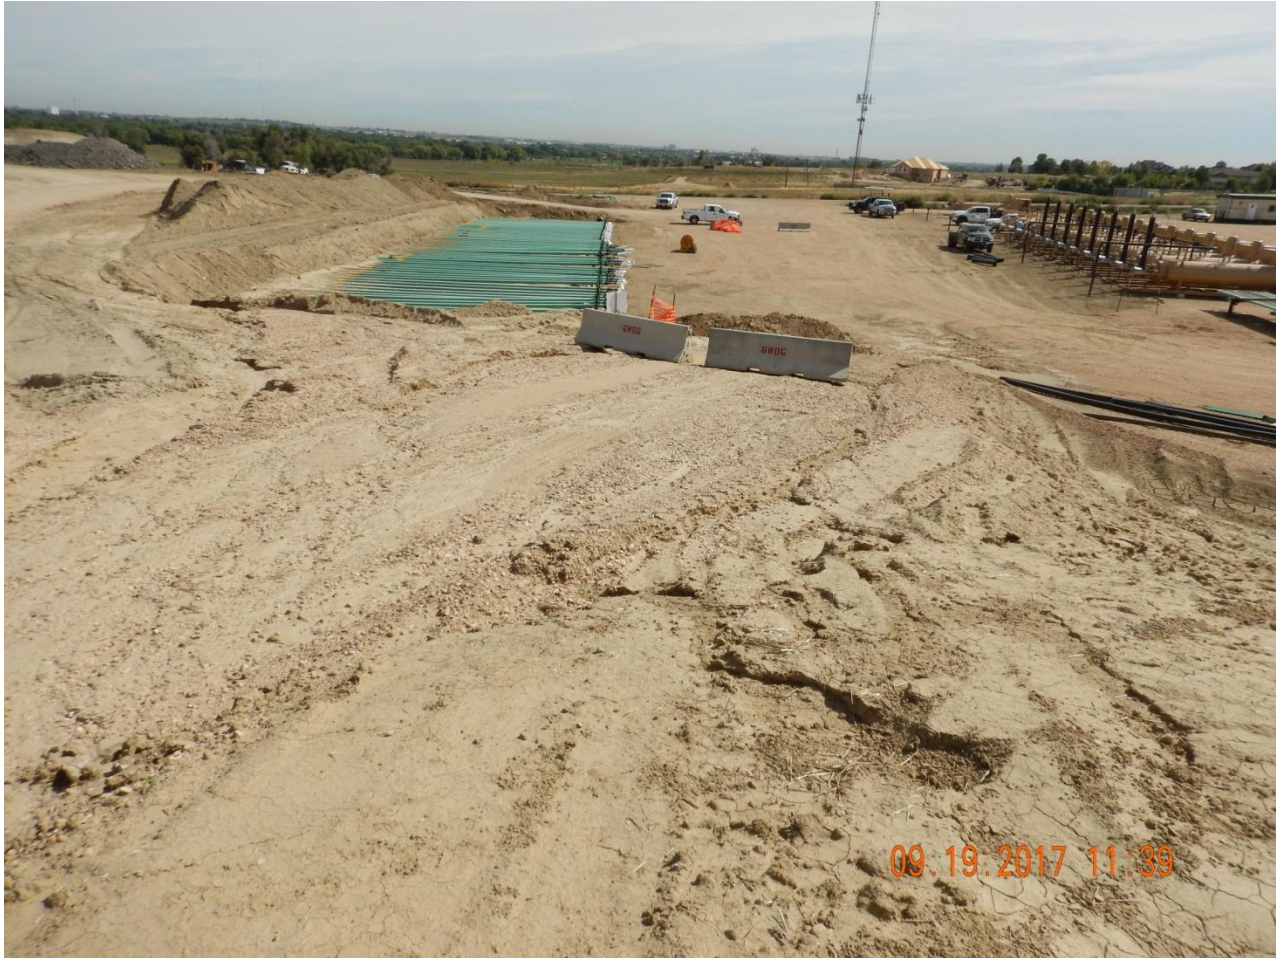
**Photo 11.** Photo taken from the northwestern location, facing East. Photo illustrates stormwater erosion traveling from the lease road onto location.

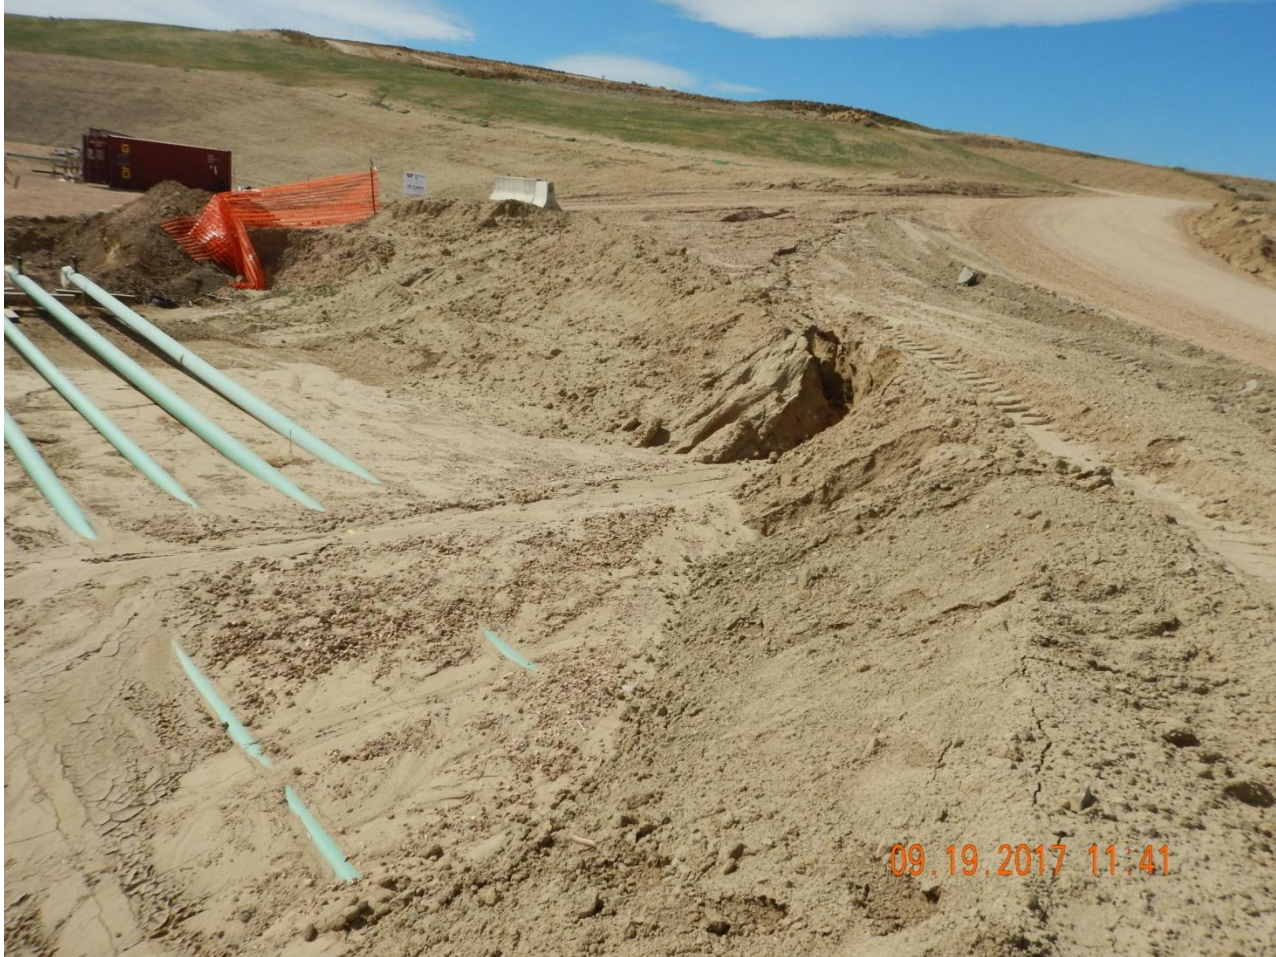
**Photo 12.** Photo taken from the northwestern location, facing Southwest. Photo illustrates gully and rill erosion occurring along the northwestern location.

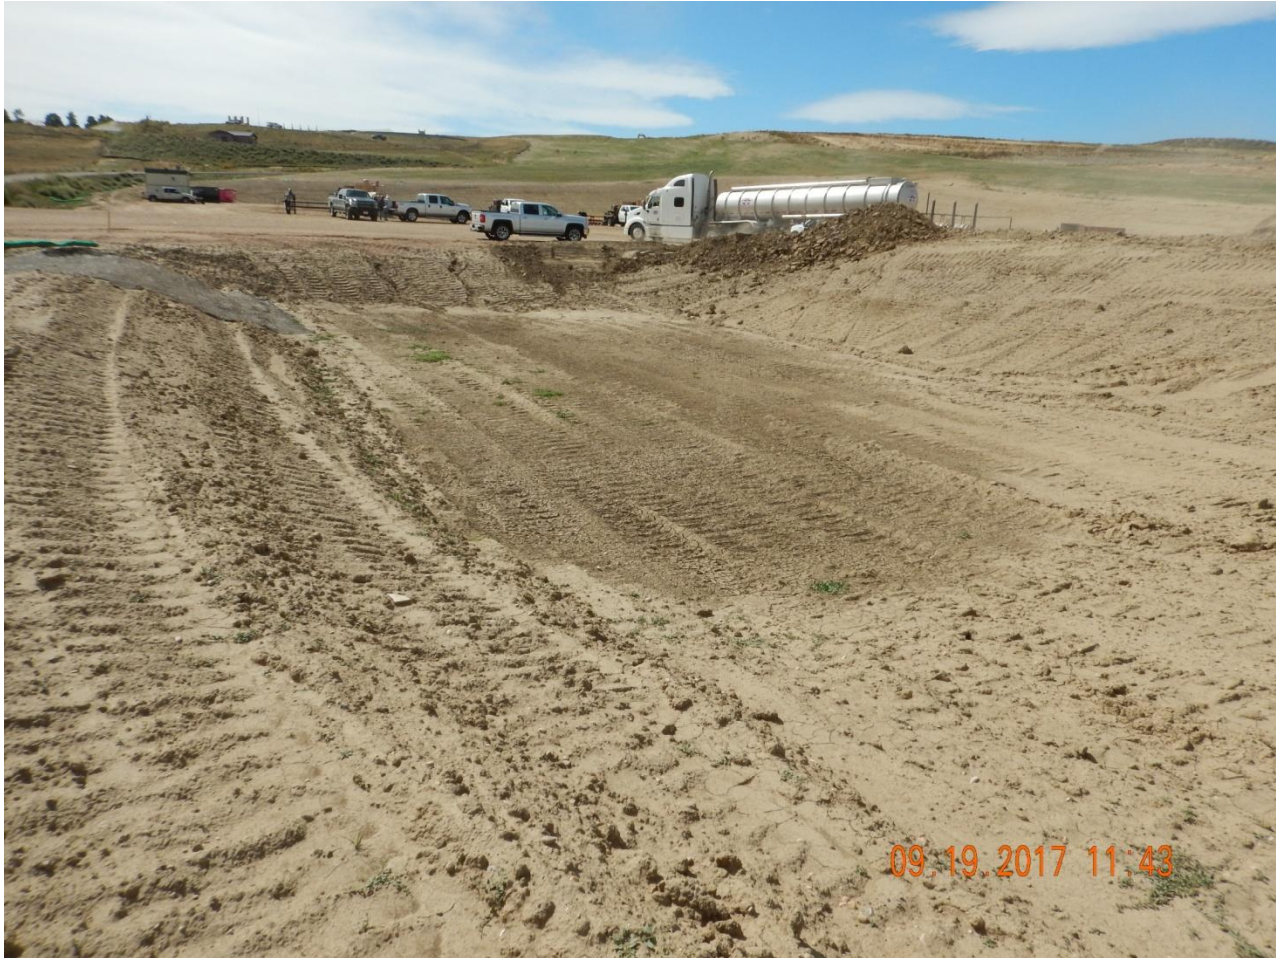
**Photo 13.** Photo taken from the northeastern location, facing South. Sediment basin has been installed with a stabilized outlet in conjunction with other stormwater BMPs. The sediment basin is downgradient from run-on erosion illustrated in Photos 11 & 12.
