**Inspection Photos**  
**Location Name: Miller 33-29**  
**API #: 05-123-19479**  
**Location ID: 330698**

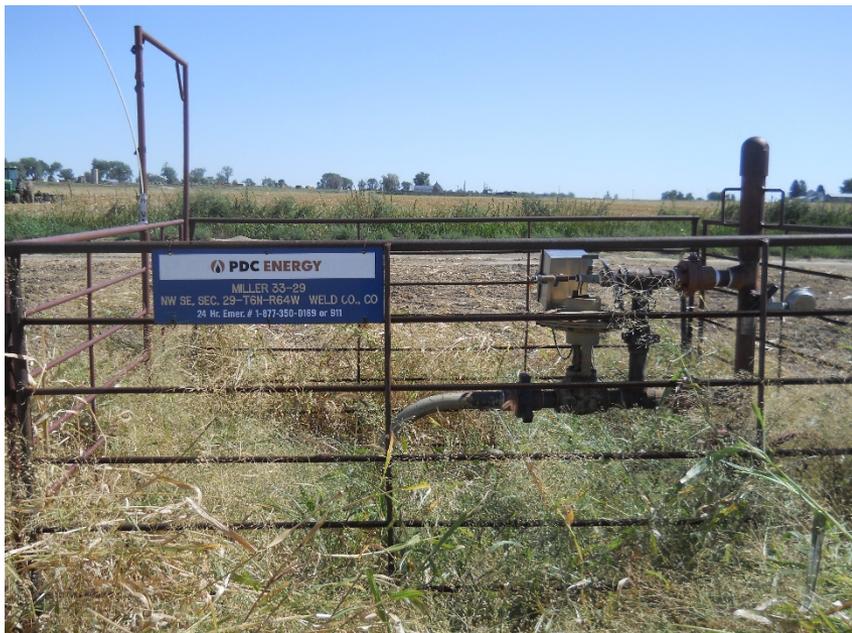
**Wellheads looking east, weeds need to be controlled**

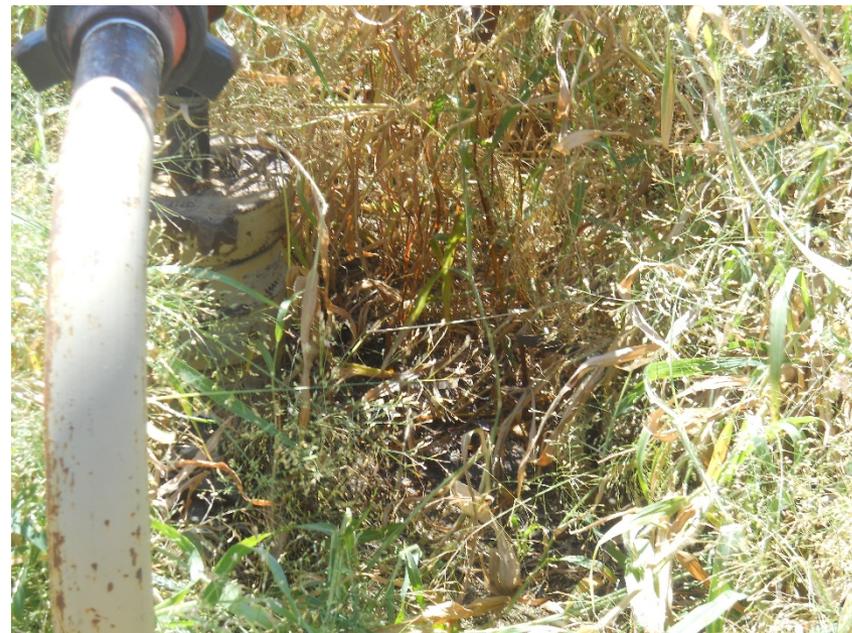
**Stained soil under master valve**

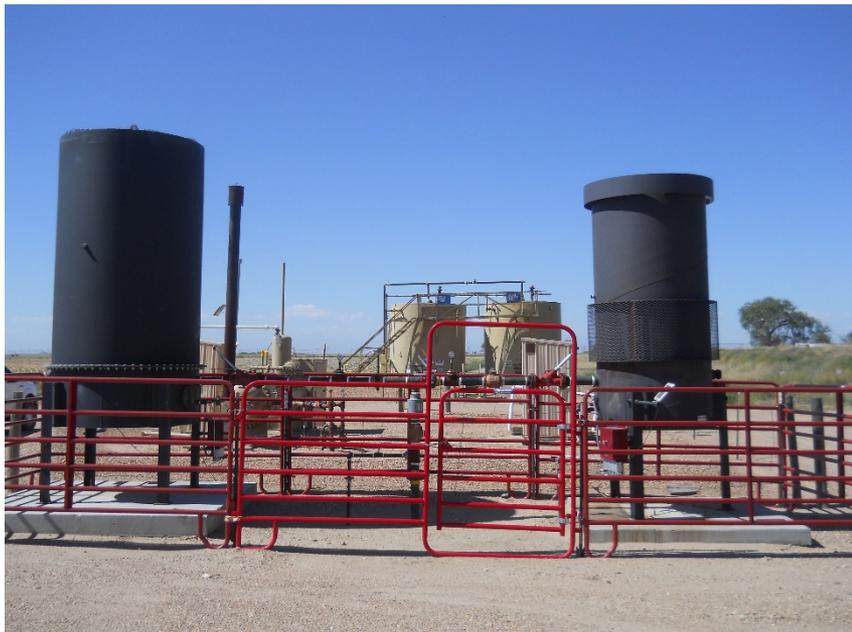
**Battery looking west**

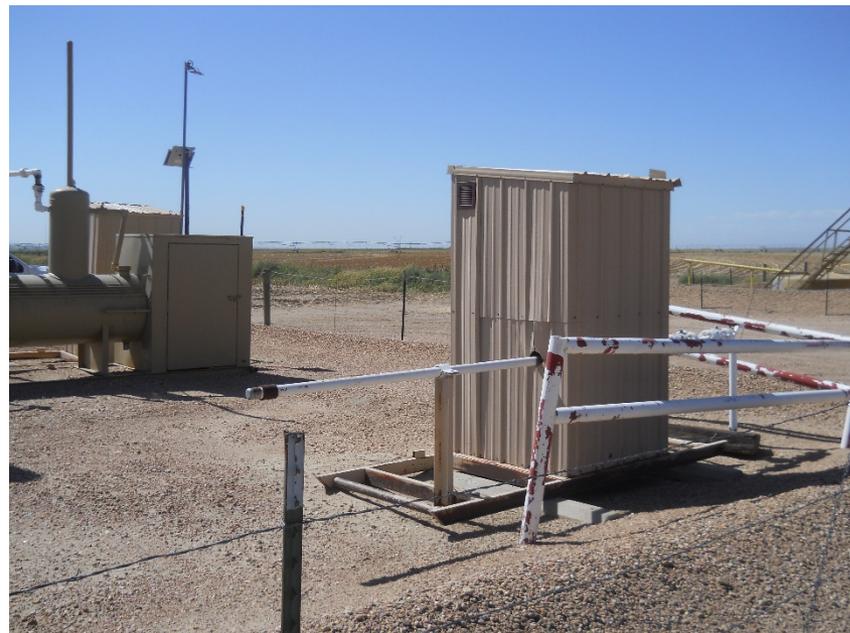
**Unused/disconnected gas meter run north of separator**
