Inspection Photos
Location Name: Green #1
API: 05-001-07299
Inspection Date: September 20, 2017

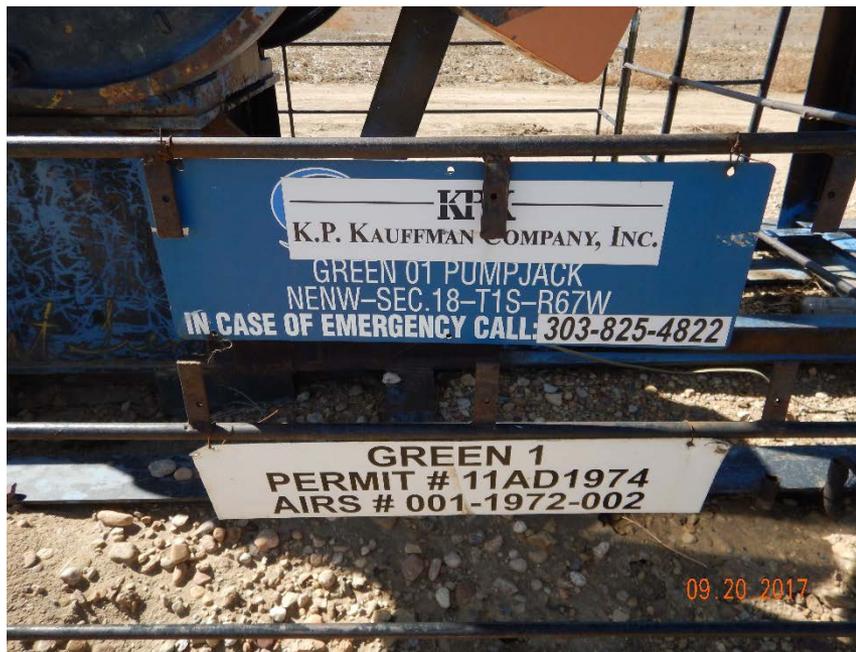
Photo #1 – Well sign.

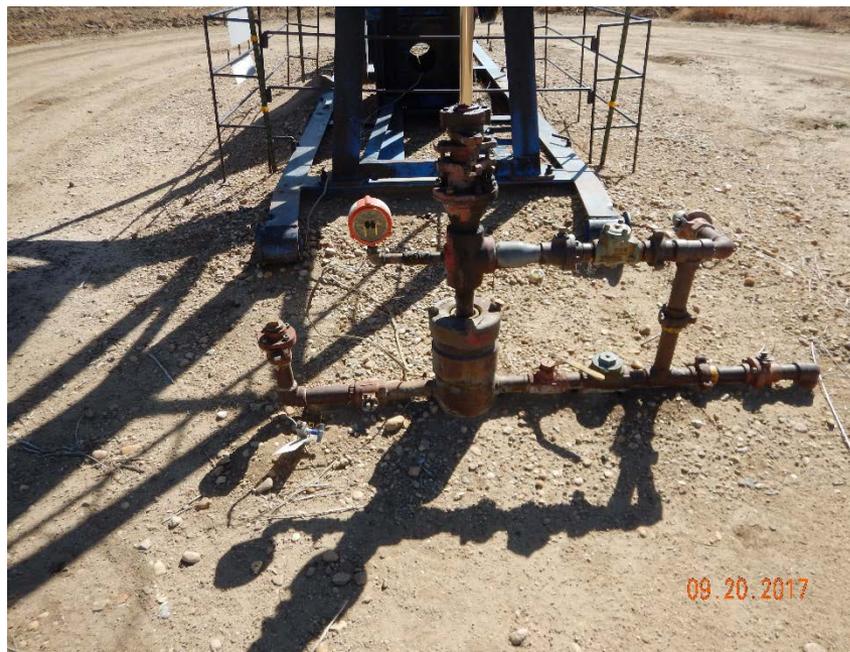
Photo #2 – Wellhead.

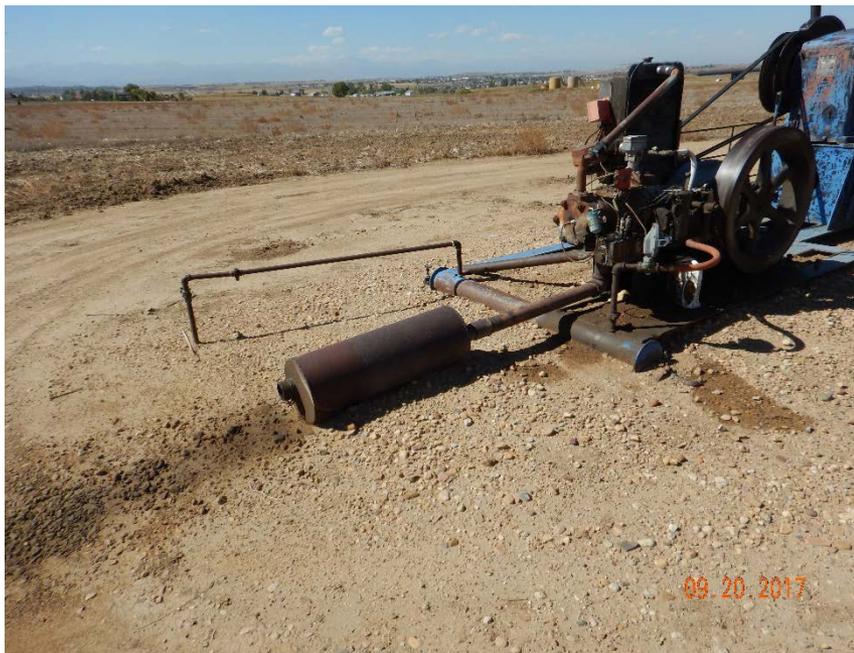
Photo #3 – Localized, oil-stained soil beneath prime mover and pump jack exhaust.

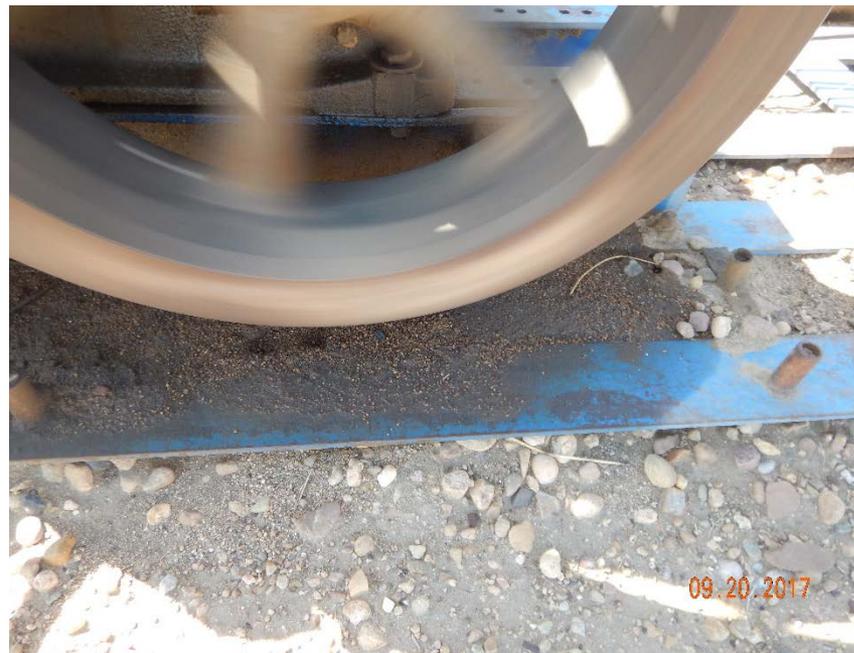
Photo #4 - Localized, oil-stained soil beneath prime mover.

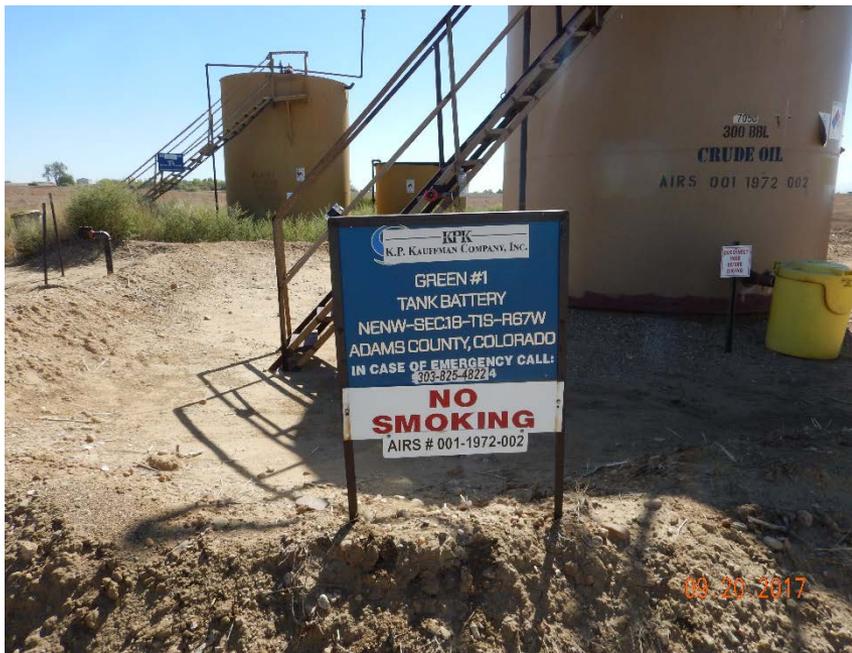
Photo #5 – Battery sign.

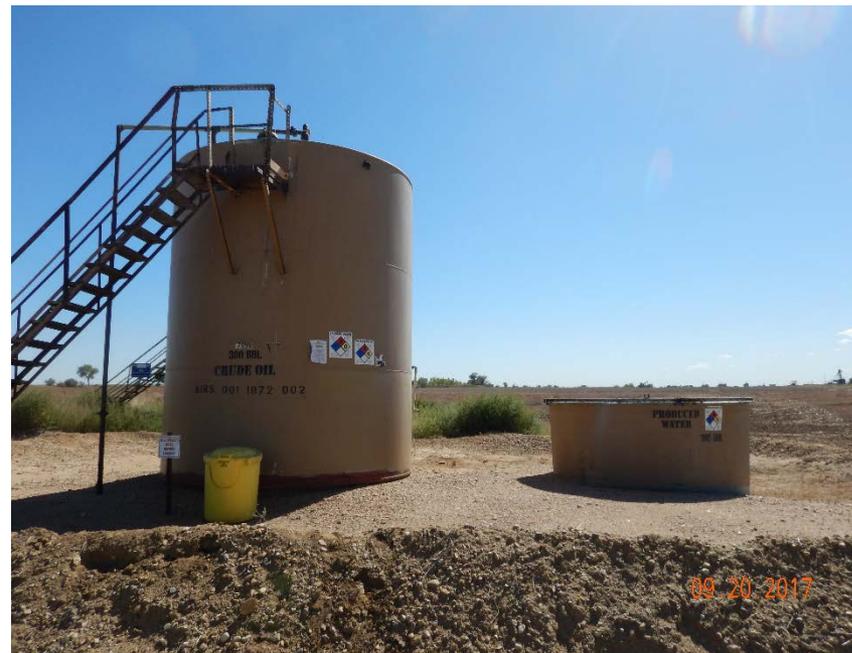
Photo #6 – Tanks with shallow earthen berm.

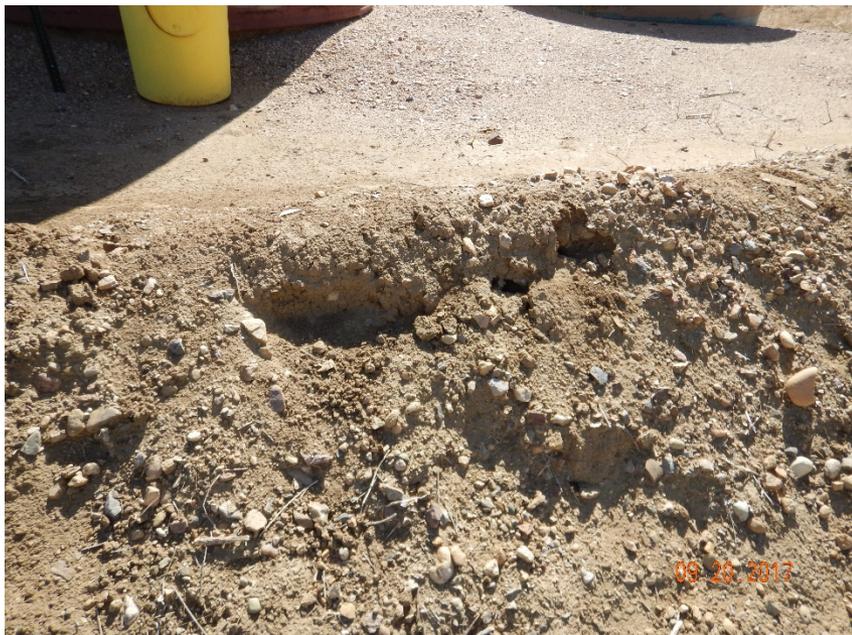
Photo #7 – Eroded earthen berm.

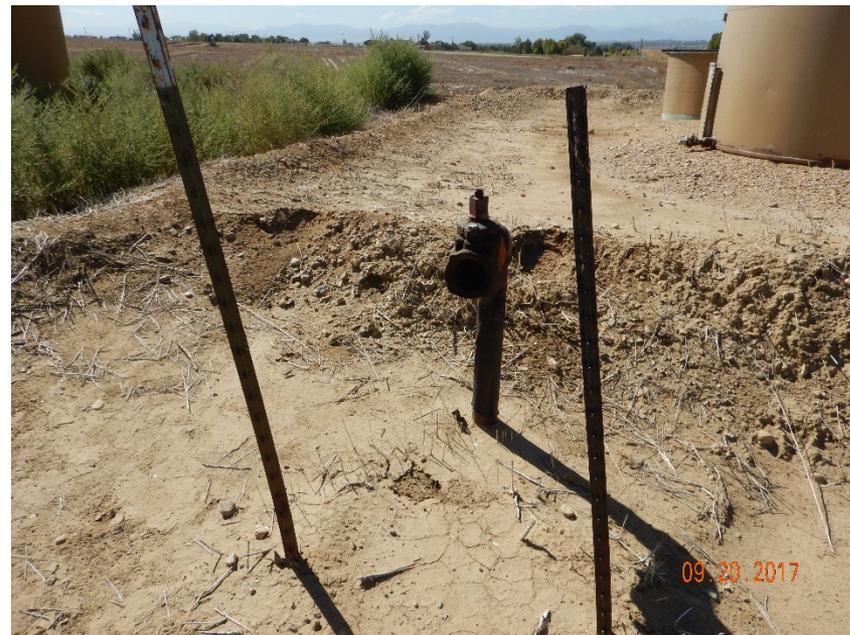
Photo #8 – Truck loadout at SE corner of tank battery lacks secondary containment device. Note eroded earthen berm in background.

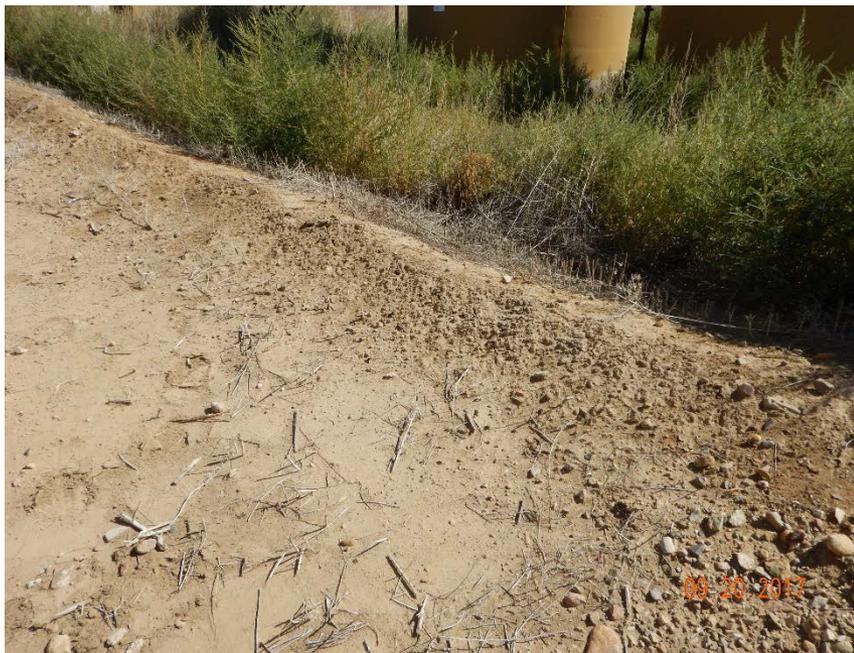
Photo #9 – South berm (shared with Energy Search battery) is shallow.

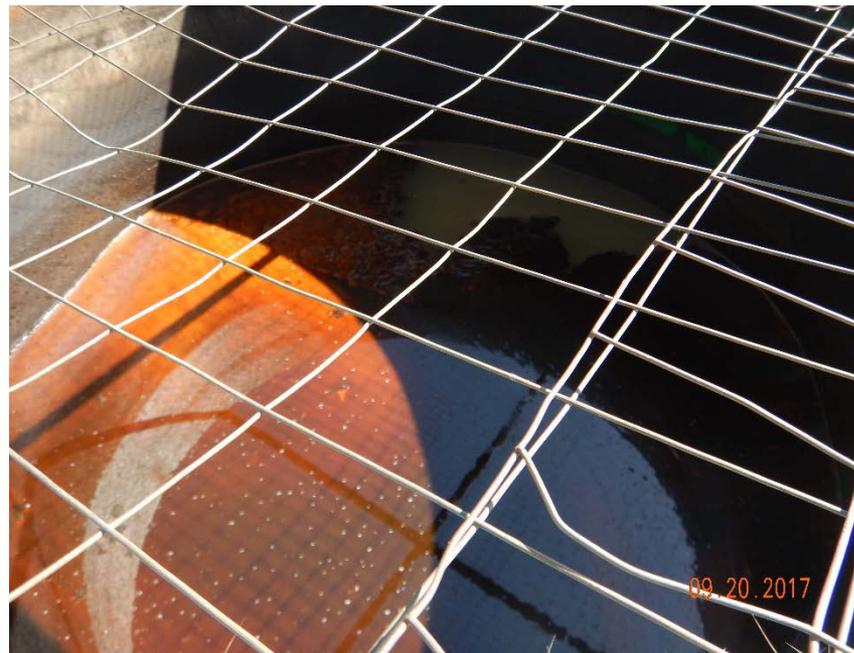
Photo #10 – Oil in produced water open-top tank.

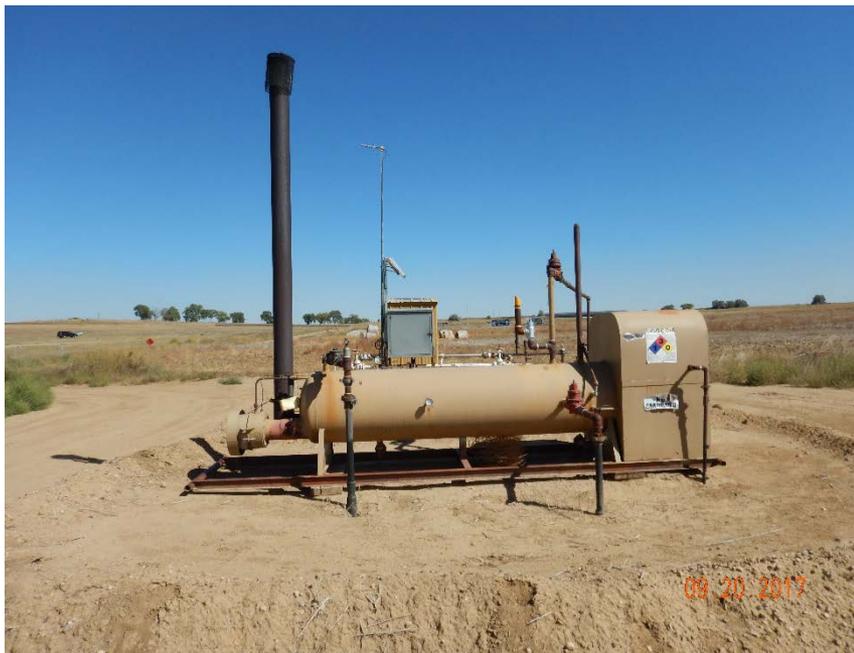
Photo #11 – Horizontal separator with bird protection.

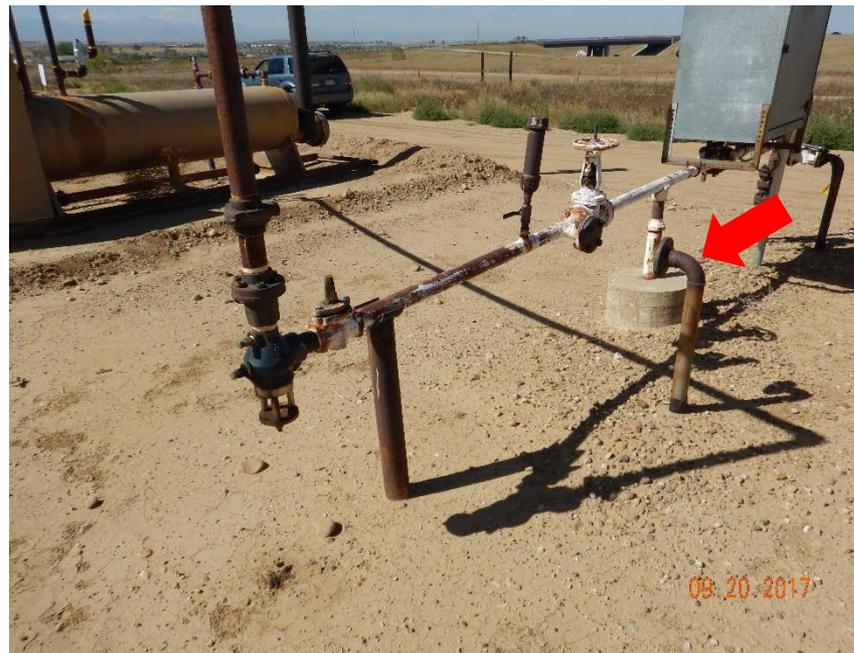
Photo #12 – Uncapped flowline riser on east side of meter run.
