Meyring 13-27 Flowline

MEYRING 13-27
WEST Dig Site
Flow Line LEAK

Flowline LEAK
East Dig Site

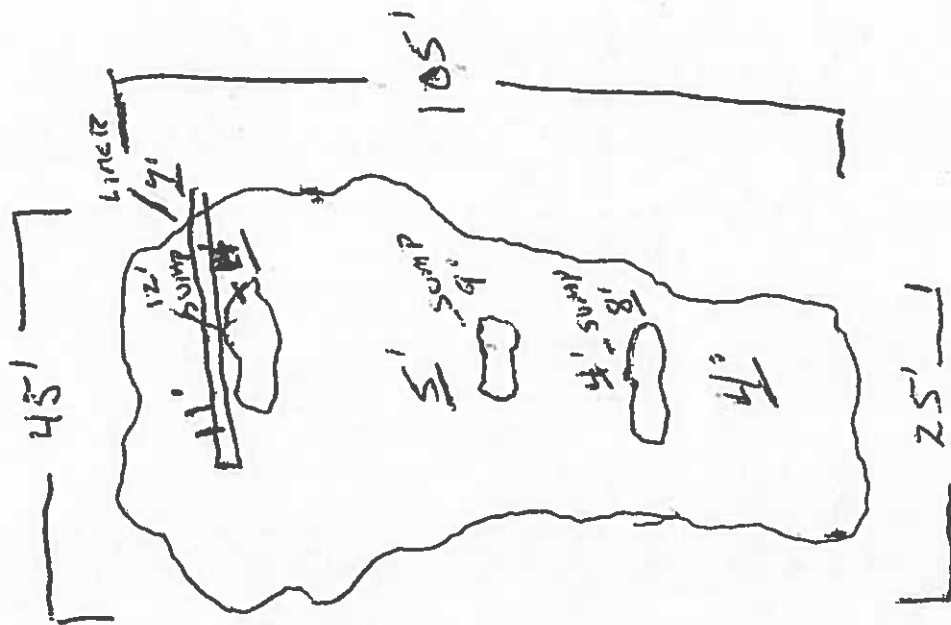
LINER 7' depth

NORTH Sump -

Flushing in oil
From north & south

CENTER DUMP -

Flushing in oil
From west & north

SOUTH Sump -
Cleared up.

TOTAL SOIL HAULED
TO DISPOSAL

1200 YARDS

TOTAL WATER
MOVED OUT

700 bbls.

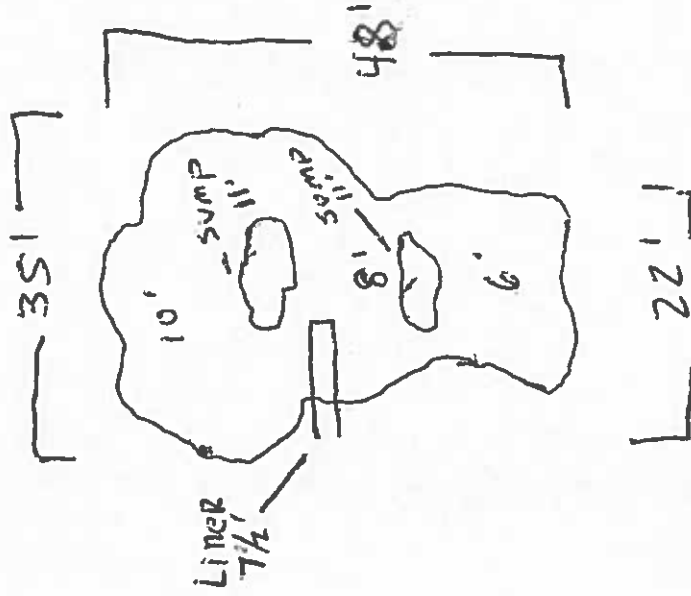
SOUTH SUMP
cleaned up

TOTAL WATER HAULED
& PUMPED.

350 bbls E

10 bbl oil

TOTAL SOIL HAULED

500 YARDS
