Inspection Photos
Location Name: Bayless API 103-07822
Pit Closure
9/28/2017

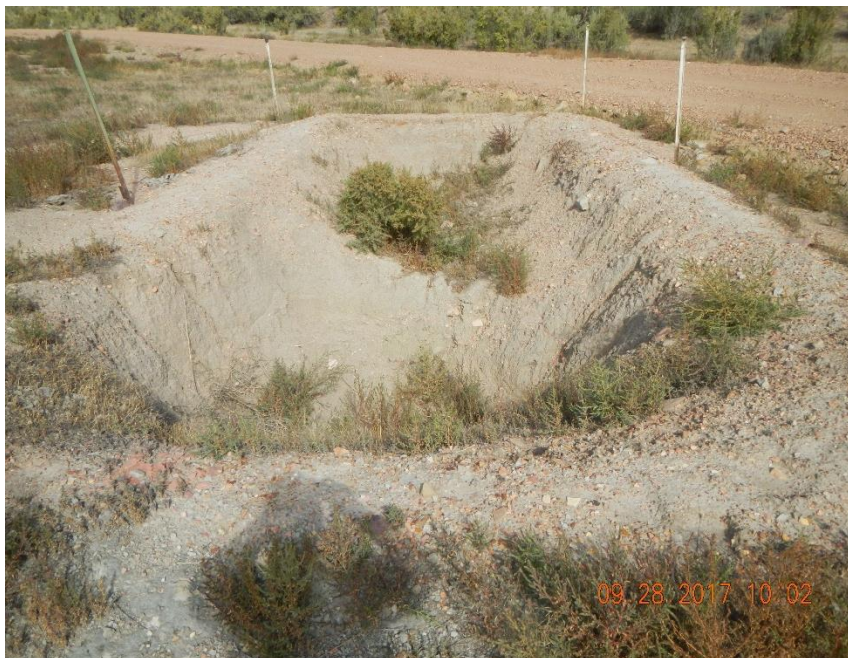
Pit looking Northwest

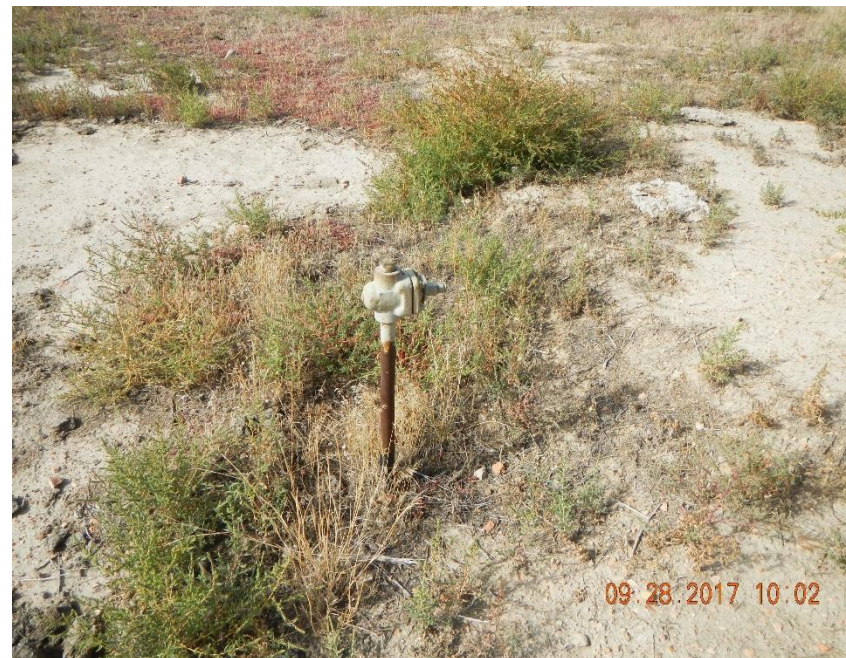
Possible flowline riser near pit
