## Inspection Photos

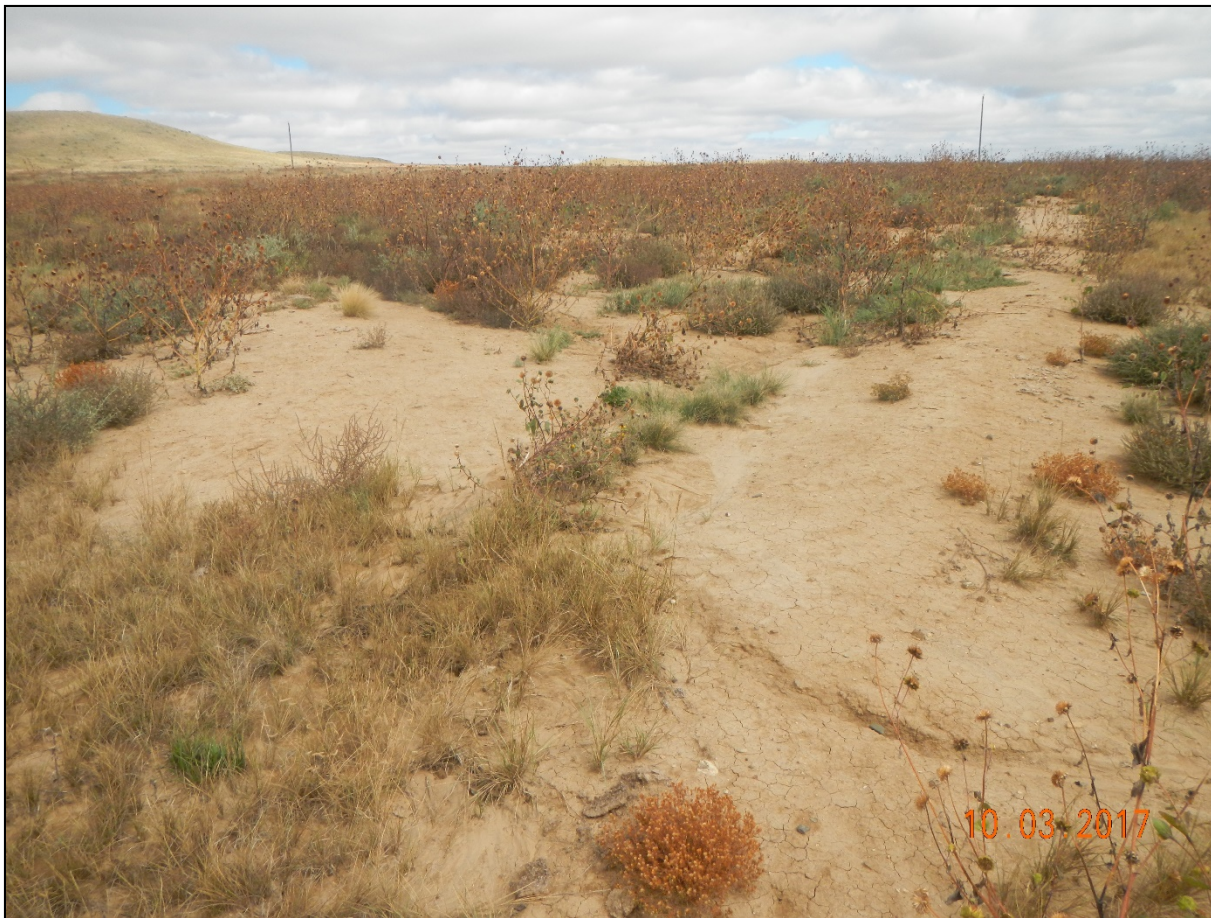
**Photo 1.** Facing northeast toward the location. The location has not been recontoured and reclaimed.

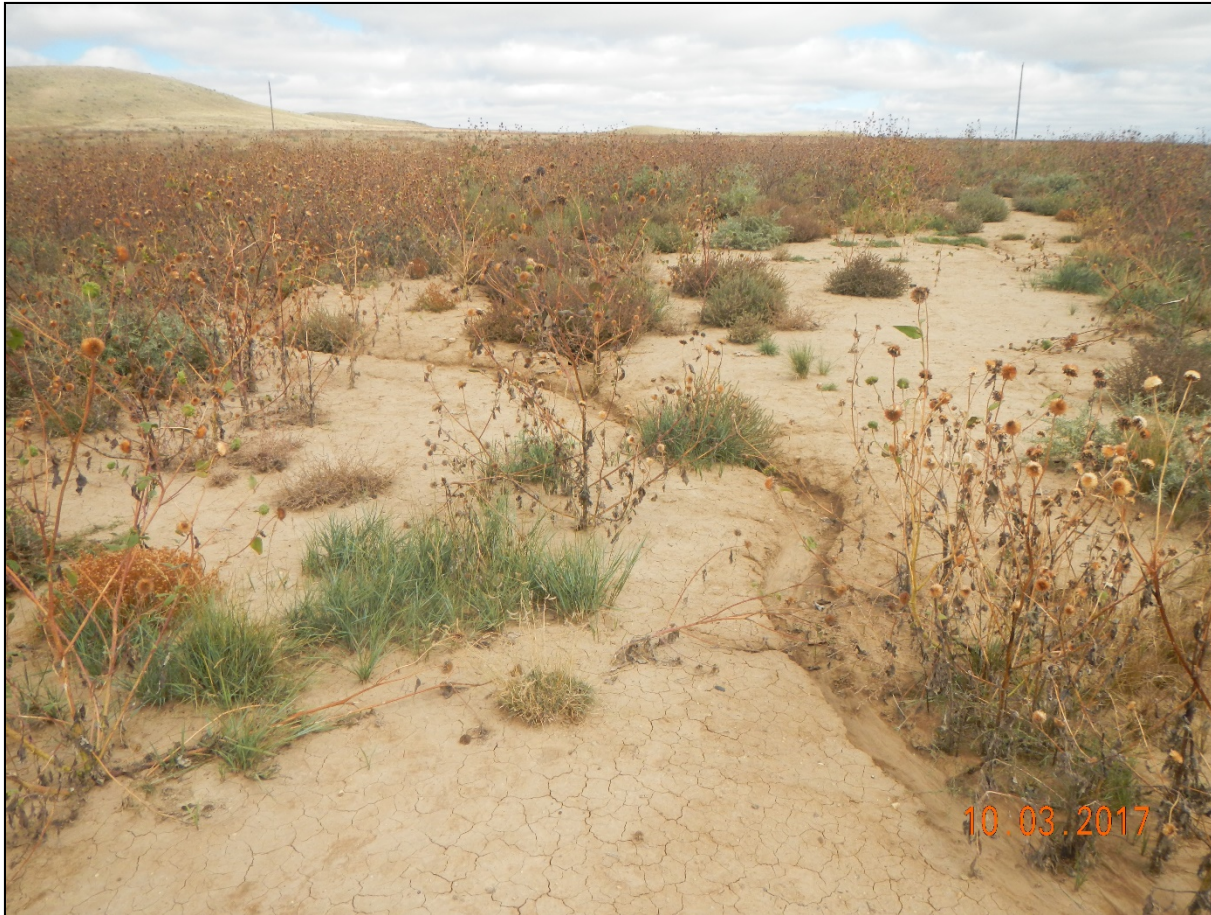
**Photo 2.** There are signs of erosion occurring off the southwestern portion of the pad.

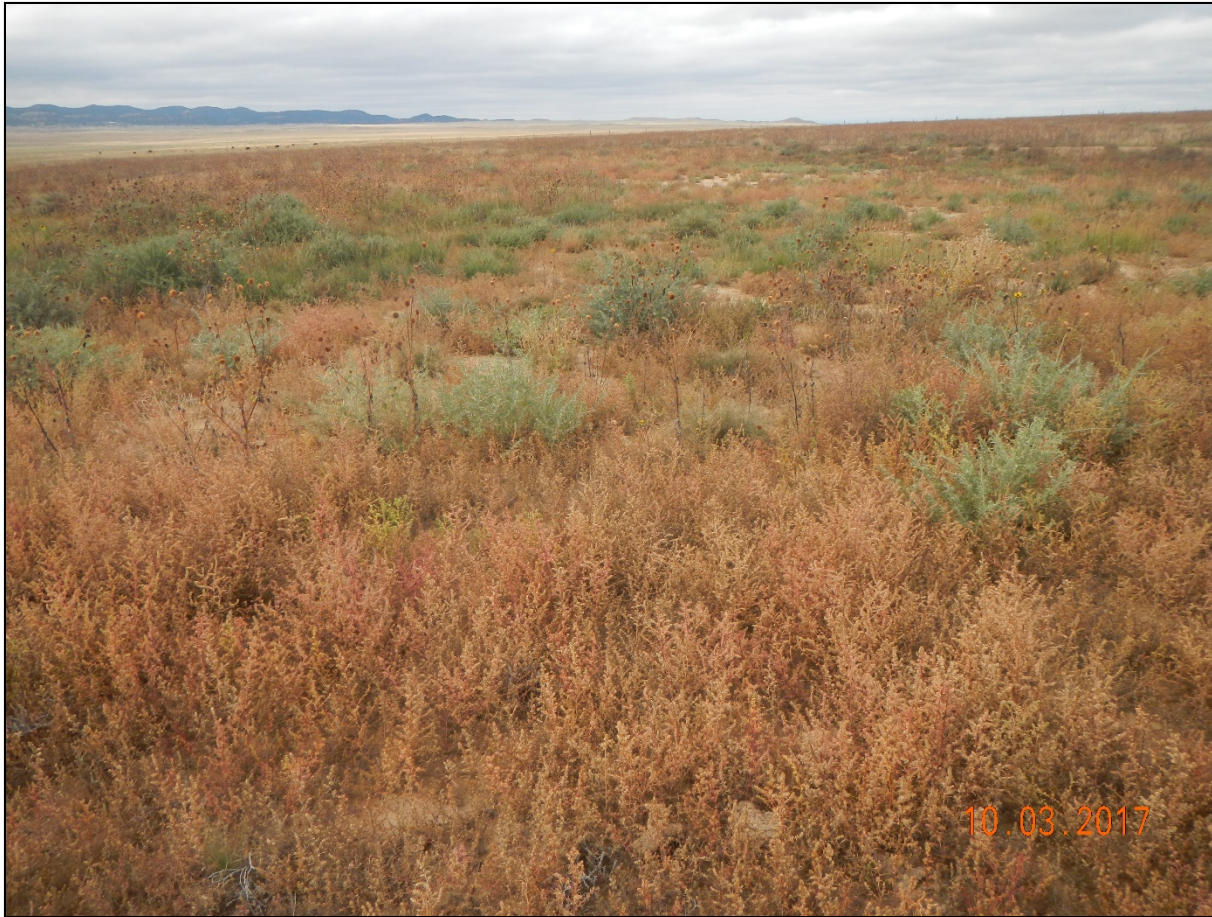
**Photo 3.** East side of the location facing northwest toward the location. The brown vegetation is undesirable weed growth ( Russian thistle).

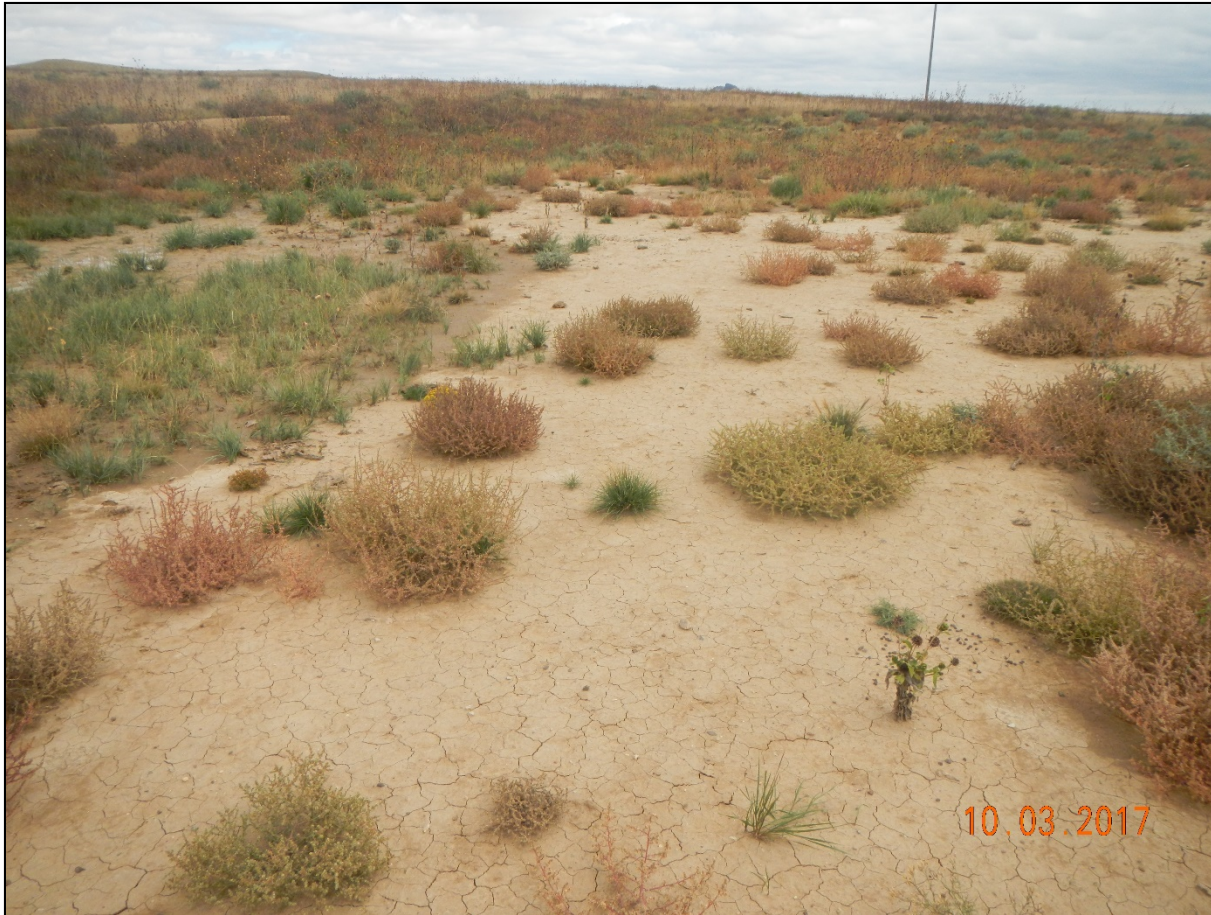
**Photo 4.** Facing northeast toward the cut slope of the location. The desirable vegetation has not re-established

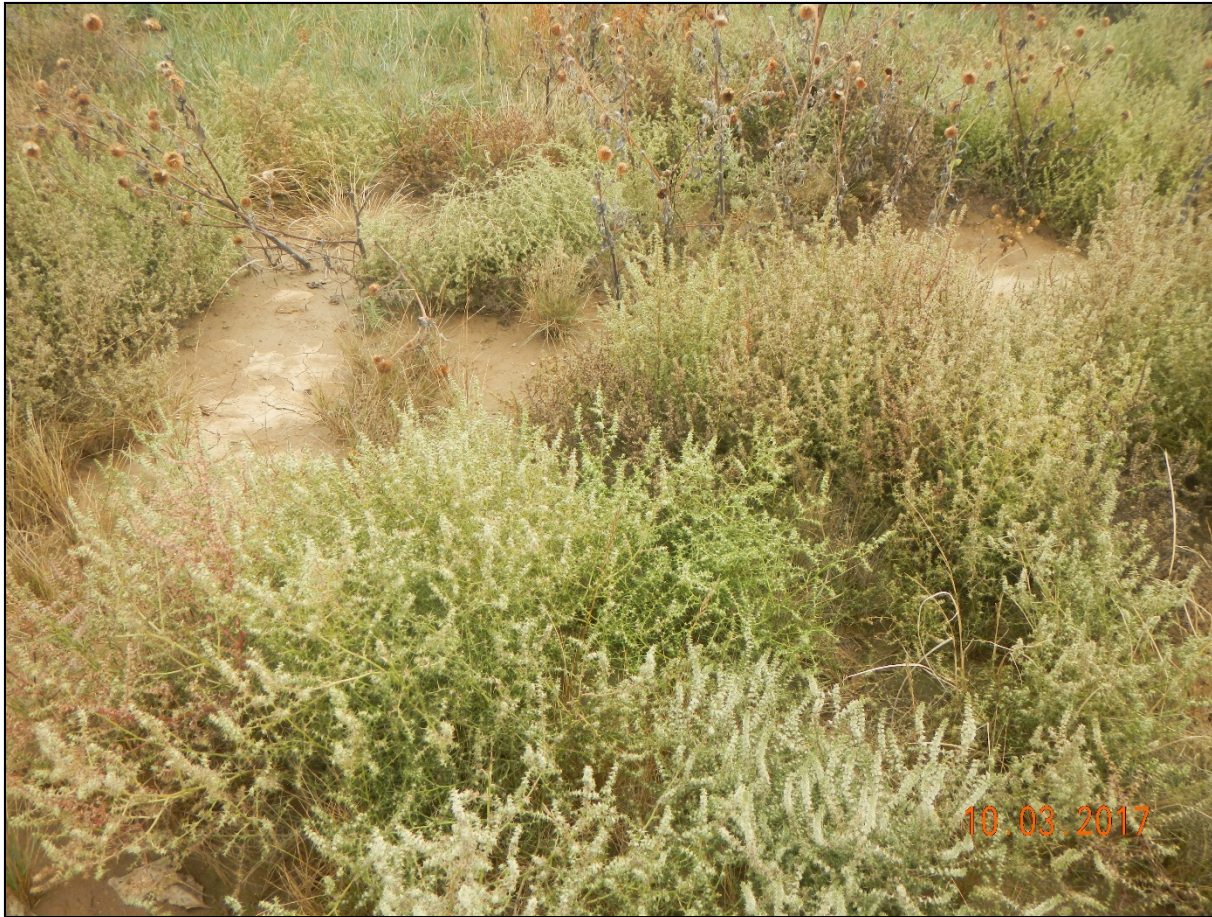
**Photo 5.** There is undesirable weed growth (*Salsola* sp.) throughout the location.

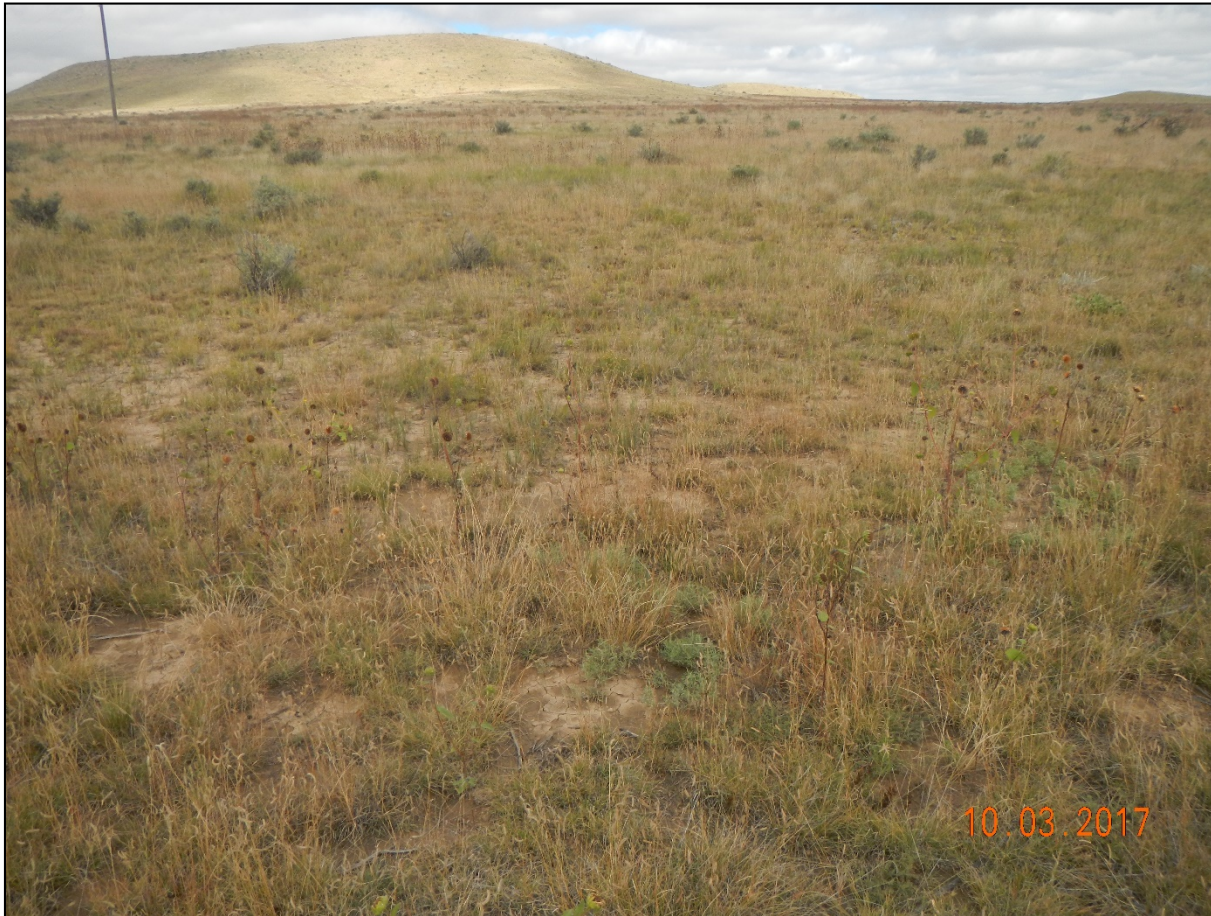
**Photo 6.** Facing north off the location toward the undisturbed vegetation.
