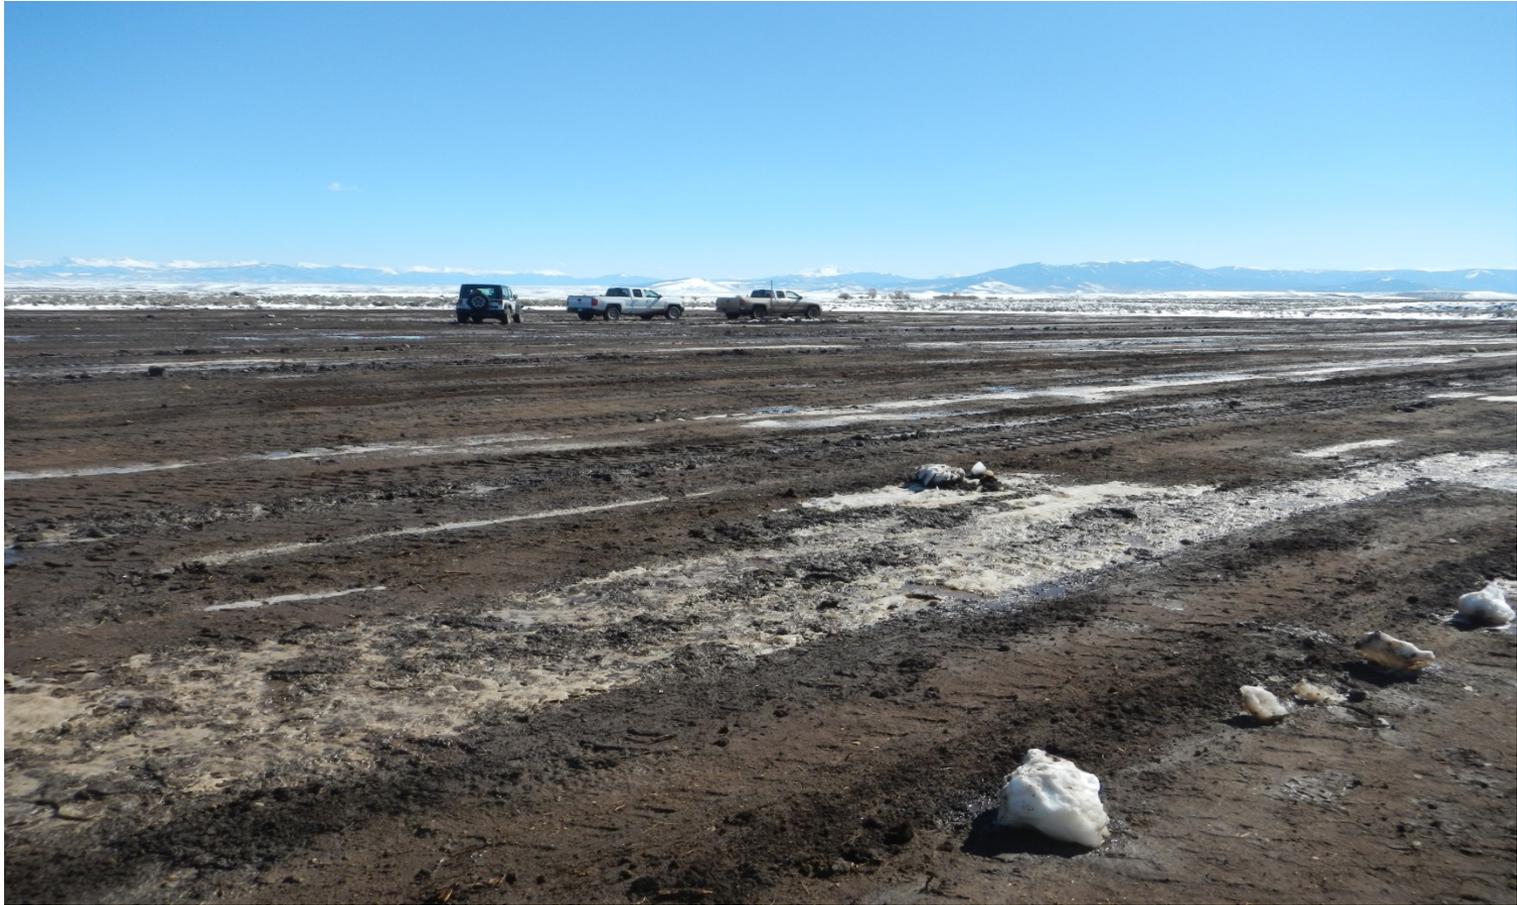
Photo#1:
Overview of Location from NE corner to SW.

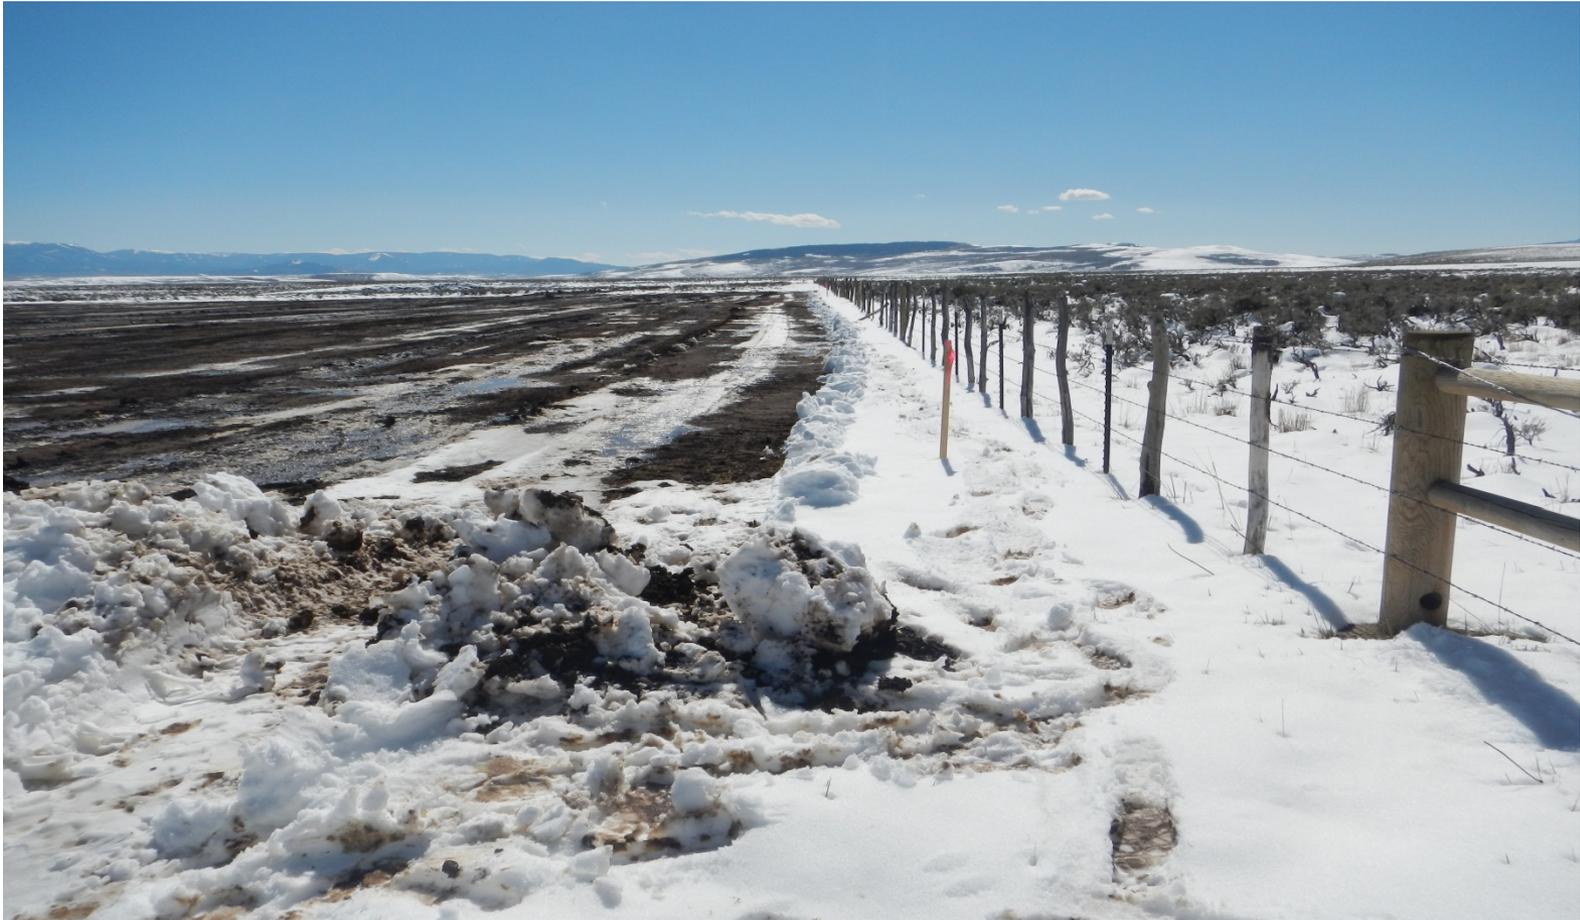
Photo#2:
View along West side of Location.

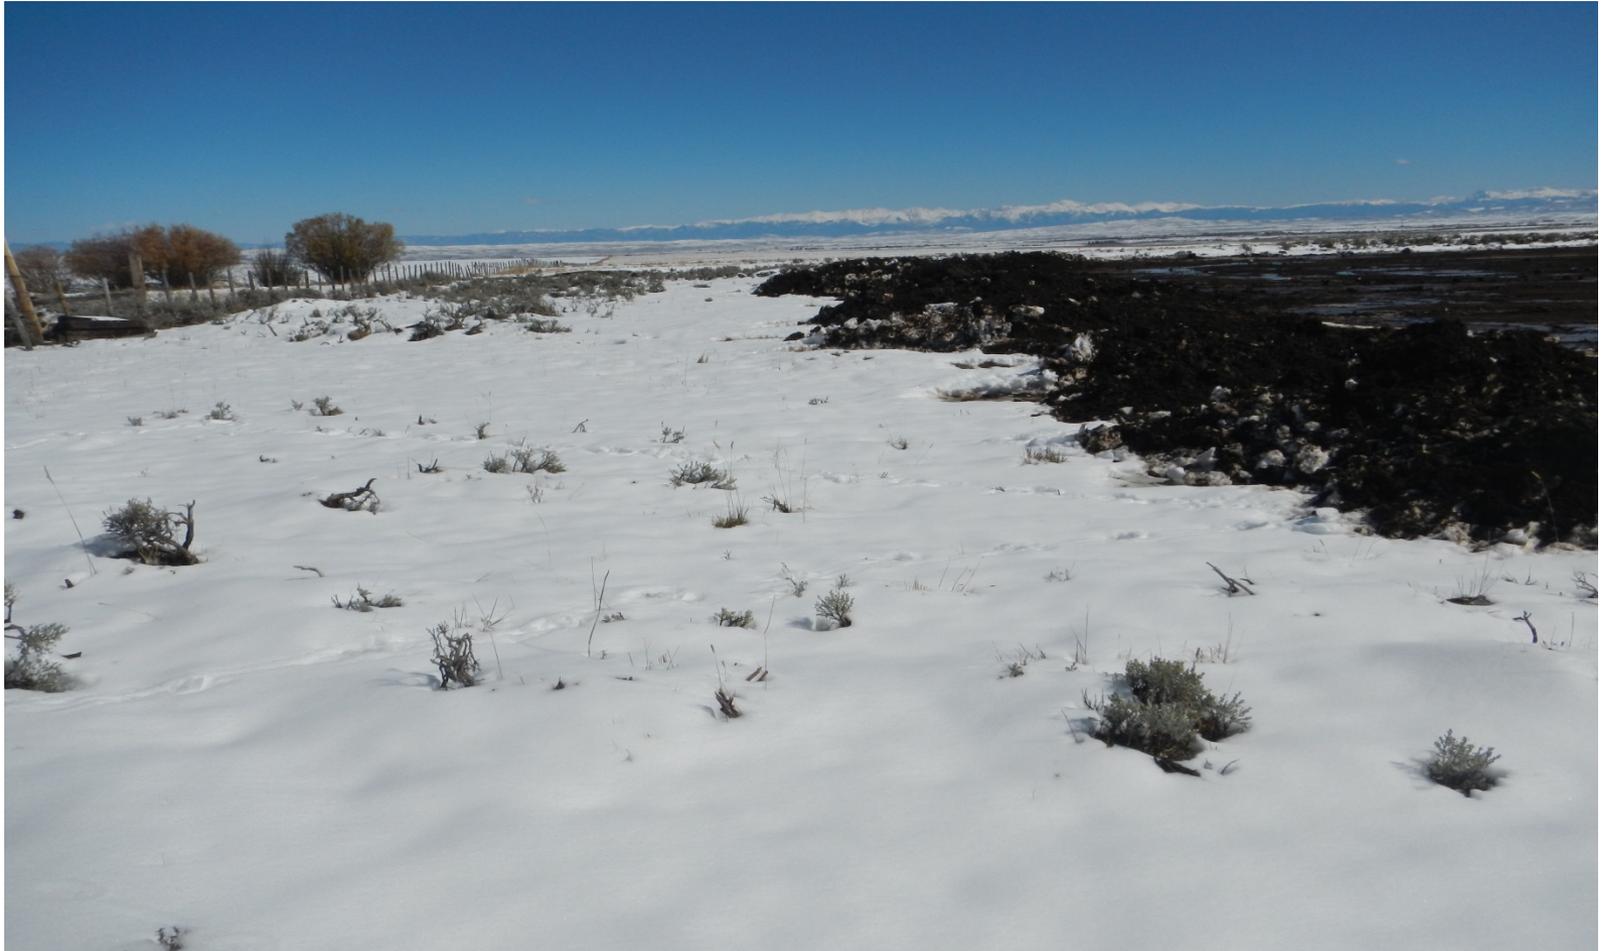
Photo#3:

Mixture of Grubbing material & Top Soil which appears to be used as unconsolidated berm/ BMP on North side of Location.

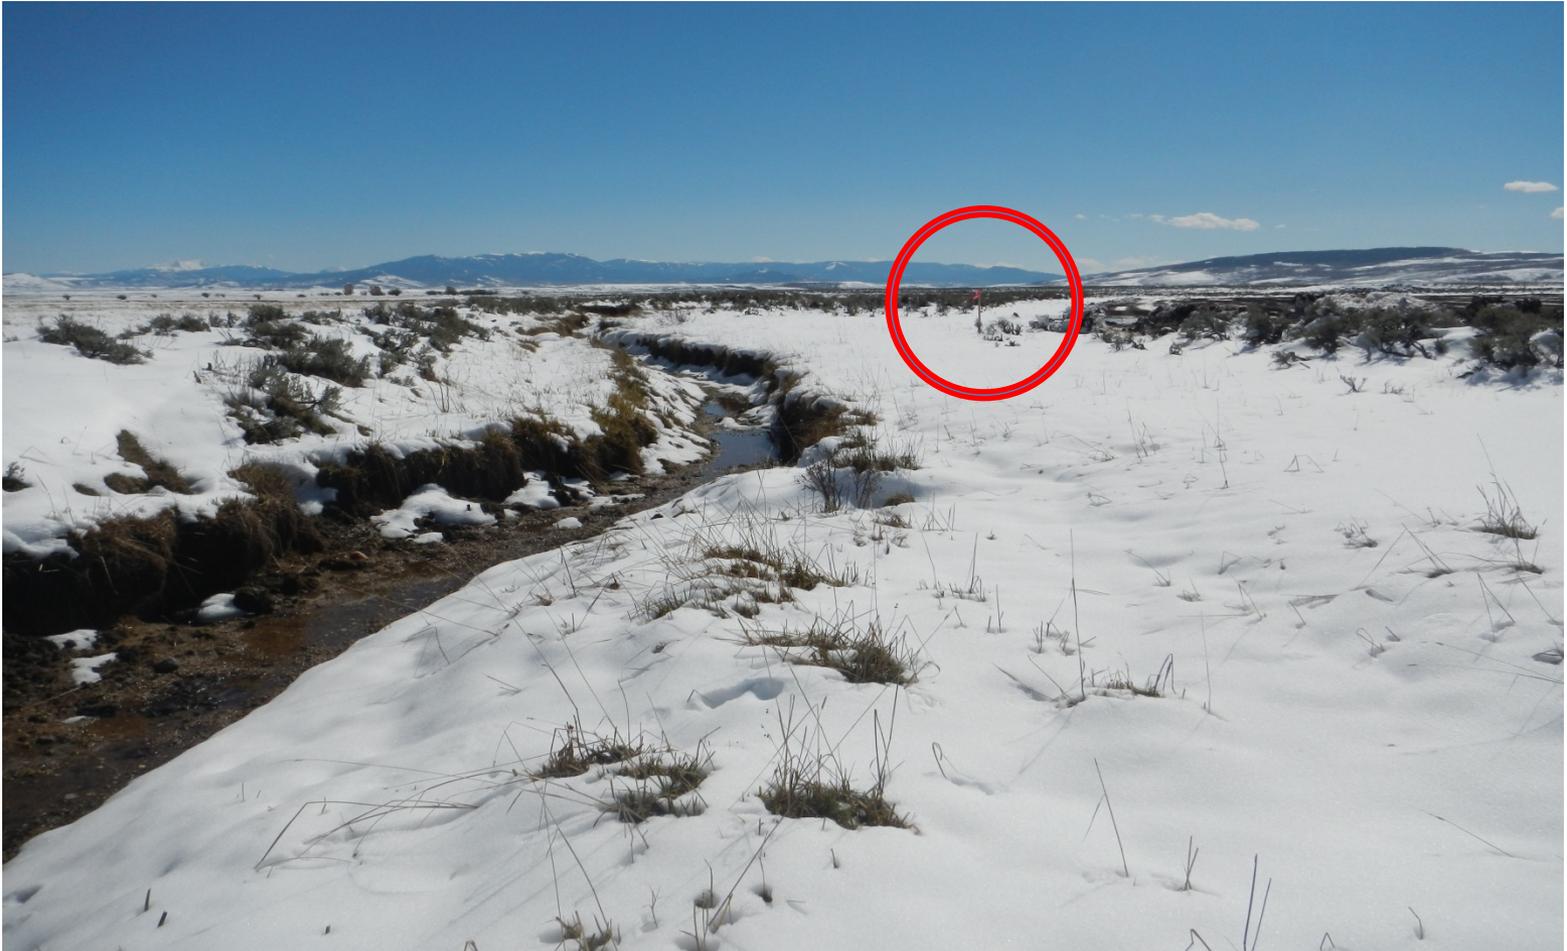
Photo#4:

Adjacent to Site is Irrigation Ditch running North to South, Curling around East side of Location. Circle shows Flagging for LOD.

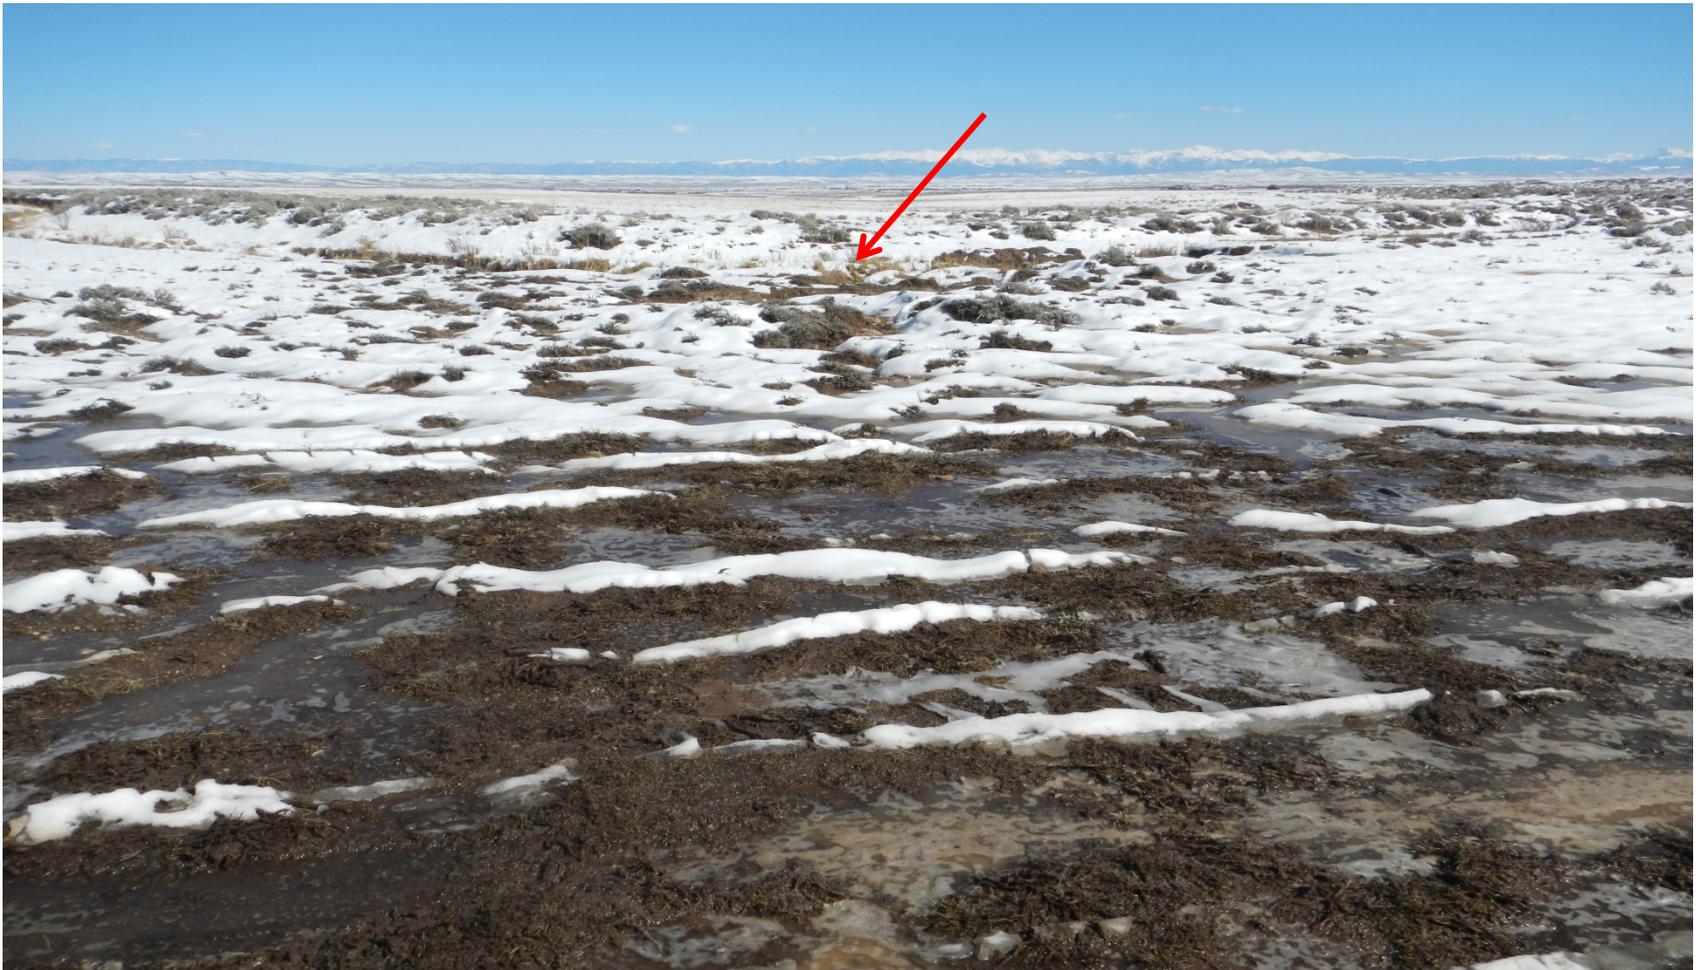
Photo#5:

Point on Access Road at turn into Location where SW is draining off Road into Irrigation Ditch (indicated with arrow). BMPs need to be installed/ repaired along Access Road

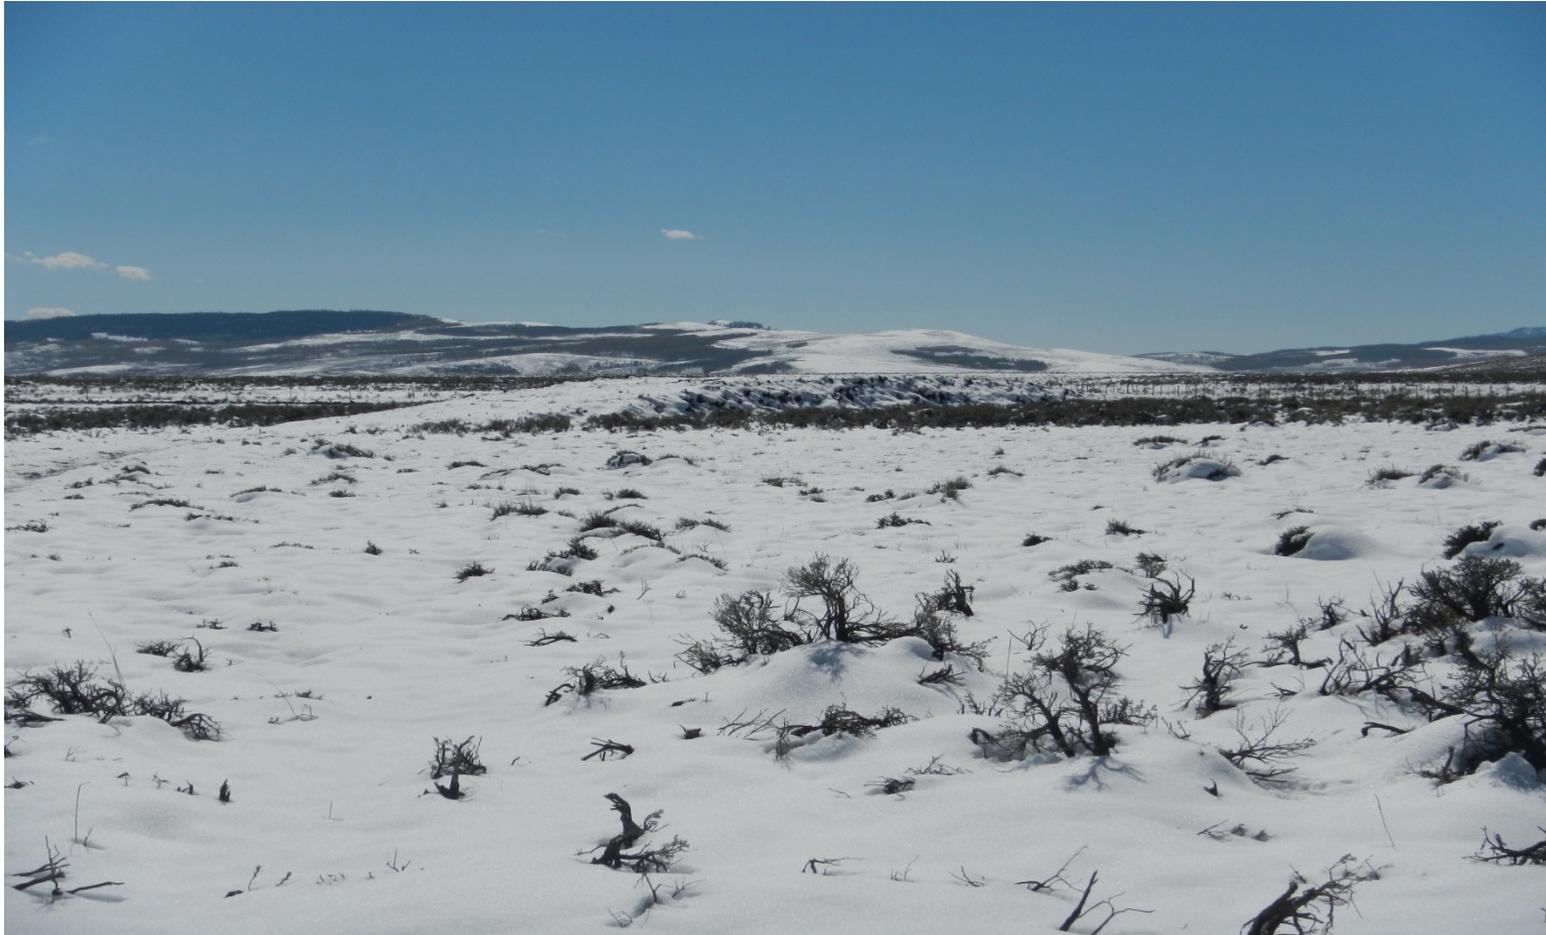
Photo#6:

Top Soil Pile piled at SW edge of what will be (per Operator) LOD when Location is Amended for future development.
