Inspection Photos

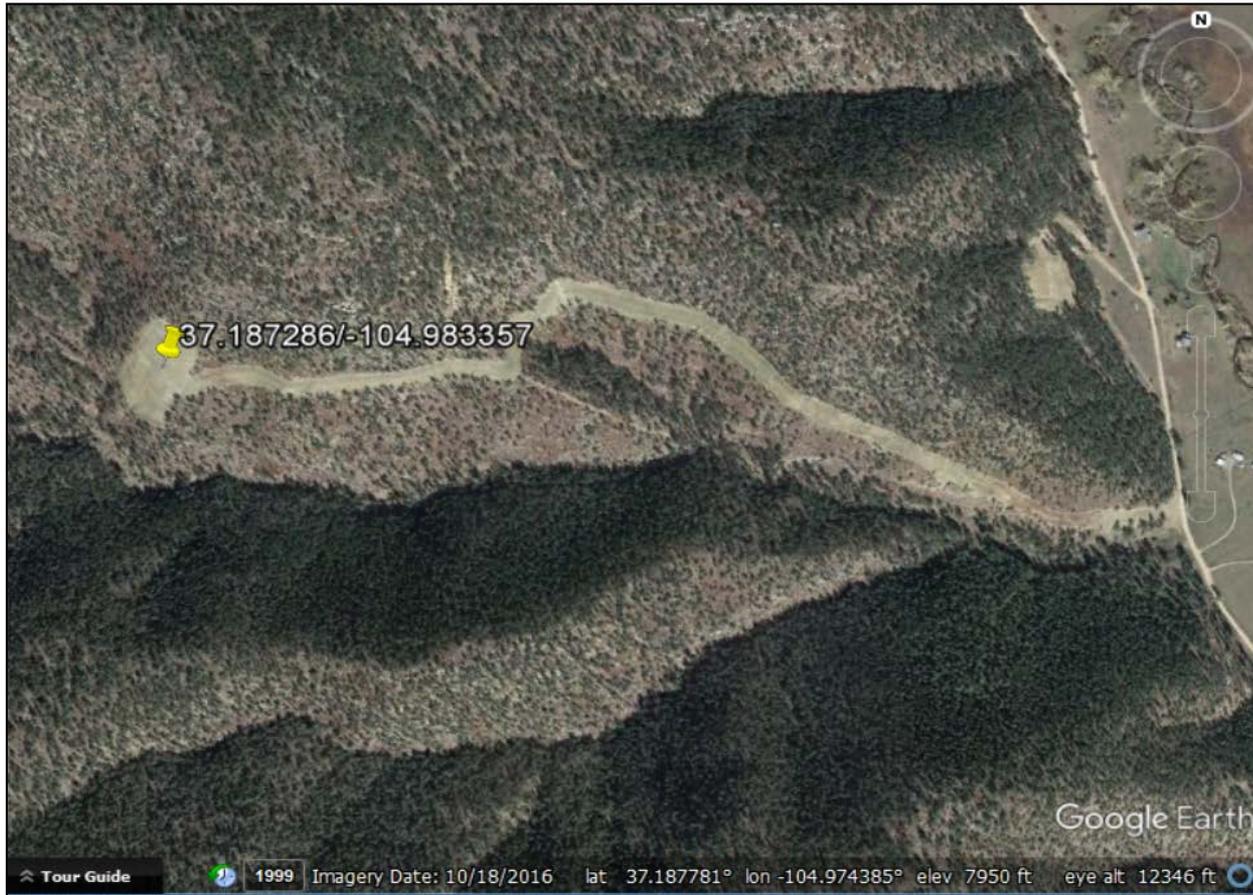
Photo 1. 2016 aerial image of the access road and location.

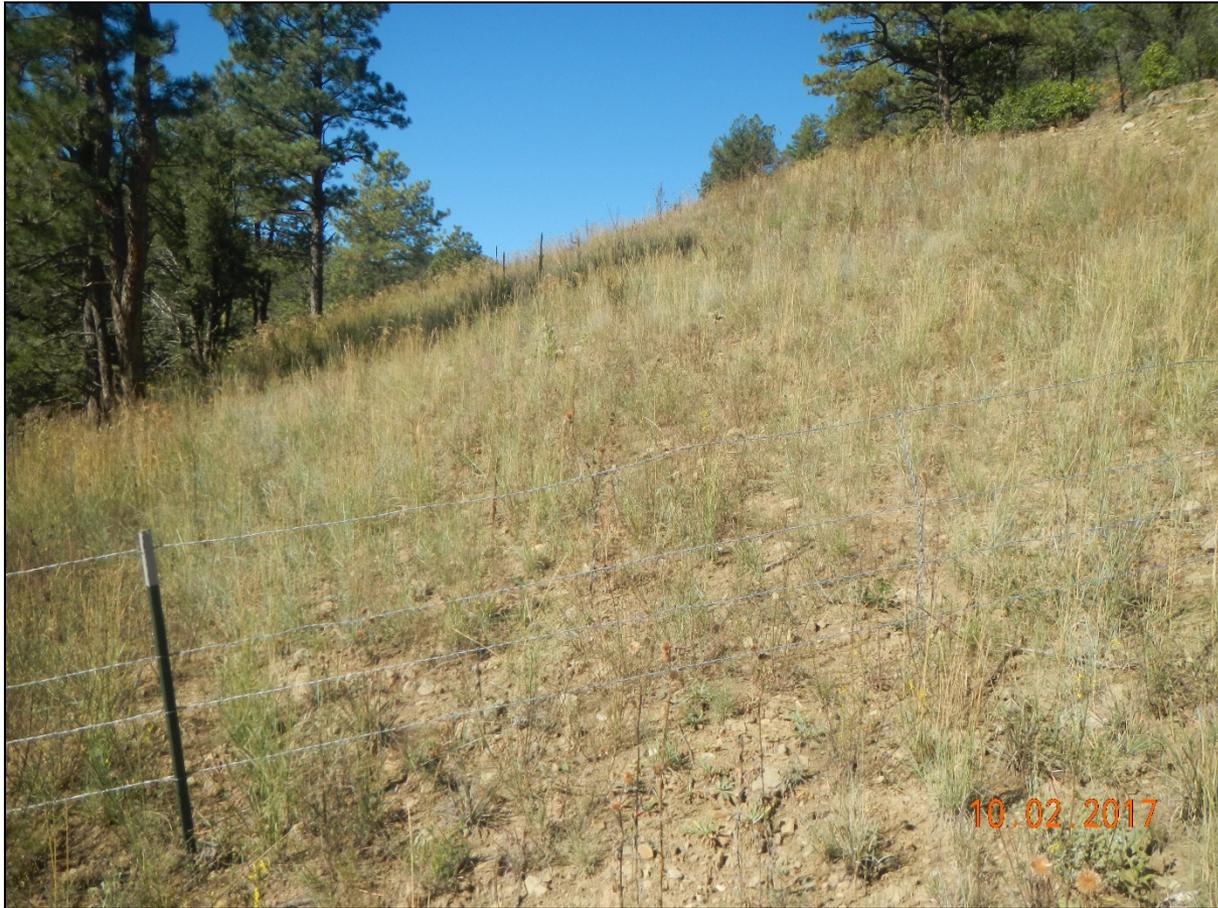
Photo 2. Beginning of the reclaimed access road standing from the county road.

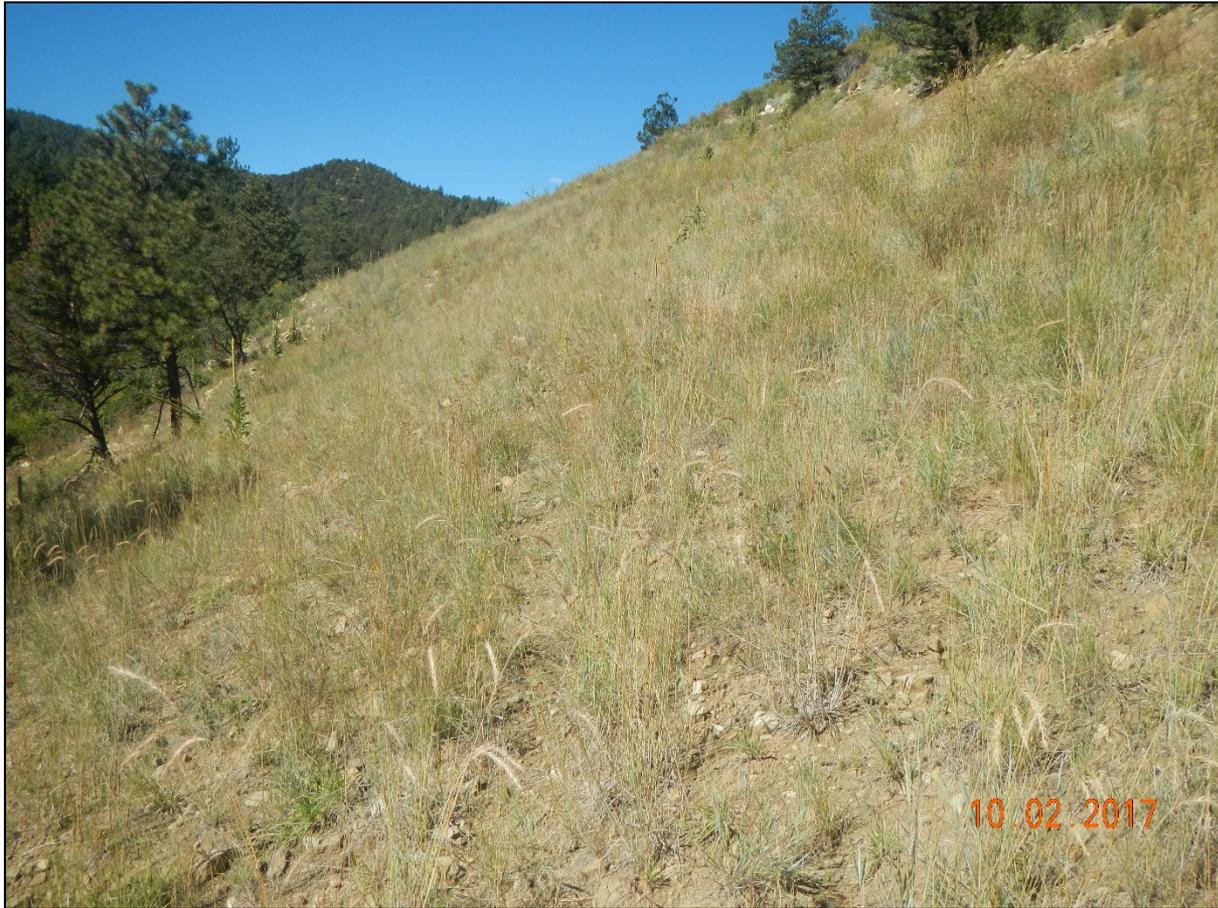
Photo 3. Facing west along the reclaimed access road.

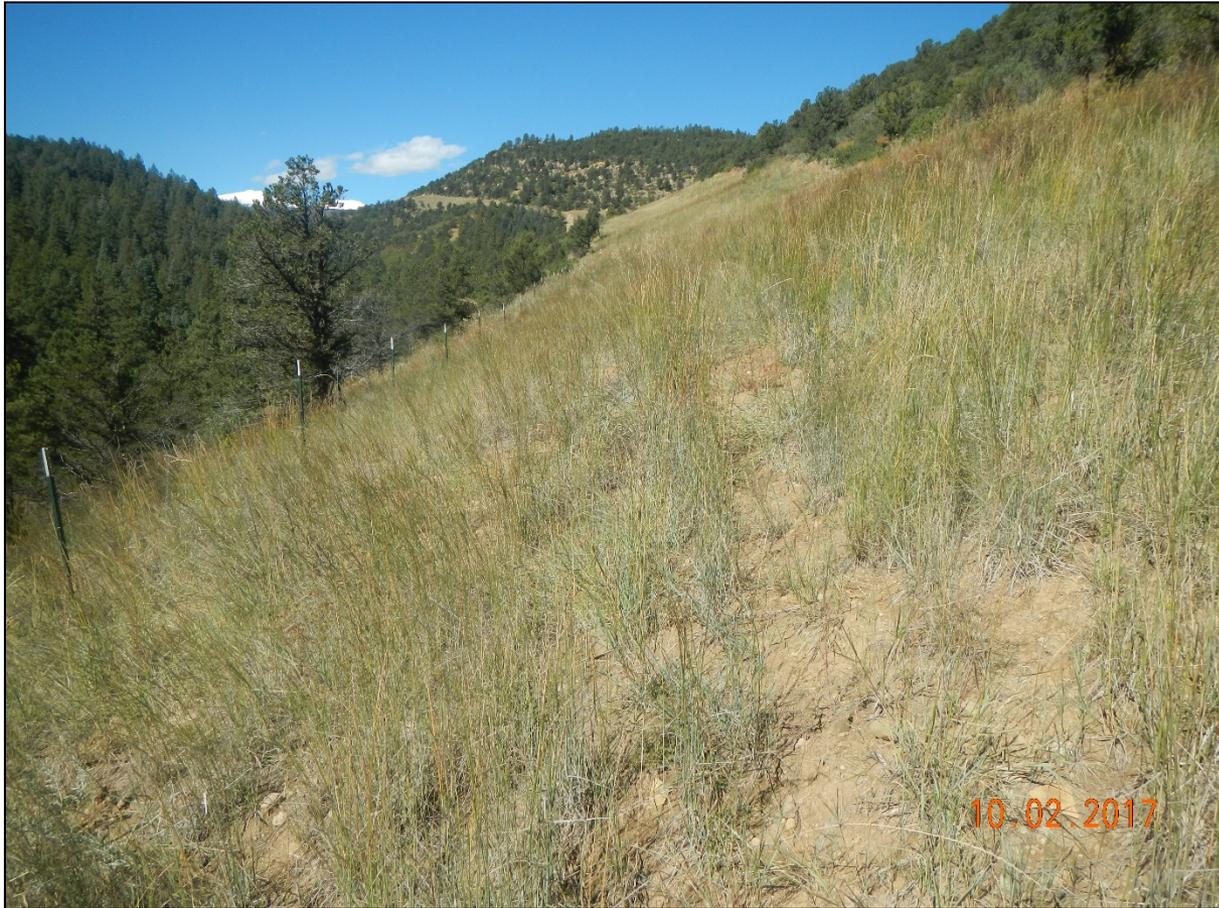
Photo 4. Facing northwest along the reclaimed access road.

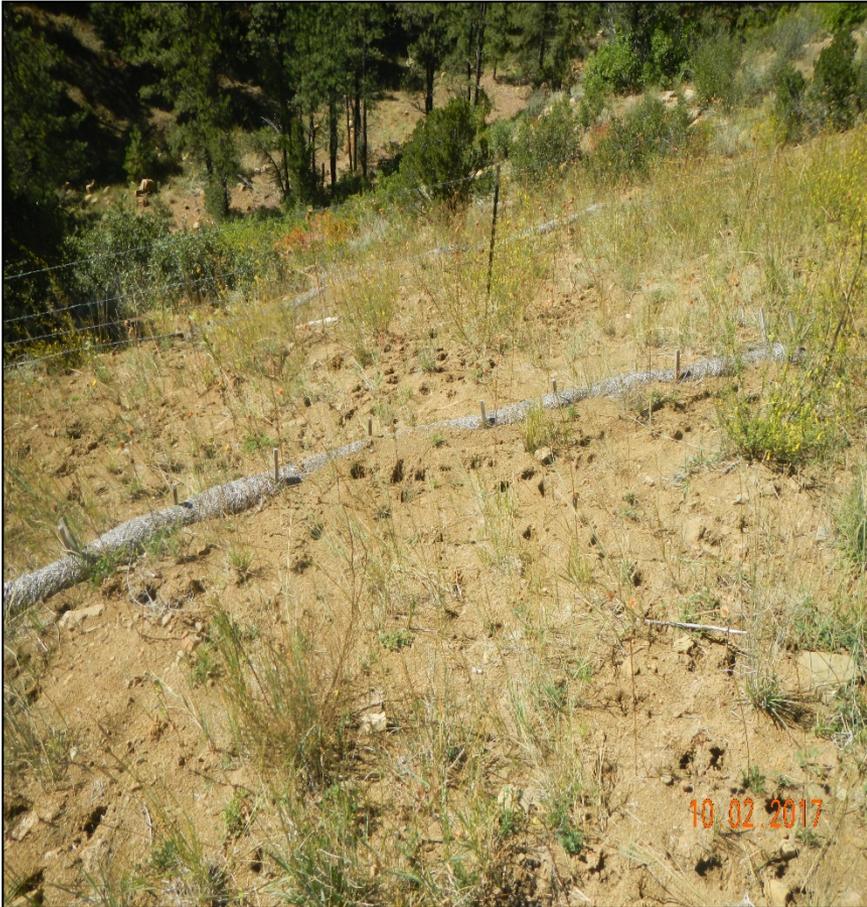
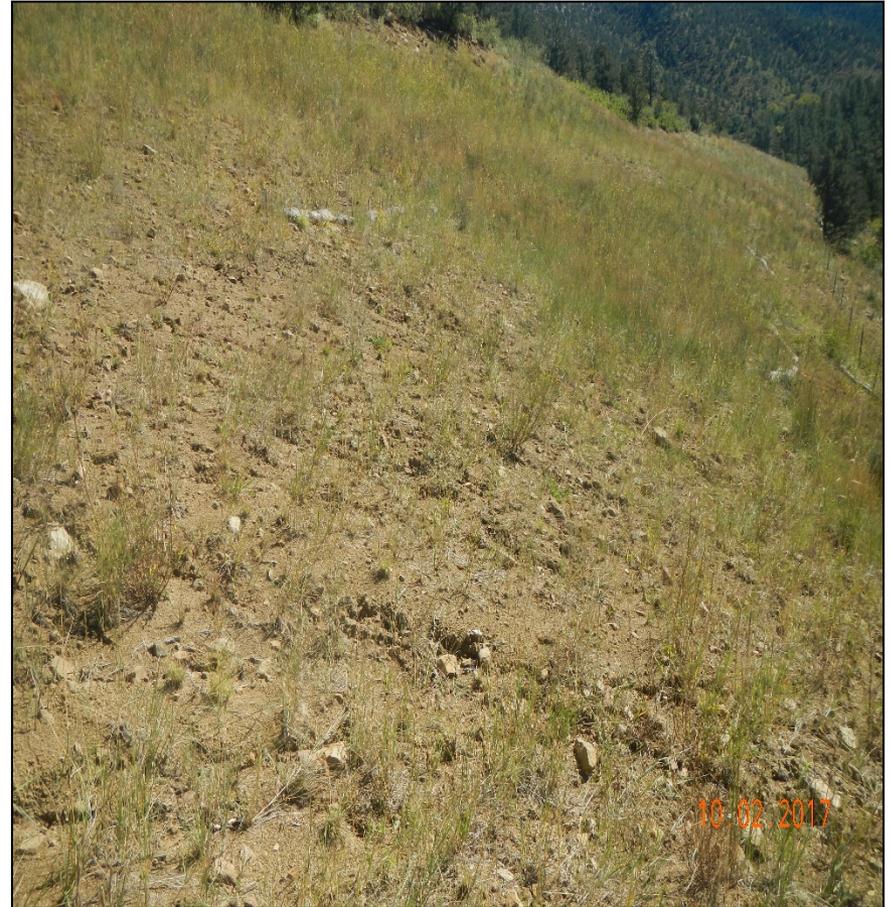
Photo 5. This area along the access road has less vegetation and erosion issues beginning to occur. The straw wattles have filled in with sediment.

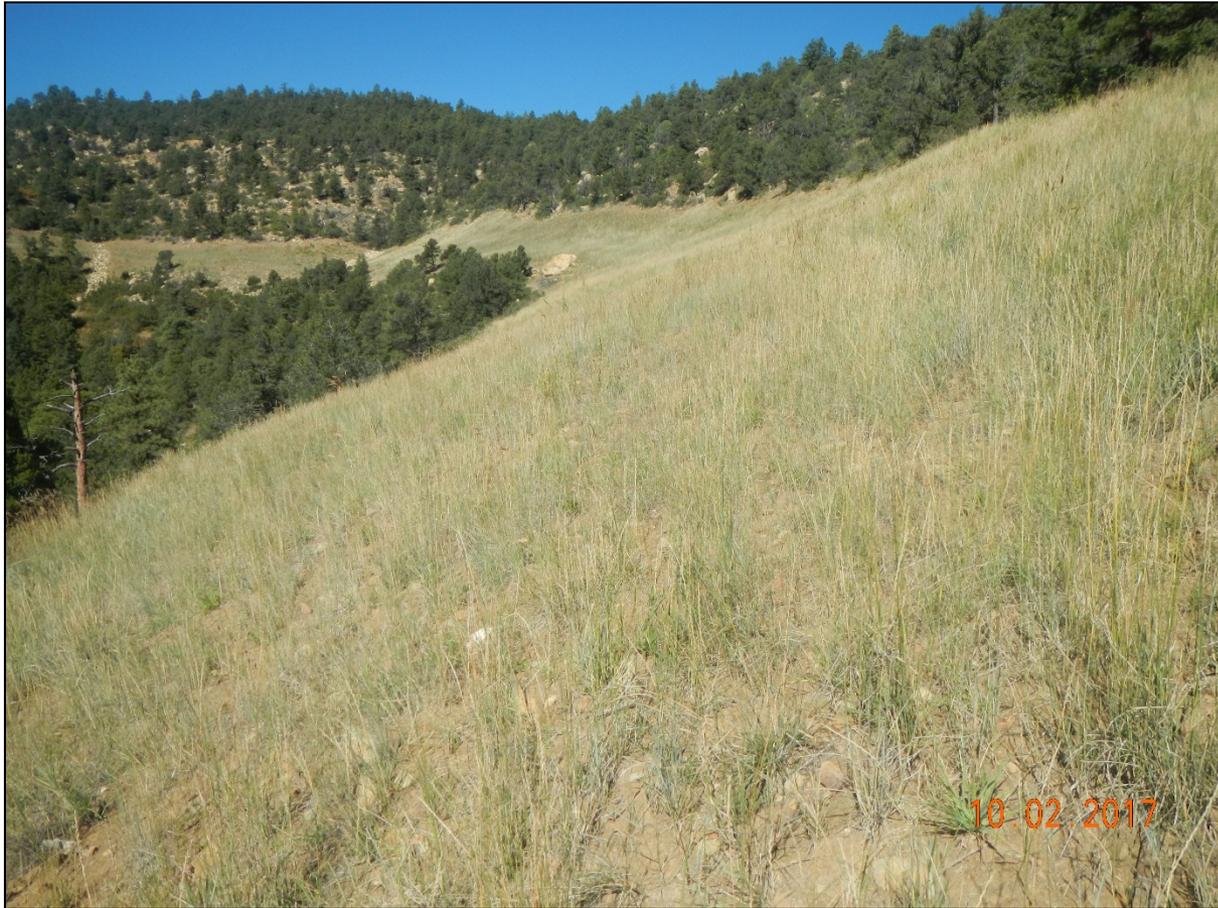
Photo 6. Facing northwest along the reclaimed access road. Vegetation is establishing throughout the reclamation area.

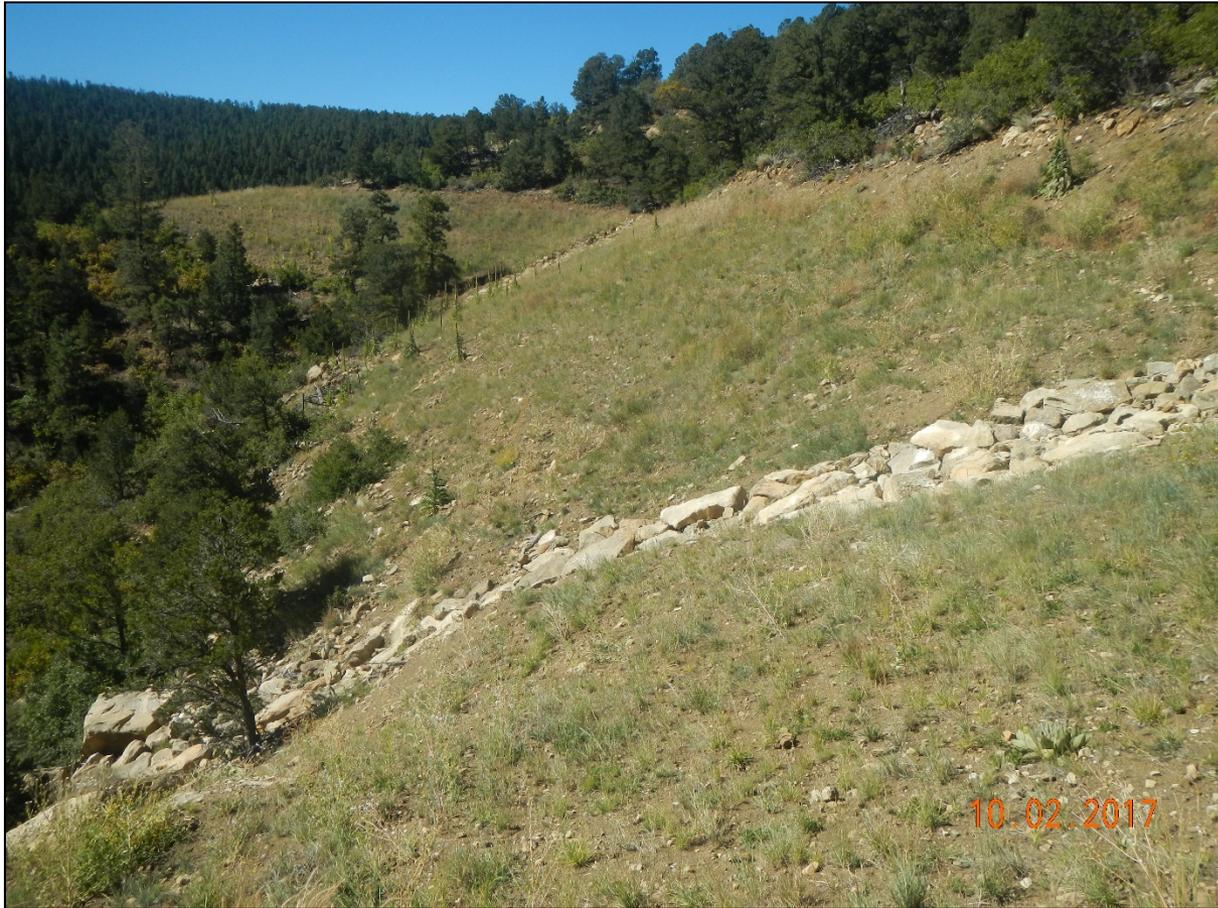
Photo 7. Facing southwest where reclamation area cross two natural drainages. Rock rip/rap was installed in these areas.

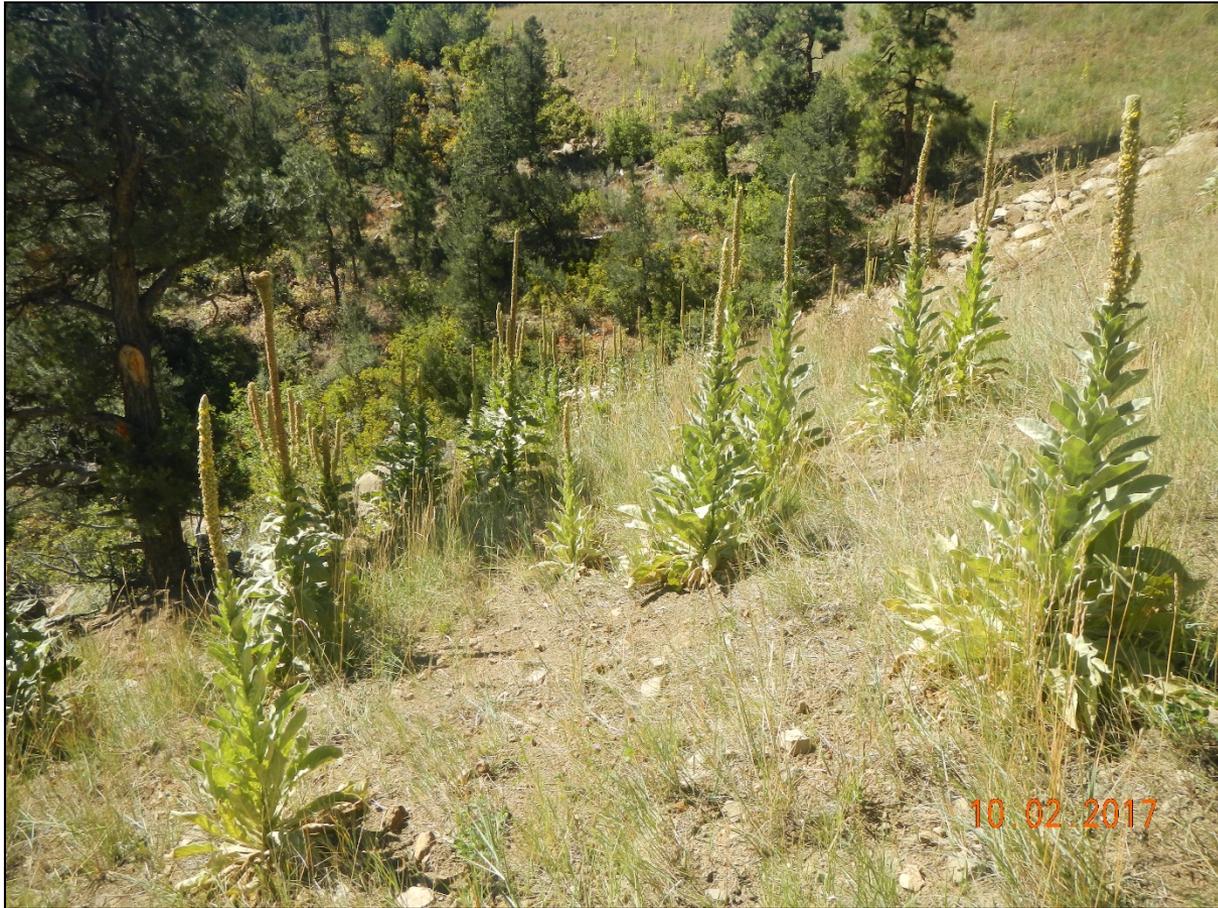
Photo 8. There are a few areas along the reclaimed access road where List C noxious weeds, Common mullien has established.

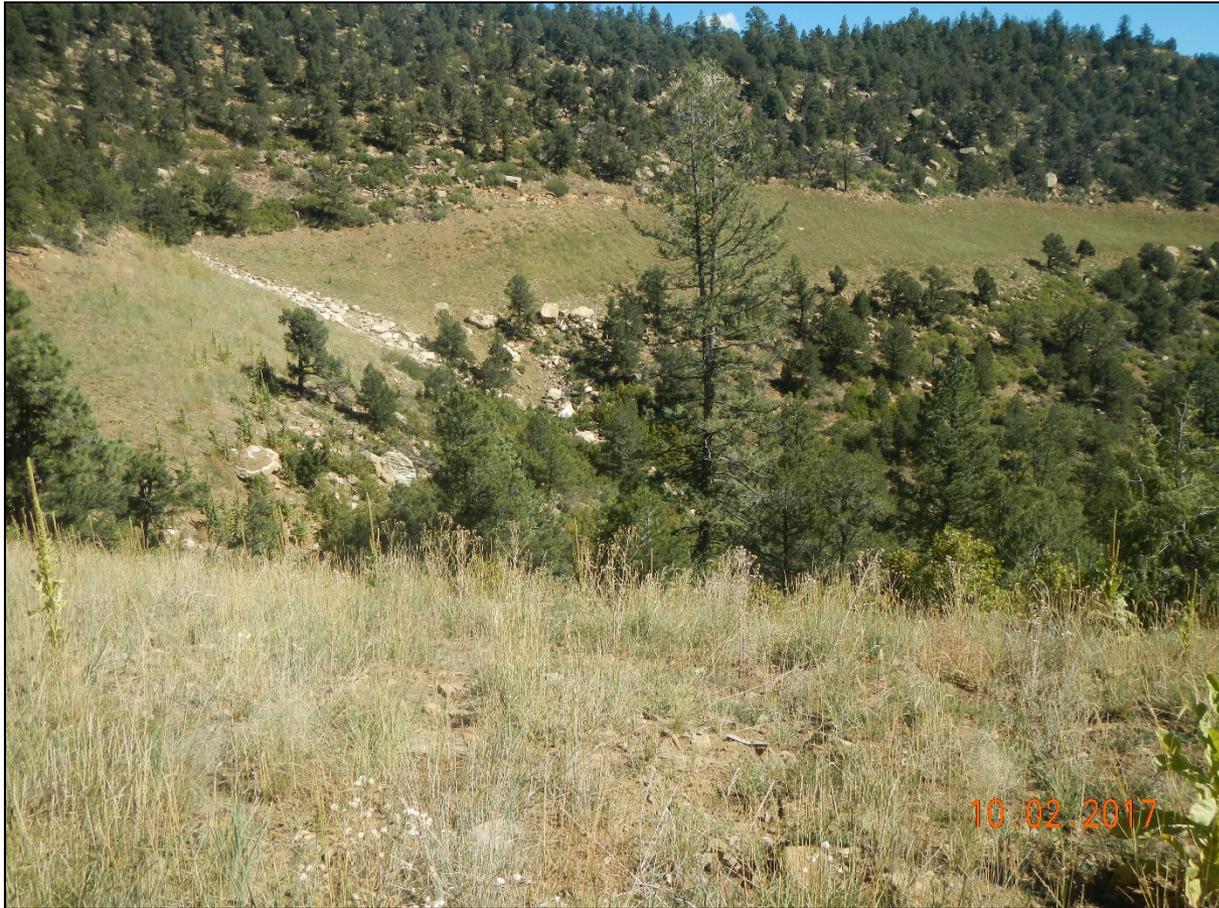
Photo 9. Facing back toward the northeast along the reclaimed access road.

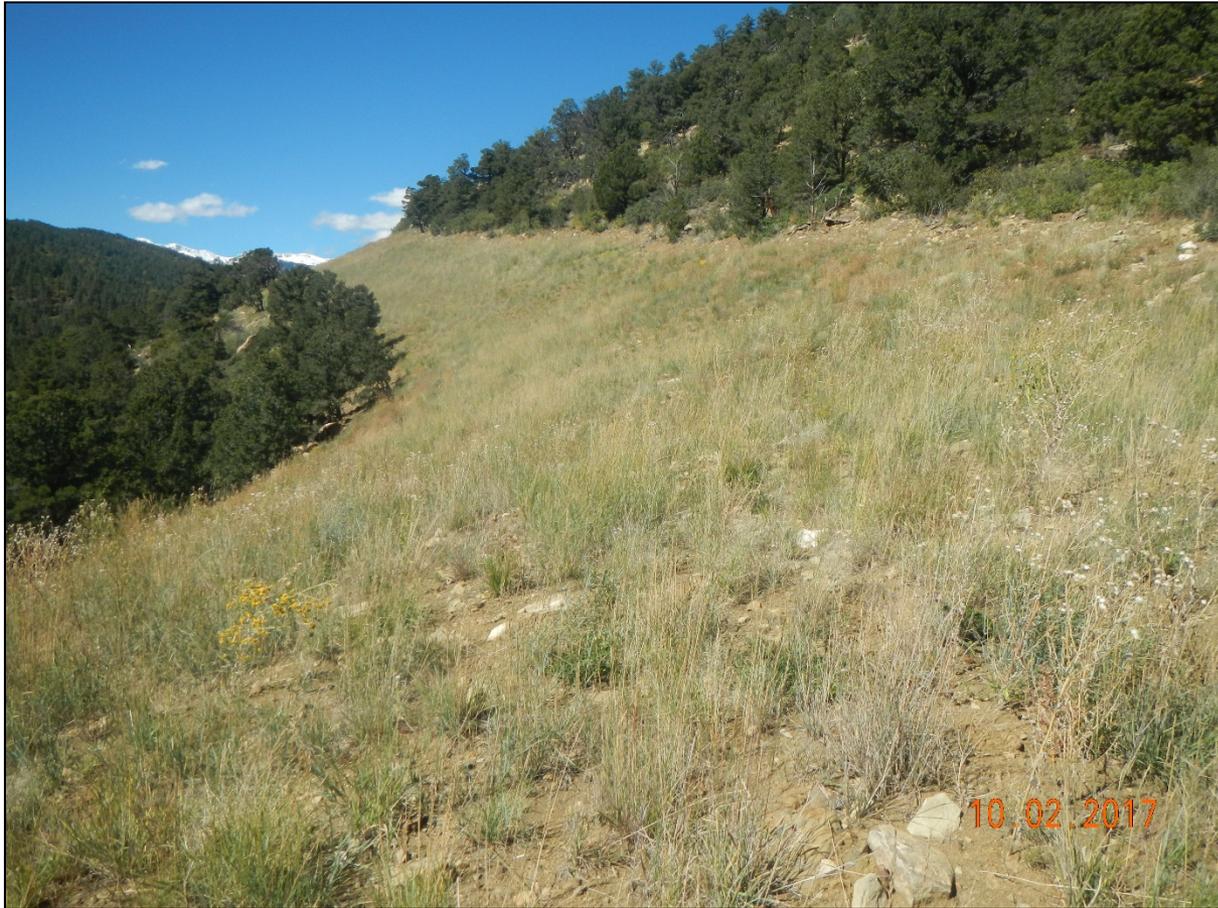
Photo 10. Facing west along the reclaimed access road.

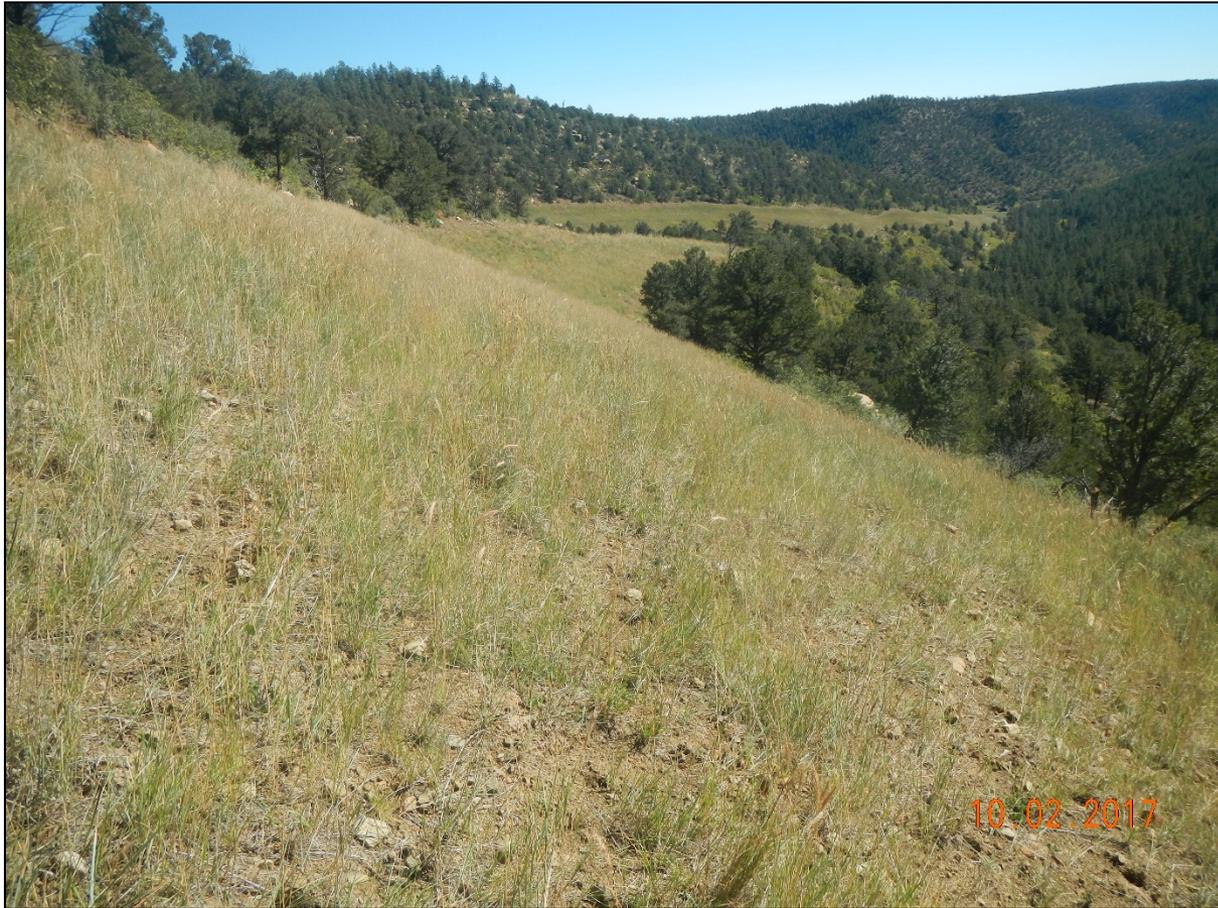
Photo 11. Facing back toward the east along the reclaimed access road.

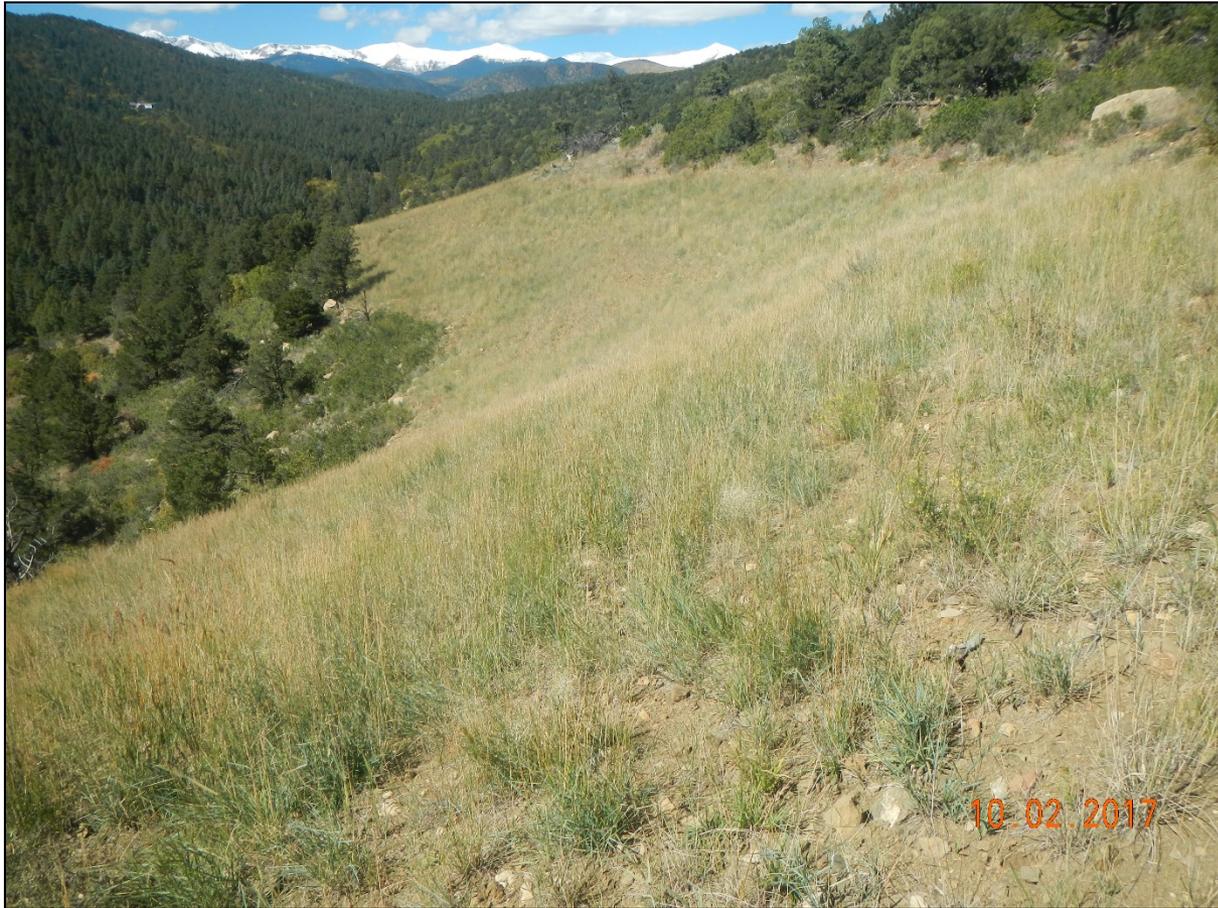
Photo 12. Facing west along the reclaimed access road near the location.

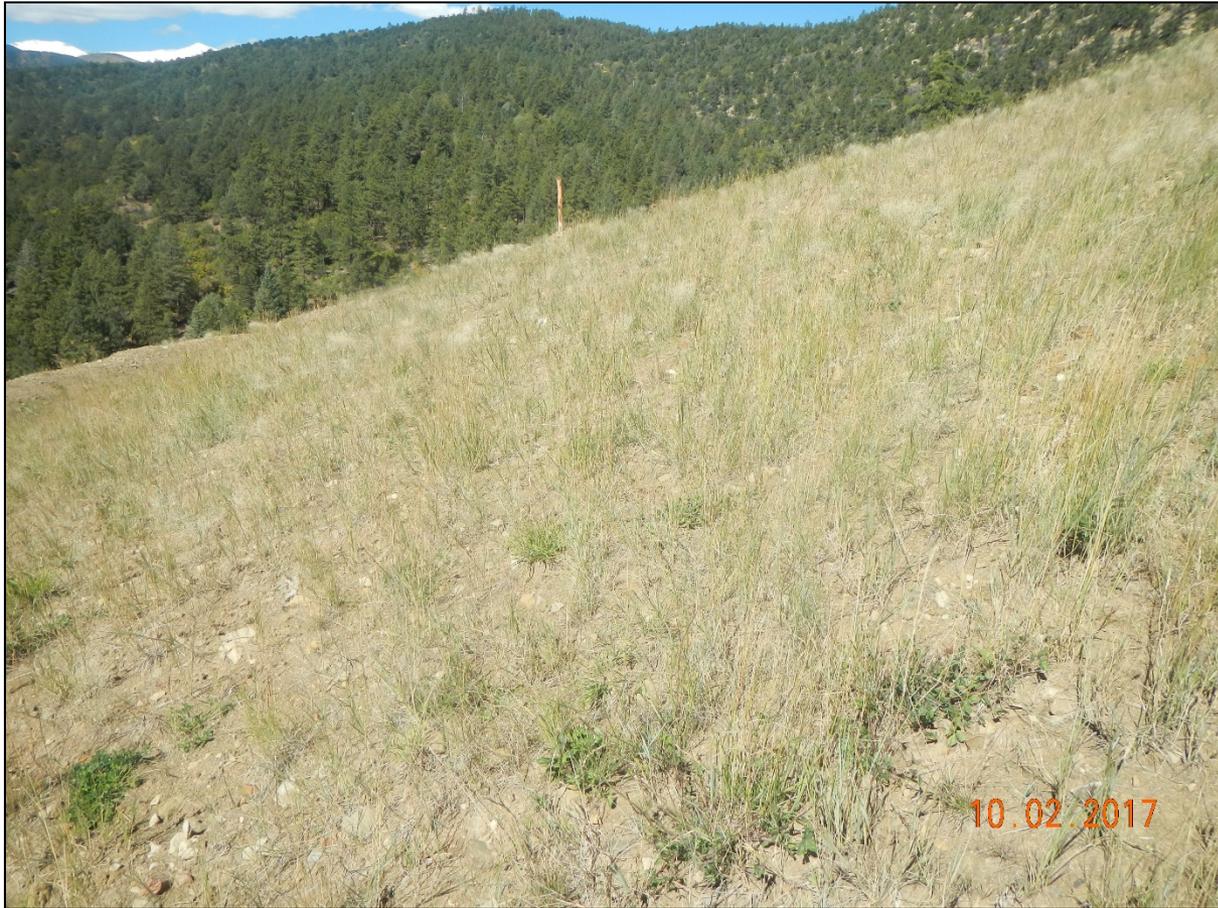
Photo 13. Facing west toward the location. A permanent well marker is installed at the center of the location.

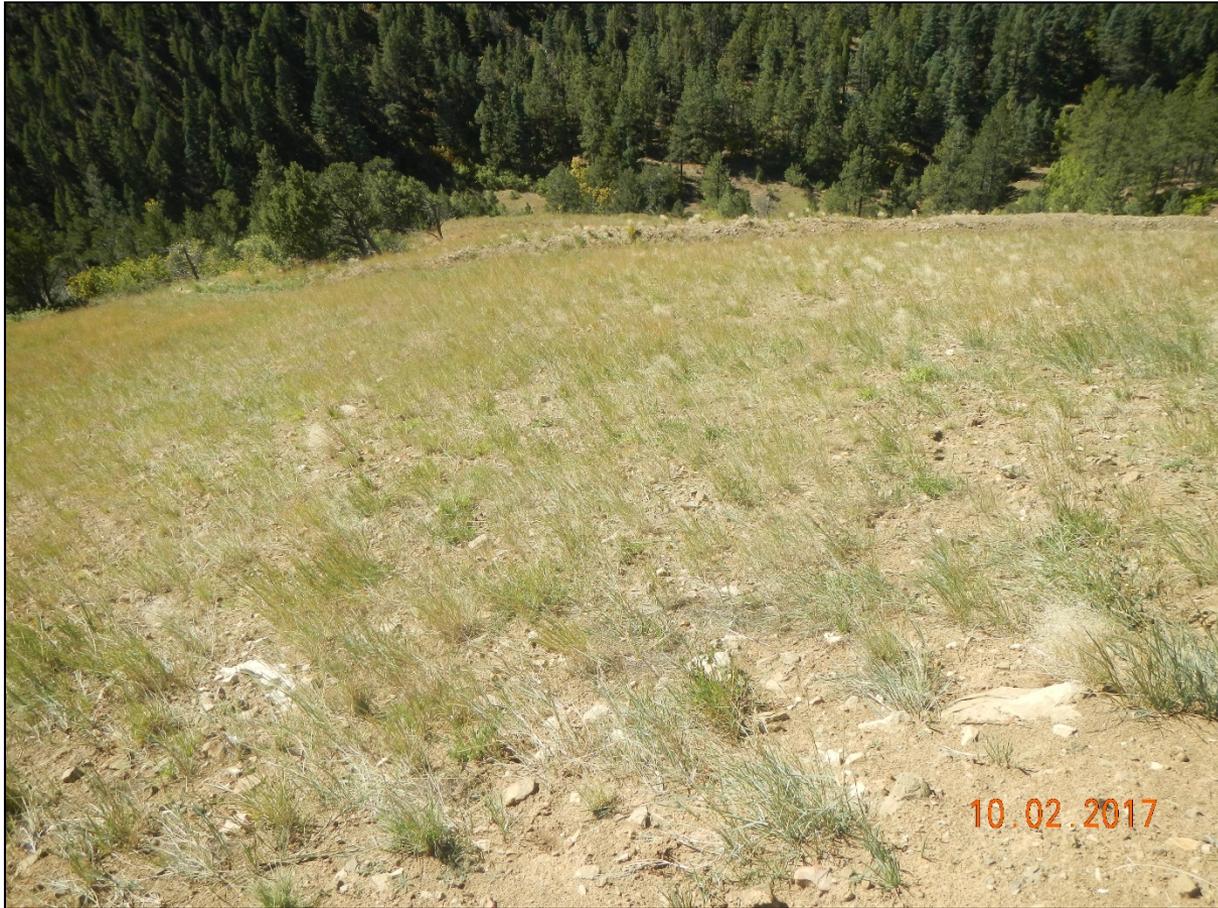
Photo 14. Facing down the slope at the location.

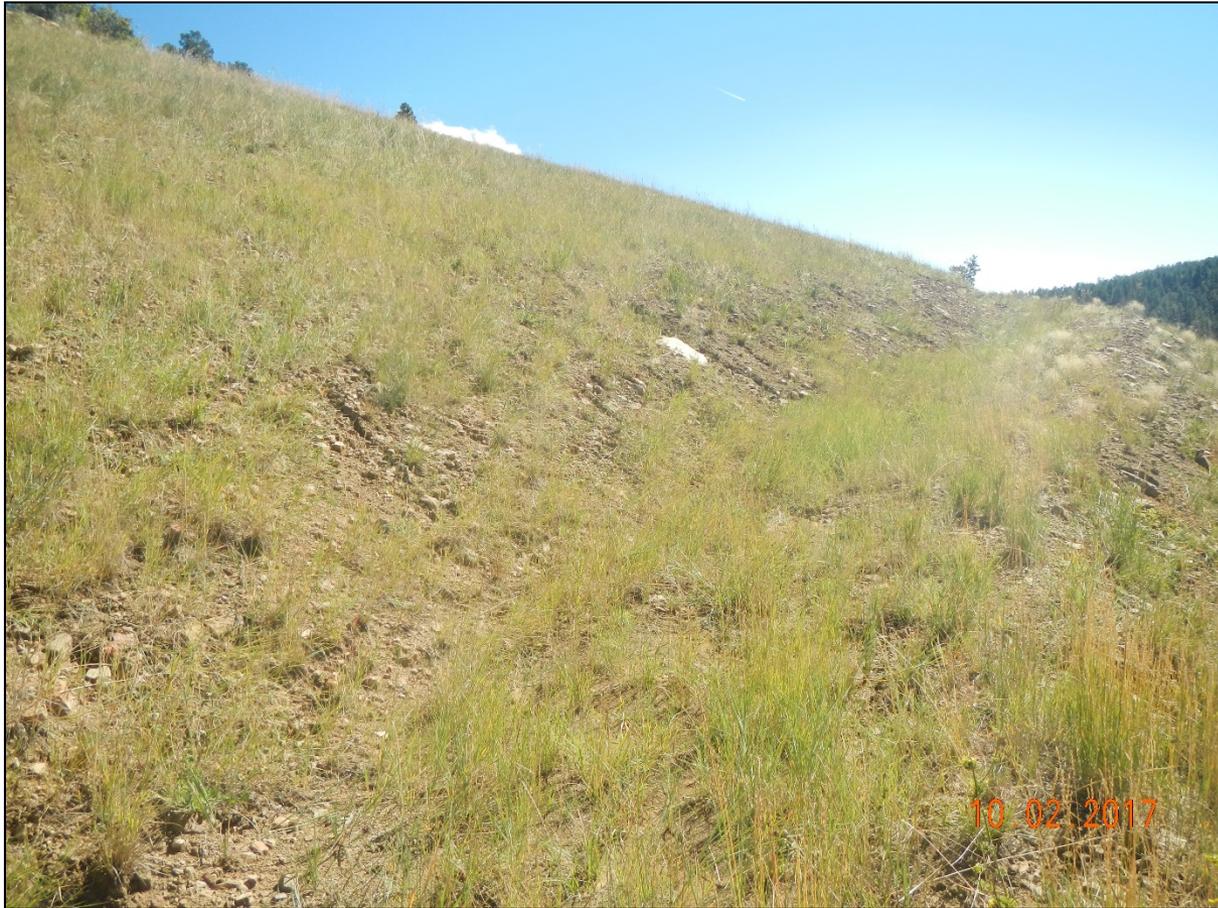
Photo 15. Facing east at the location. There are diversion ditches installed along the contour of the location.

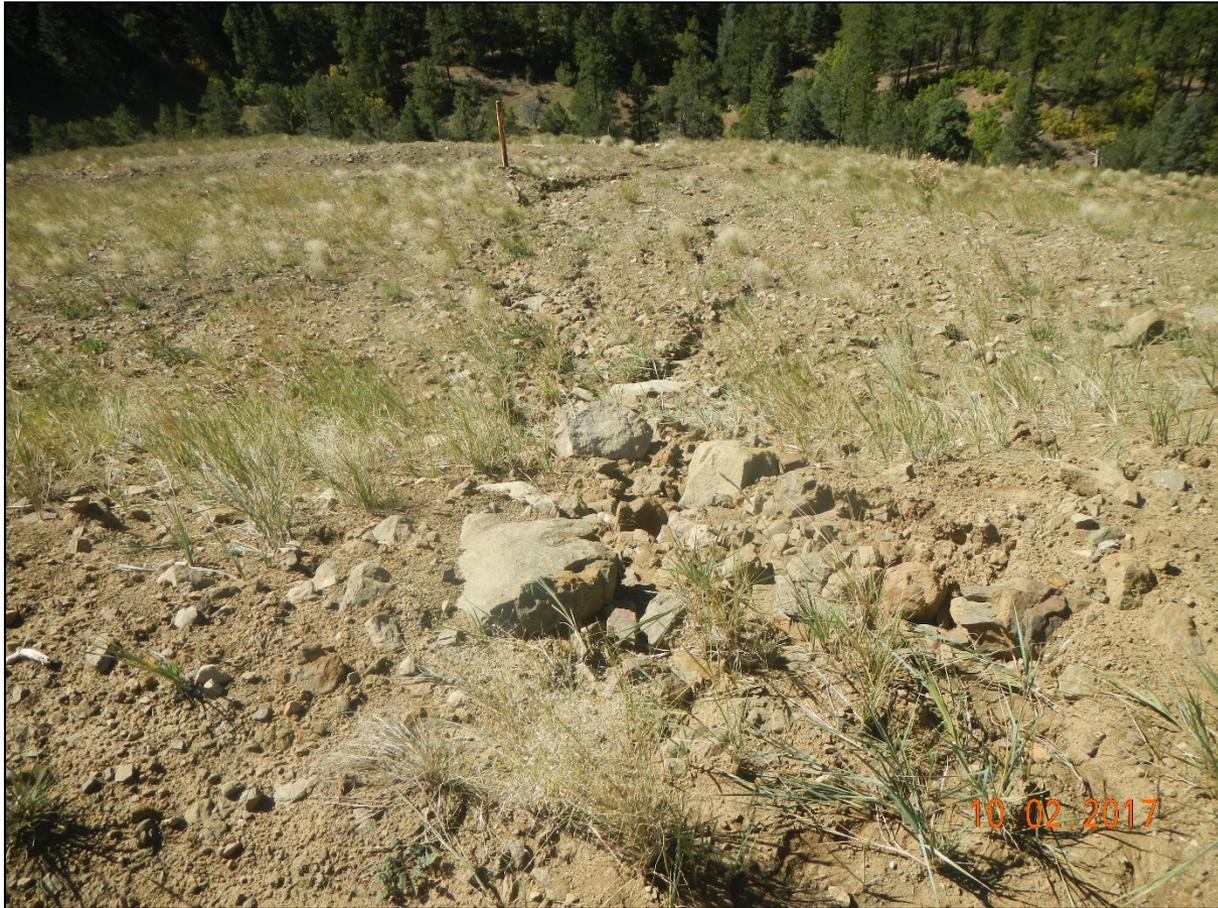
Photo 16. Sediment has filled in the diversion ditch causing stormwater to be directed down the center of the location causing erosion.

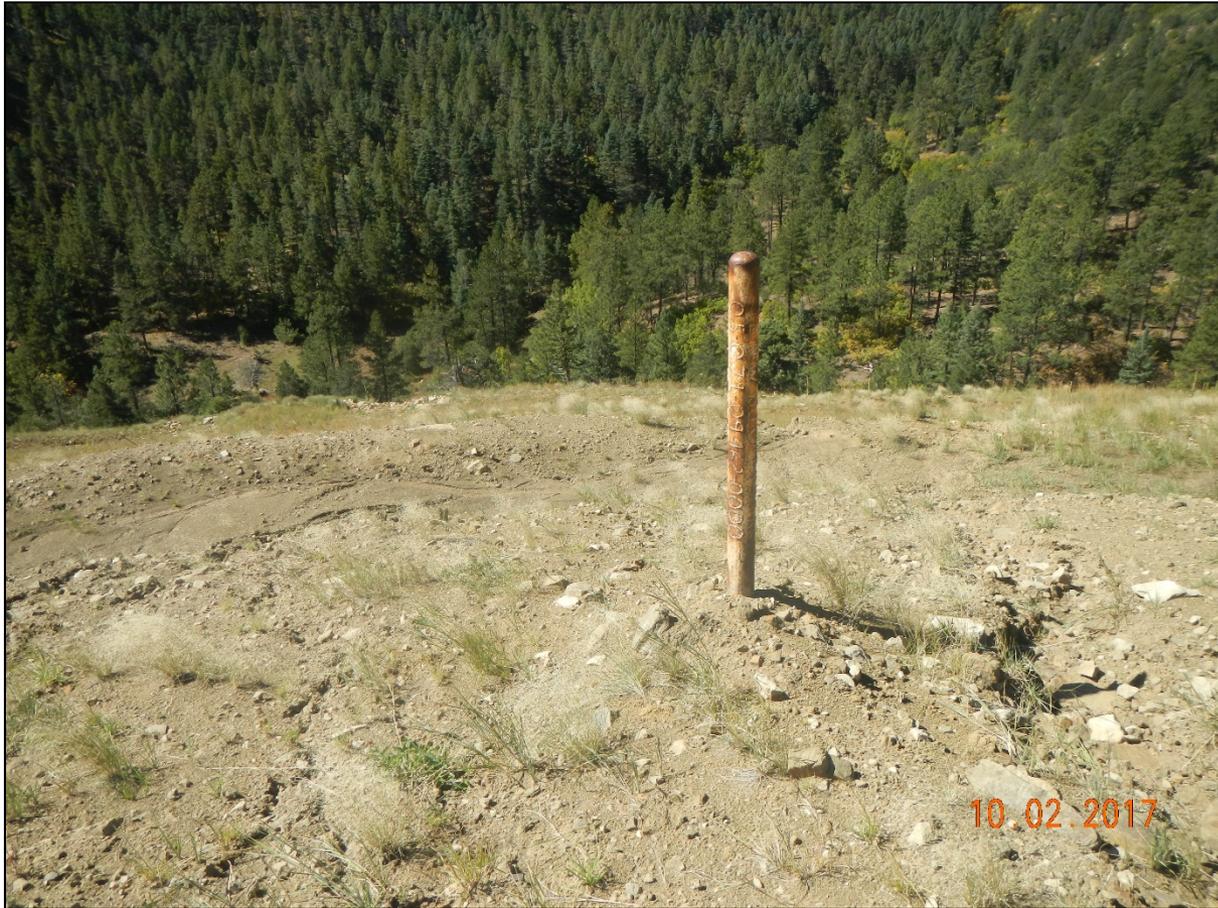
Photo 17. There is erosion occurring near the well marker.

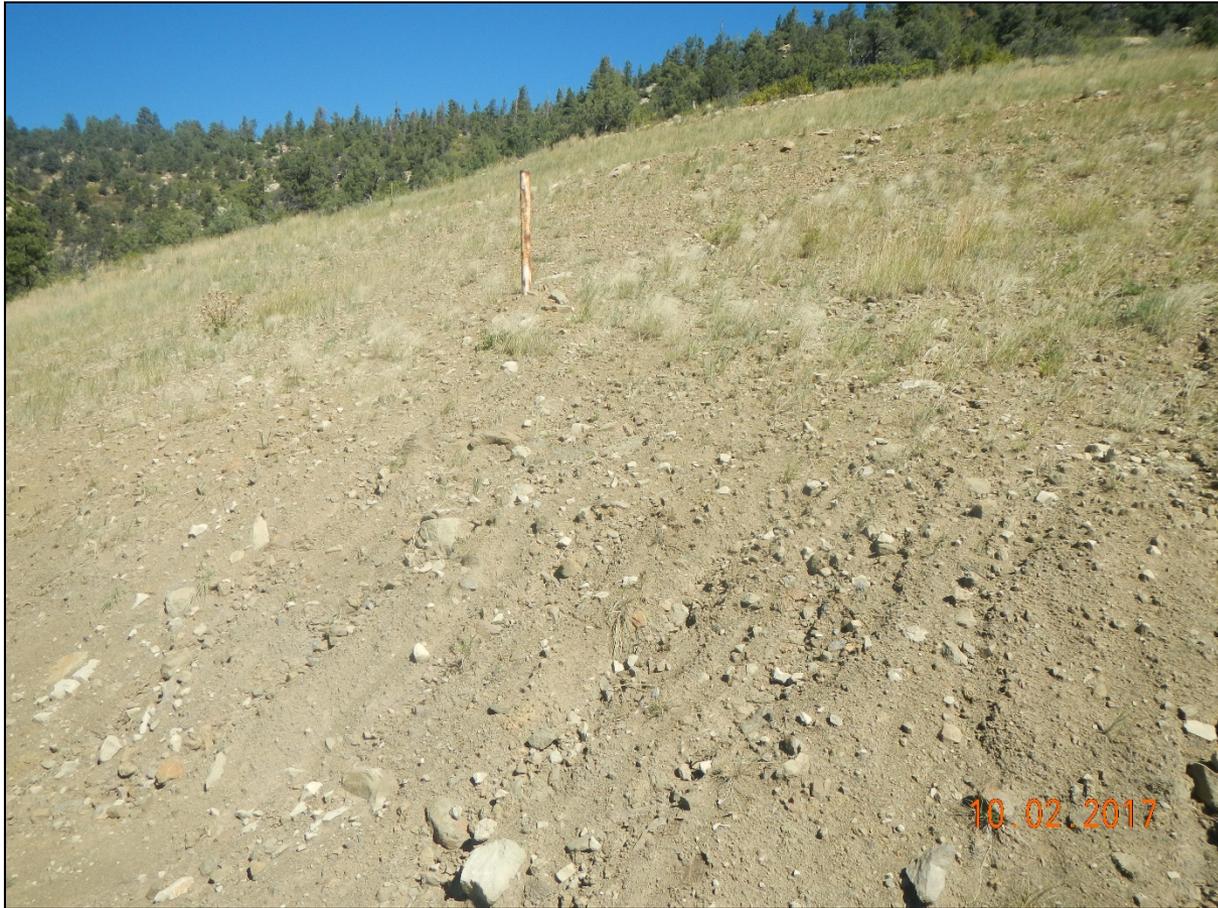
Photo 18. Facing north at the location. Well marker can be seen in the photo.

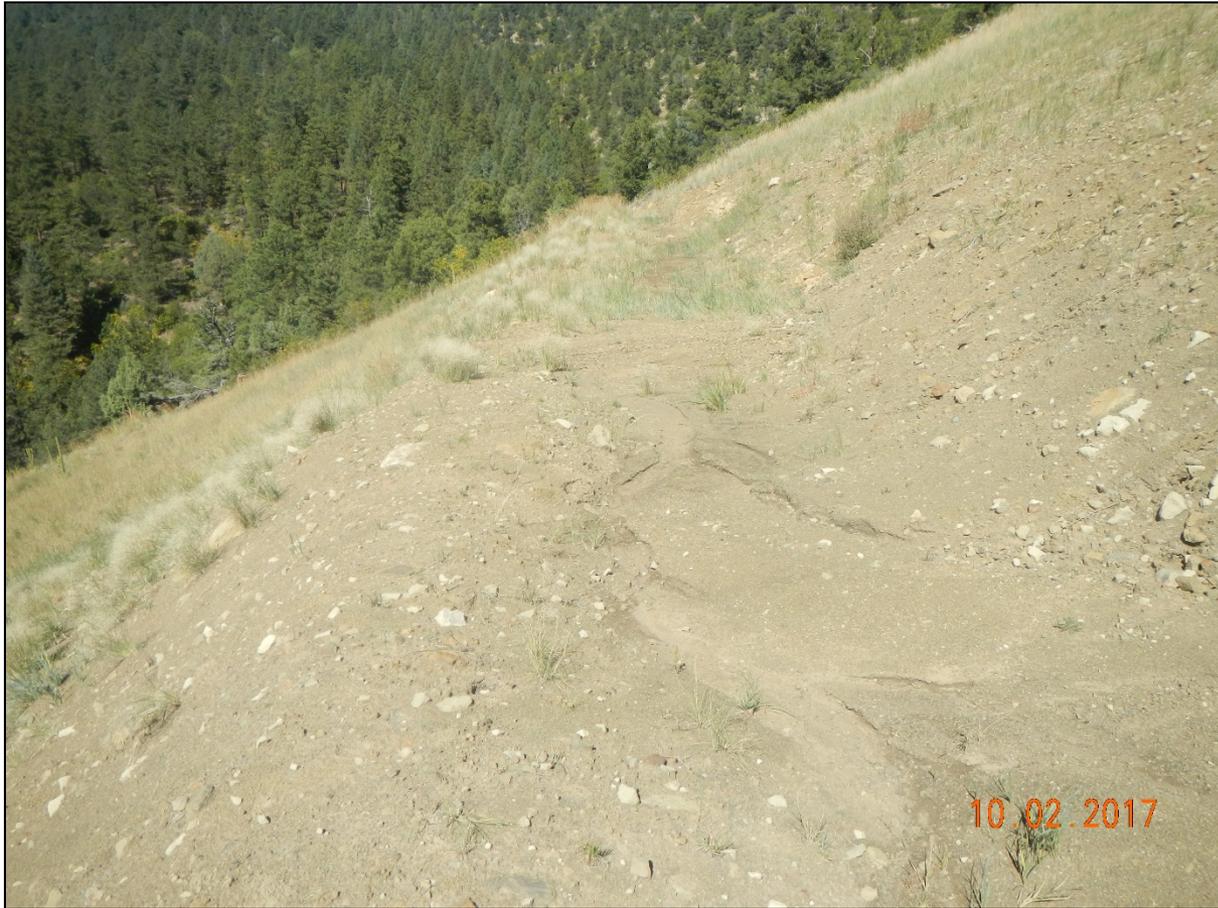
Photo 19. Sediment has filled into the diversion ditch causing stormwater to be directed down the center of the location.

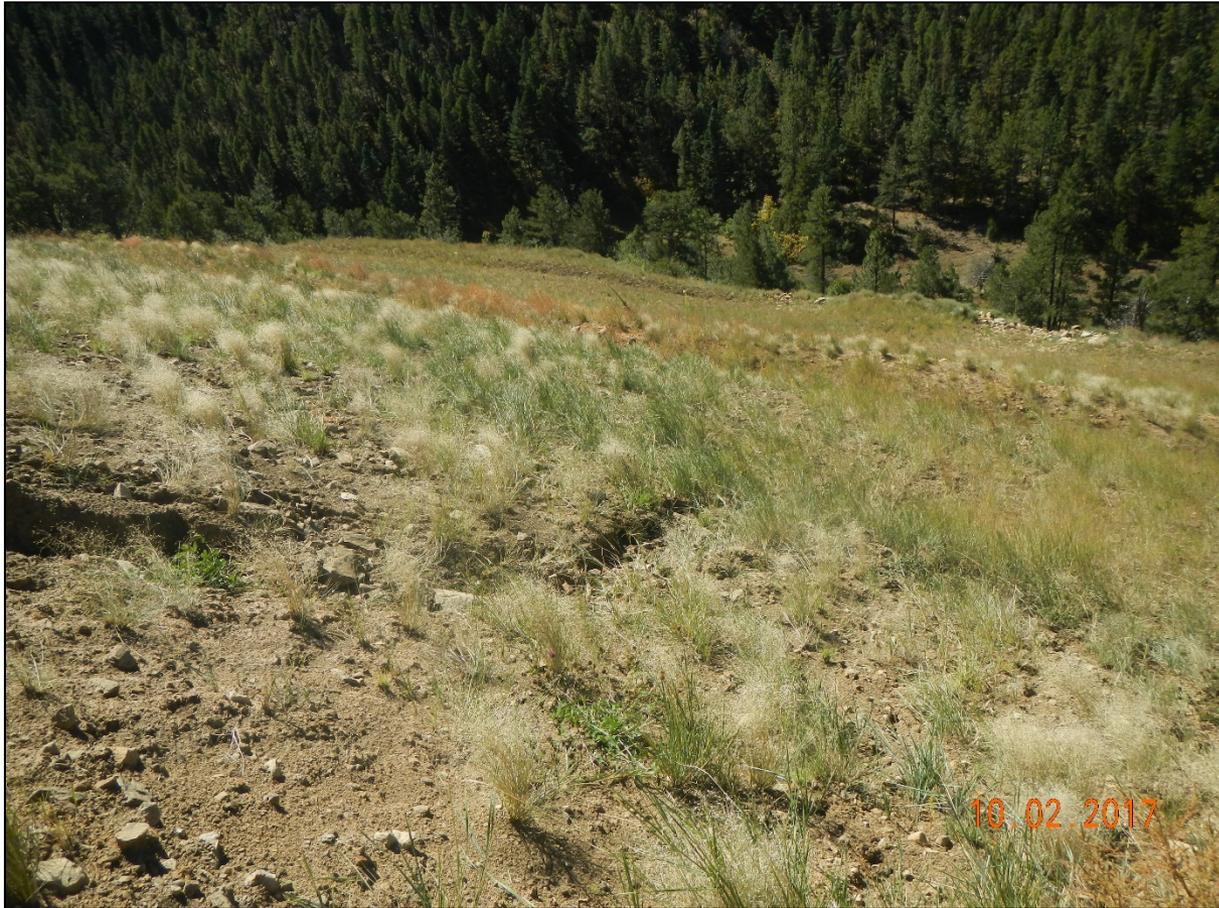
Photo 20. Facing down southwest at the location.
