Inspection Photos

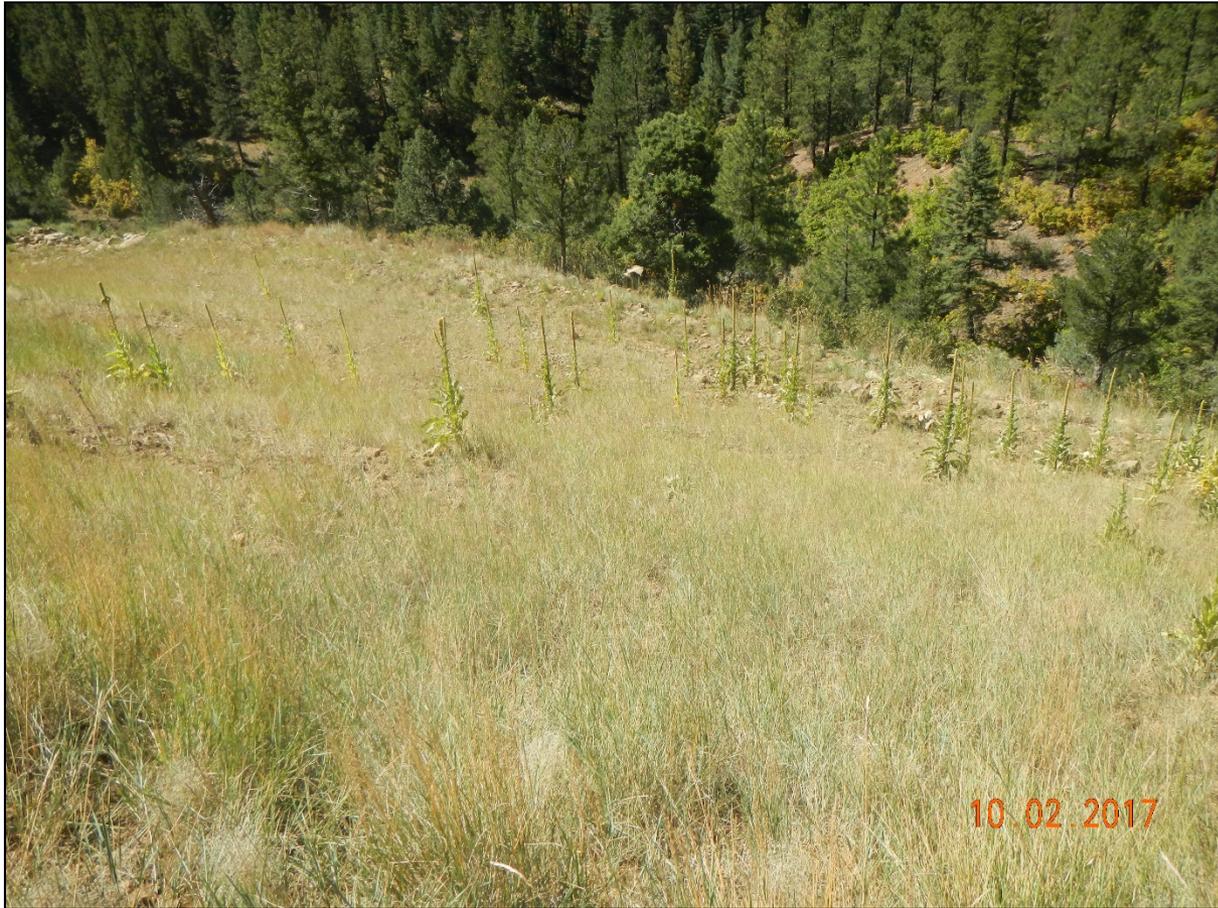
Photo 21. Facing toward the bottom of the location. There is some List C noxious weeds; Common mullien growing in this area.

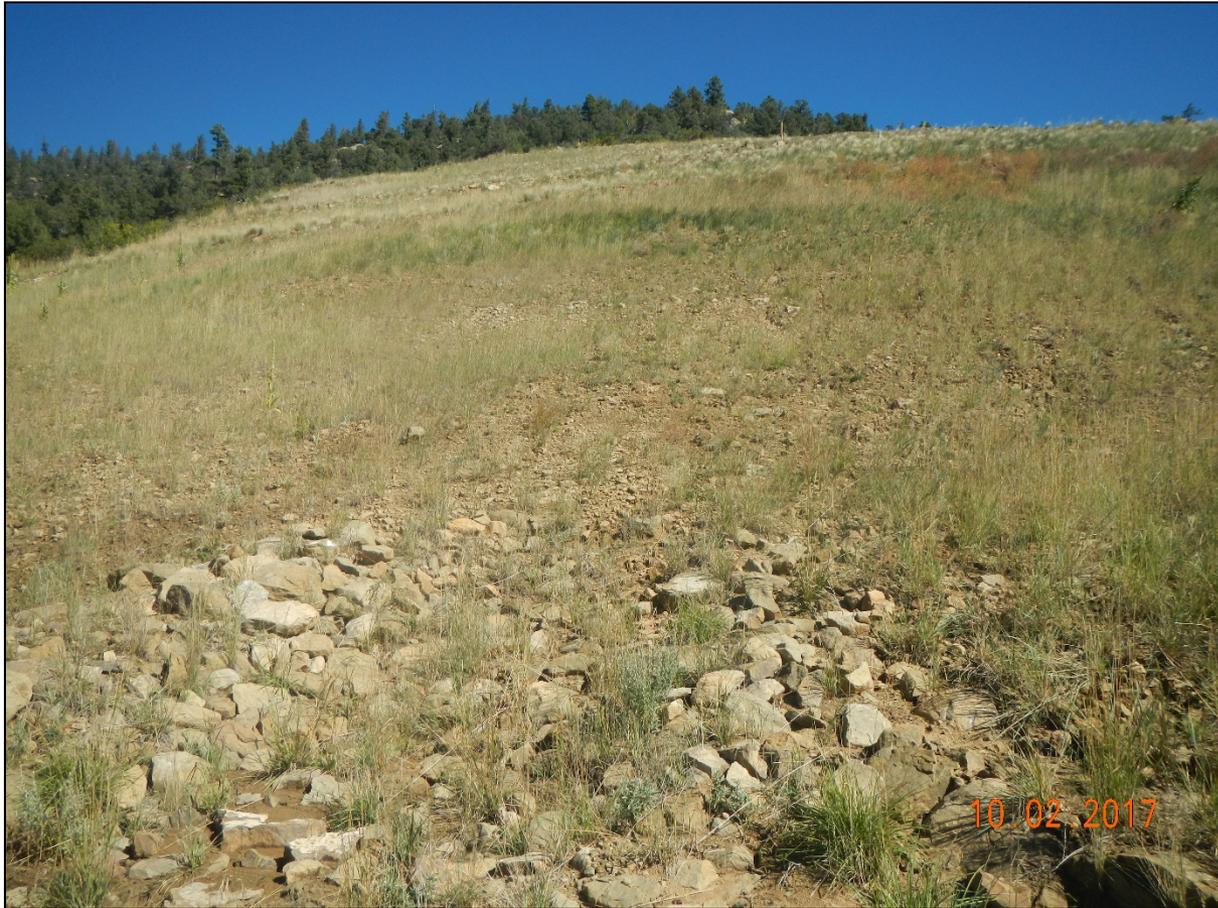
Photo 22. Bottom south side of the location facing north. Overall revegetation is establishing well throughout the location.
