Inspection Photos

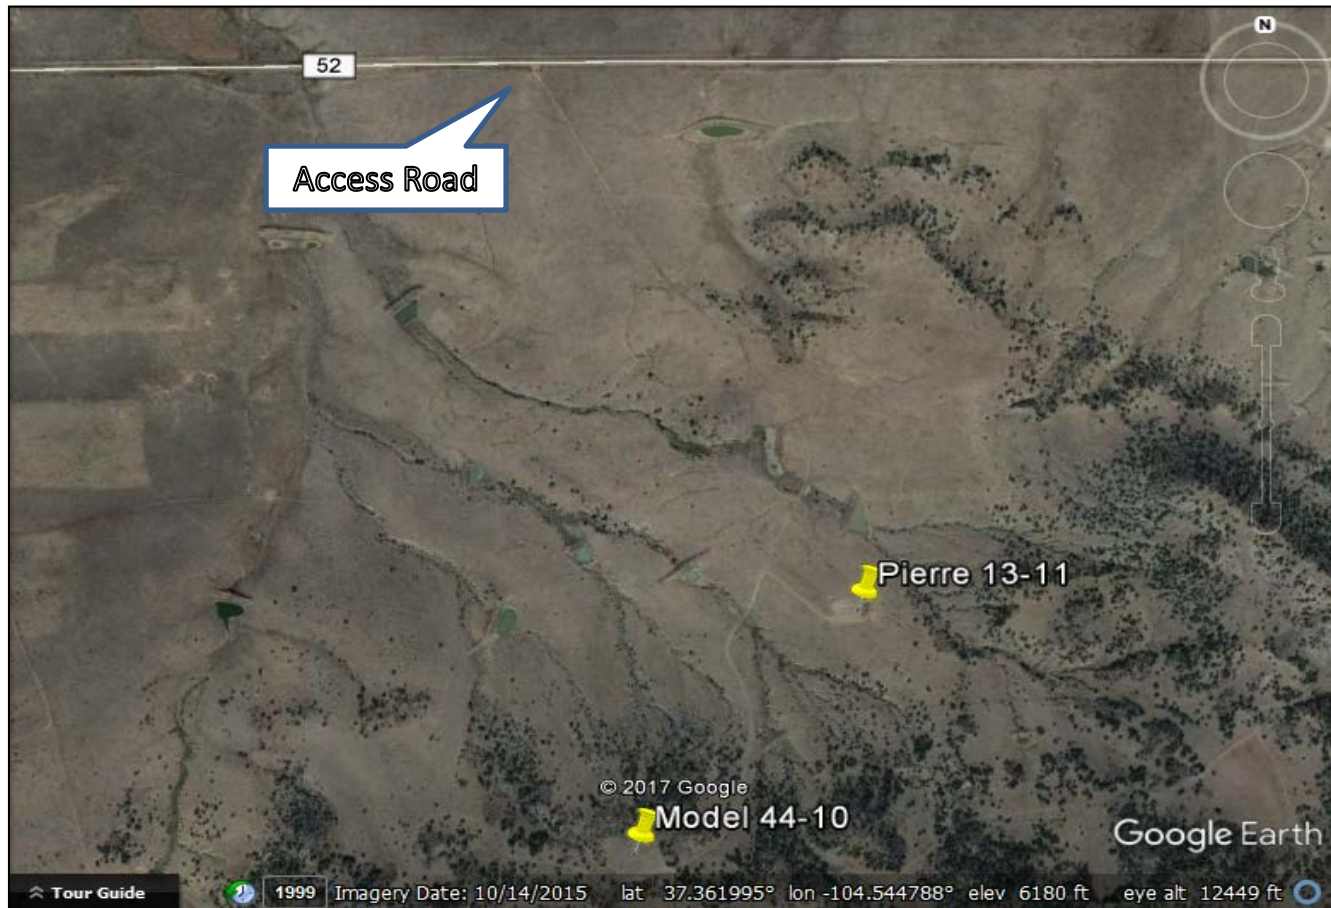
Photo 1. 2015 aerial image of the access road and location.

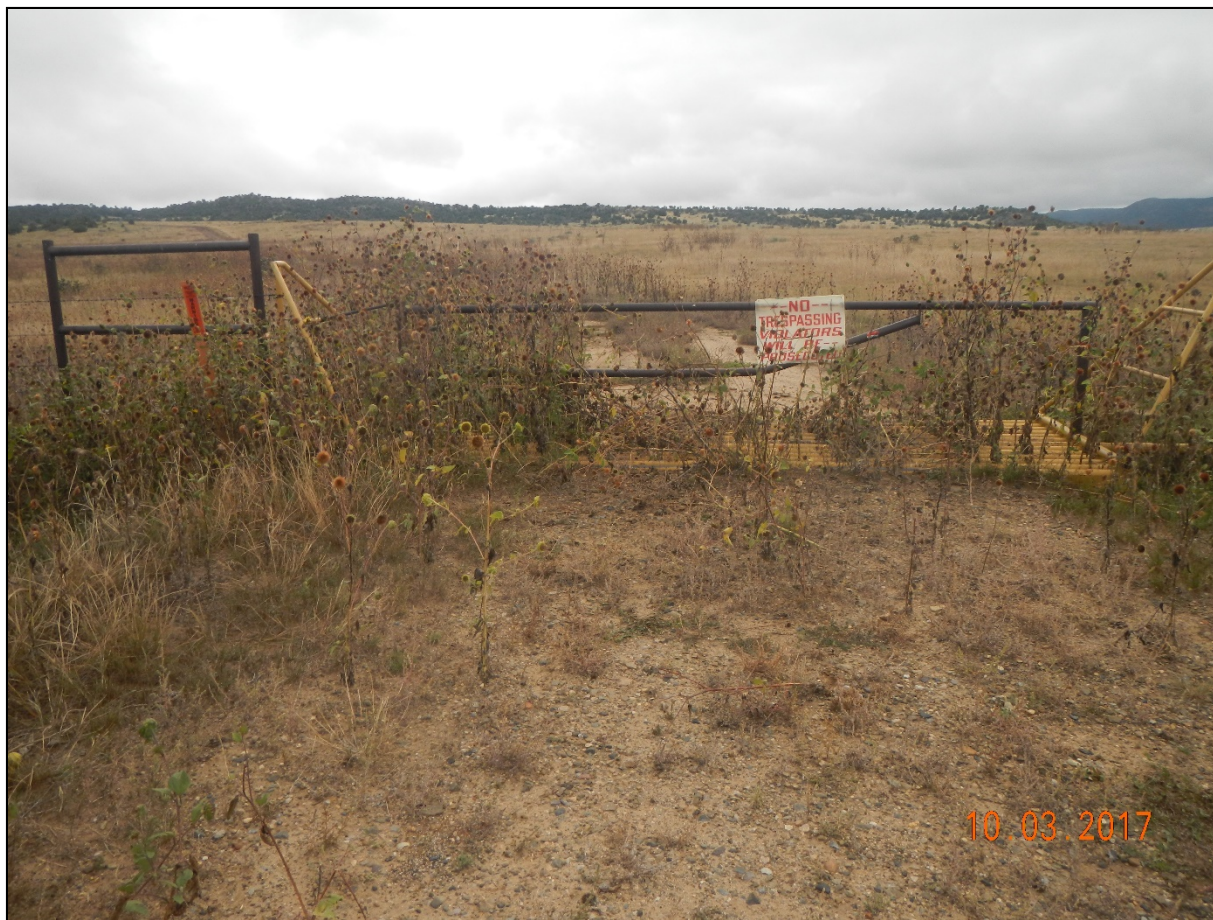
Photo 2. Beginning of the access road facing south.

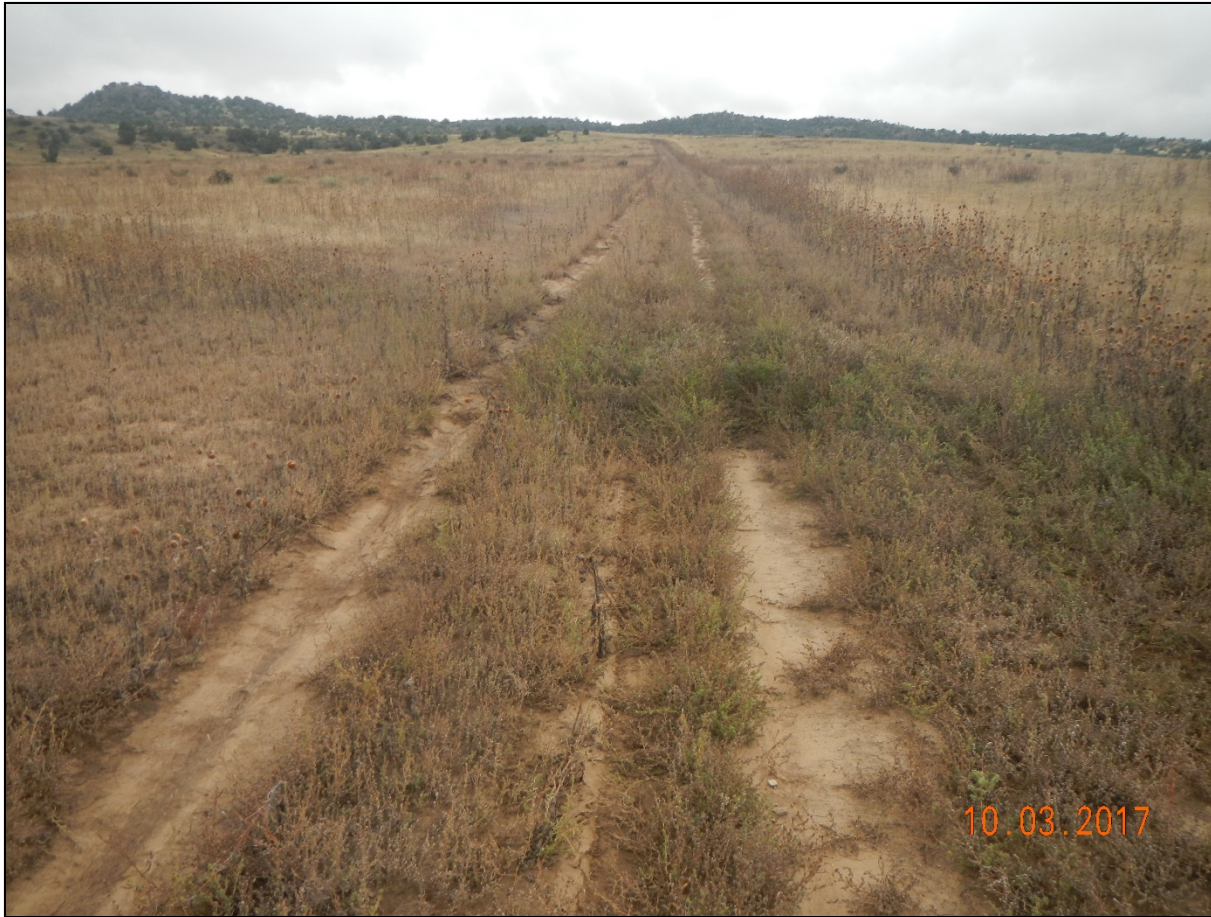
Photo 3. Facing southeast along the access road. There is predominately undesirable weeds (Kochia) growing along the road. There is no gravel present along the road.

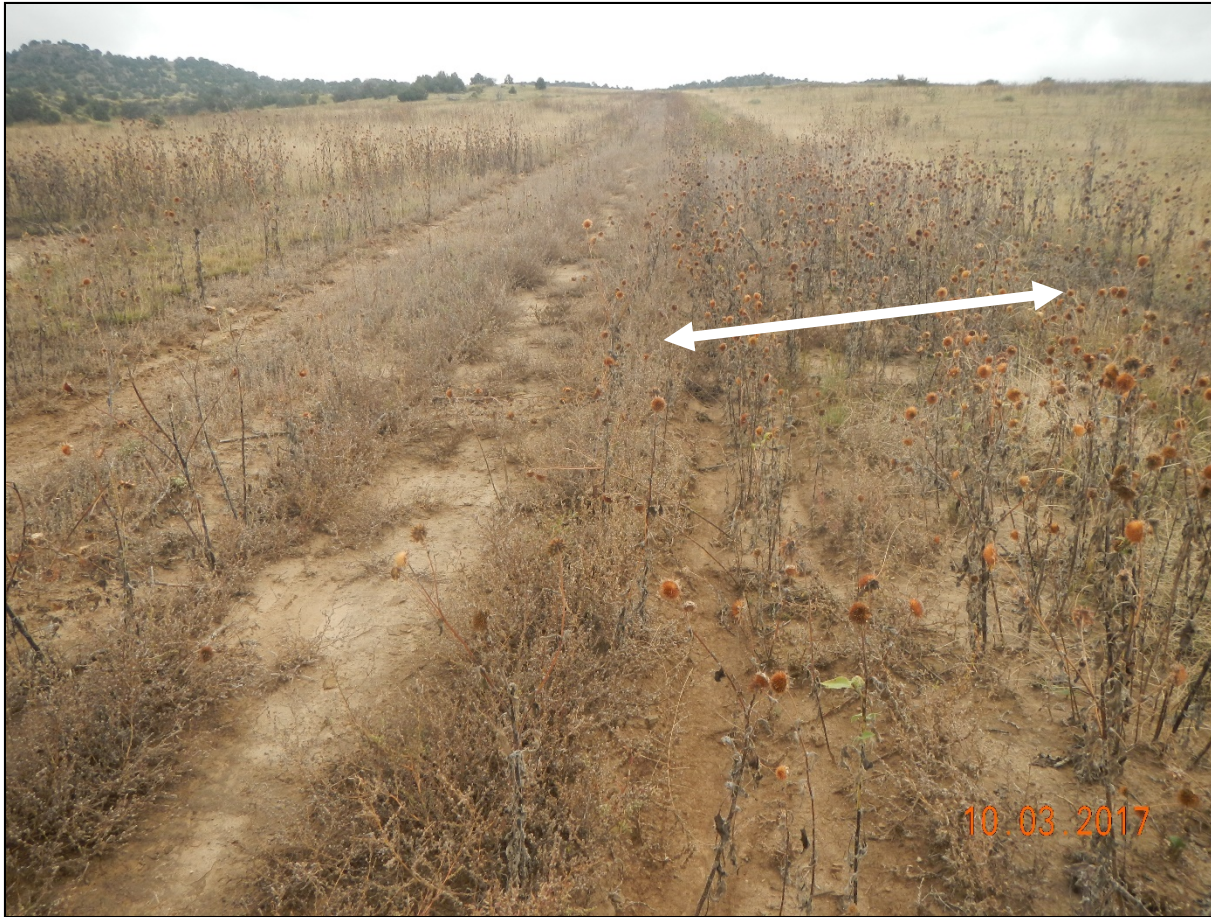
Photo 4. Facing southeast along the access road. The area along the side of the road contains undesirable weeds and is not adequately stabilized with desirable vegetation.

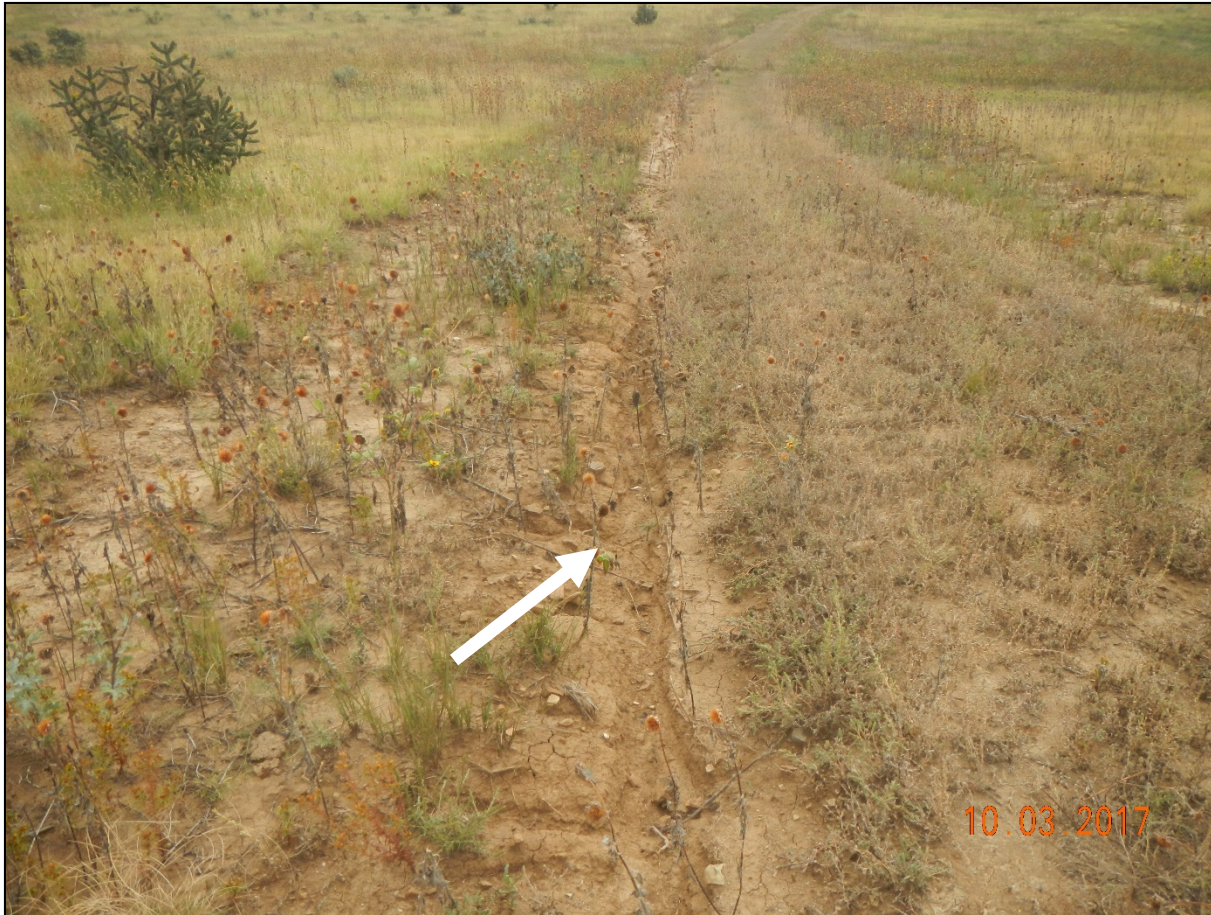
Photo 5. There are signs of stormwater erosion occurring along the road.

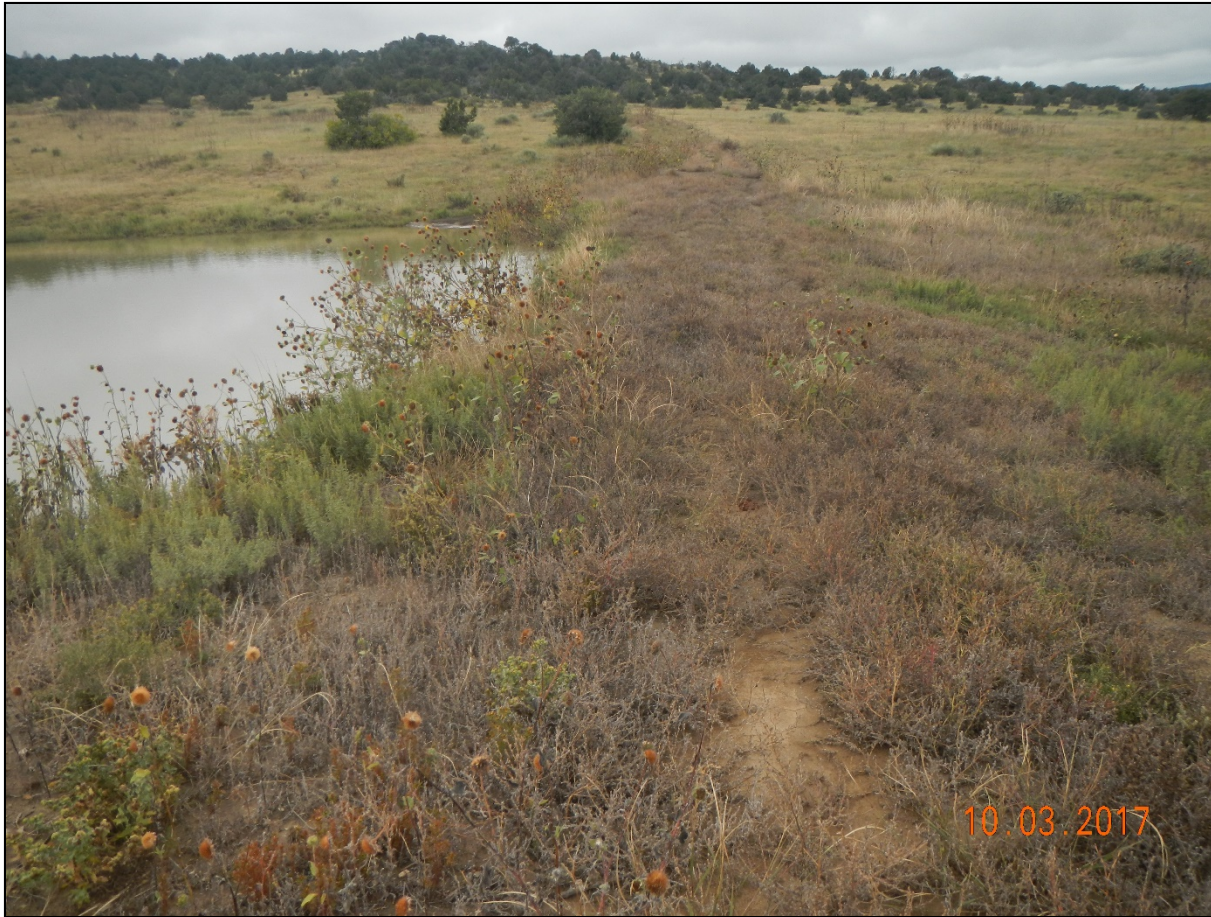
Photo 6. Facing southwest along the access road. There is stormwater held back by the road on the eastern side. There is a potential for stormwater to flow across the road causing erosion however there was minimal signs of this occurrence.

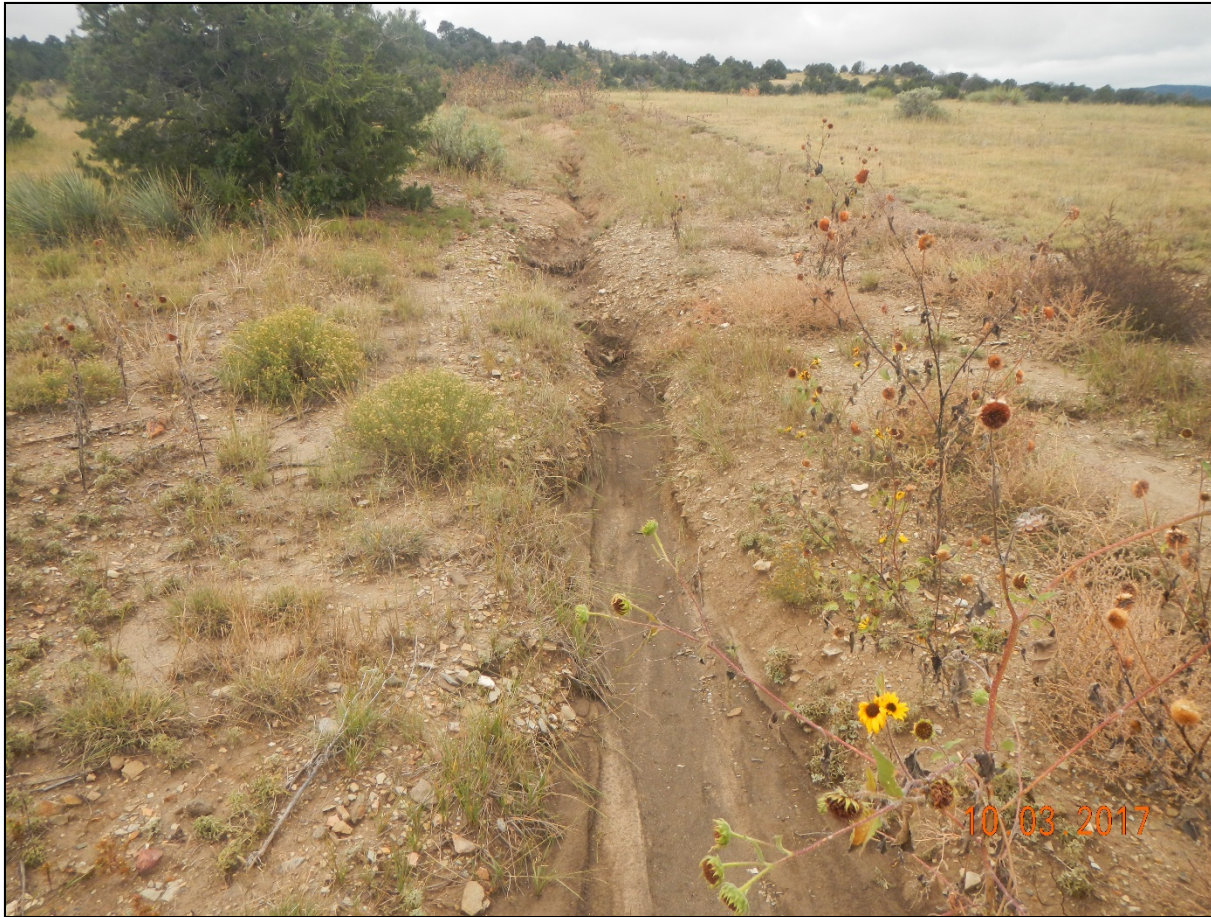
Photo 7. Facing southwest along the access road where it gradually ascends. There is erosion occurring from this point at the bottom of the slope all the way to the top near the location. Approximately 1500 ft.

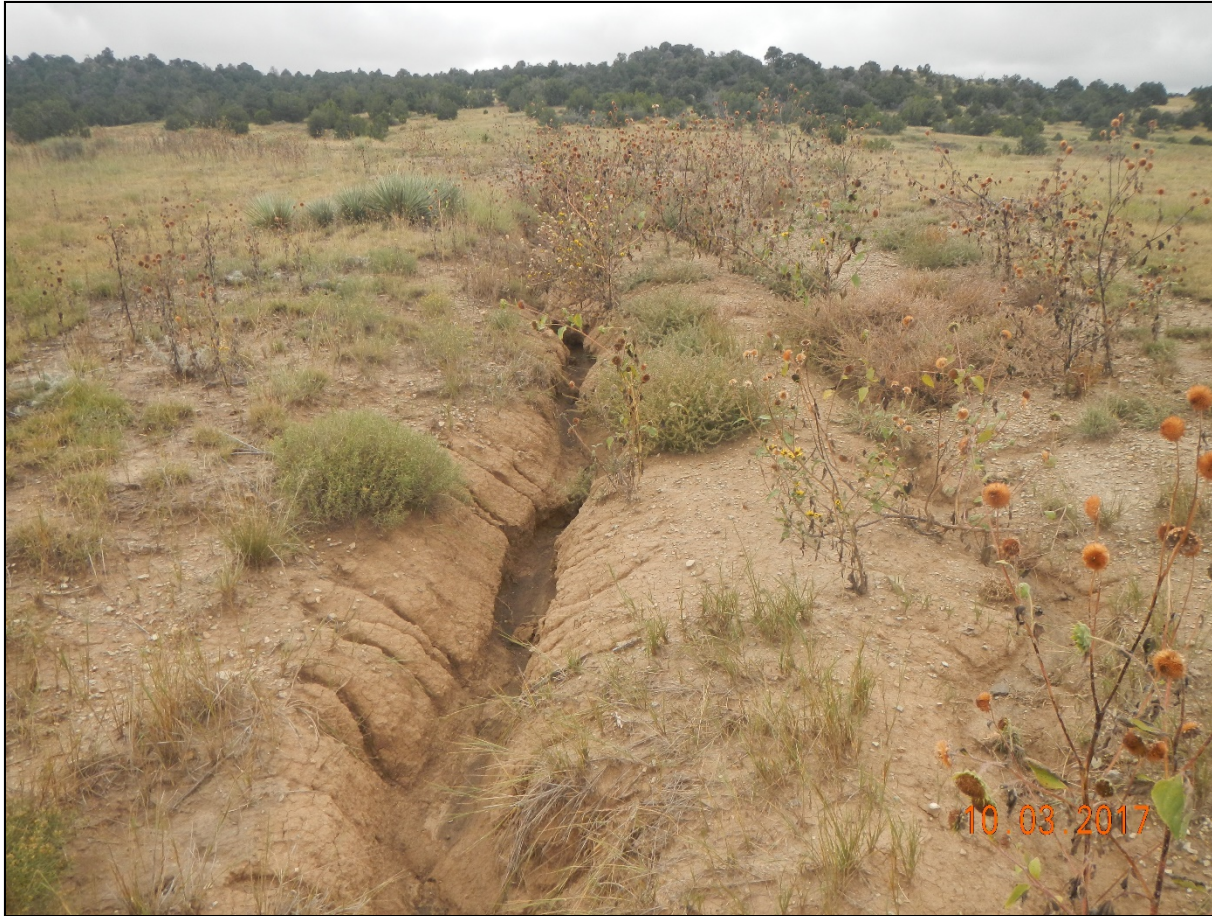
Photo 8. Facing south where access road continues to ascend to the location. There is erosion occurring down the slope of the road.

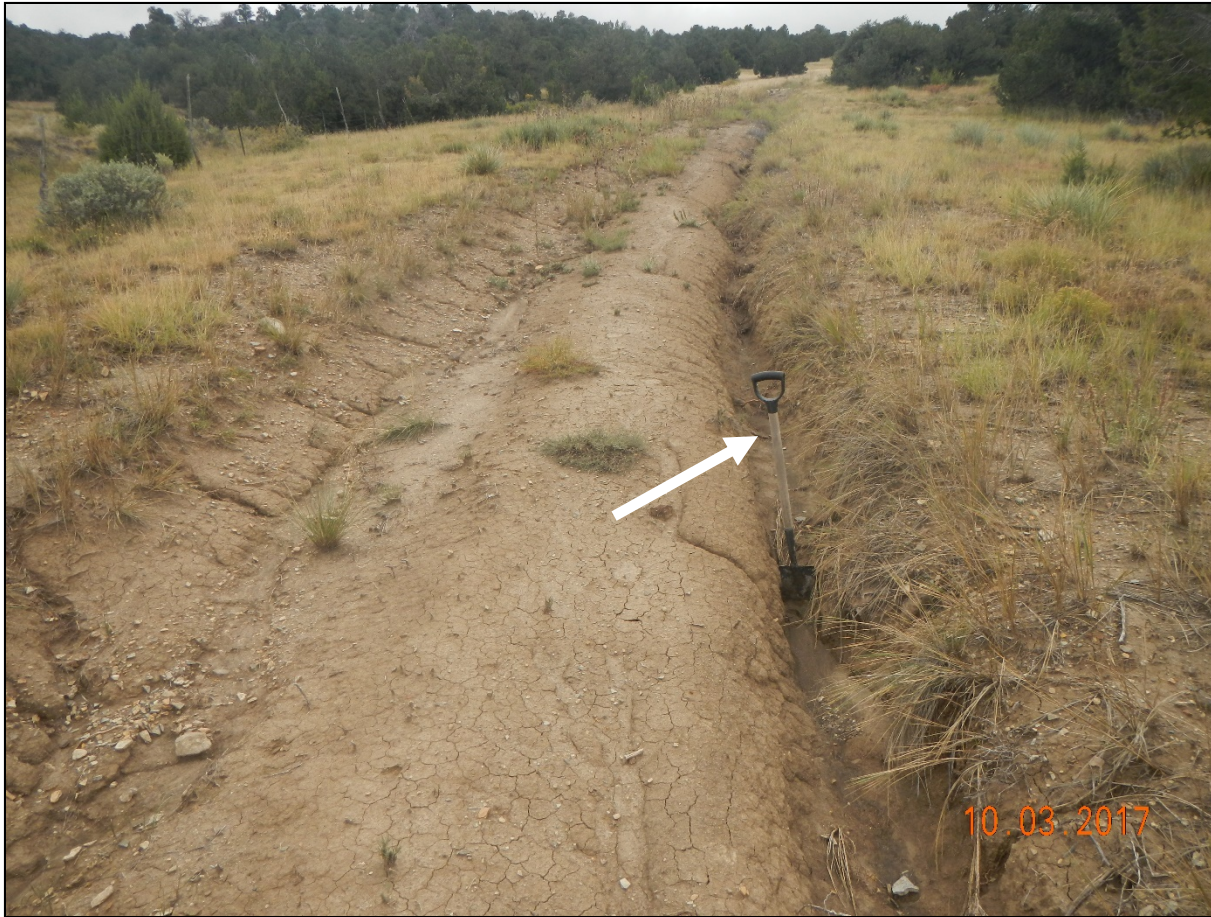
Photo 9. There is erosion occurring down the slope of the road. The arrow points to a 3.5 ft. shovel in the erosion channel which indicates depth.

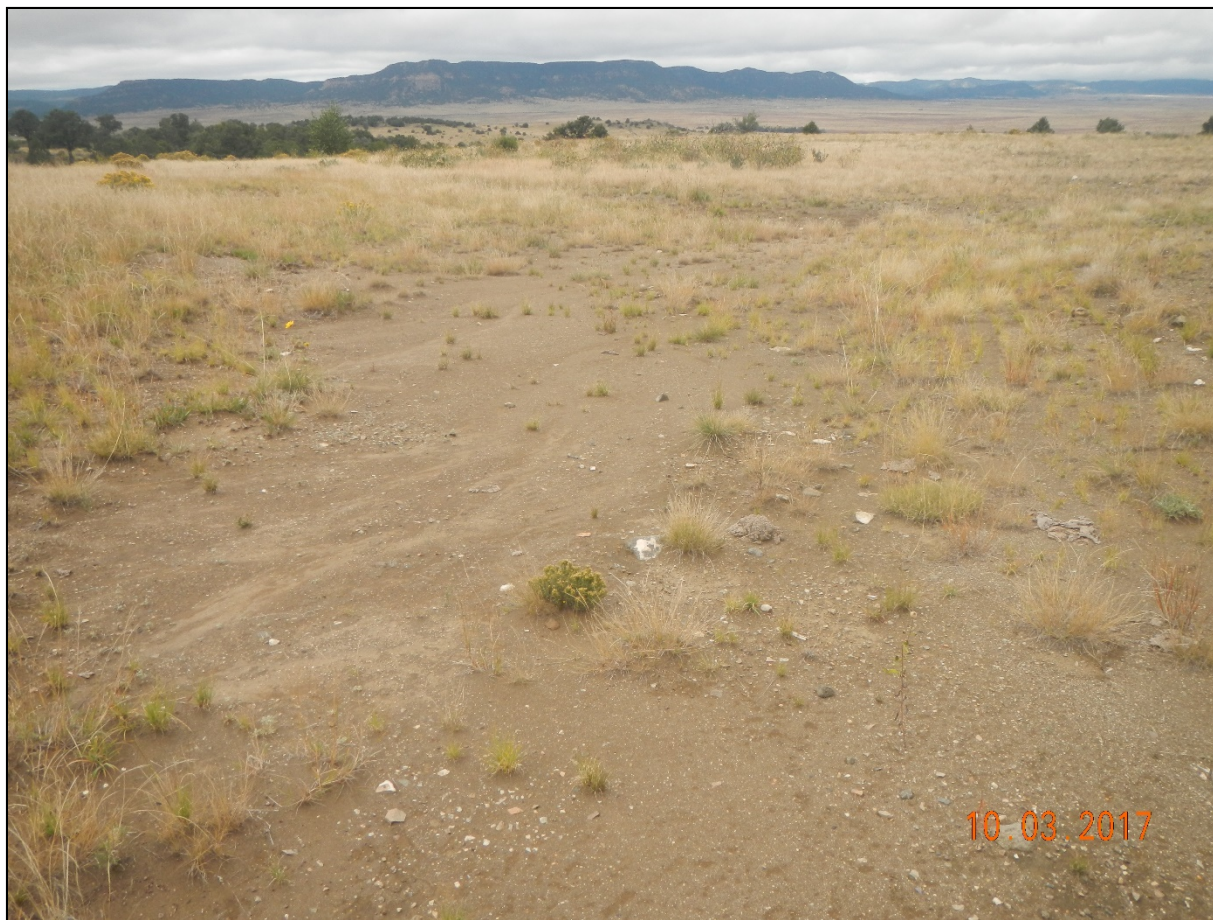
Photo 10. Facing west toward the location at the top of the hill.

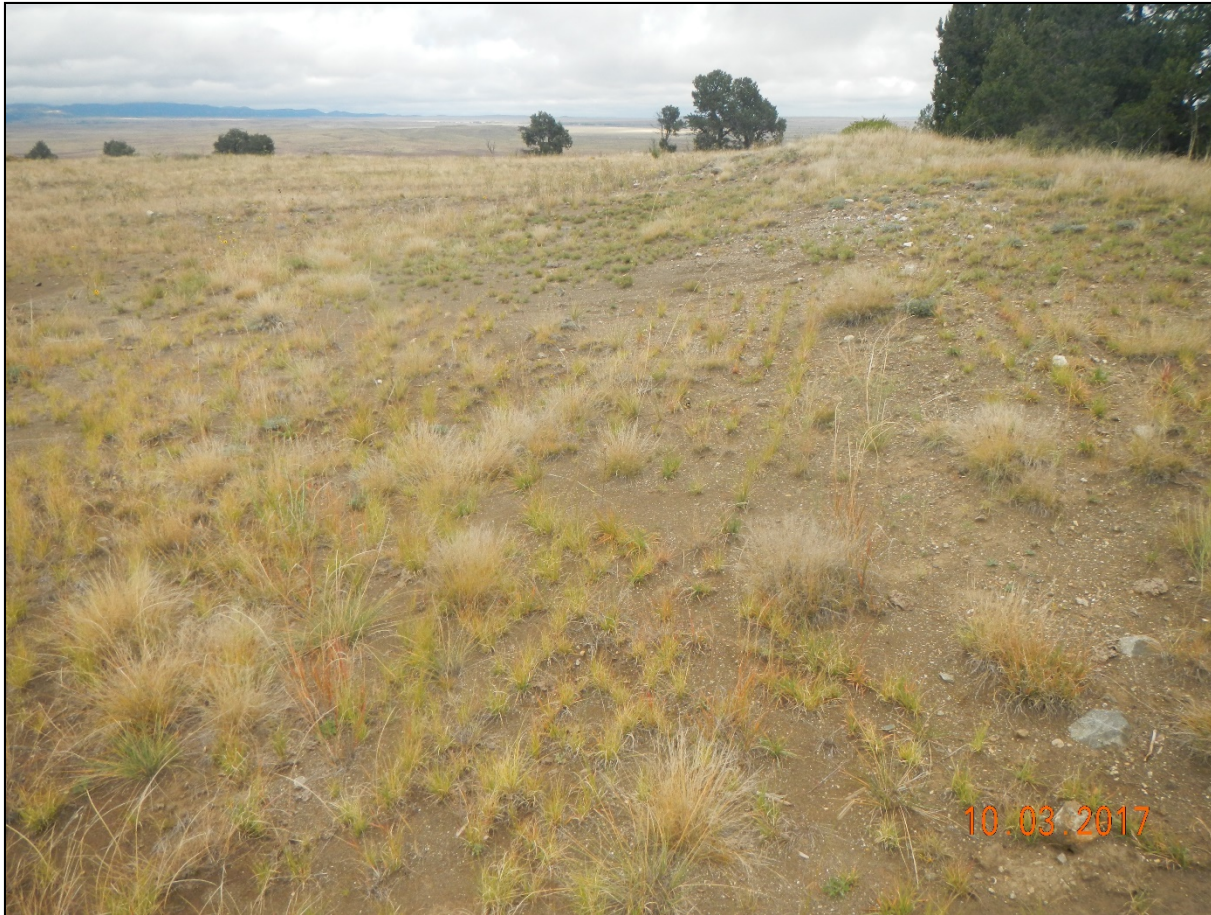
Photo 11. Facing northwest at the location.

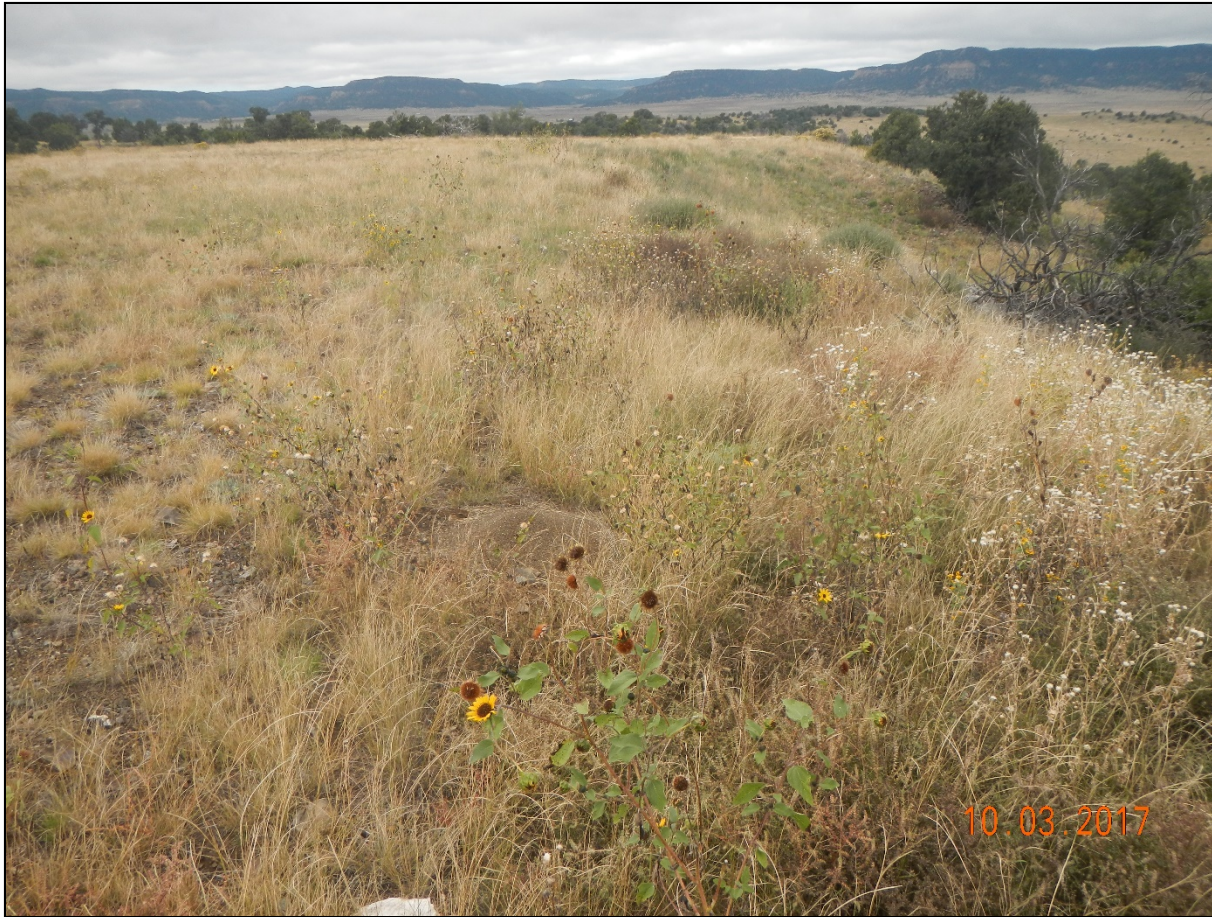
Photo 12. Facing southwest along the fill slope of the location.

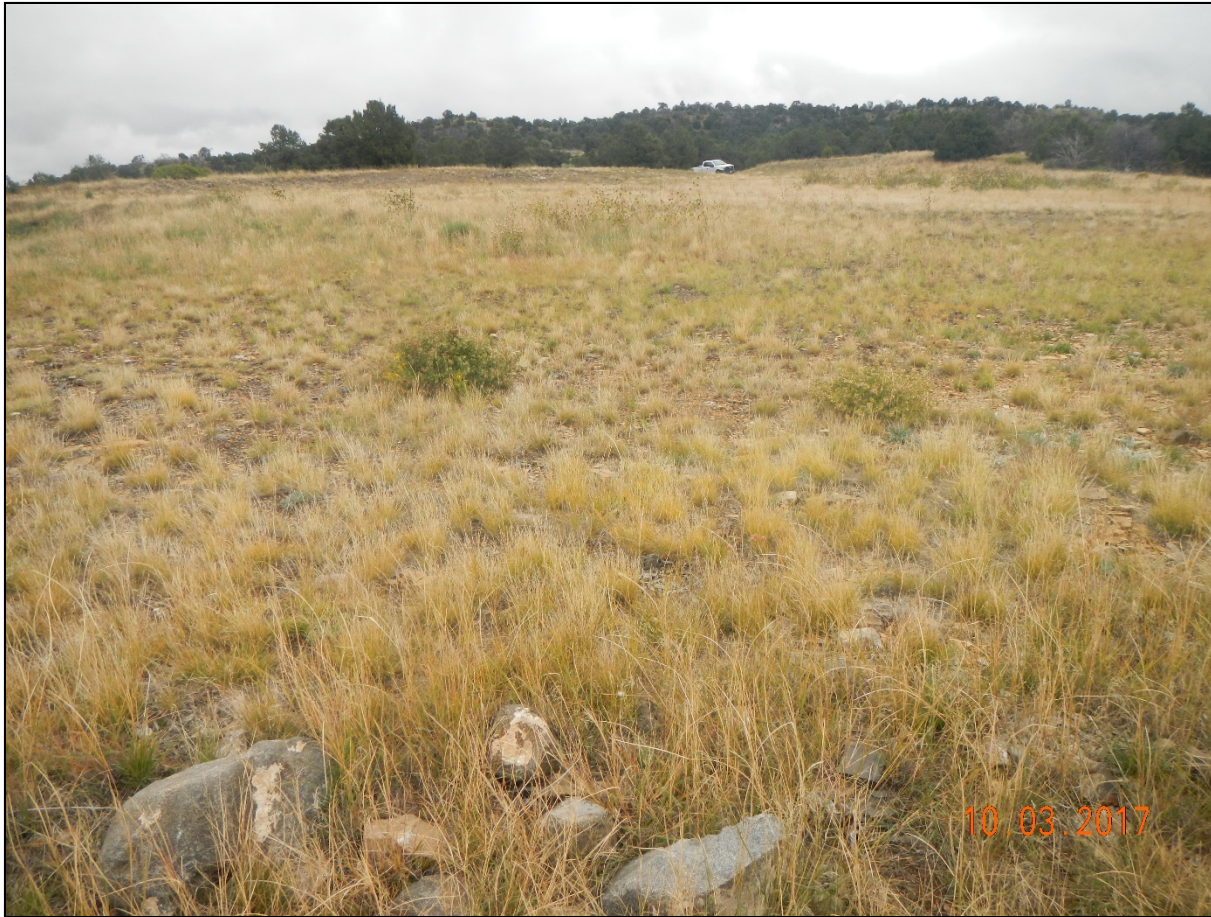
Photo 13. Northwest side of the location facing southeast.

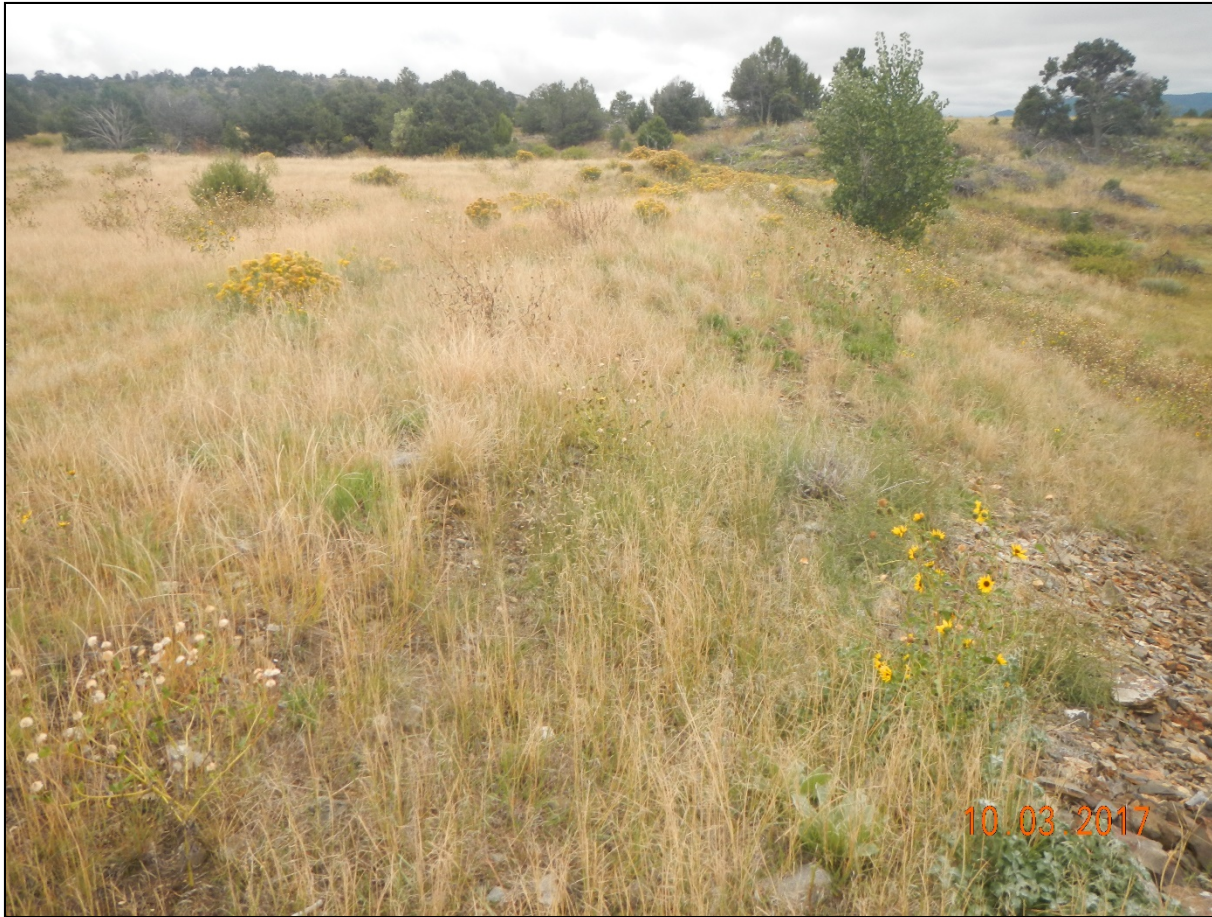
Photo 14. Northwest side of the location facing south along the fill slope.

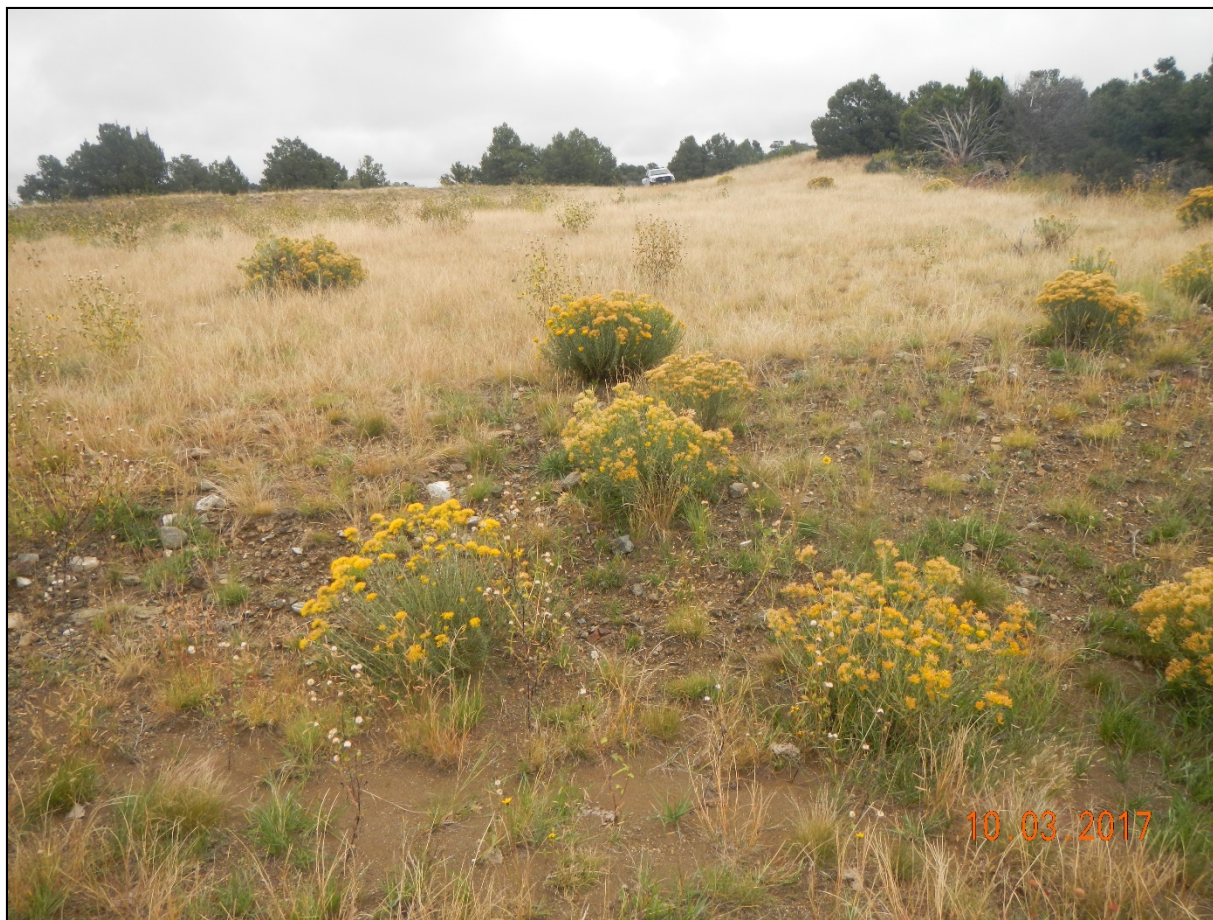
Photo 15. West side of the location facing east.

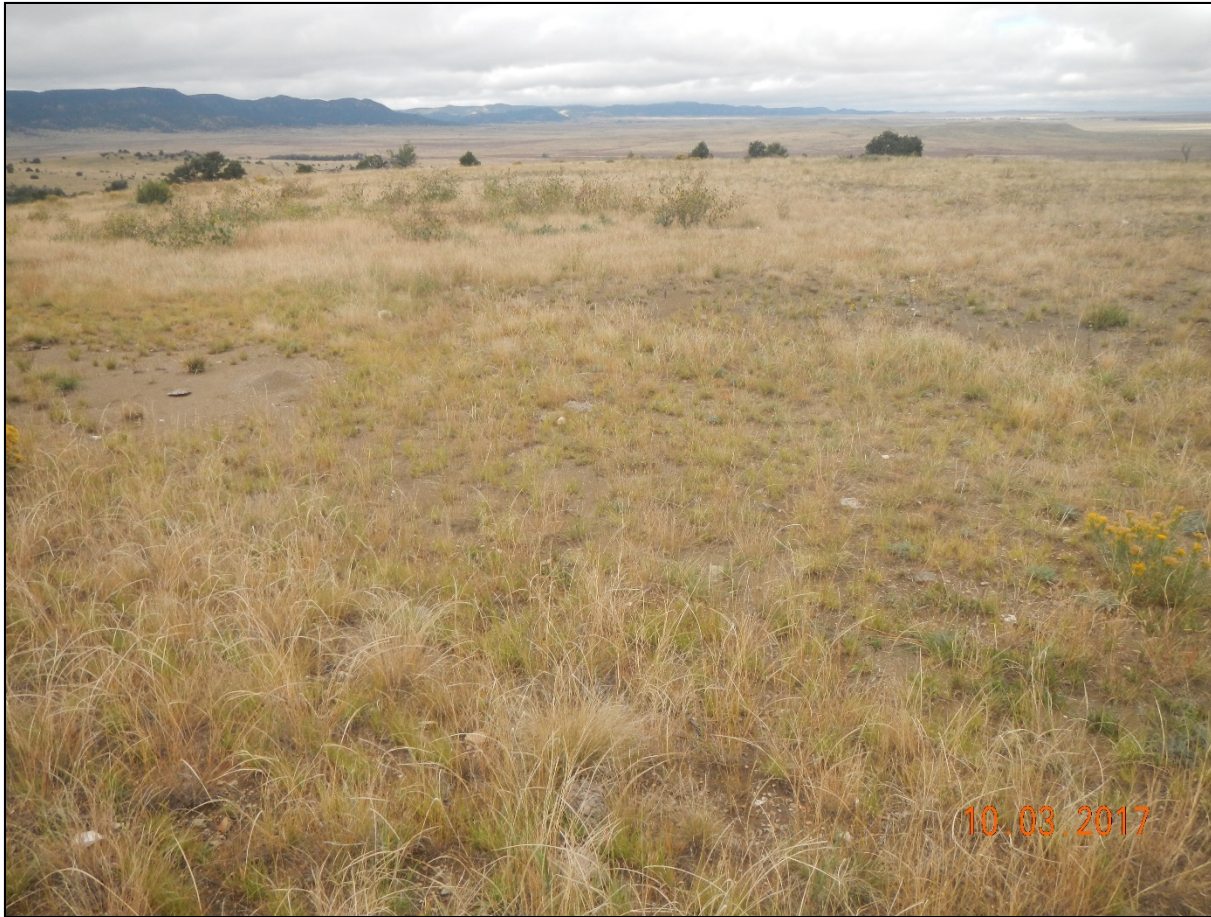
Photo 16. Facing northwest at the location.
