COLORADO
Oil & Gas Conservation
Commission
Department of Natural Resources

Inspection Photos: Santa Fe Nat Res JSR 4-1 API#081-07070

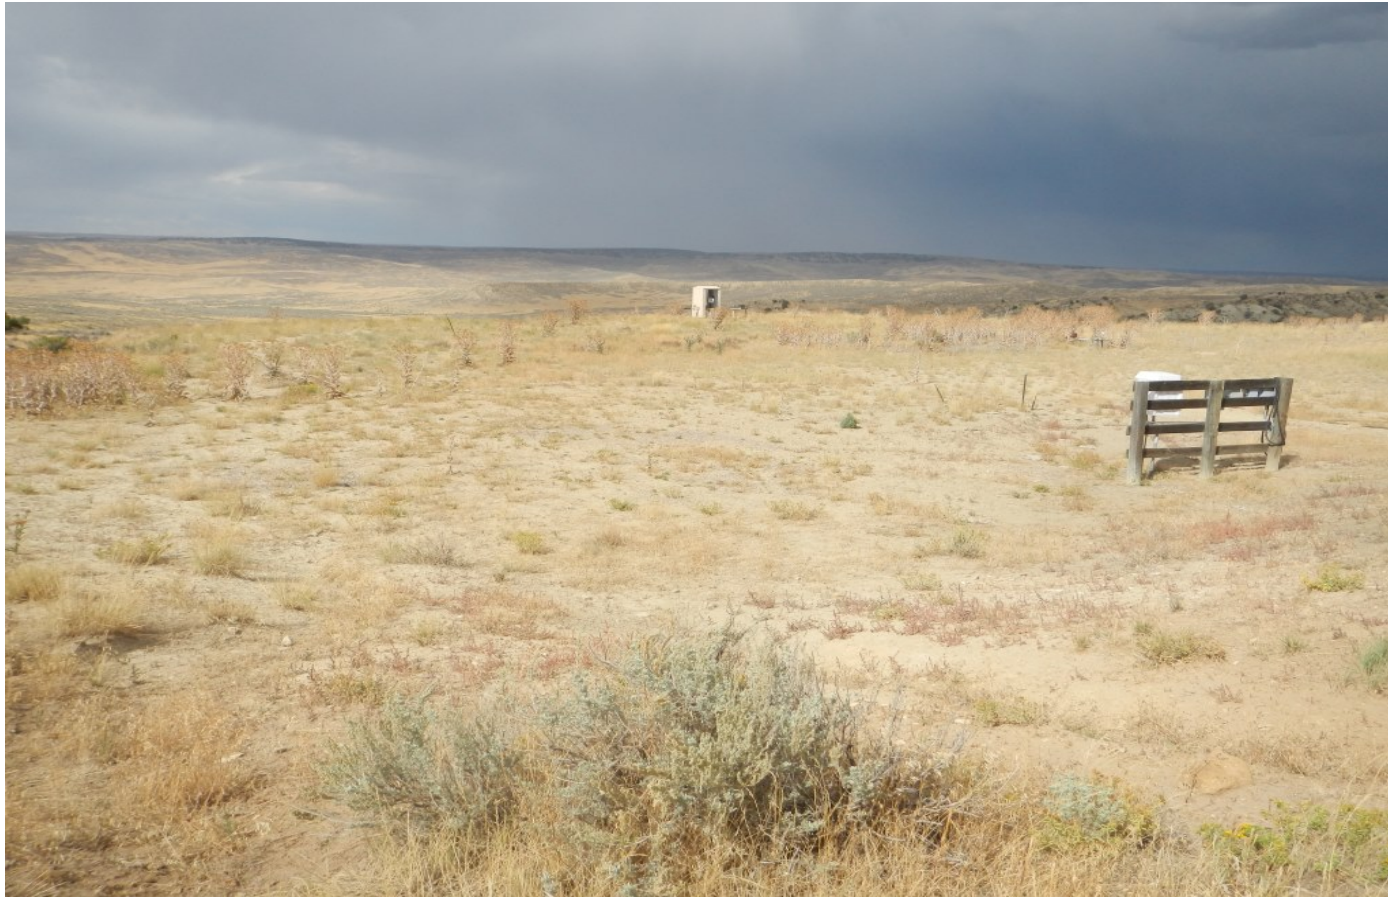
Photo#1:
Overview of Location to North East.

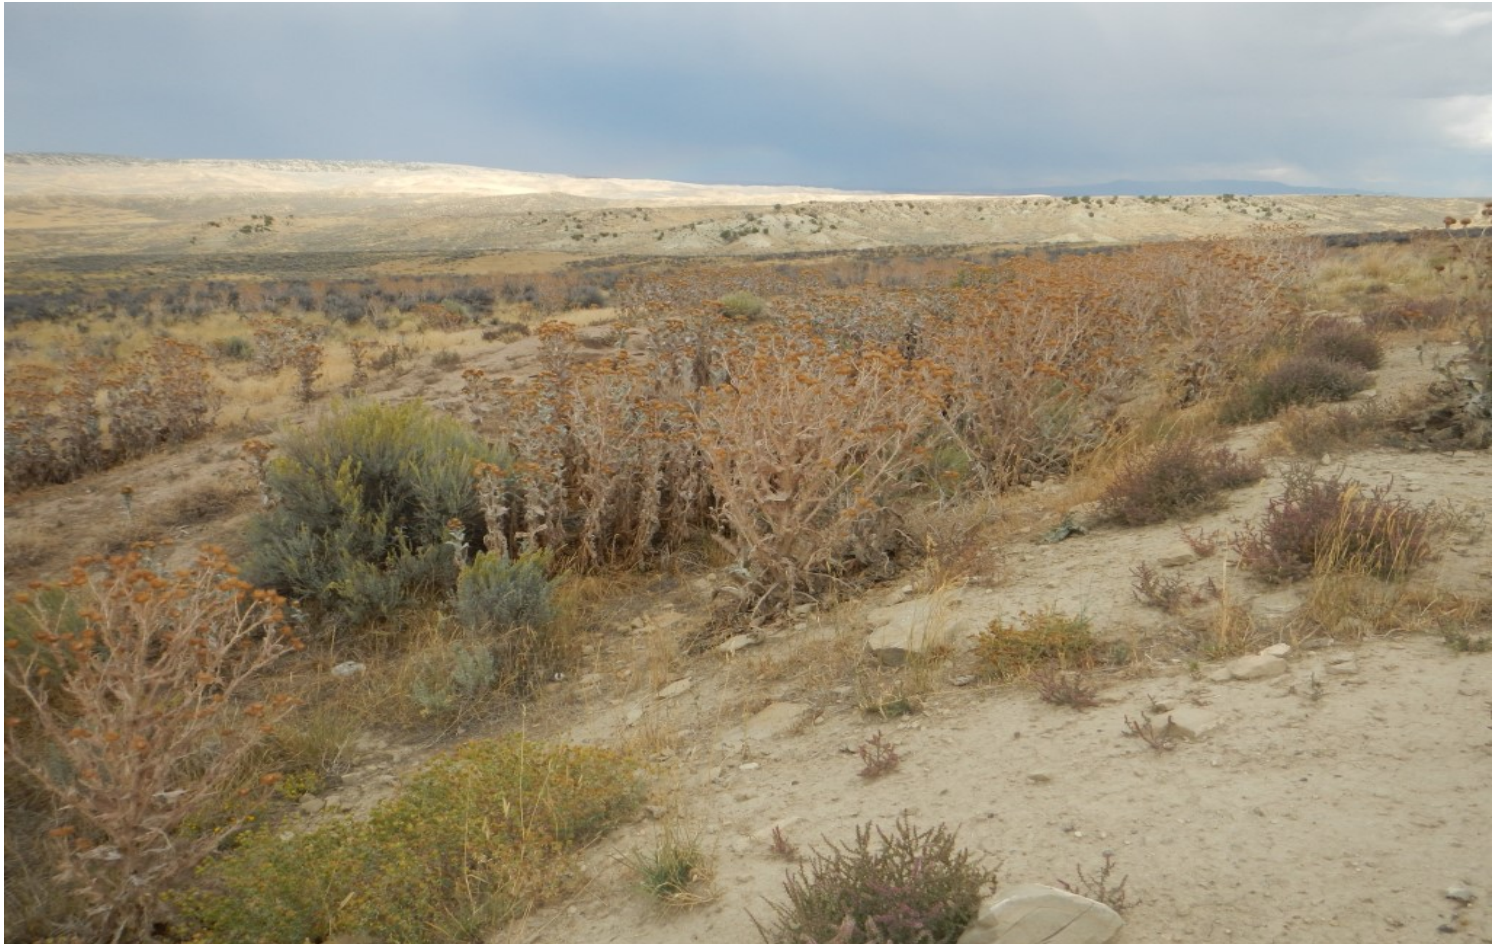
Photo#2:

Heavy infestation of Scotch Thistle on Fill Slope.

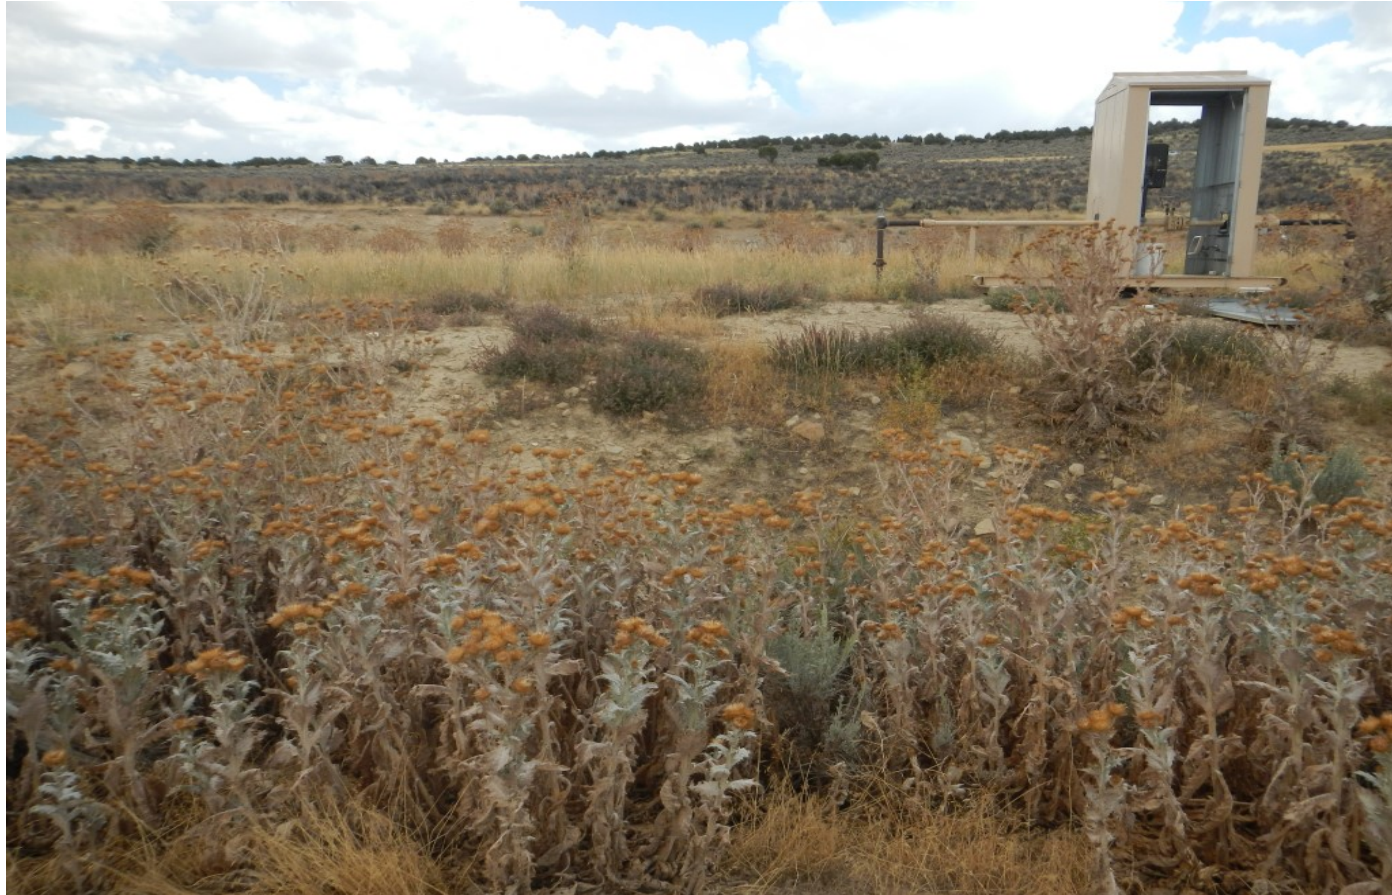
Photo#3:

View of Site from bottom of Fill Slope to Cut Slope @ South East.

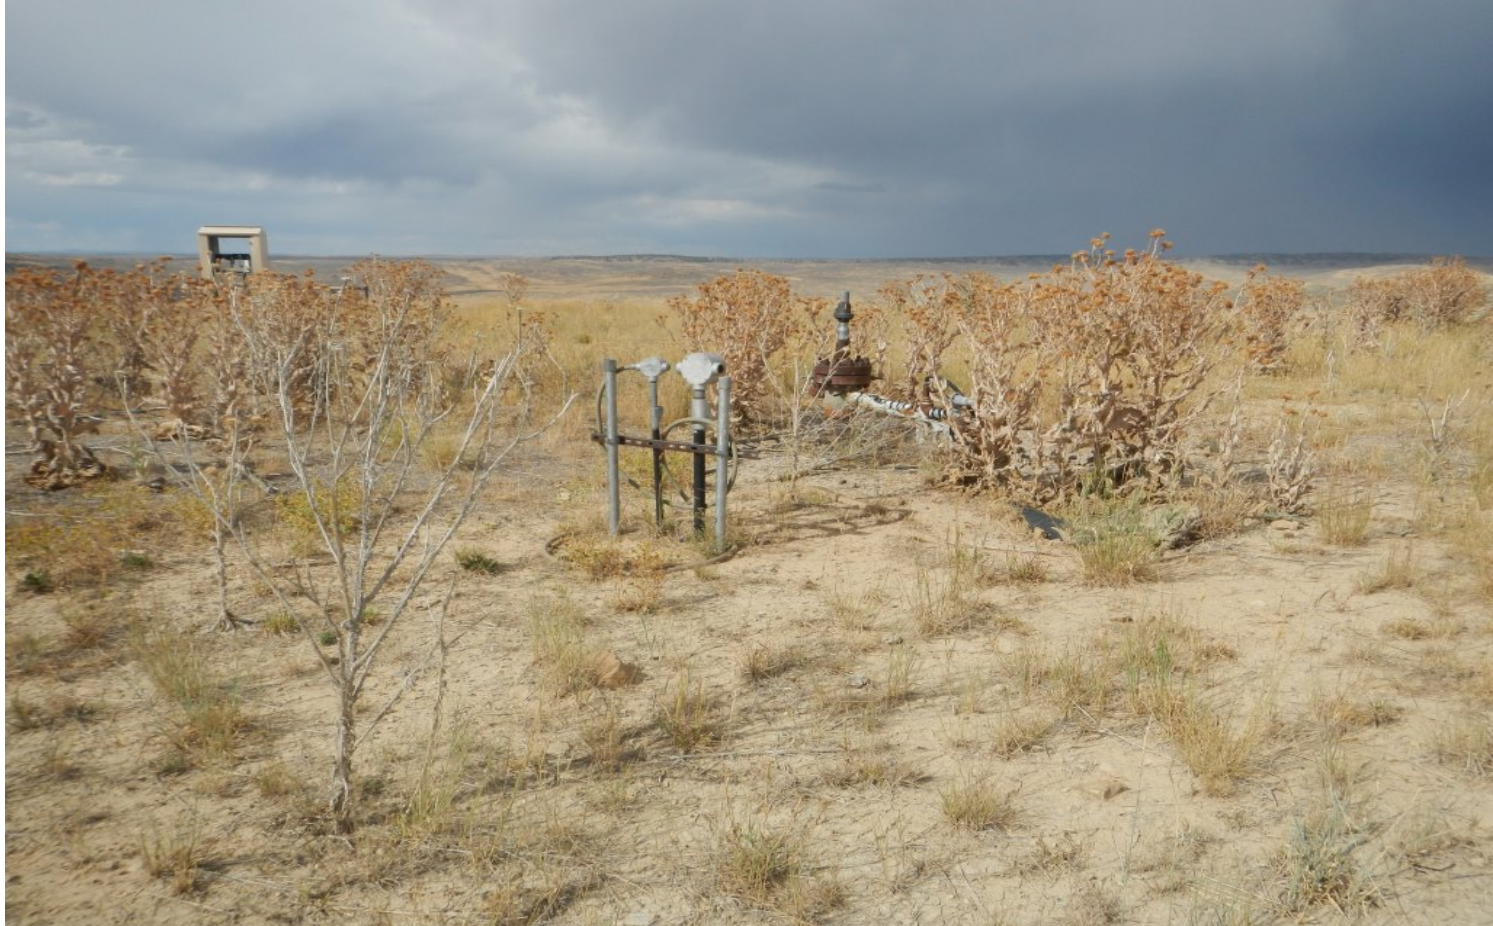
Photo#4:

Scotch Thistle established within the 25 ft. Safety Zone of Well Head.

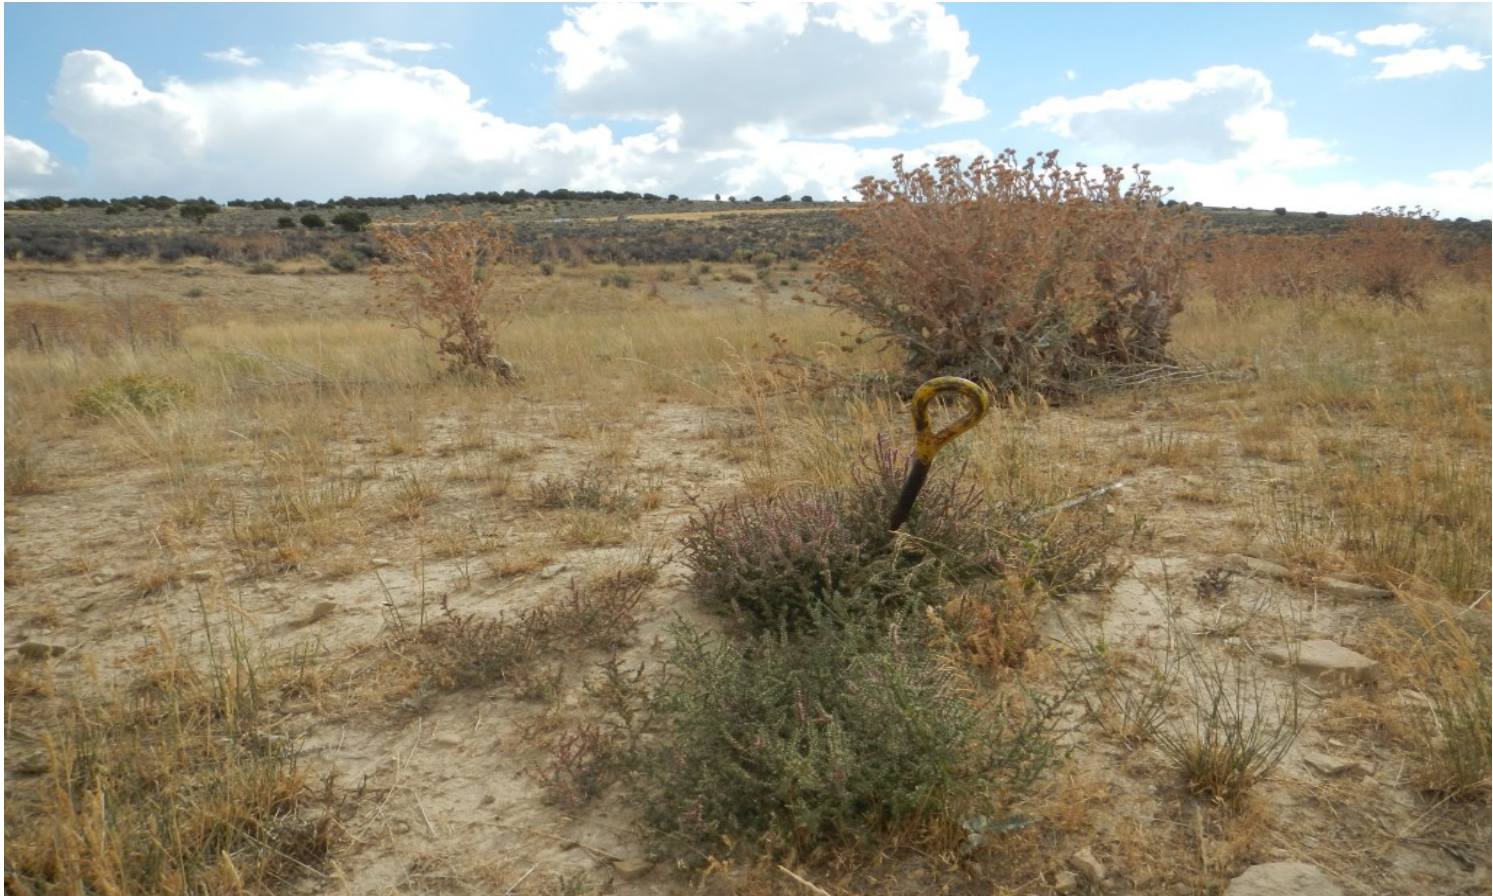
Photo#5:
Unmarked Guy Anchor surrounded by Russian Thistle.

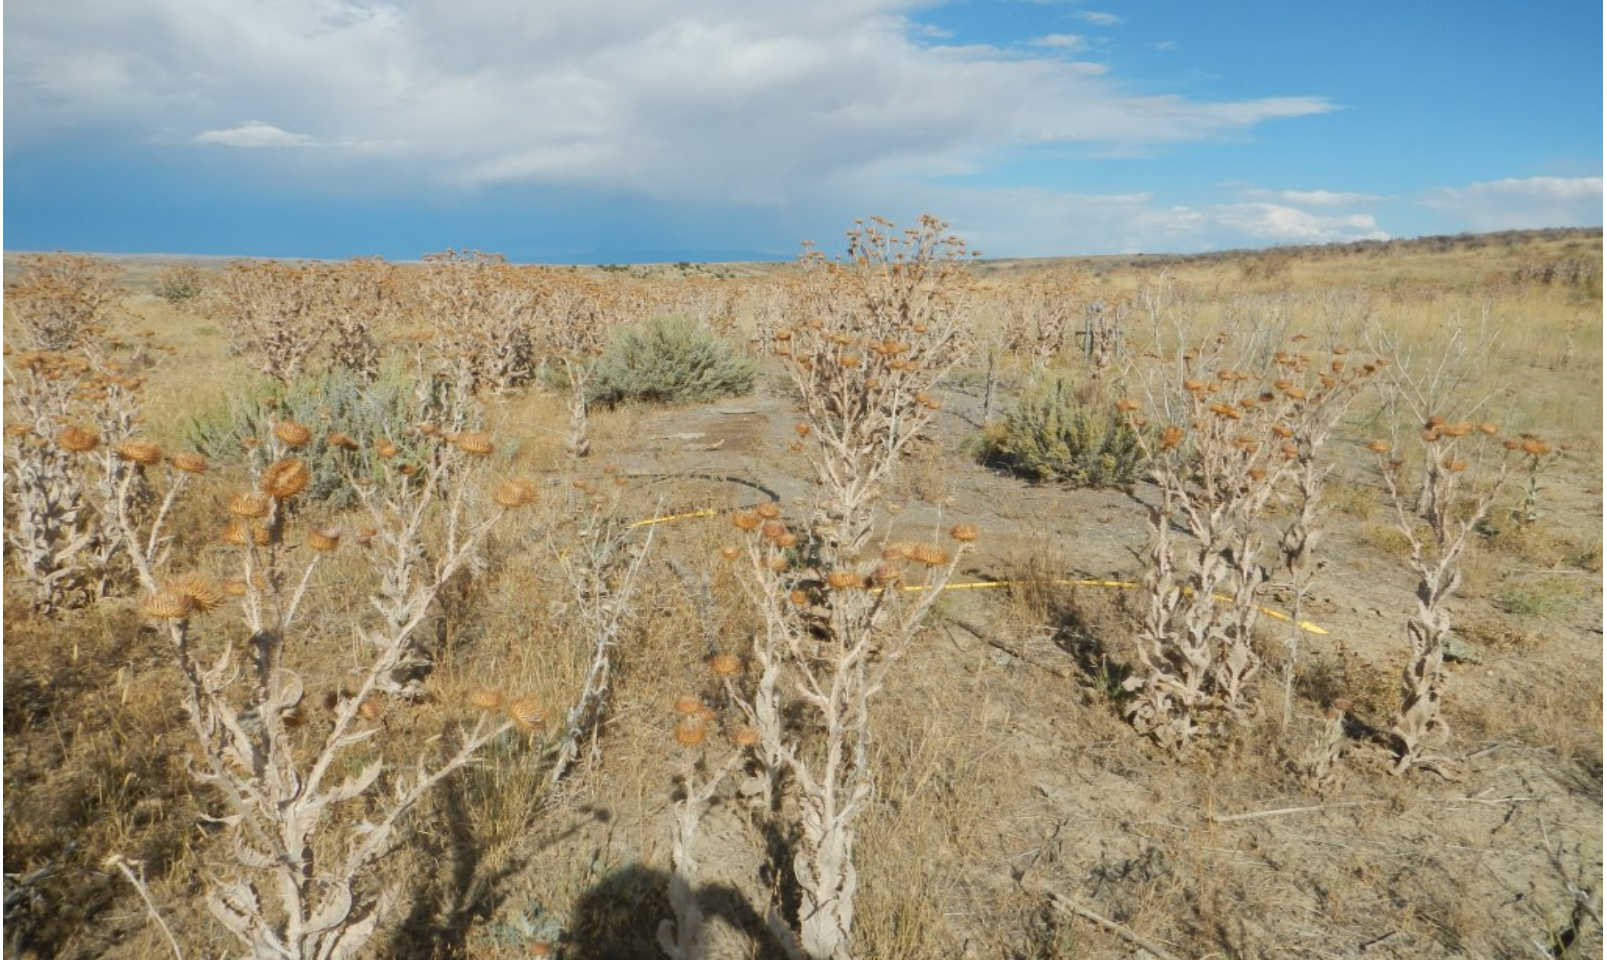
Photo#6:
Metal & Thistle Debris in Pad area.

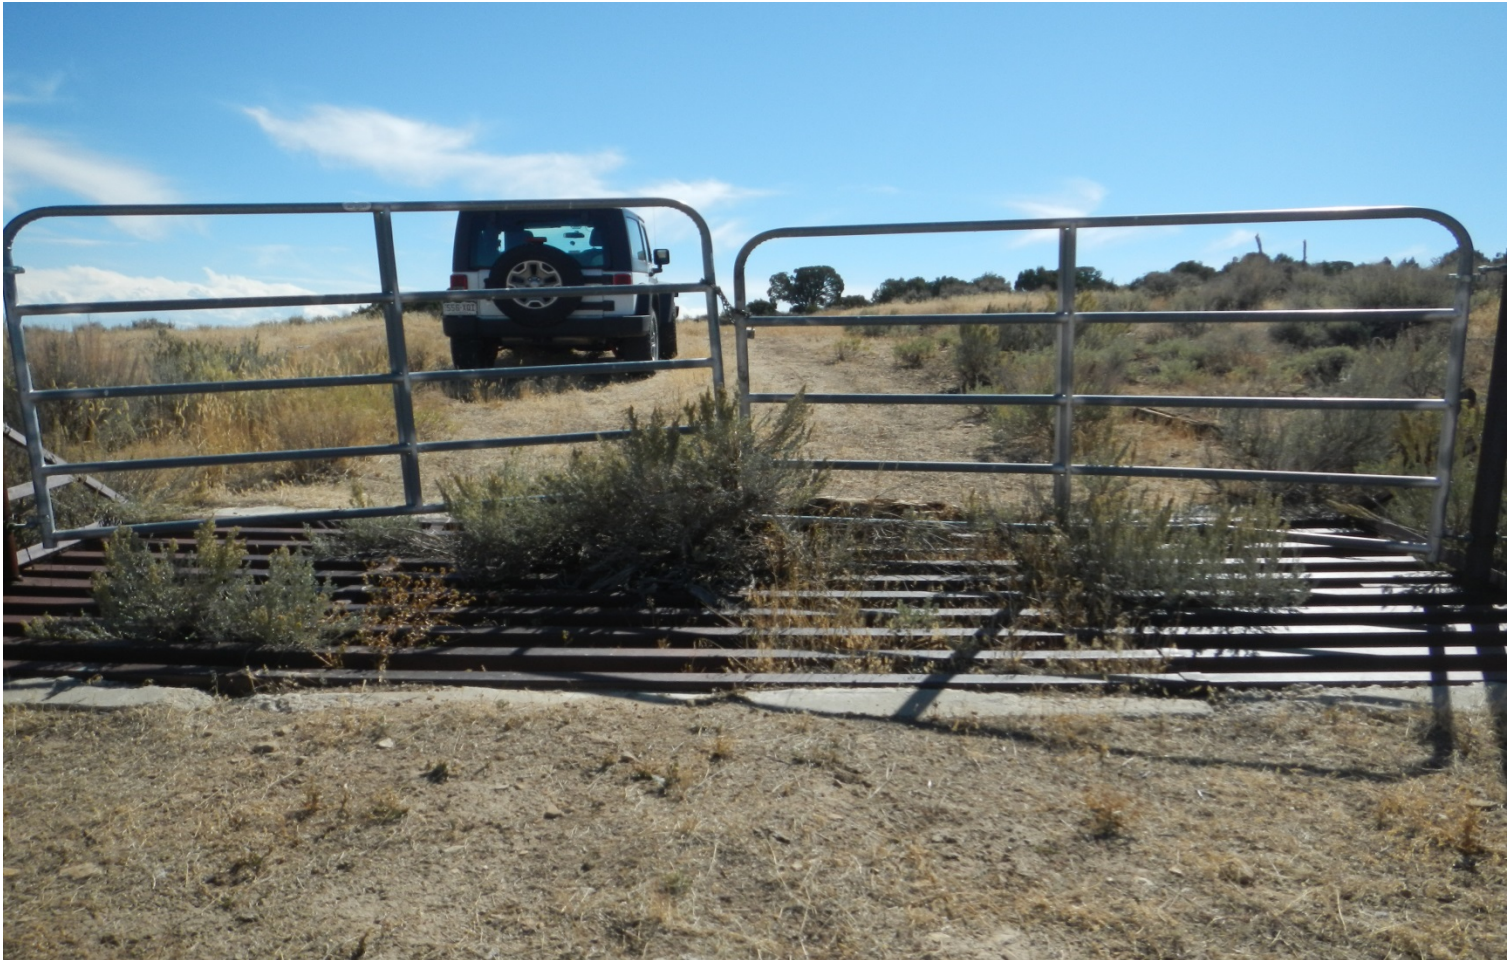
Photo#7:

Looking out from Access Road Entry to South East.

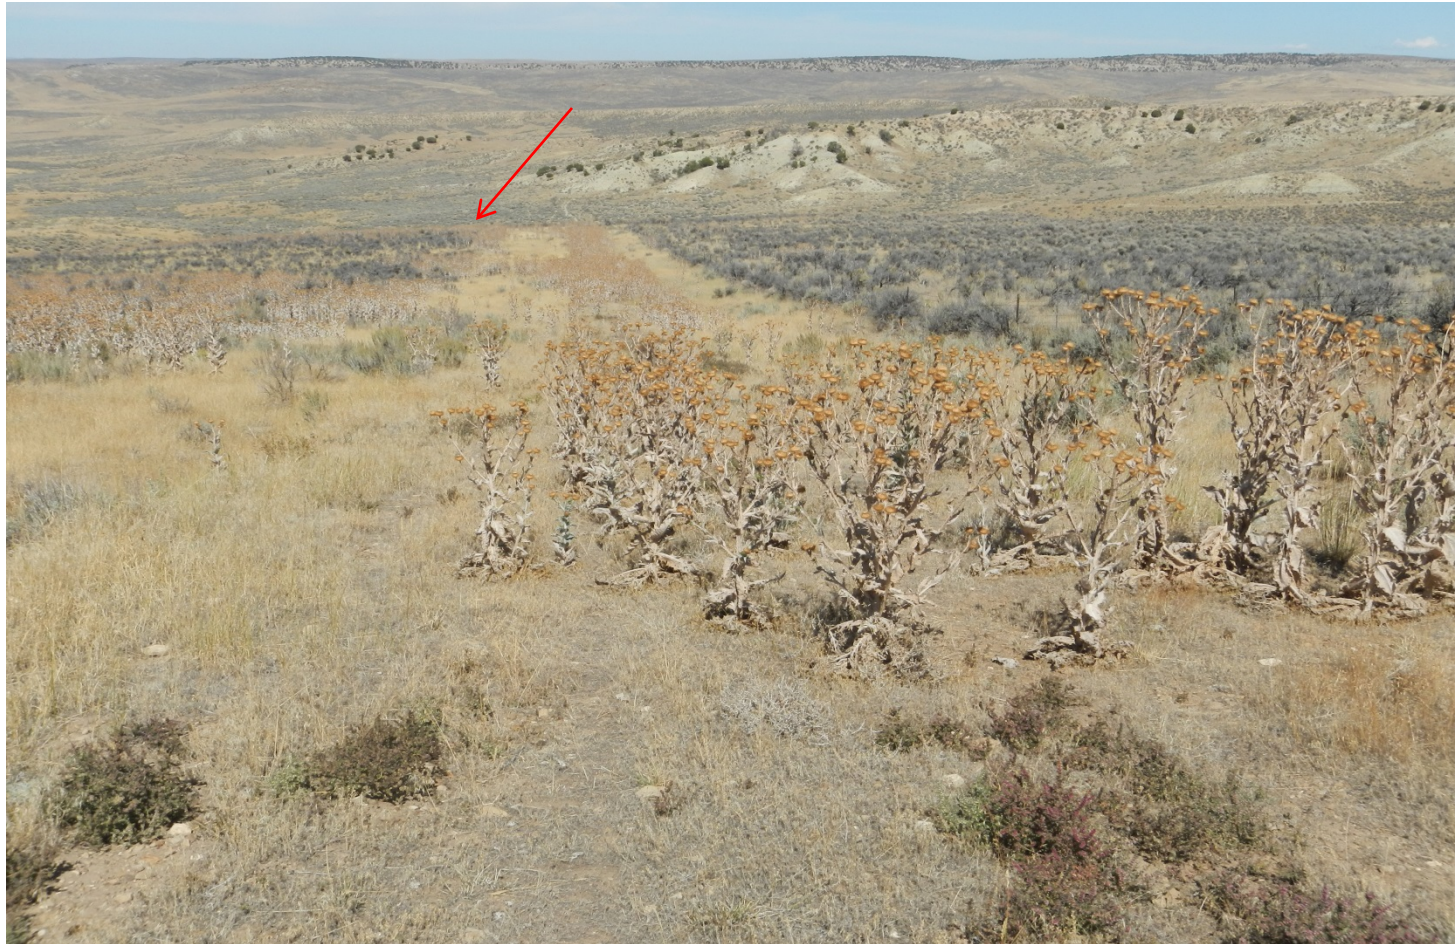
Photo#8:

Looking North West from Access Road Entry, along Road which is defined by Scotch Thistle growth. Arrow indicates point at which road turns to West towards Location. Road is approximately $\frac{3}{4}$ of a mile in length.

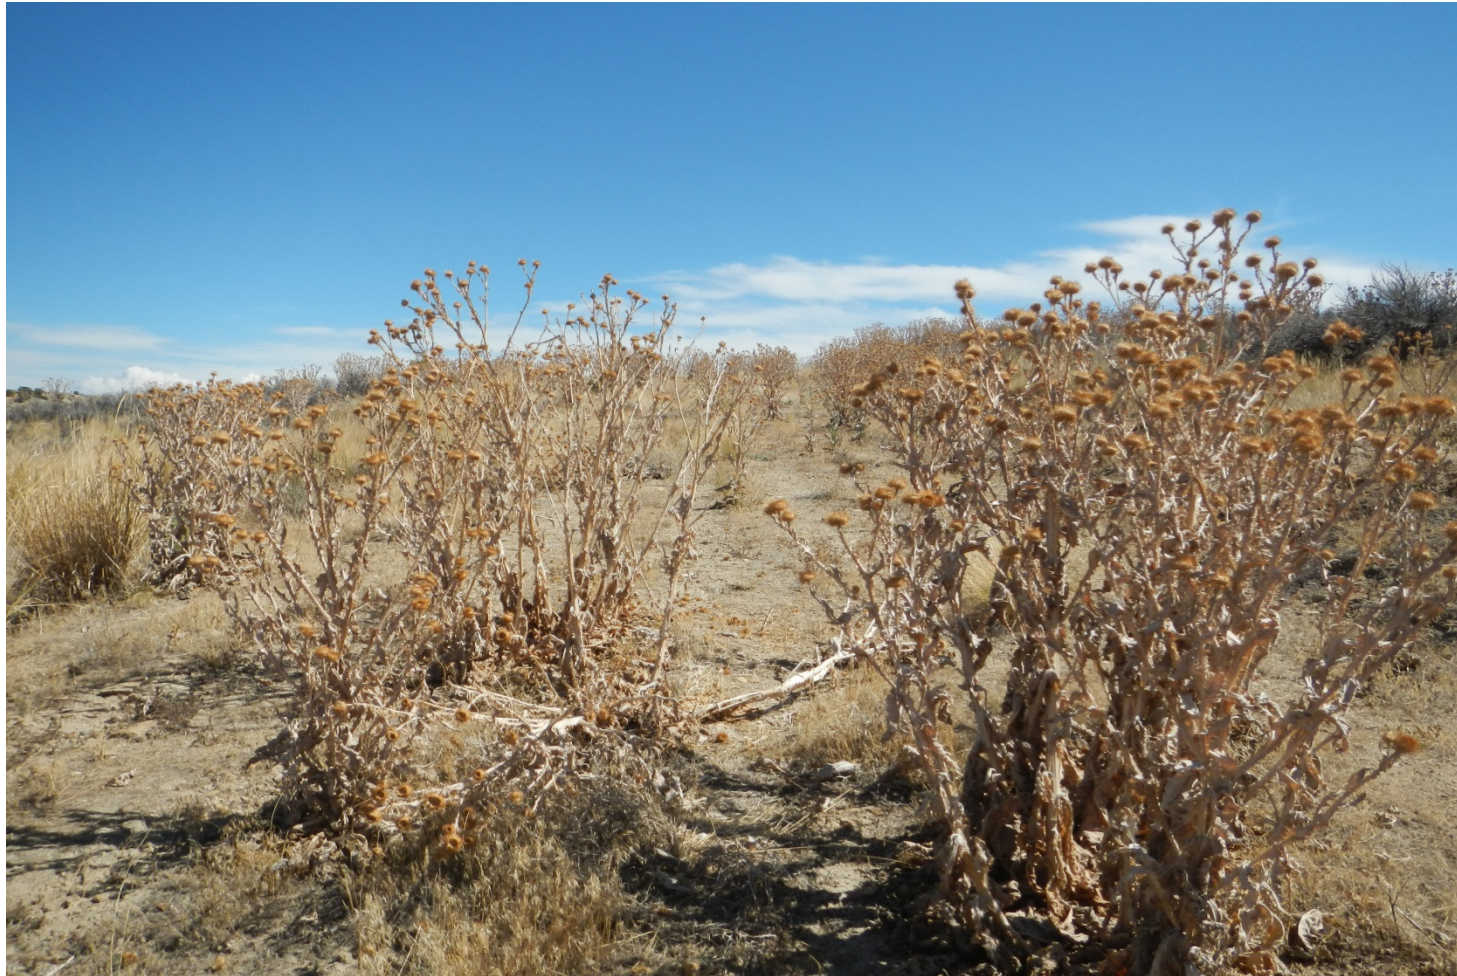
Photo#9:

Close up of Thistle on Access Road..
