# Final Reclamation Inspection

October 5, 2017

Operator: CHESAPEAKE OPERATING LLC- 16660

Inspection Photos  
Location Name: HEIBY 18-8-66 #1H  
API: 05-123-34627

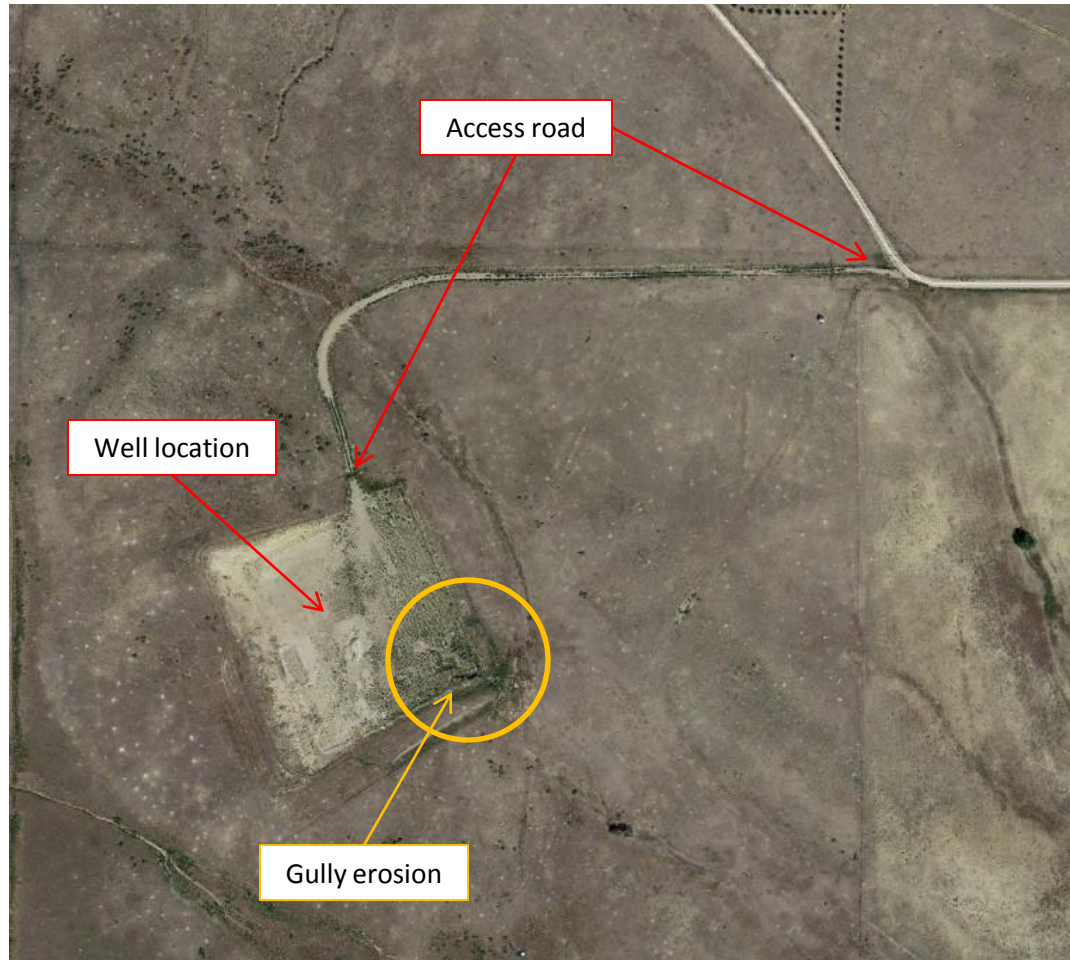
Google Earth imagery taken September 7, 2016 illustrating the ~0.26 mile access road and location (~4.9 acres in size) that have not been reclaimed. Well was plugged July 2, 2014. Refer to the following National Wetlands Inventory aerial imagery illustrating the intermittent stream in relation to the location.

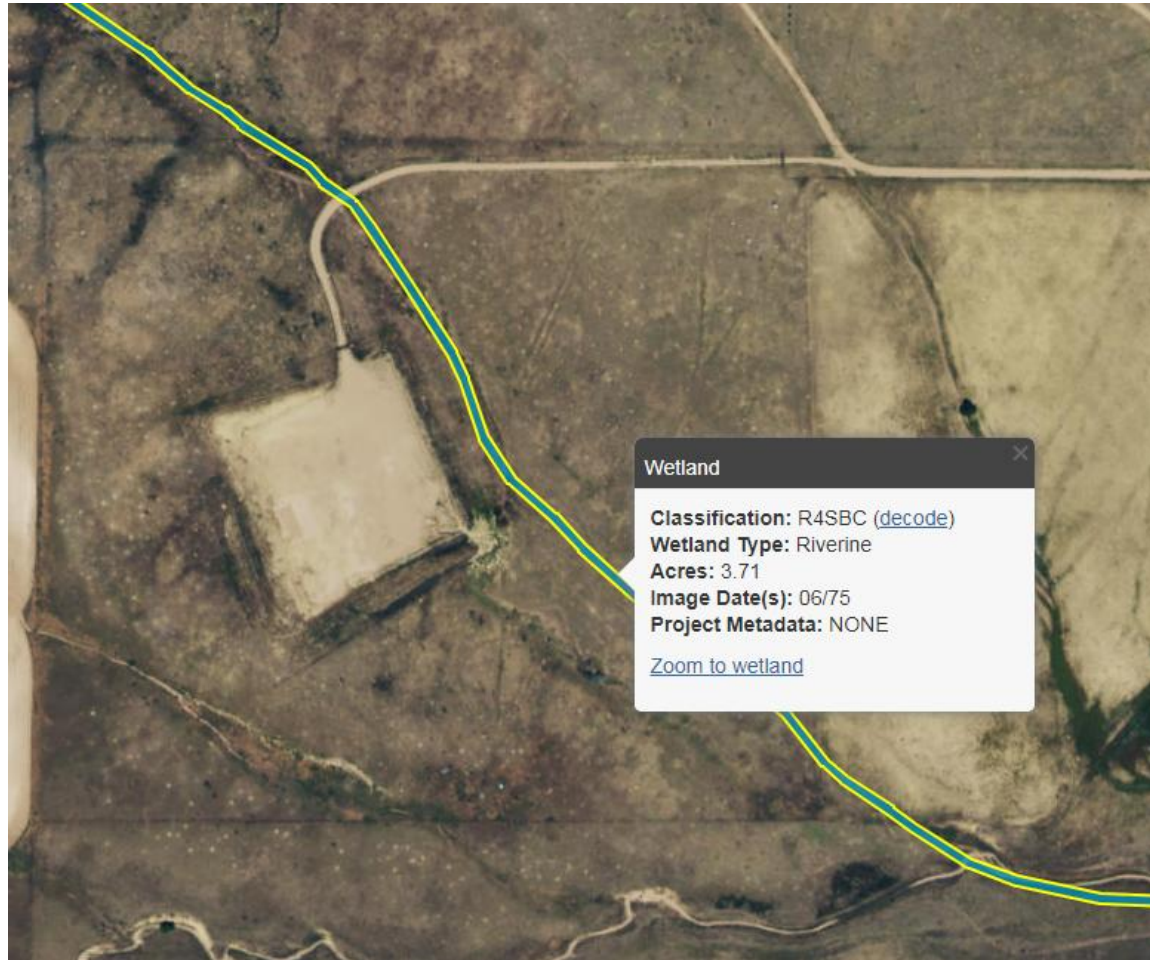
National Wetlands Inventory (date last modified October 1, 2017) aerial imagery illustrating the intermittent stream in relation to the location. Intermittent stream is downgradient approximately 200 feet.

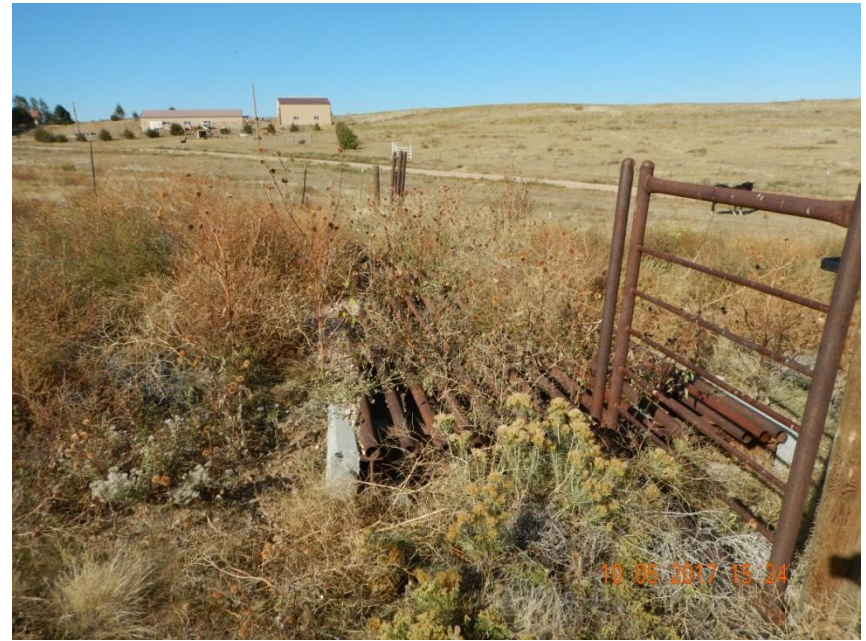
**Photo 2.** Photo taken from the beginning of the access road, facing North. Cattle guard has not been removed.

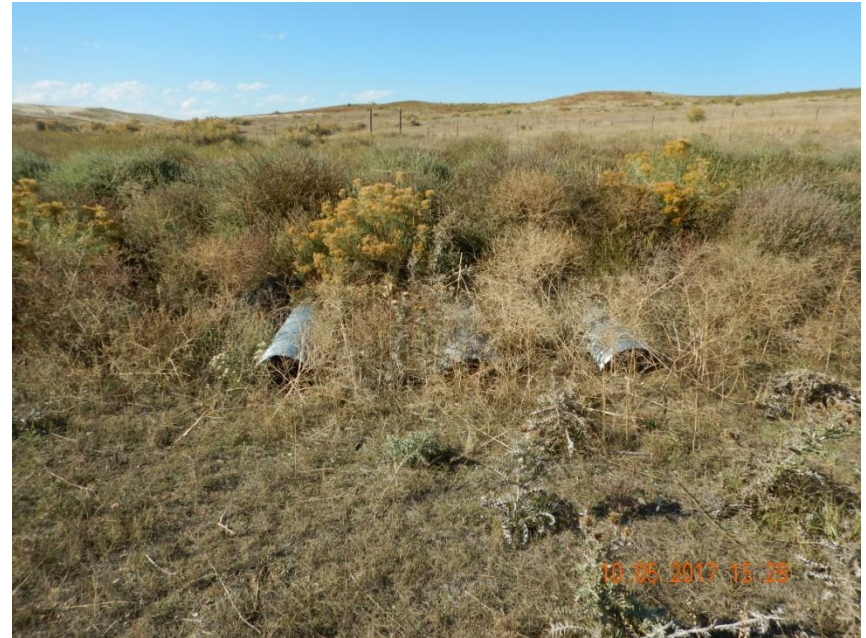
**Photo 4.** Photo taken along the portion of access road that intersects with an intermittent stream, facing North. Culverts have not been removed.

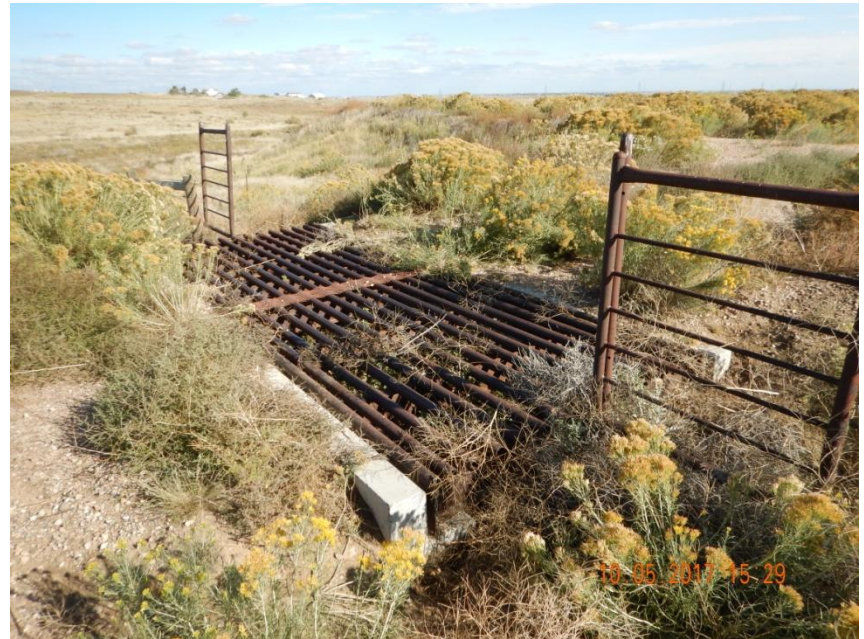
**Photo 6.** Photo taken from the entrance of the location, facing East. Cattle guard has not been removed.

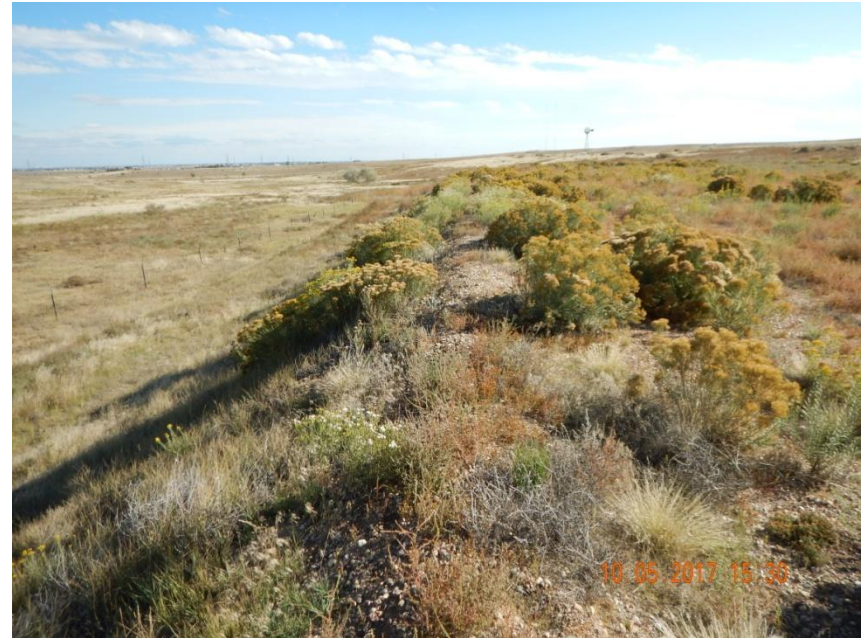
**Photo 7.** Photo taken from the northern location, facing East. Photo illustrates the location has not been contoured to the surrounding landscape and the perimeter fence around the entire location remains.

**Photo 8.** Photo taken from the northeastern location, facing South. See comments under Photo 7.

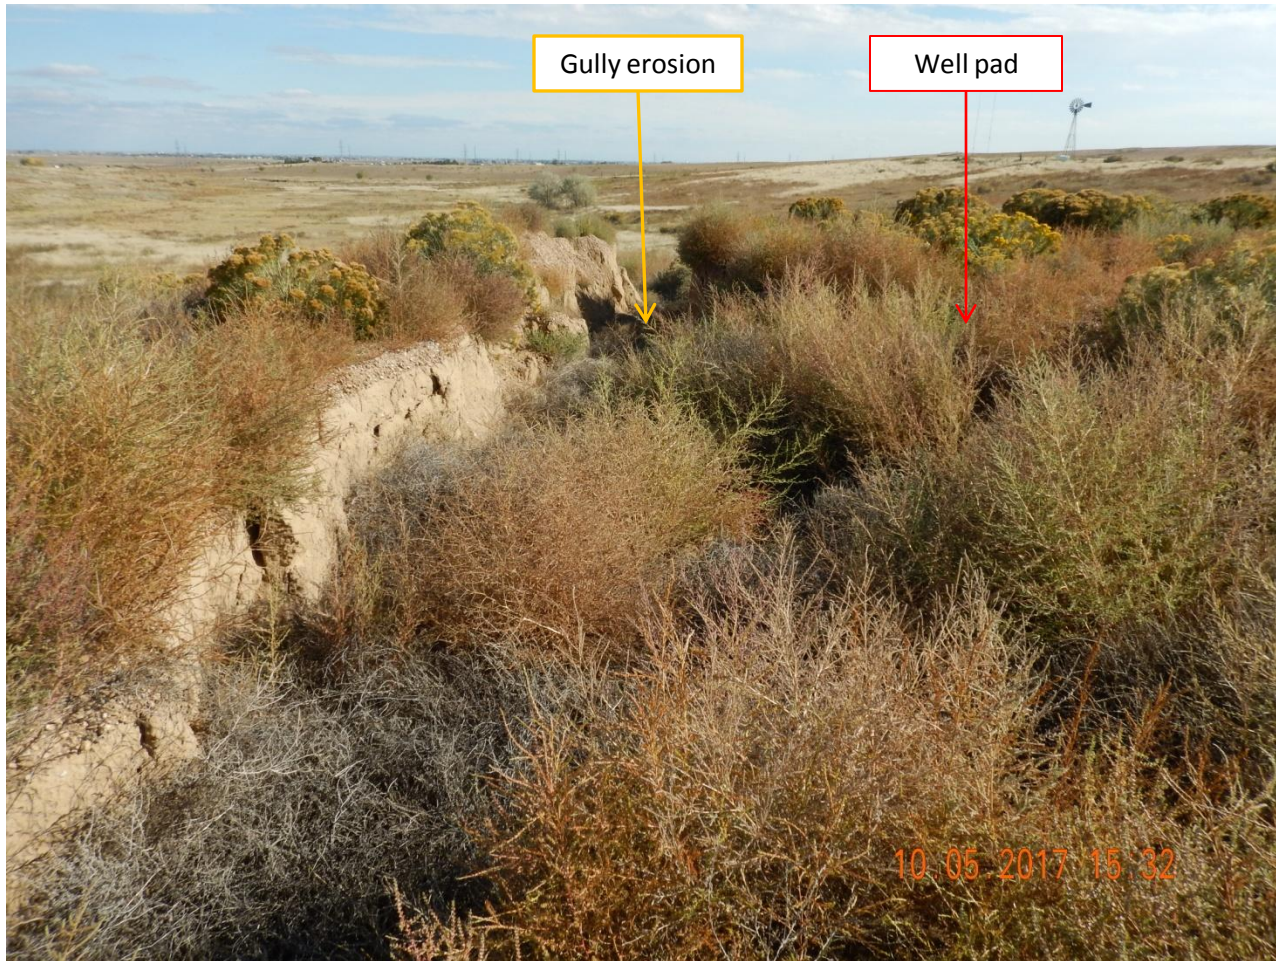
**Photo 9.** Photo taken from the southeastern location, facing South. Gully erosion- 6 feet in depth- observed throughout the southeastern well pad location. Russian thistle growth and weed debris observed throughout the southeastern location.

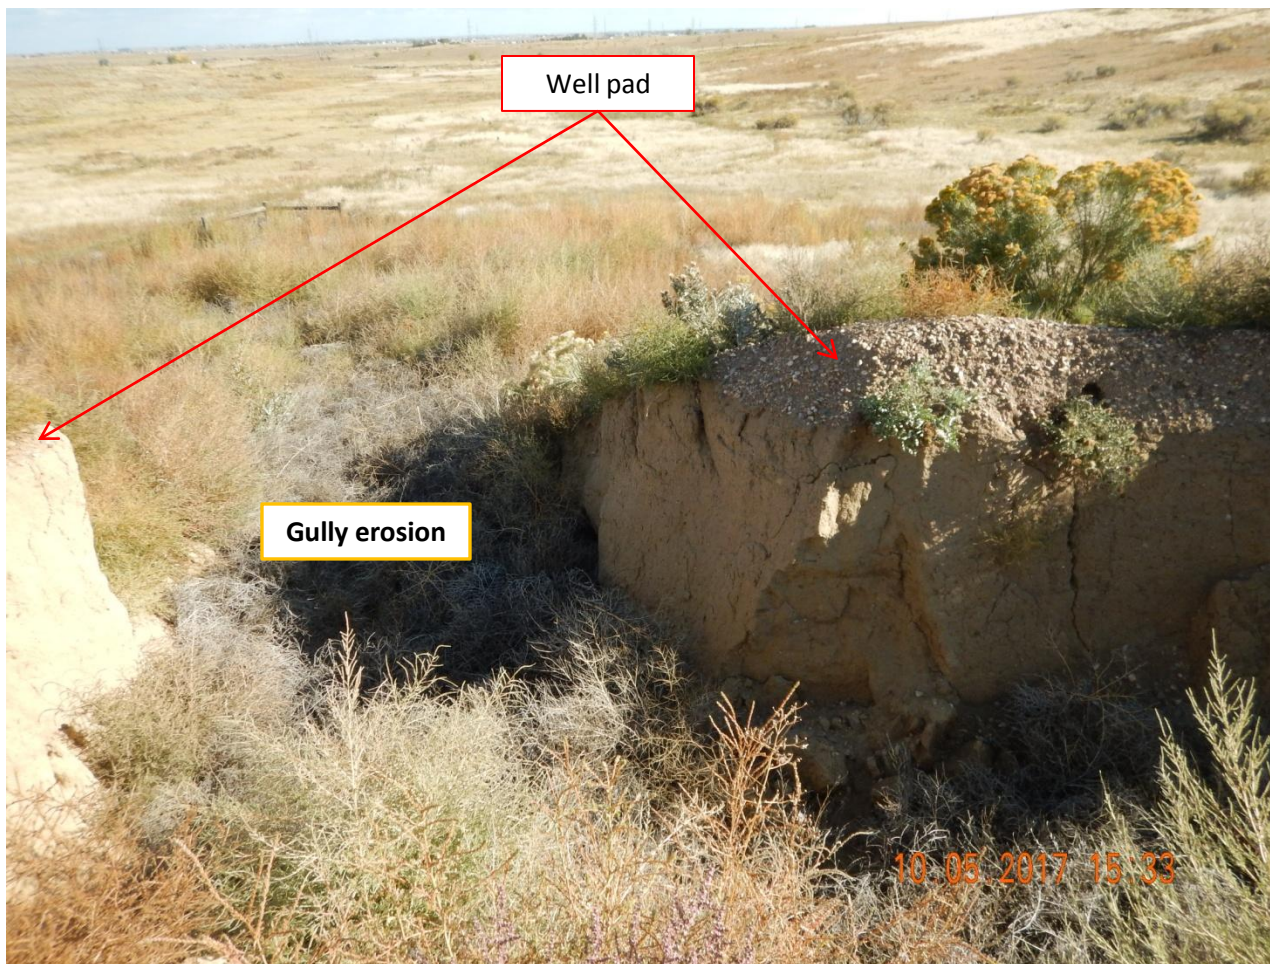
**Photo 10.** Photo taken from the southeastern location, facing Southeast. See comments under Photo 9.

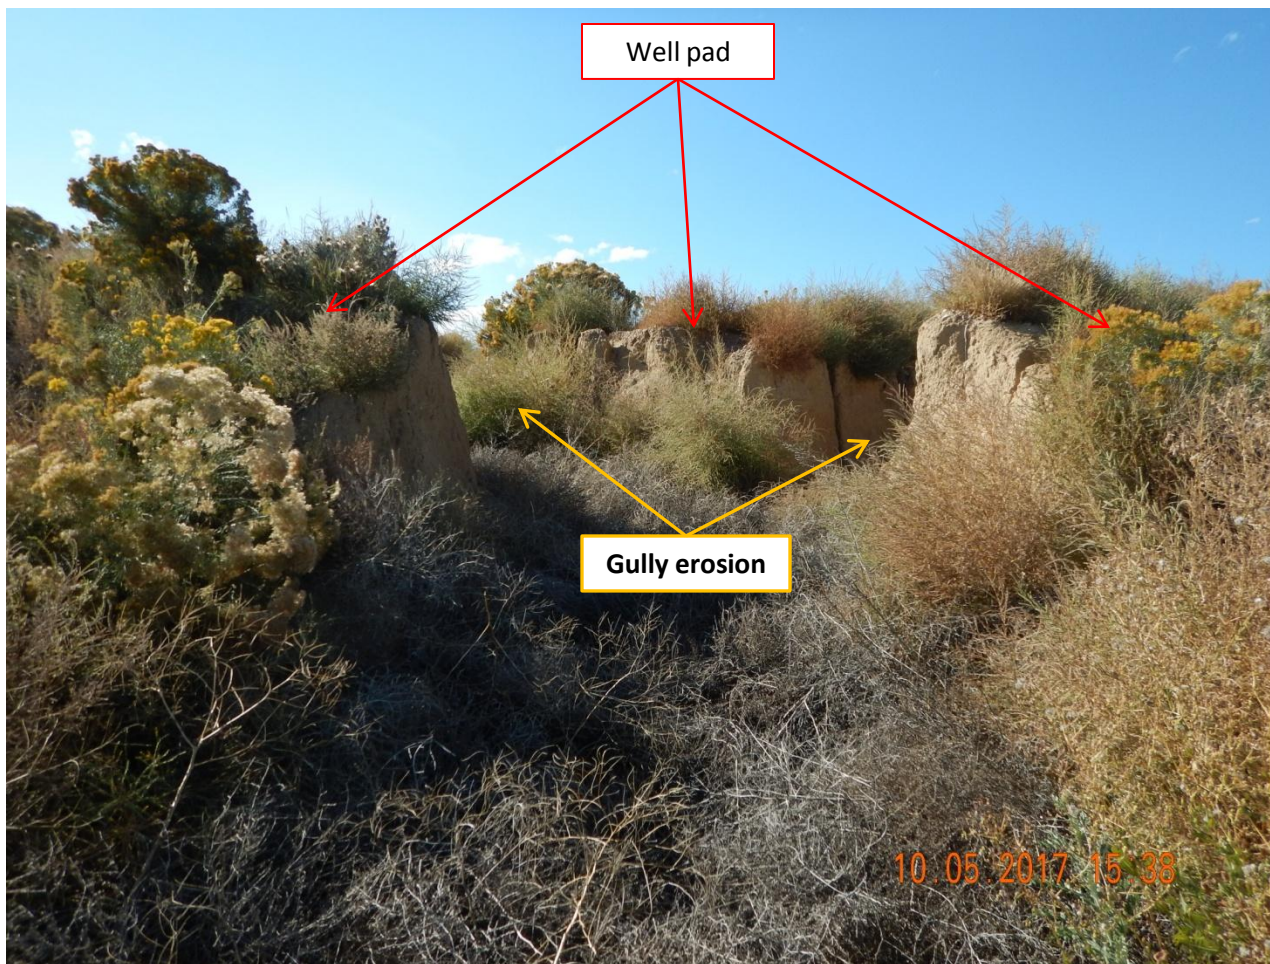
**Photo 11.** Photo taken from the southeastern location, facing Northwest. See comments under Photo 9.

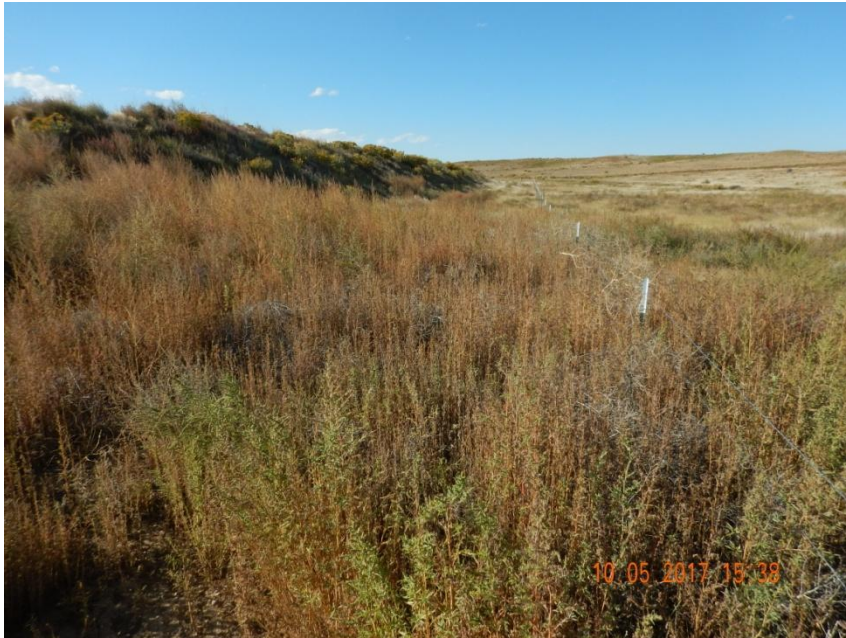
**Photo 12.** Photo taken from the southeastern location, facing North. Sediment appeared to be built up to depths of ~2' or more along the southeastern location and off location. Russian thistle appears to have spread onto adjacent lands due to the disturbance of erosion overtime.

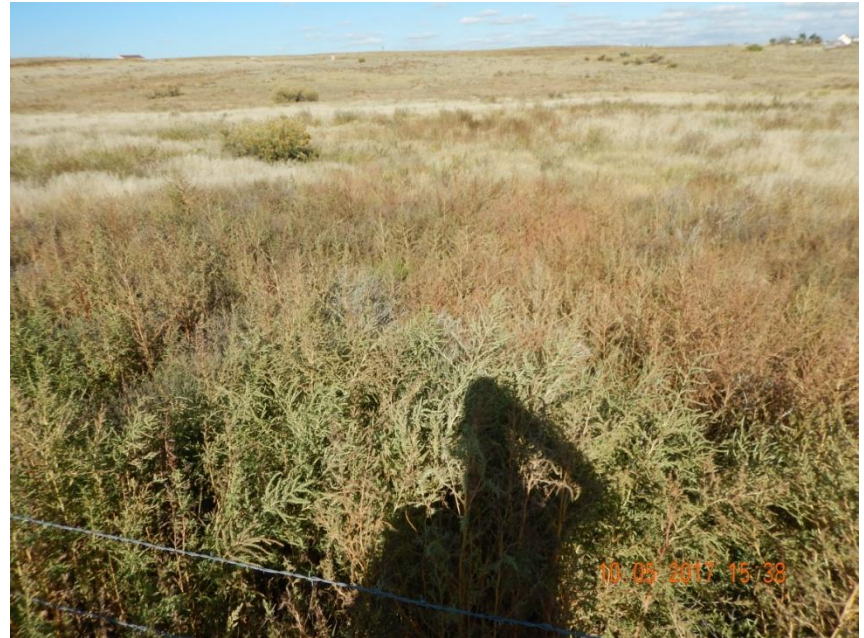
**Photo 13.** Photo taken from the previous photo location, facing East. Photo illustrates the Russian thistle growth that appears to have spread onto adjacent lands.

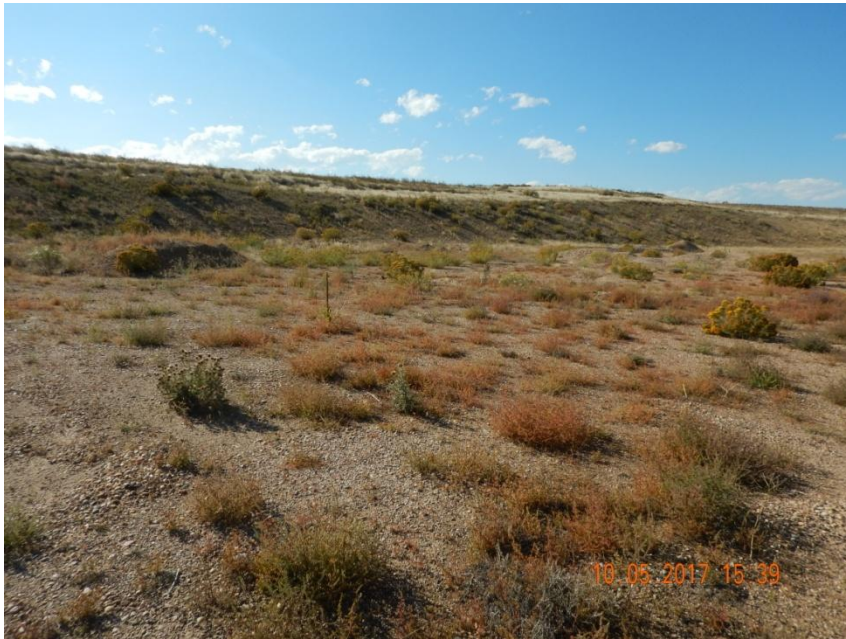
**Photo 14.** Photo taken from the southwestern location, facing North. Photo illustrates the Operator has not performed final reclamation based on the following: 1)location has not been contoured to the surrounding landscape, 2)gravel remains at location, and 3)location has not been seeded.

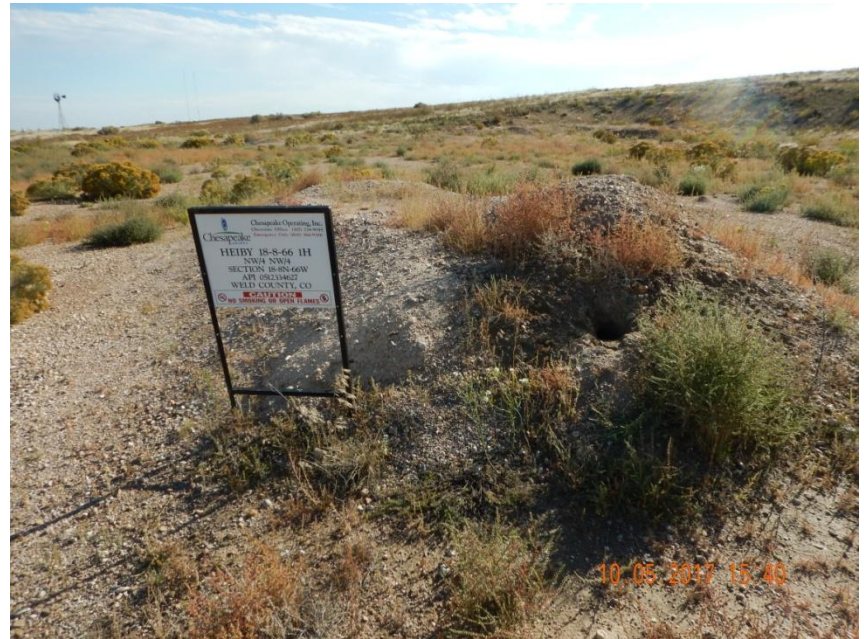
**Photo 15.** Photo taken from the approximate center of location, facing South. See comments under Photo 14.
