Final Reclamation Inspection

Operator: CHESAPEAKE OPERATING LLC- 16660

API: 05-123-34670

Inspection Photos
Location Name: BRENT 20-8-66 #1H
API: 05-123-34670

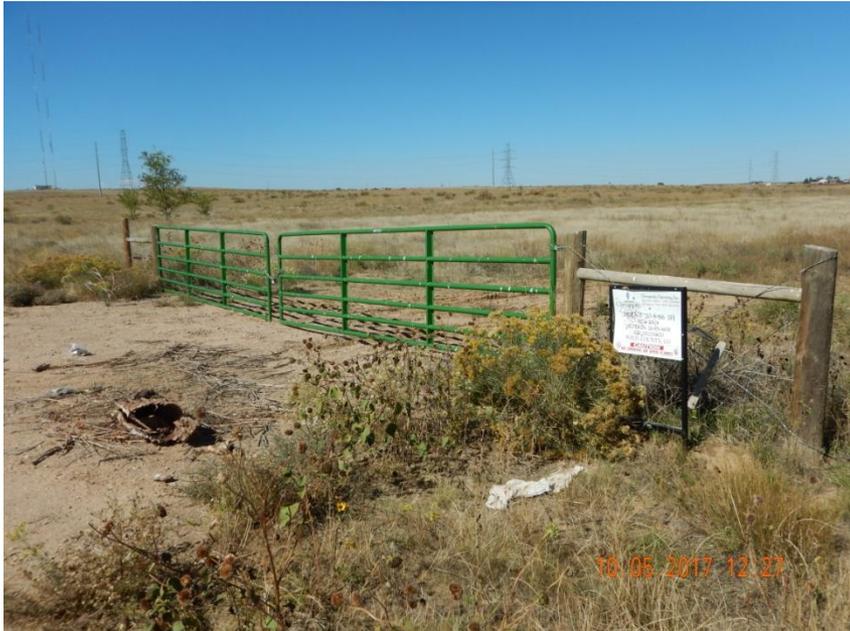
Photo 1. Photo taken from the entrance of the location off CR 90, facing West. Appears approach and gate have been left “AS IS” per the request of the surface owner (Form 4 Document #400669495).

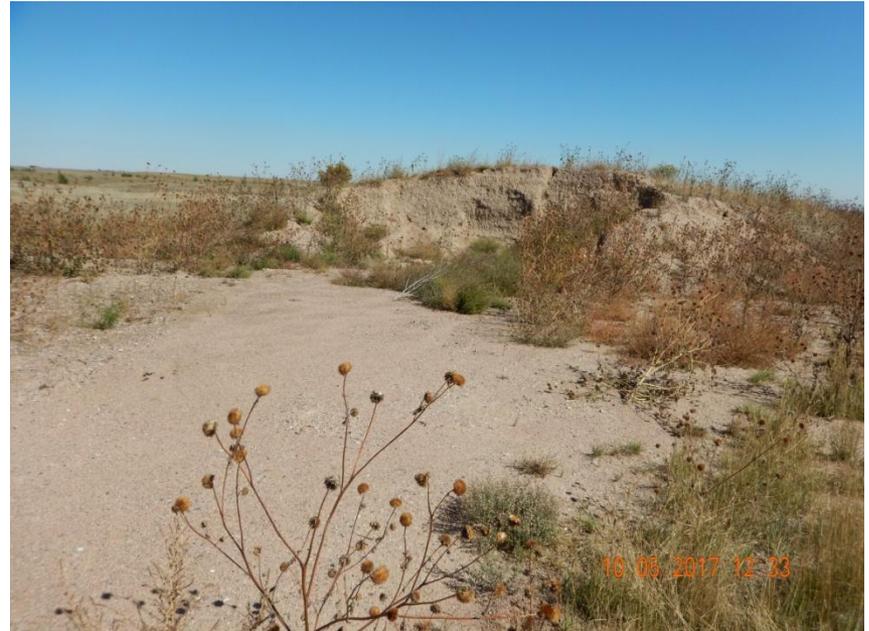
Photo 2. Photo taken from the entrance of the location, facing East. Appears gravel has been stockpiled at the entrance of location per the request of the surface owner (Form 4 Document #400669495).

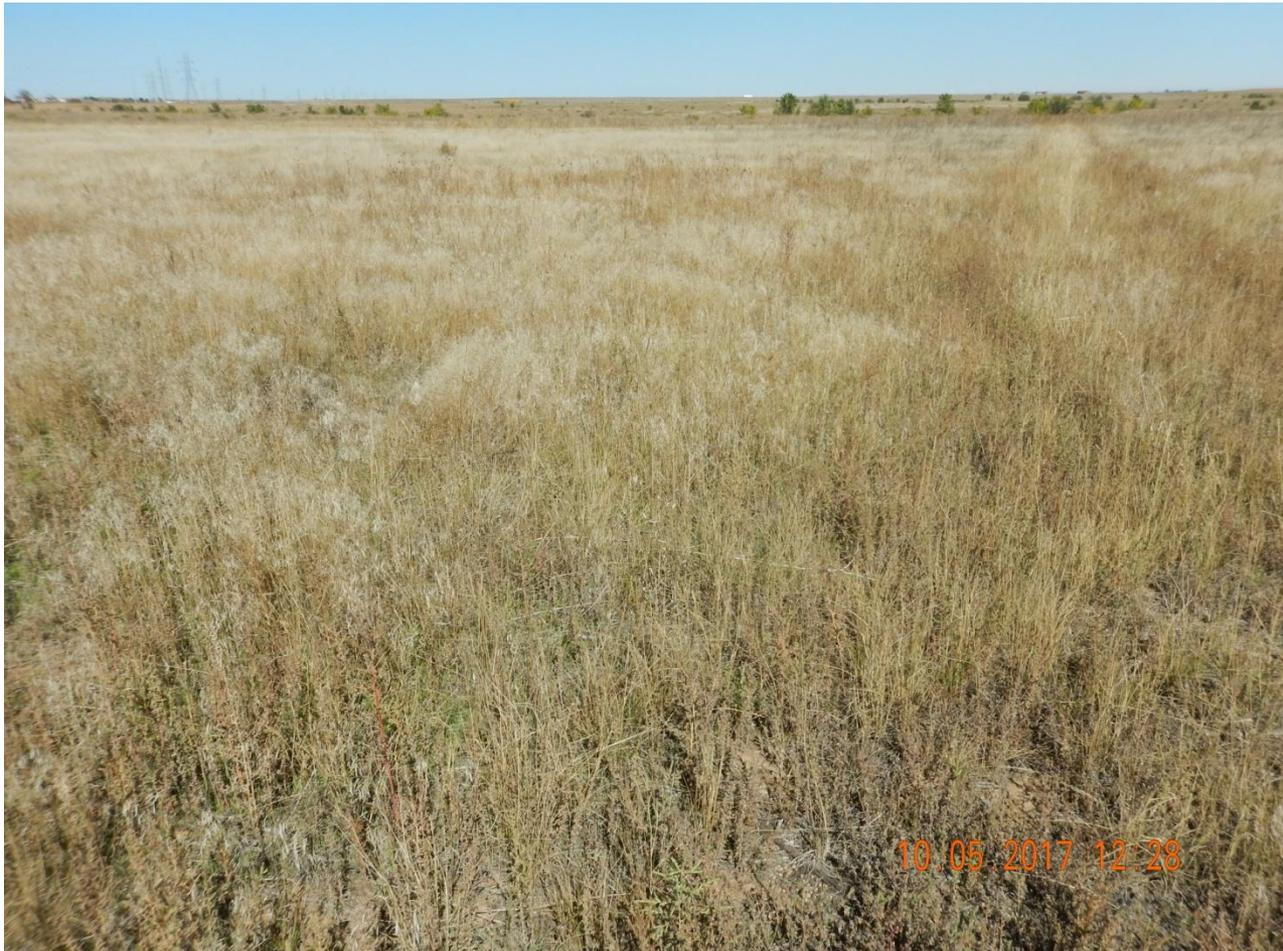
Photo 3. Photo taken from the approximate center of the location, facing North. Cheatgrass (*Bromus tectorum*) was the dominant vegetative cover, including, but not limited to, Crested wheatgrass (*Agropyron cristatum*) and Western wheatgrass (*Pascopyrum smithii*).

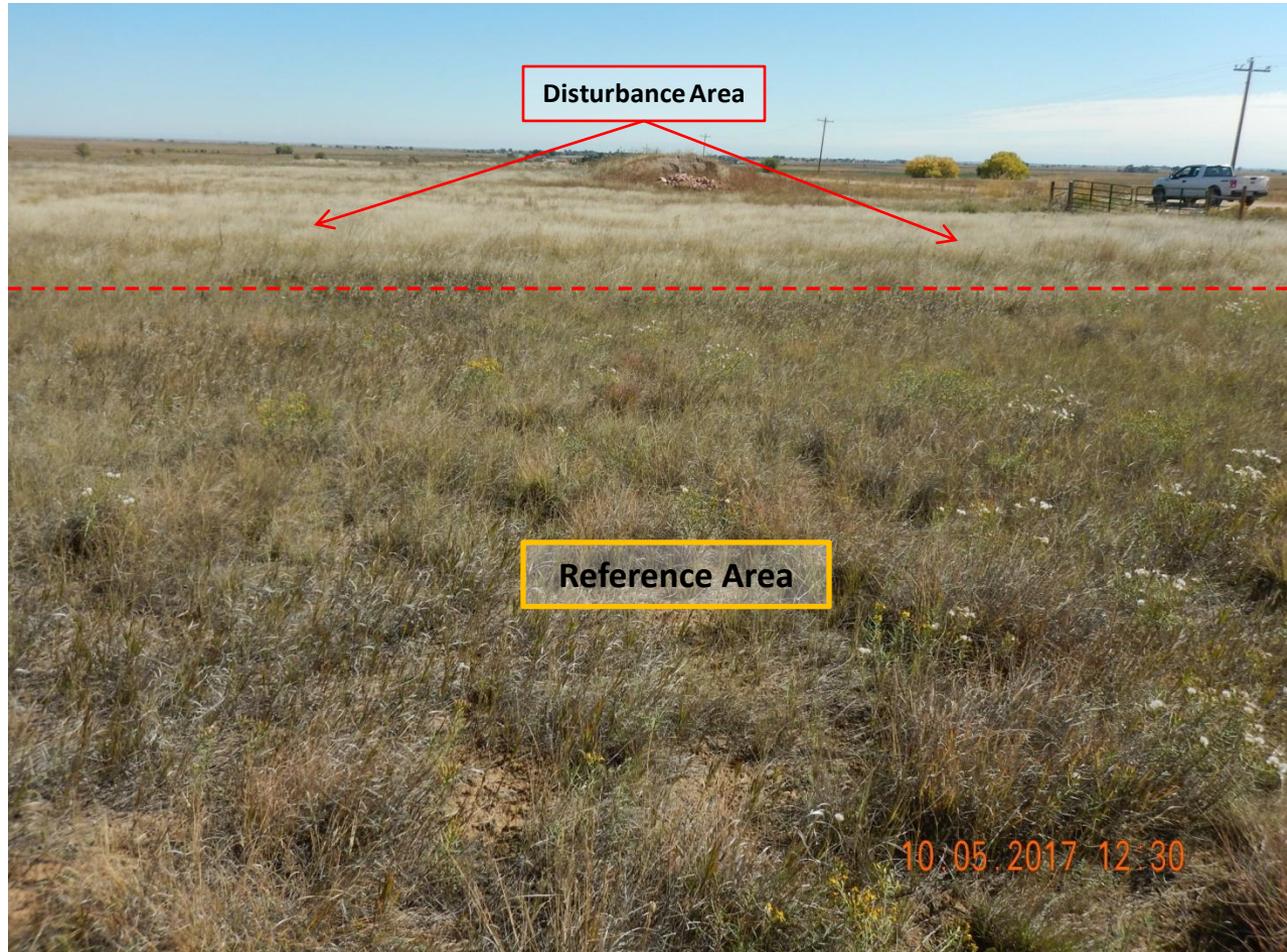
Photo 4. Photo taken west of the location, facing East. Photo illustrates the difference in vegetative cover from the disturbance area (everything above the red-dashed line) versus the reference area (everything below the red-dashed line). Reference area vegetative cover consisted mainly of Smooth brome (*Bromus inermis*), Switchgrass (*Panicum virgatum*), Sideoats grama (*Bouteloua curtipendula*), and Crested wheatgrass. Cheatgrass was not observed in reference areas.

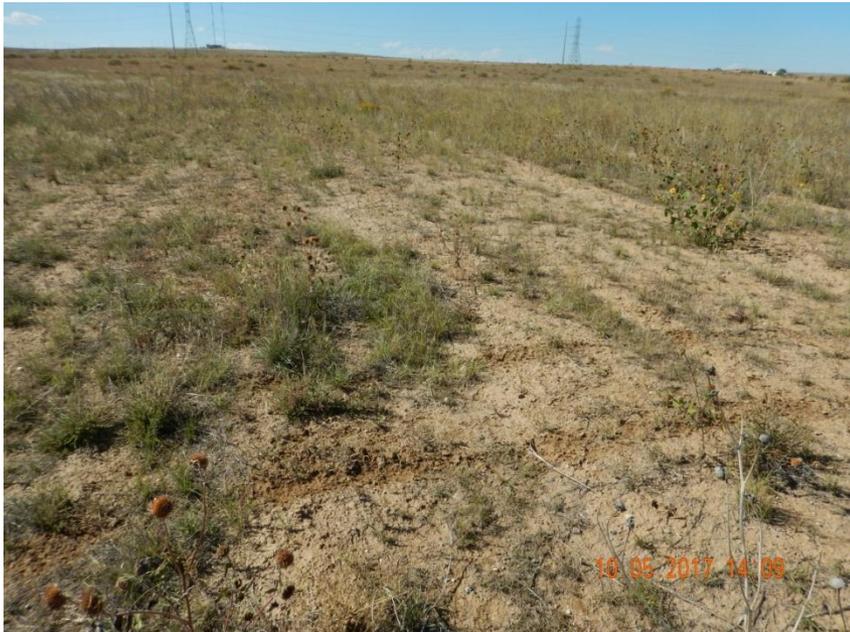
Photo 5. Photo taken from the northern location, facing West. Photo illustrates areas with little, to no, germination that is not reflective of reference area levels.

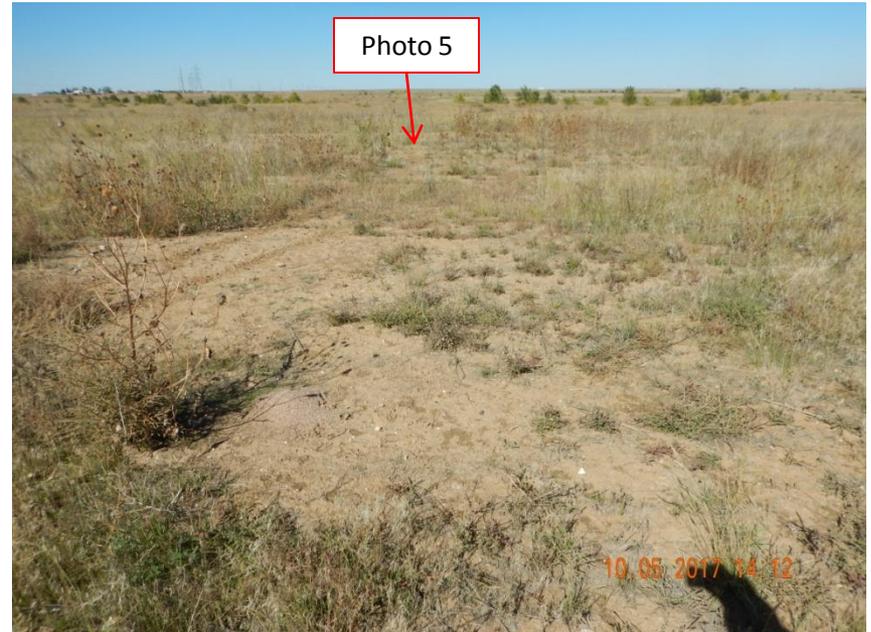
Photo 6. Photo taken from the northern location, facing North. See comments under Photo 5.

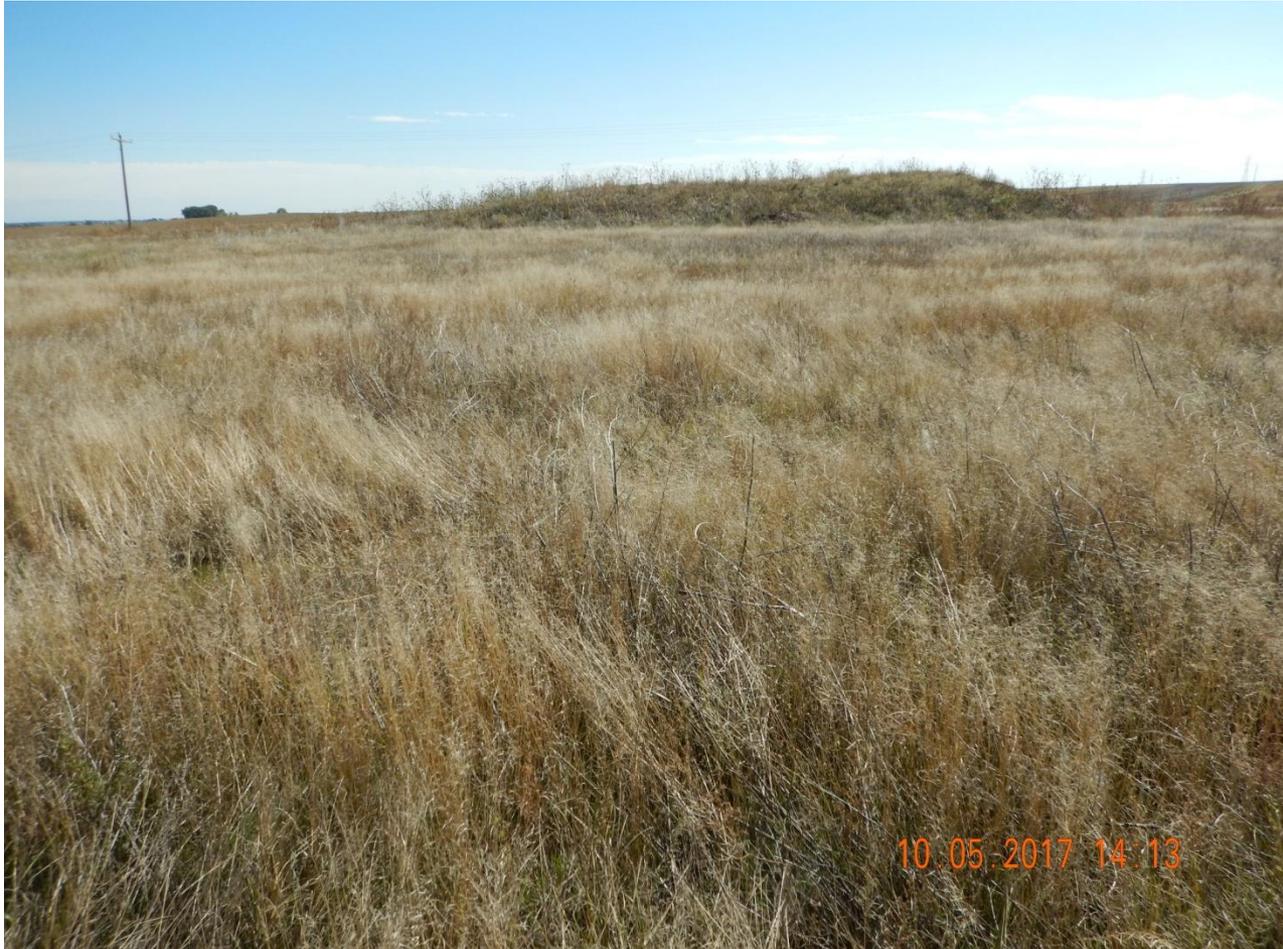
Photo 7. Photo taken from the approximate center of the location, facing South. See comments under Photo 3.
