COLORADO
Oil & Gas Conservation
Commission
Department of Natural Resources

Inspection Photos: Grynberg PA Chivington API#081-05709

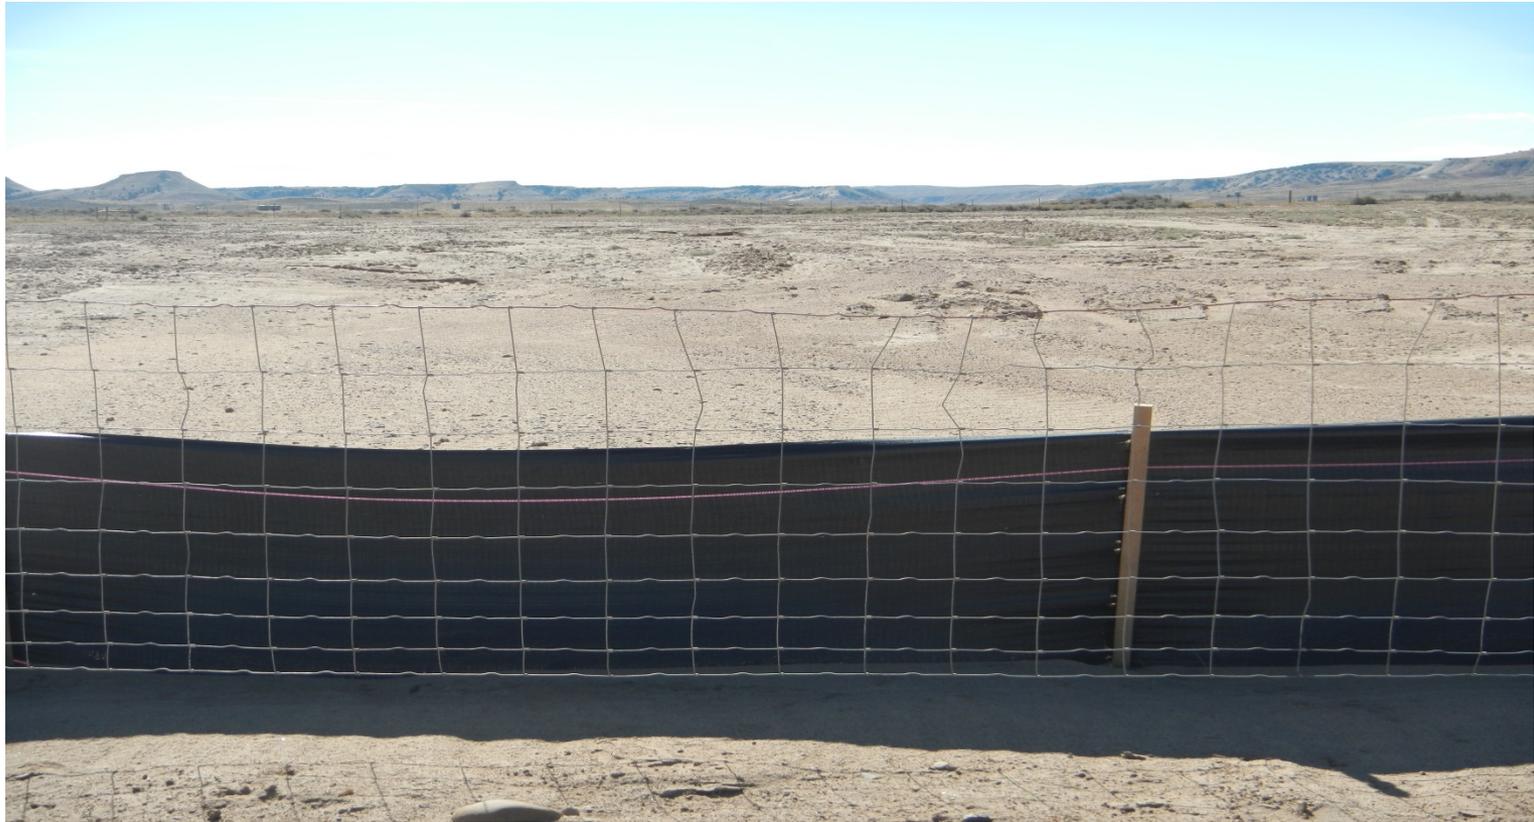
Photo#1:
Overview of Location from Entry Gate too South West

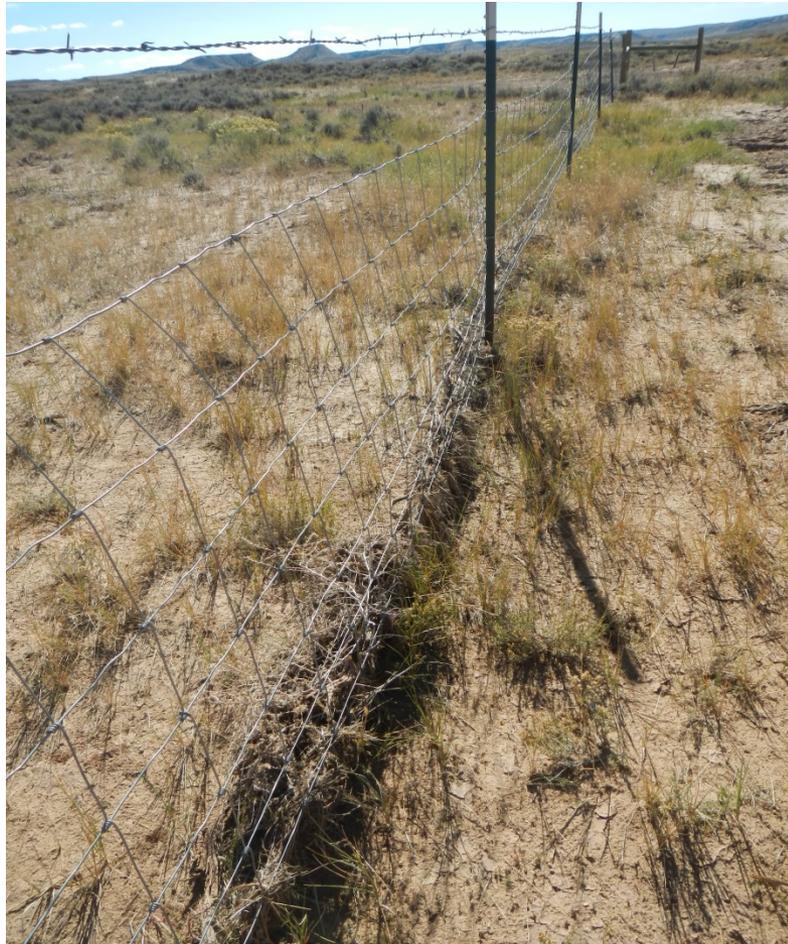
Photo#2:

Most of the SW Run on is coming from the SE flowing through the netting fence, flowing NW.

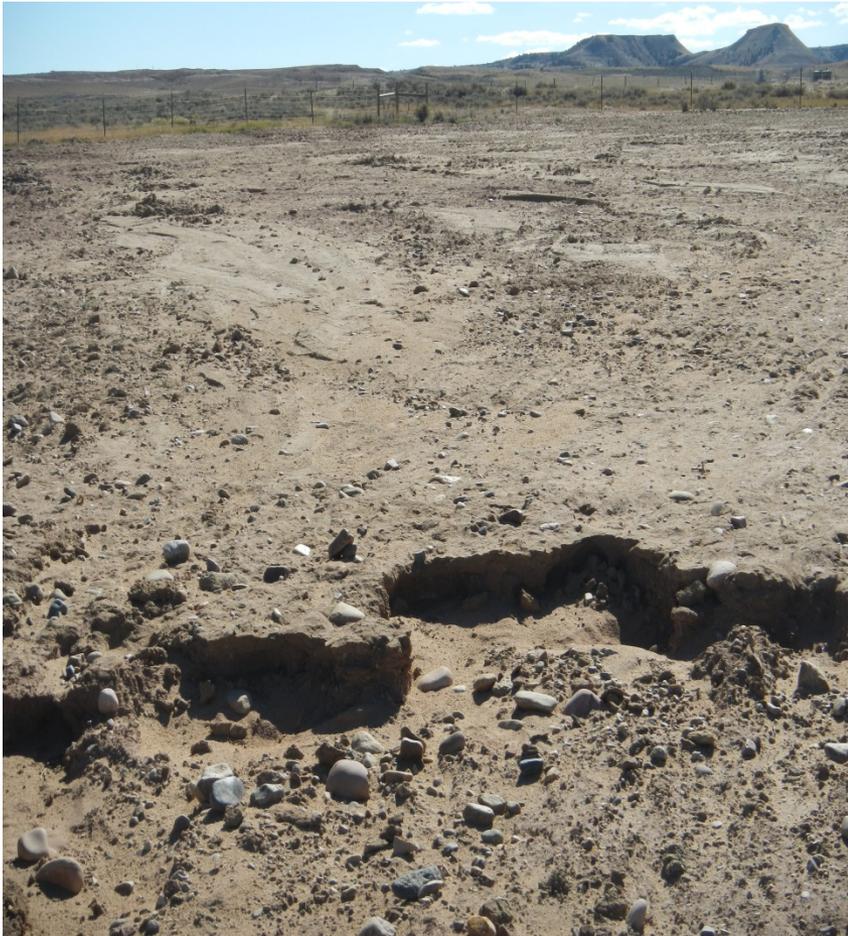
Photo#4:

Most of the Run on is coming from the SE flowing through the netting fence, flowing NW, eroding Pad surface.

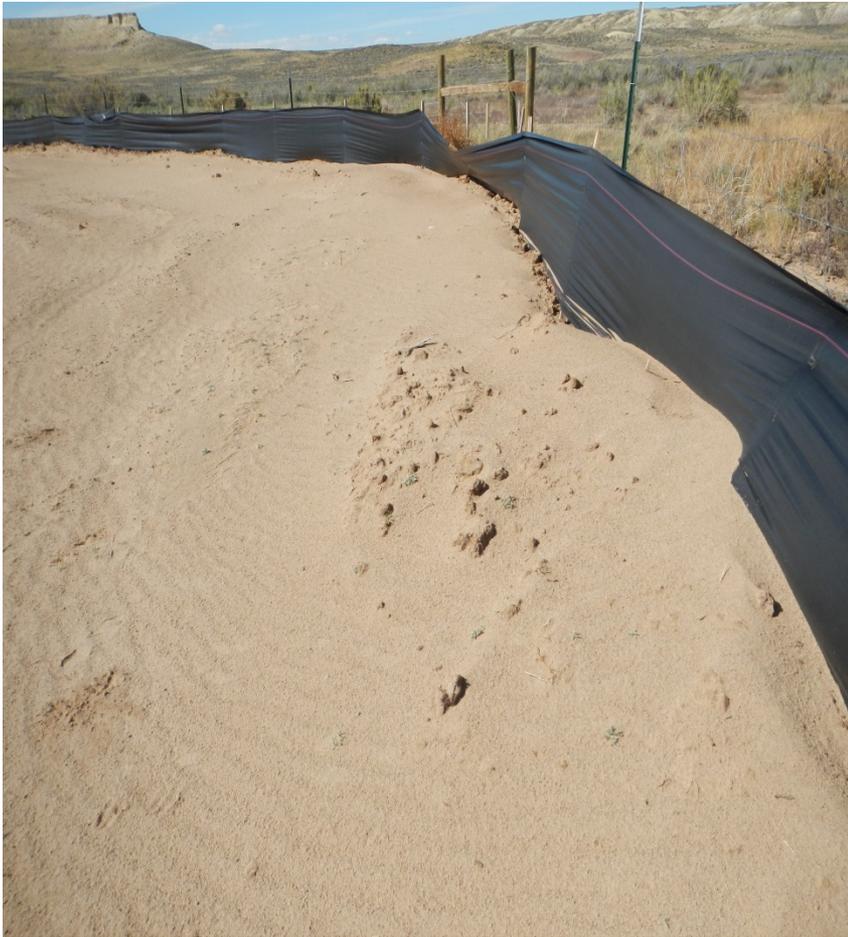
Photo#6:

Most of the Run on is coming from the SE flowing through the netting fence, flowing NW, eroding Pad surface and depositing considerable sediment at North end Silt Fence.

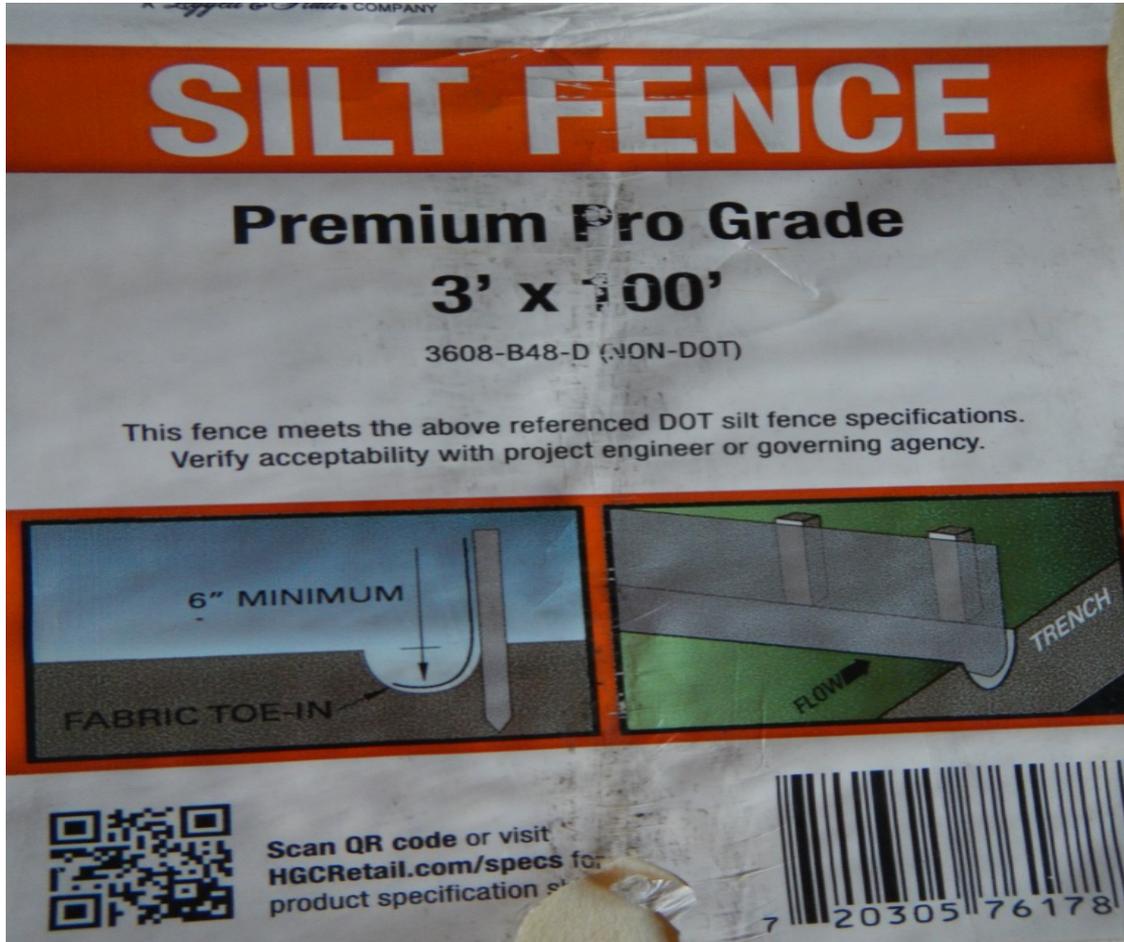
Photo#8:

Silt Fence Label found on Site which notes Installation Specs.

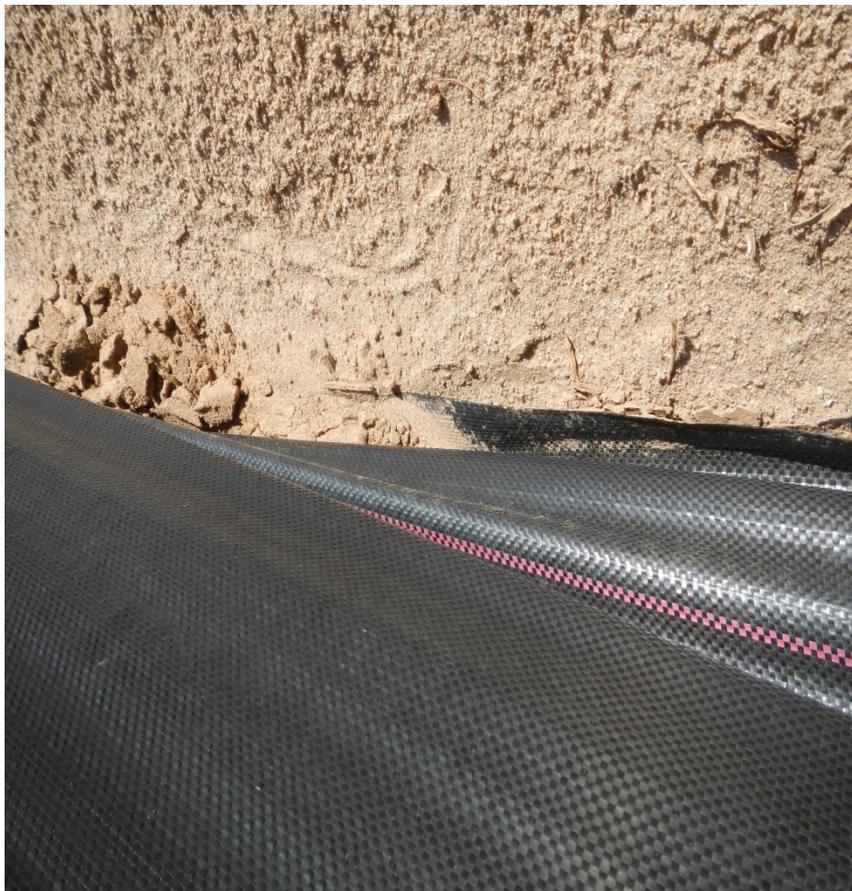
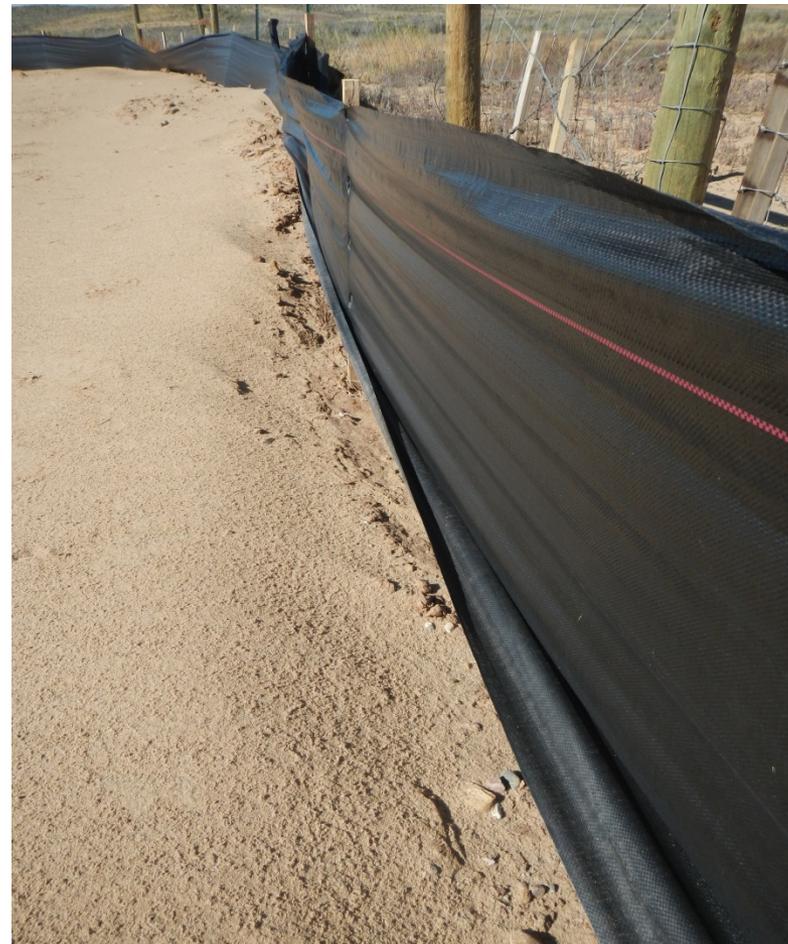
Photo#9:
Photo#10:

Portions of Fence showing poor installation

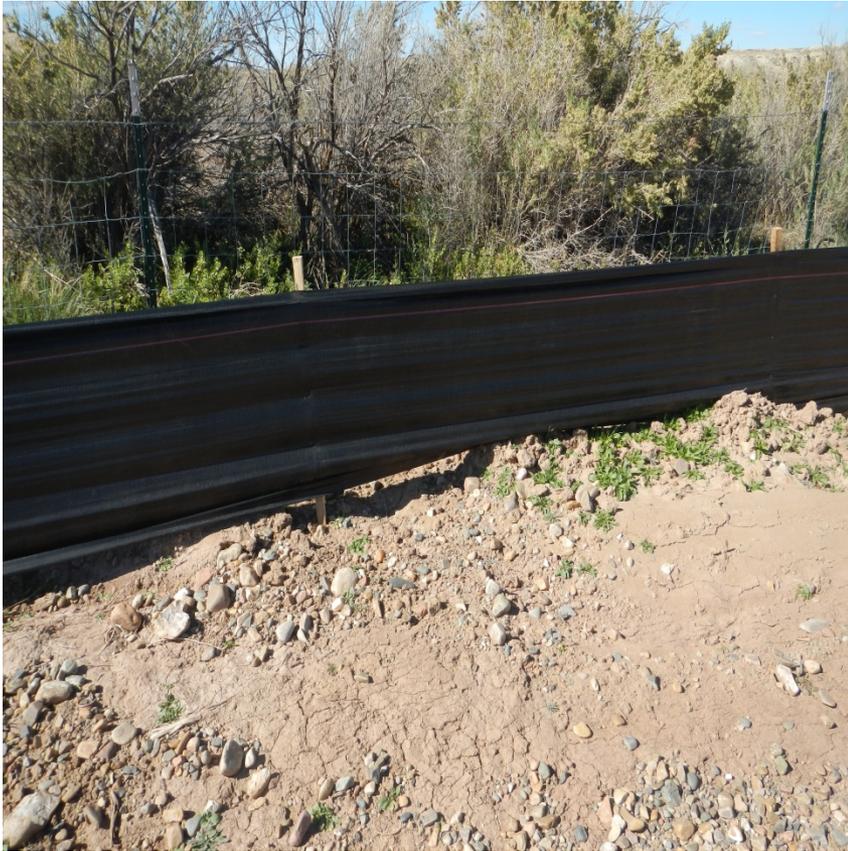
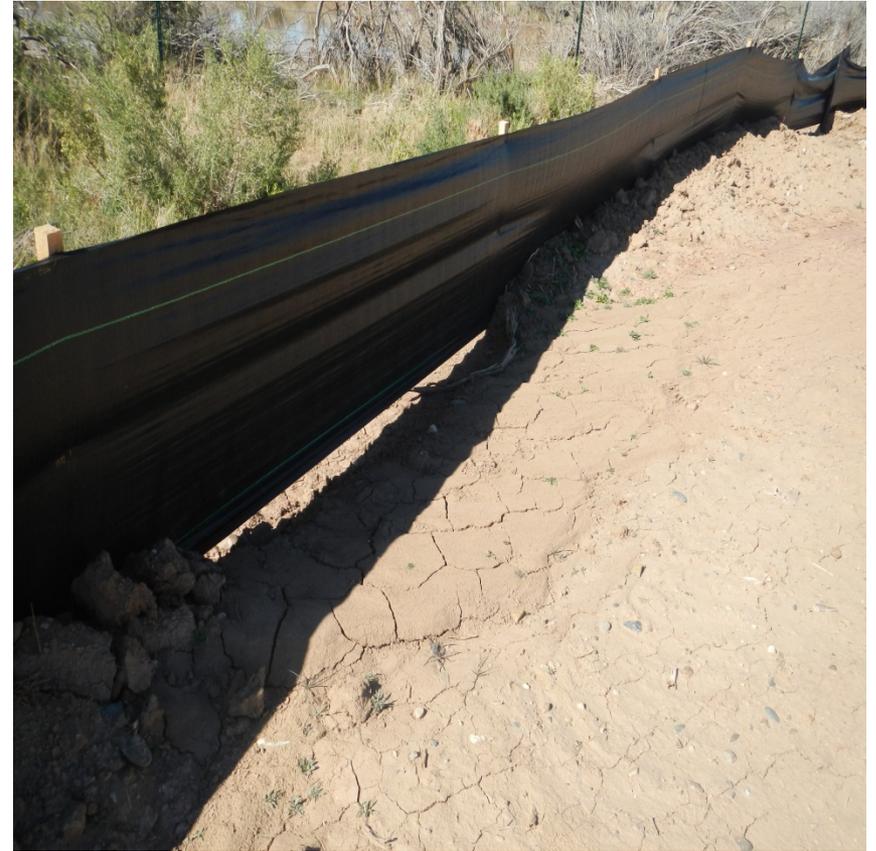
Portions of Fence showing poor installation.

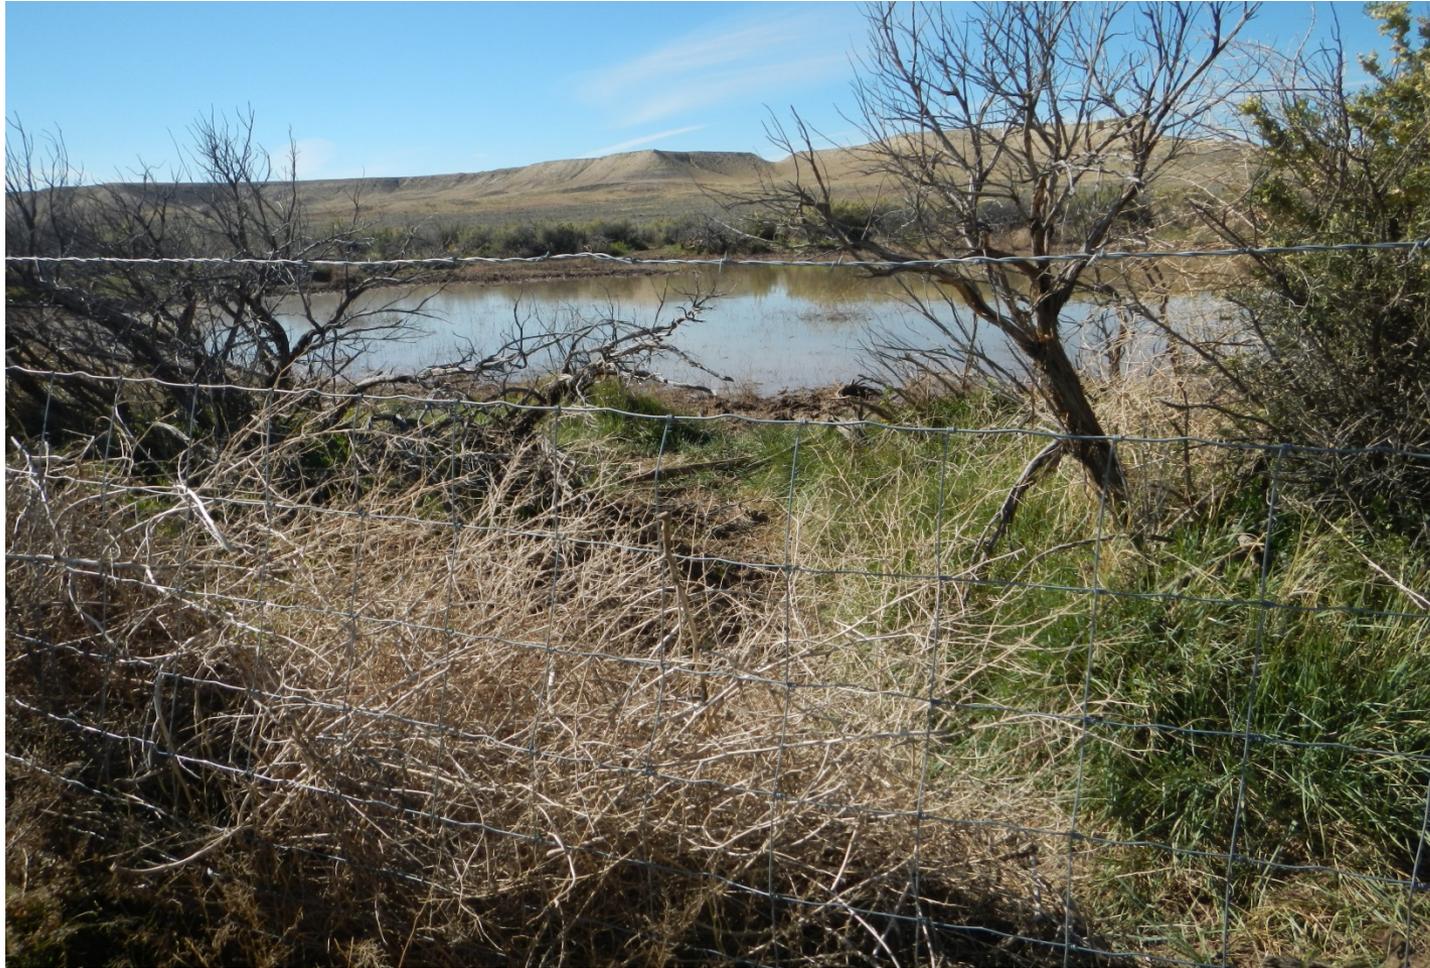
Photo#13:

Reservoir / Pond adjacent (NW) to Site that when overfull may be discharging out along & under Silt Fence and Running onto Location.

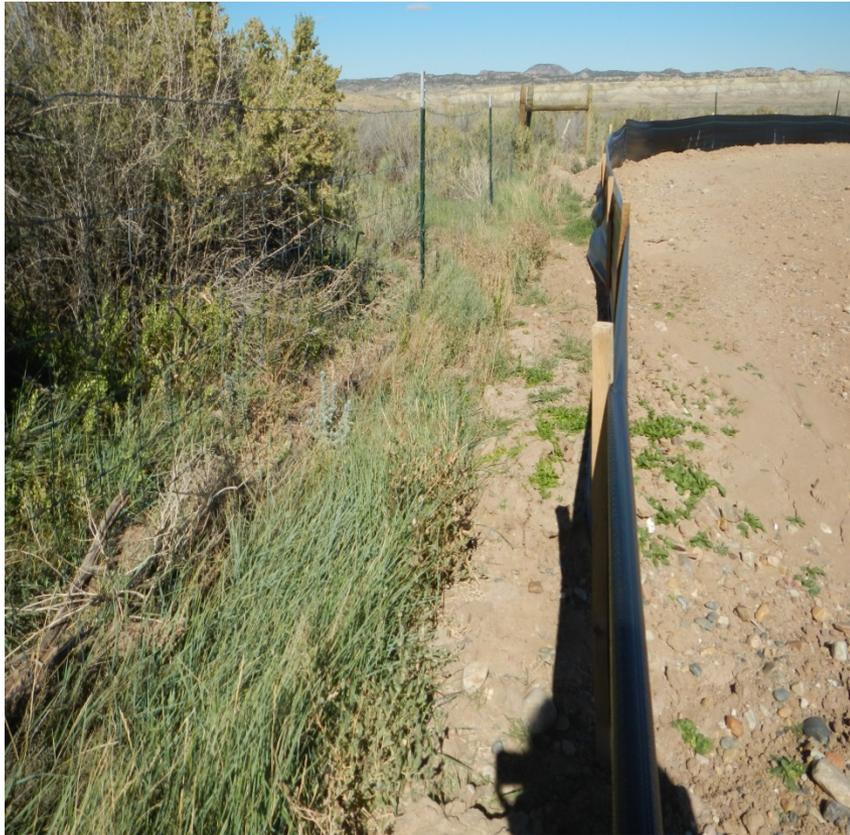
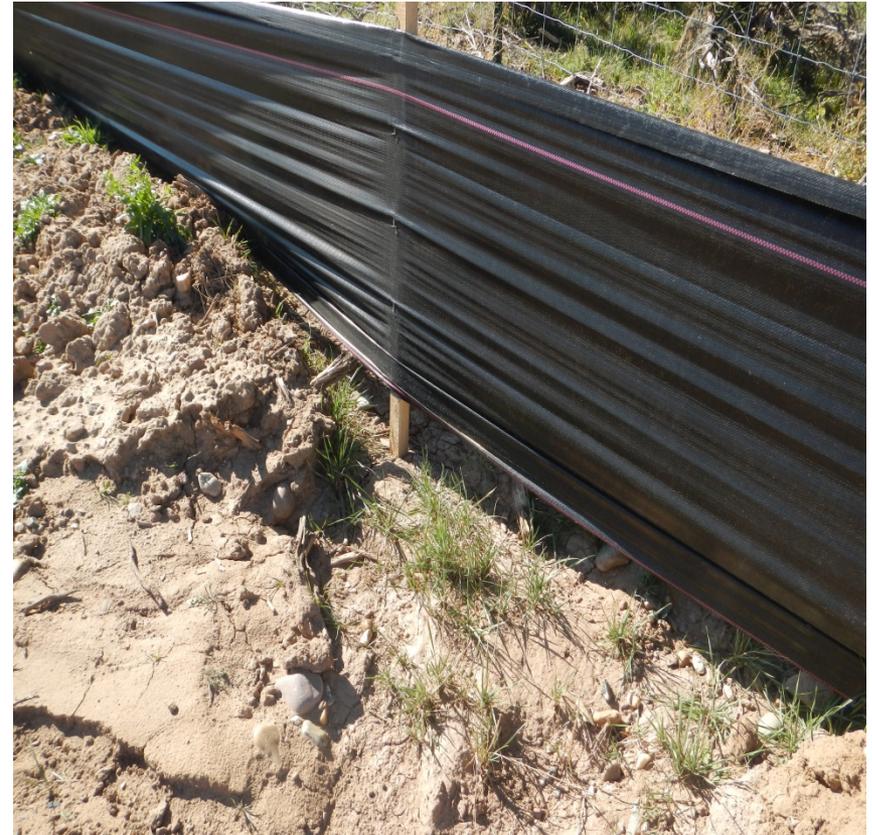
Reservoir / Pond adjacent (NW) to Site that when overfull may be discharging out along & under Silt Fence and Running onto Location.
