Final Reclamation Inspection

Operator: CHESAPEAKE OPERATING LLC- 16660

API: 05-123-34095

Inspection Photos
Location Name: HEDIGER 24-9-67 #1H
API: 05-123-34095

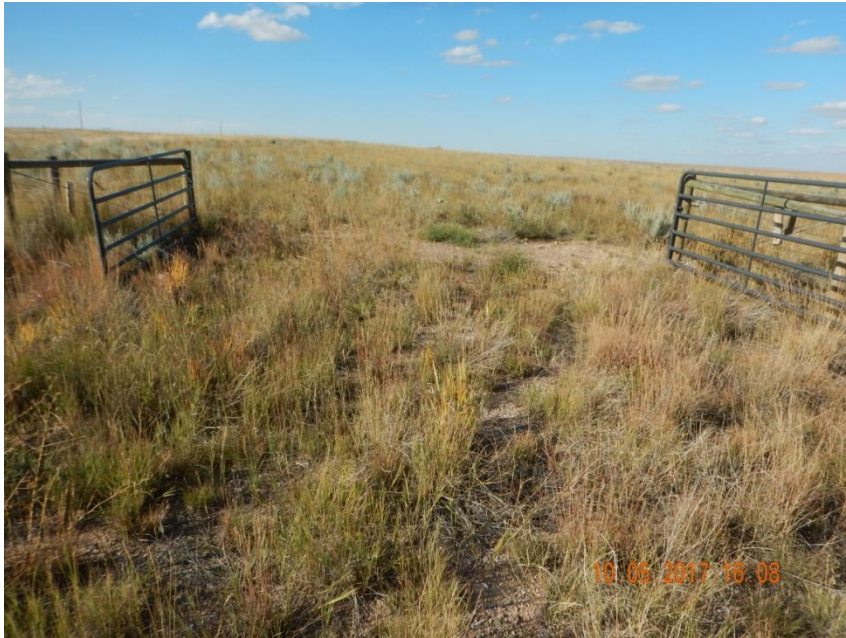
Photo 1. Photo taken from the entrance of the well location, facing North. Appears the gate and fence material around the entire location remains.

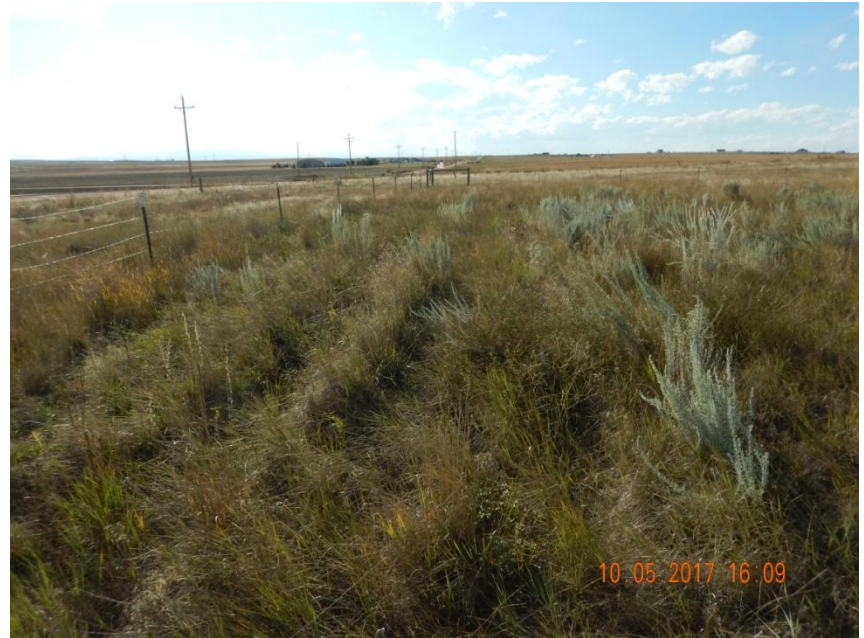
Photo 2. Photo taken from the entrance of the well location, facing West. See comments under Photo 1.

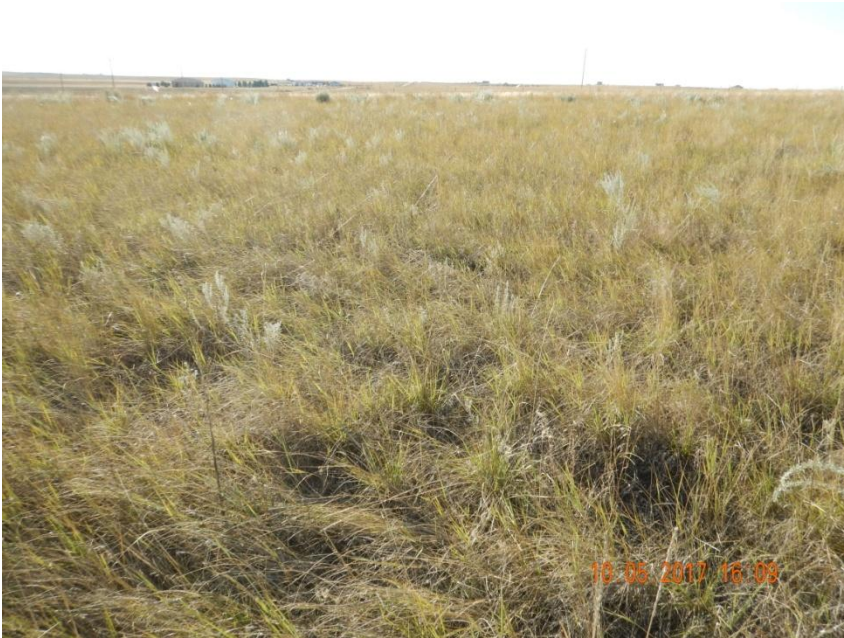
Photo 3. Photo taken from the approximate center of the well location, facing West. Unable to find evidence of oil and gas activities and/or disturbances. Well location appears reflective of reference areas.

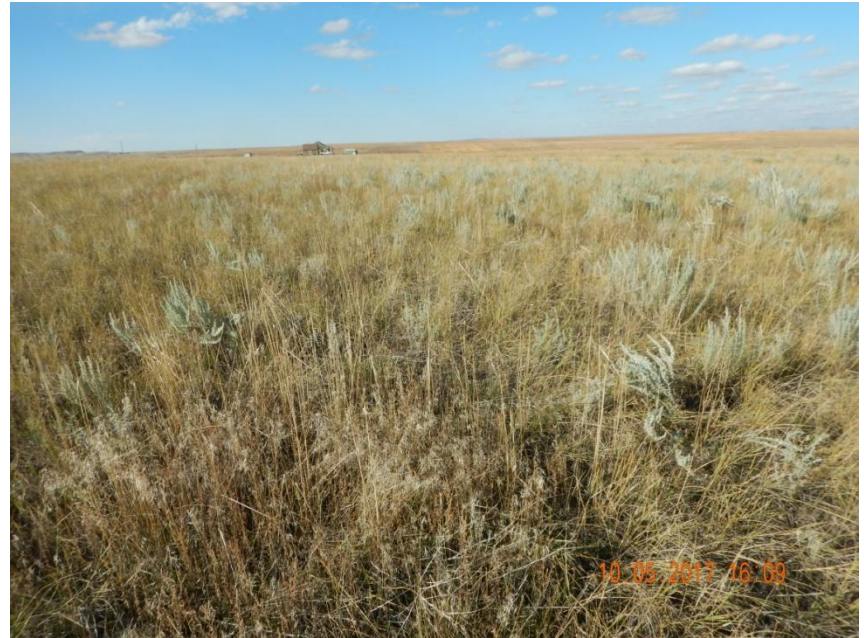
Photo 4. Photo taken from the approximate center of the well location, facing North. See comments under Photo 3.

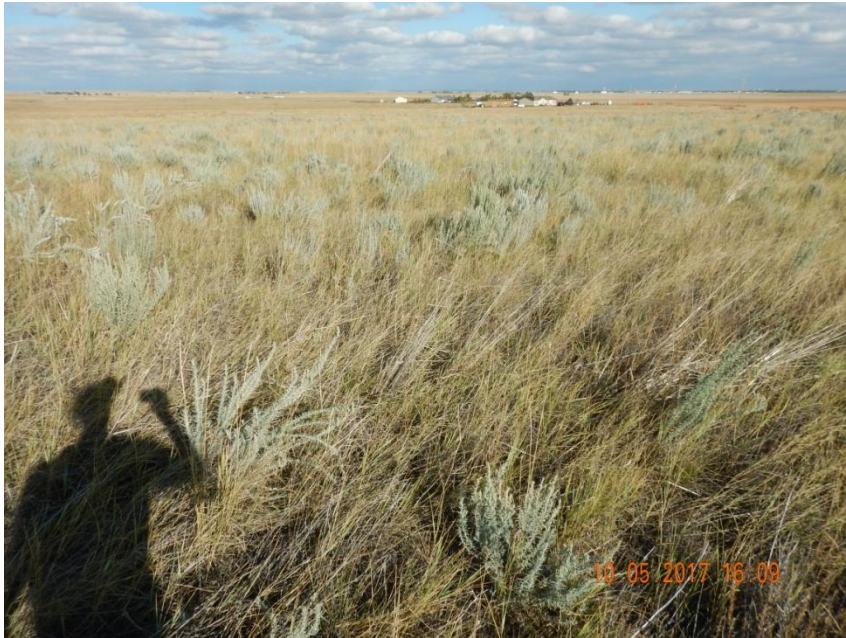
Photo 5. Photo taken from the approximate center of the well location, facing East. See comments under Photo 3.

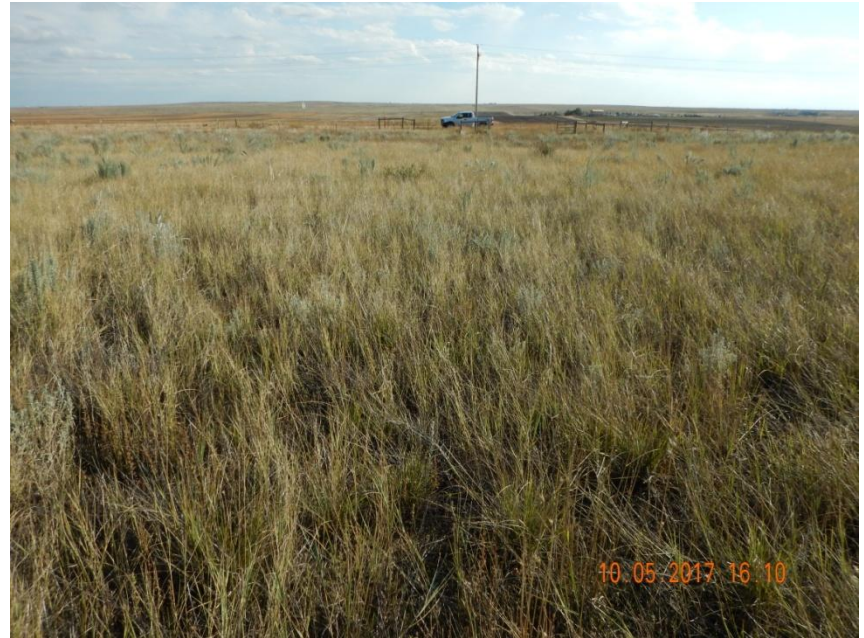
Photo 6. Photo taken from the approximate center of the well location, facing South. See comments under Photo 3.

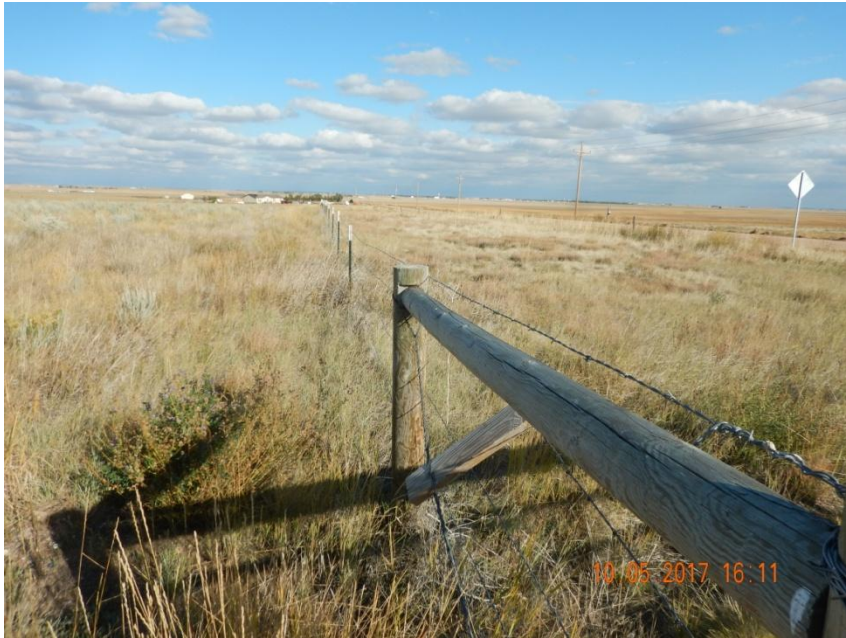
Photo 7. Photo taken from the entrance of the well location, facing East. See comments under Photo 1. .

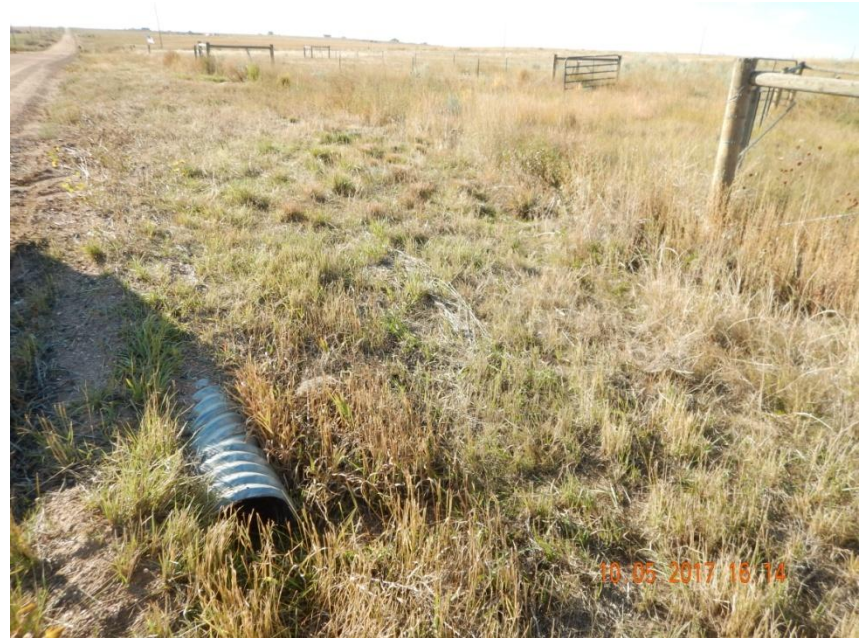
Photo 8. Photo taken from the entrance of the location, facing West. Culvert remains at the entrance of the location.
