COGCC conducted an inspection of the LC11-13 location (Location ID 445209) on August 17, 2017 (Document 682402645). During that inspection, COGCC made the following observations:

Name: LC11-13

Location ID: 445209

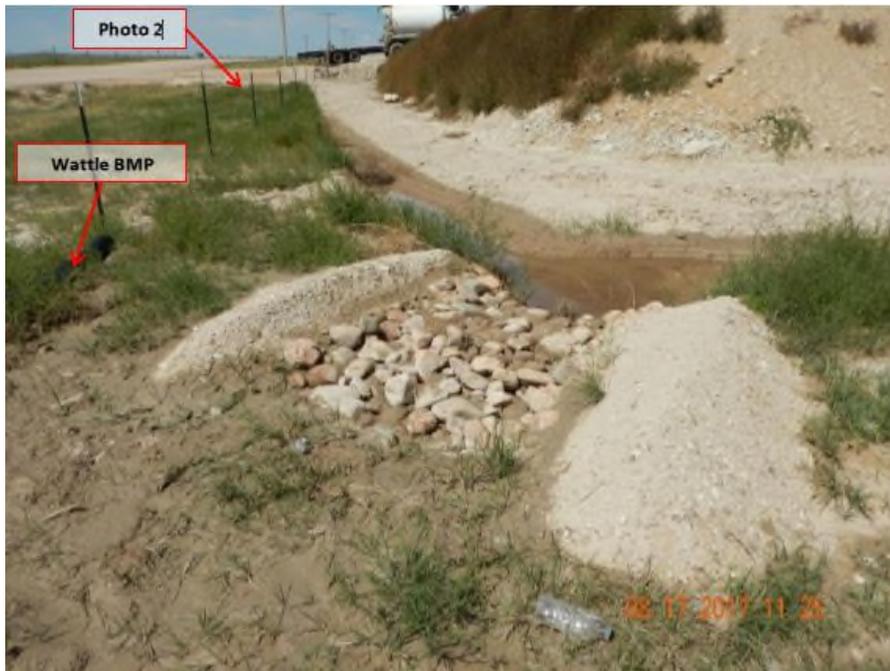
Photo 1. Photo taken from the southeast Tombstone pad, facing West. Sediment discharge observed beyond the outlet area of the sediment trap as shown in this photo. Does not appear the wattle BMP beyond the outlet area of the sediment trap is preventing sediment discharge from location. Sediment trap has not been enlarged since the previous inspection on July 11, 2017.

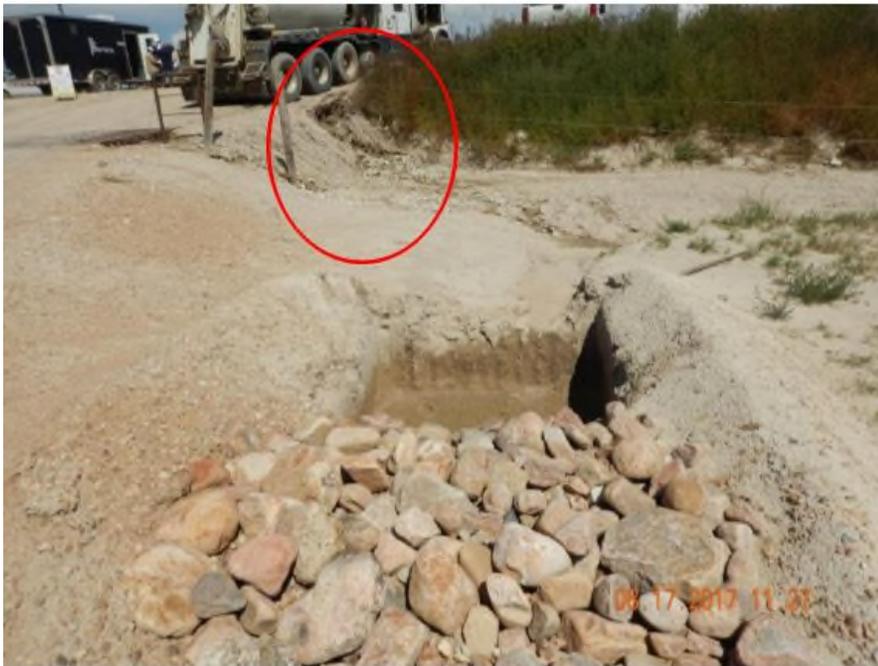
Photo 2. Photo taken from the entrance of the Tombstone pad, along the east side, facing North. Sediment trap has been installed to capture stormwater runoff from the access road. Gully erosion occurring along the east access road entrance (red circle)- refer to Photo 3.

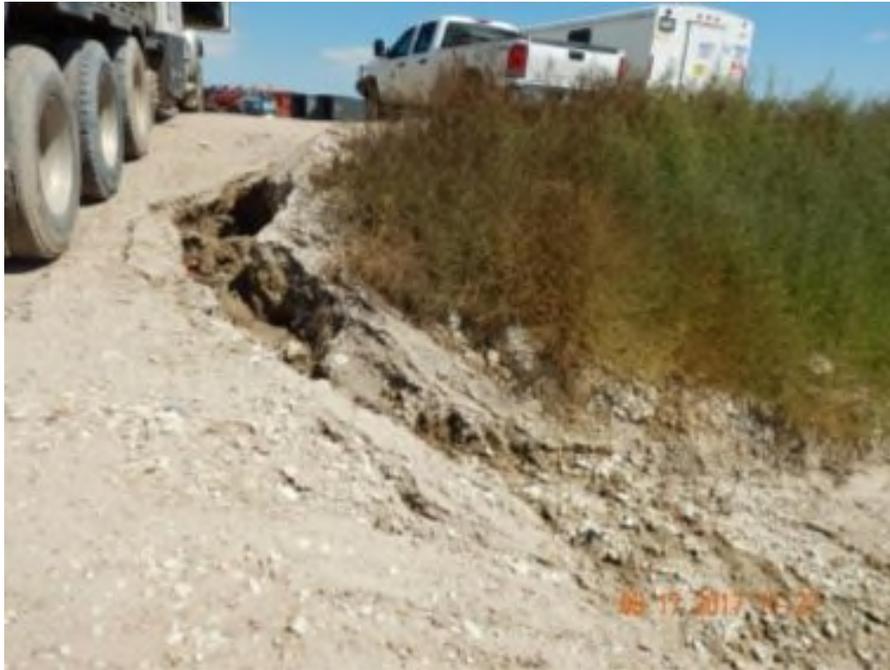
Photo 3. Photo taken from the previously mentioned gully erosion along the entrance of the Tombstone pad, facing Northeast.

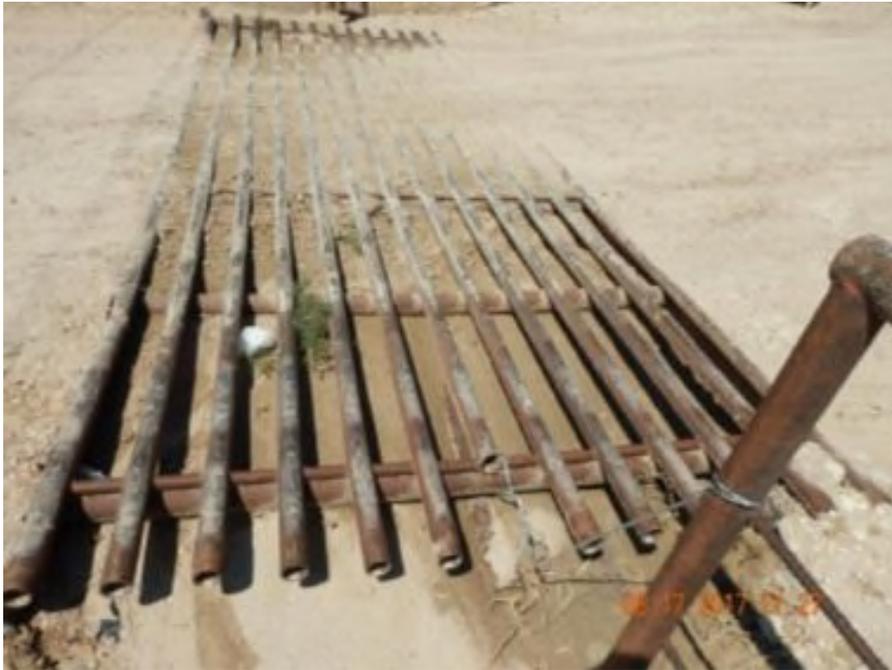
Photo 4. Photo taken from the cattle guard of the Tombstone entrance, facing West. Cattle guard in need of maintenance. COGCC staff observed a crew cleaning out cattle guard while at location.

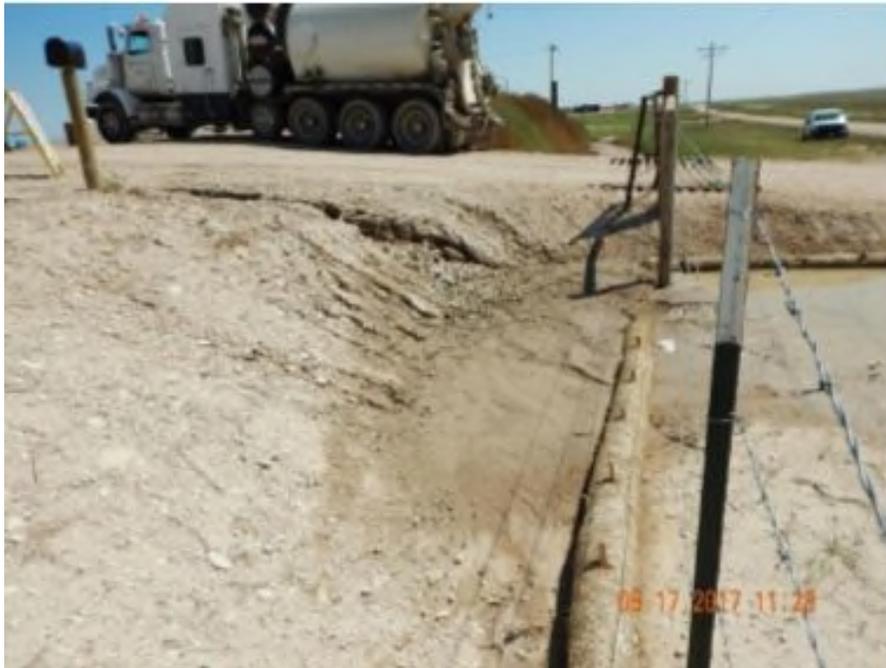
Photo 5. Photo taken from the entrance of the Tombstone pad, along the west side, facing East. Gully erosion occurring along the west entrance access road. Wattle BMPs are not preventing sediment discharge from location.

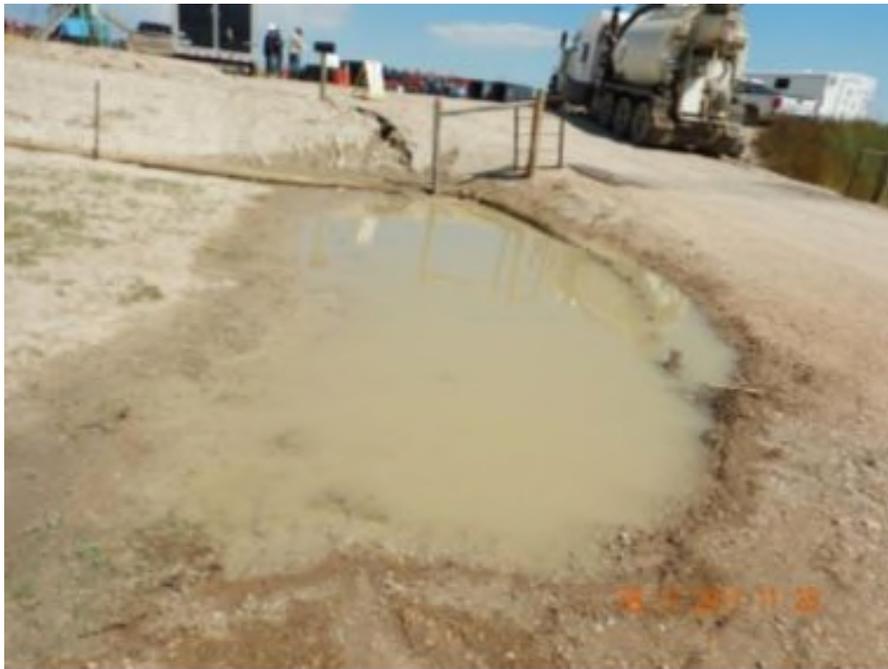
Photo 6. Photo taken from the entrance of the Tombstone pad, along the west side, facing North. Sediment discharge observed, as the wattle BMP does not appear to be sufficient.

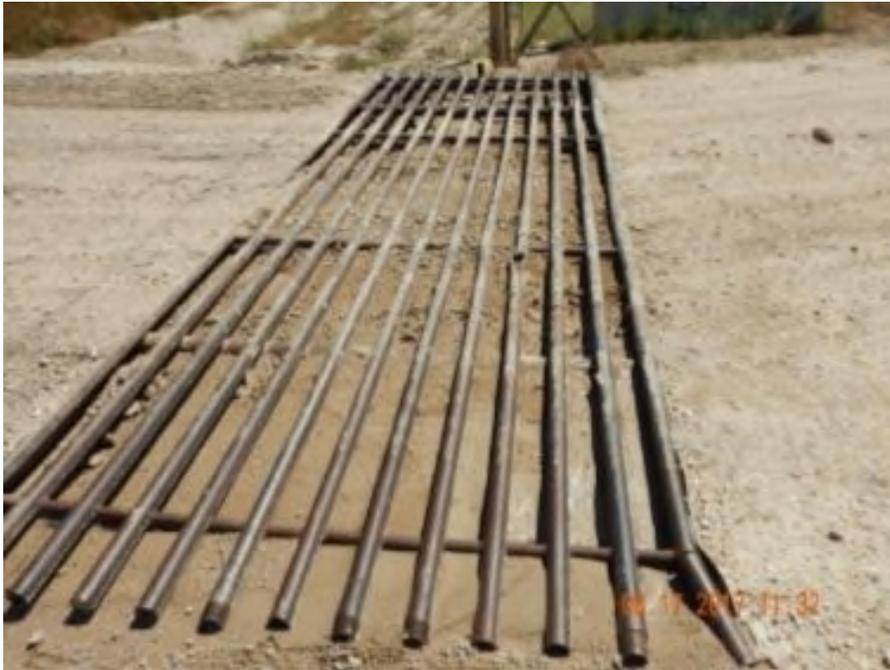
Photo 7. Photo taken from the cattle guard of the Holliday east entrance, facing East. Cattle guard in need of maintenance.

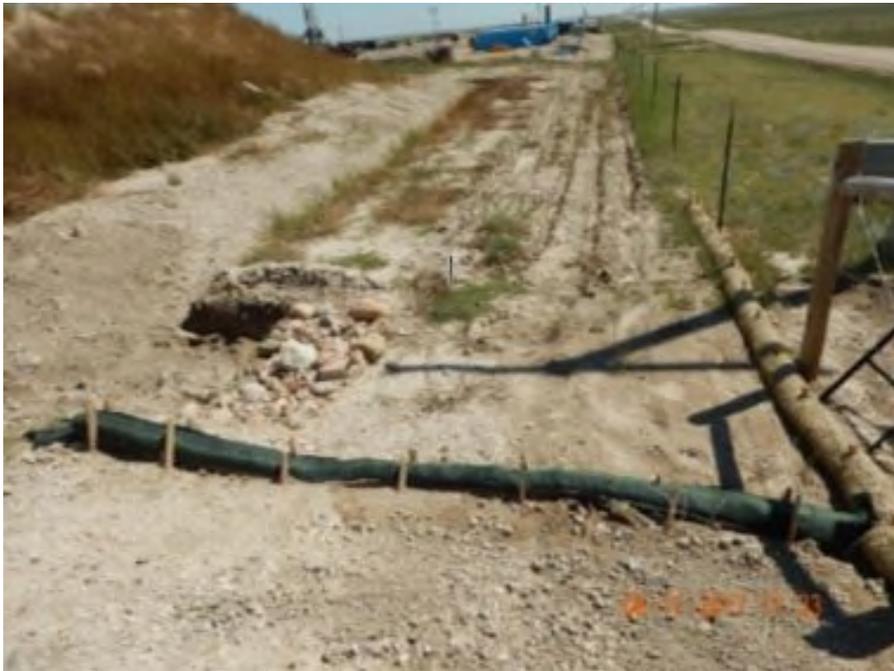
Photo 8. Photo taken from the entrance of the east Holliday entrance, facing East. Sediment trap does not appear to be a sufficient size and does not appear to be constructed with good engineering practices.

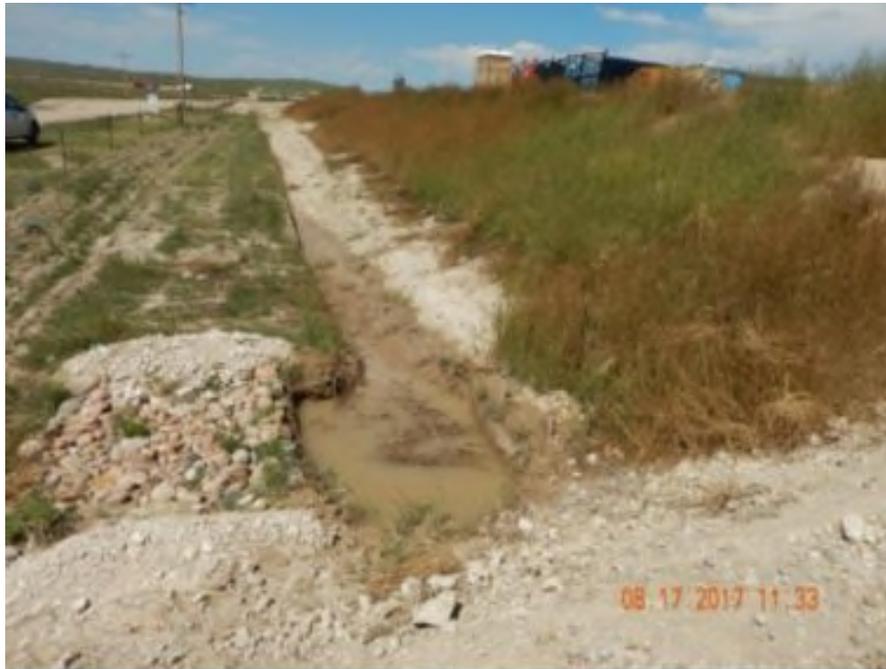
Photo 9. Photo taken from the entrance of the east Holliday entrance, facing West. Sediment trap does not appear to be a sufficient size.

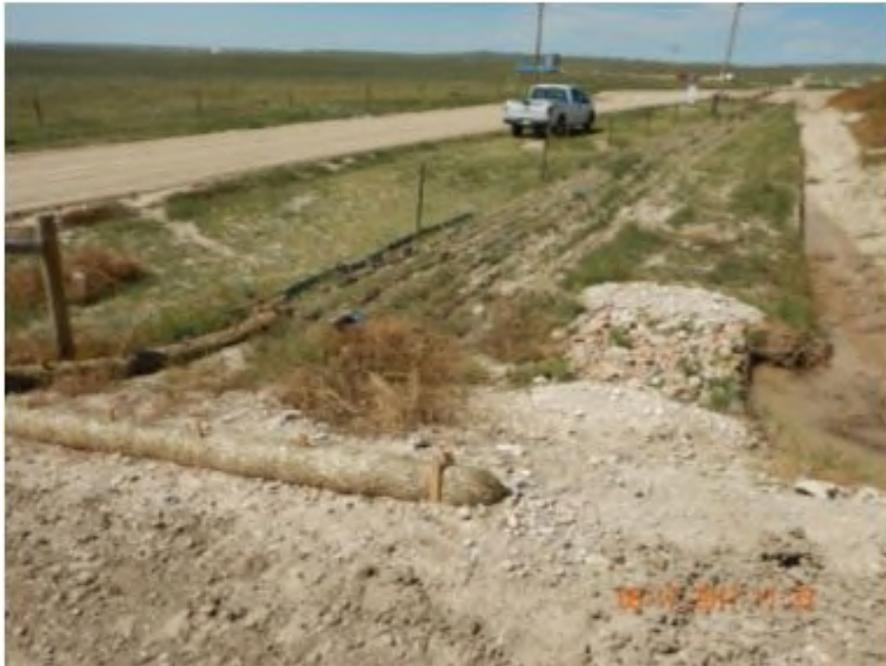
Photo 10. Photo taken from the previous photo, facing Southwest. Other BMPs (surface roughening and wattles) have been installed downgradient of the outlet area but may not be sufficient because the sediment trap appears too small.

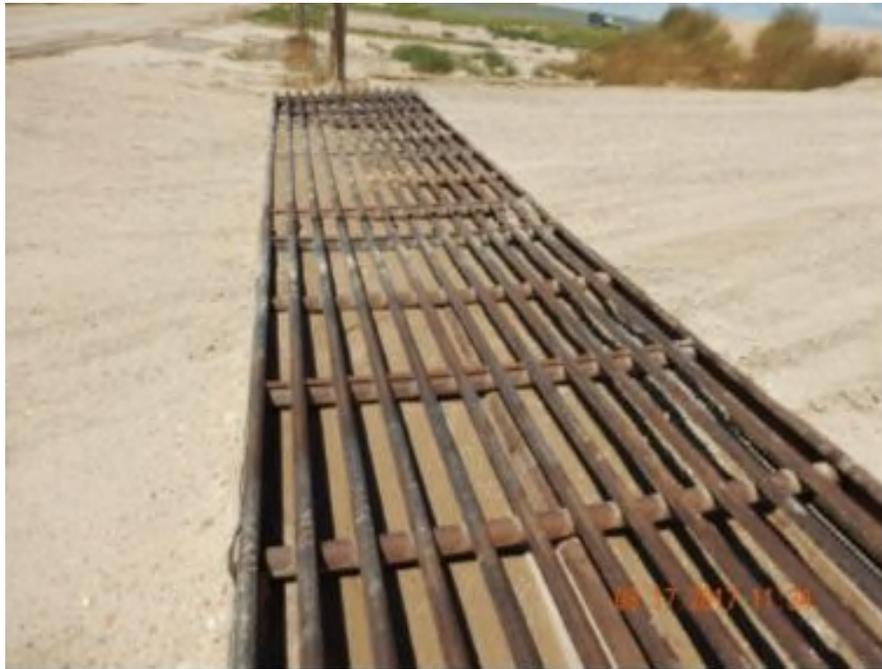
Photo 11. Photo taken from the cattle guard of the Holliday west entrance, facing West. Cattle guard in need of maintenance.

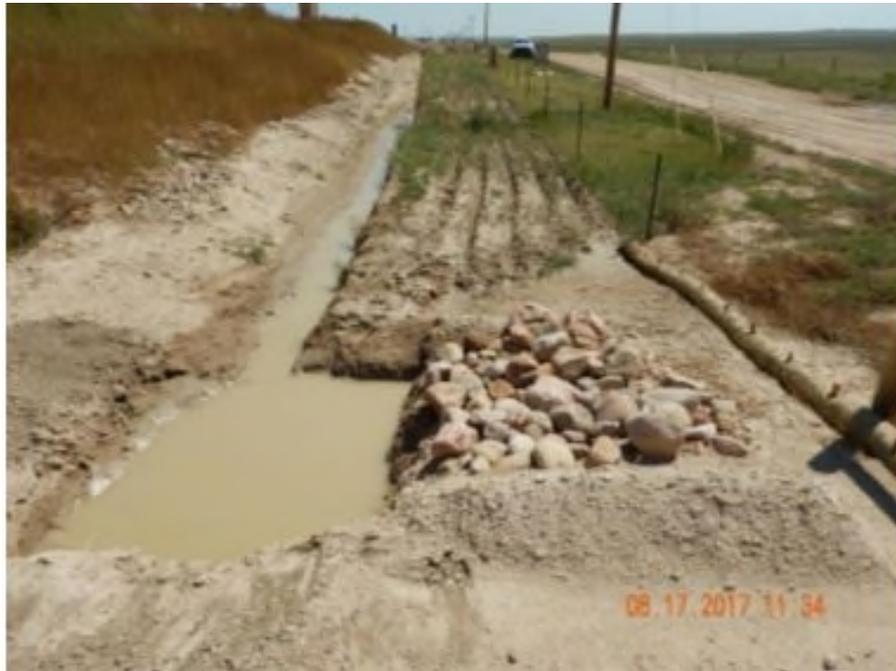
Photo 12. Photo taken from the entrance of the west Holliday entrance, facing East. Sediment trap does not appear to be a sufficient size. Appears flows have discharged over the embankment berms and around the outlet area.

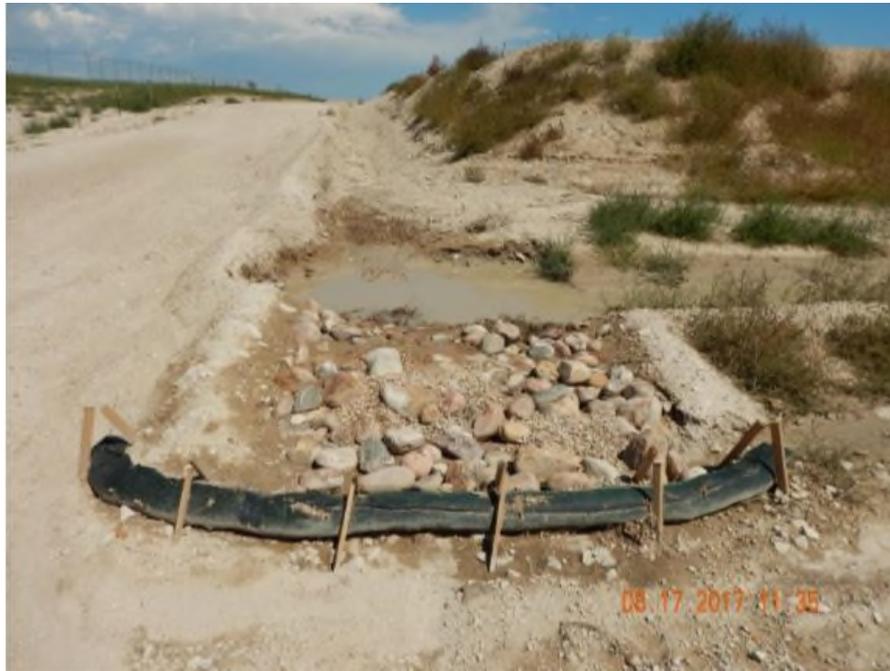
Photo 13. Photo taken from the southwest location of the Holliday pad, facing North. Sediment trap does not appear to be a sufficient size and does not appear to be constructed with good engineering practices. Sediment discharge was observed beyond the outlet area of the sediment trap.
