Photo log for Response to August 17, 2017 Inspection

Document 682402641

Name: LC 11-16 Multi

Location ID: 433936

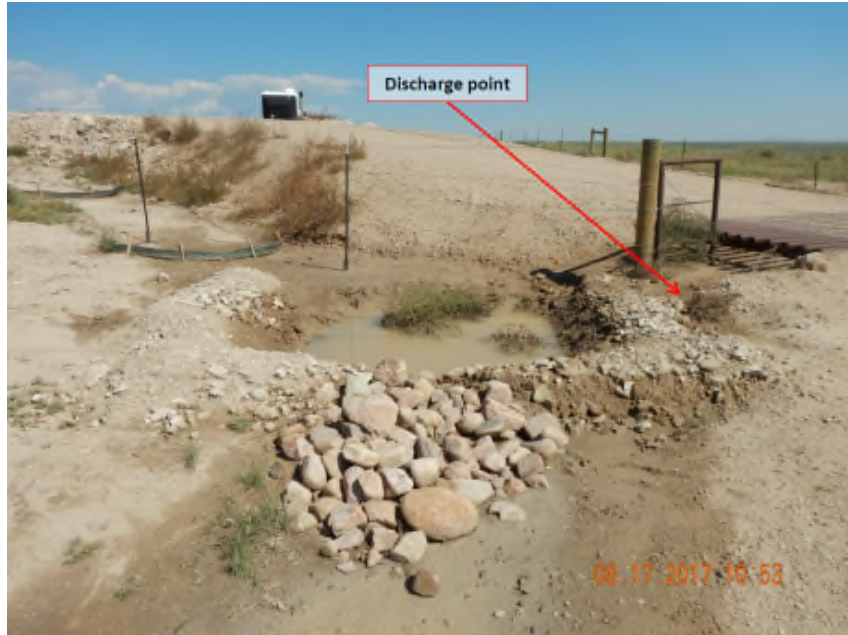
Photo 1. Photo taken from the east well pad, east entrance along the west side, facing Northeast. Operator has installed a second sediment trap near the entrance of the location. A discharge point was observed at the cattle guard as shown above. Embankment material and embankment construction does not appear to be sufficiently compacted, as it appears unconsolidated material could be contributing to sediment loss. Sediment trap outlet area does not appear to be properly constructed to capture outlet flows. Sediment trap size could be enlarged to help capture sediment laden stormwater runoff.

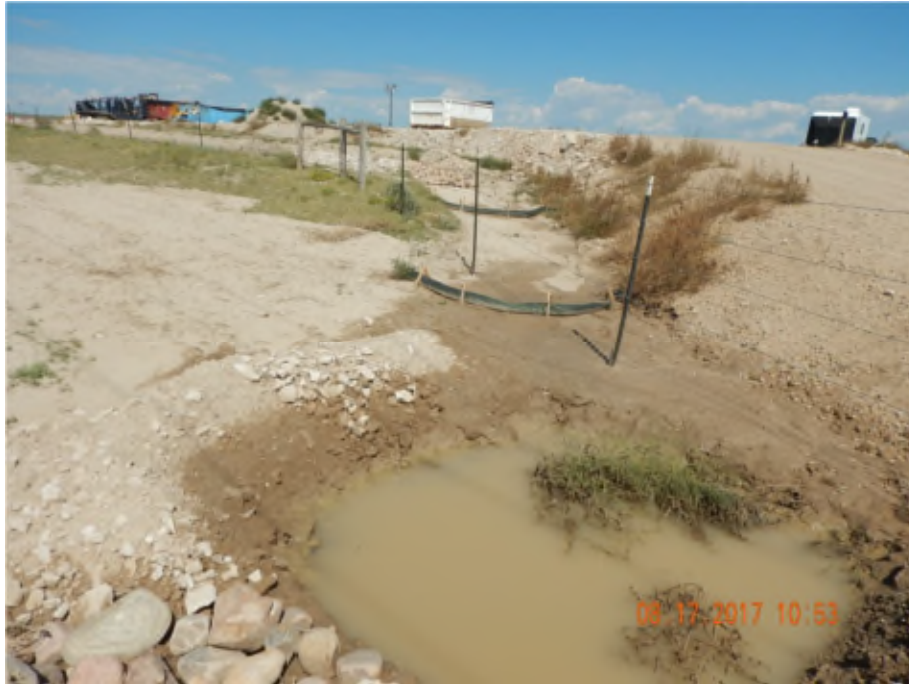
Photo 2. Photo taken from the previous sediment trap, facing North. Operator has installed a shallow ditch from the outlet area of the upgradient sediment trap to the inlet area of the downgradient sediment trap. Operator has installed filtrex wattles along the shallow ditch. Appears stormwater flows are going around the embankment berm of the downgradient sediment trap.

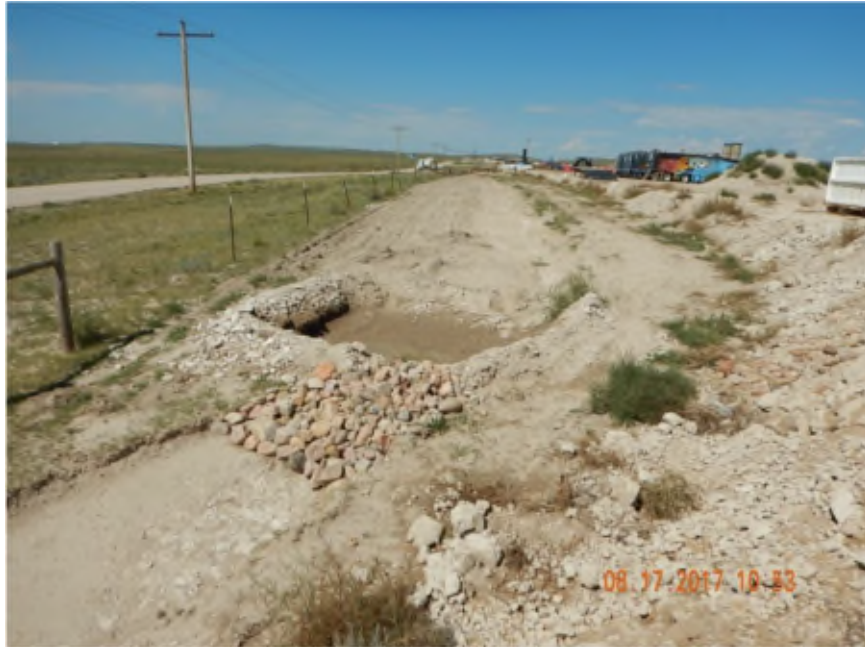
Photo 3. Photo taken from the previously mentioned upgradient sediment trap, facing West. Appears the Operator has enlarged the sediment trap size with a stabilized outlet area. Embankment material and embankment construction does not appear to be sufficient compacted, as it appears unconsolidated material could be contributing to sediment loss. Appears the Operator has re-installed surface roughening along the southern perimeter of the location. Refer to Photo 4 for a picture taken of the sediment trap from the July 11, 2017 inspection.

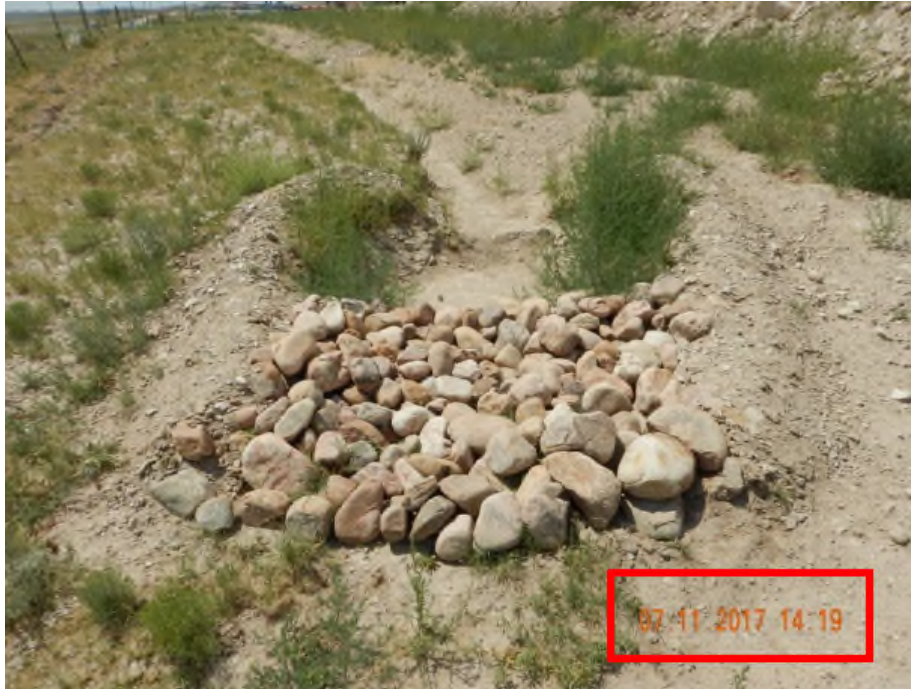
Photo 4. Photo taken of the sediment trap in Photo 3 from the July 11, 2017 inspection.

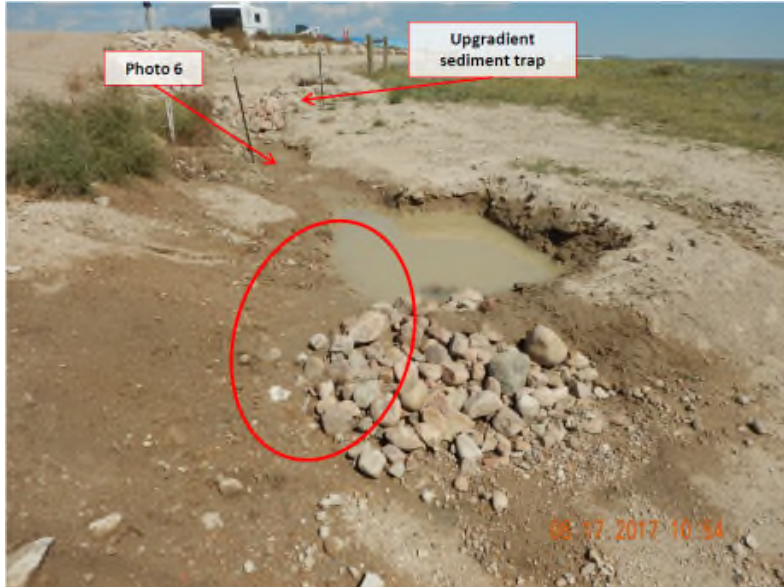
Photo 5. Photo taken from the east well pad, east entrance along the east side, facing Northwest. Operator has installed a second sediment trap near the entrance of the location. Embankment material and embankment construction does not appear to be sufficiently compacted, as it appears unconsolidated material could be contributing to sediment loss. Sediment trap outlet area does not appear to be properly constructed to capture outlet flows. Appears sediment laden stormwater is discharging from the western outlet area (red circle). Sediment trap size could be enlarged to help capture sediment laden stormwater runoff.

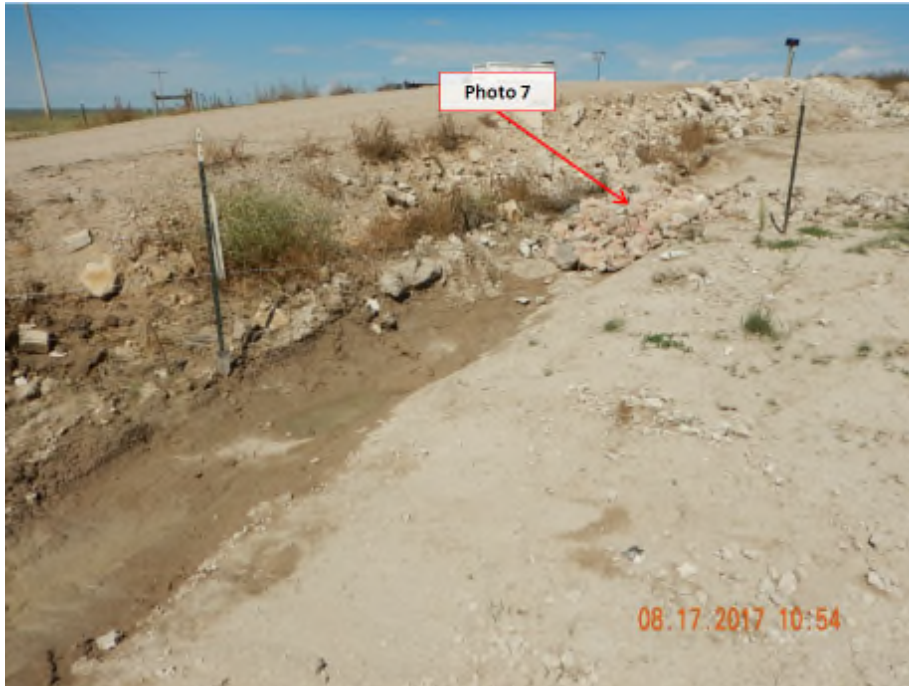
Photo 6. Photo taken from the ditch area between the two sediment traps, facing West. Operator has installed a shallow ditch from the outlet area of the upgradient sediment trap to the inlet area of the downgradient sediment trap. Ditch size may not be a sufficient depth to contain both outlet flows from the upgradient sediment trap and stormwater runoff from the access road.

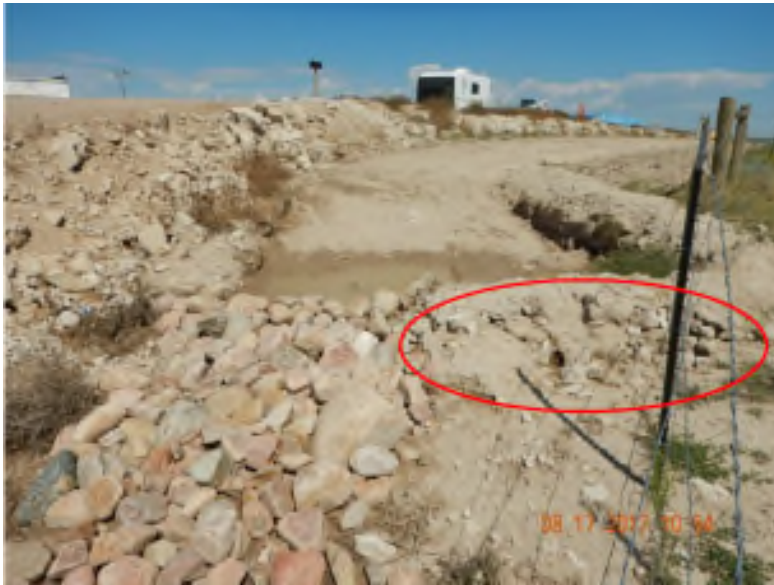
Photo 7. Photo taken from the previously mentioned upgradient sediment trap, facing Northwest. Appears the Operator has enlarged the sediment trap size with a stabilized outlet area. Embankment material and embankment construction does not appear to be sufficient compacted, as it appears unconsolidated material is contributing to sediment loss (red circle). Refer to Photo 8 for a picture taken of the sediment trap from the July 11, 2017 inspection.

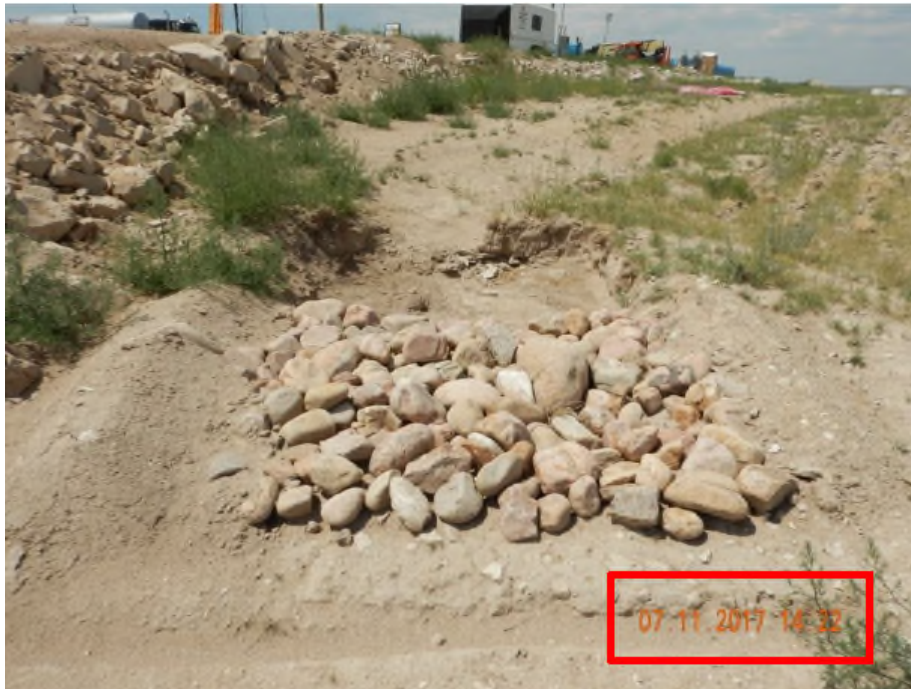
Photo 8. Photo taken of the sediment trap in Photo 7 from the July 11, 2017 inspection.

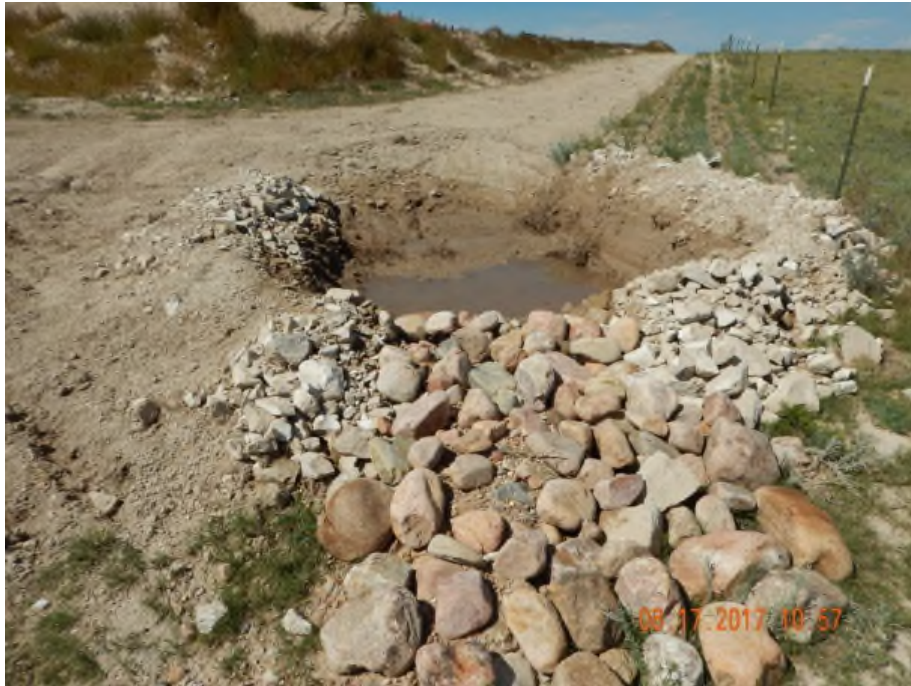
Photo 9. Photo taken from the northeast east well pad, facing West. Appears the Operator has enlarged the sediment trap size with a stabilized outlet area. Embankment material and embankment construction does not appear to be sufficient compacted, as it appears unconsolidated material could be contributing to sediment loss. Refer to Photo 10 for a picture taken of the sediment trap from the July 11, 2017 inspection.

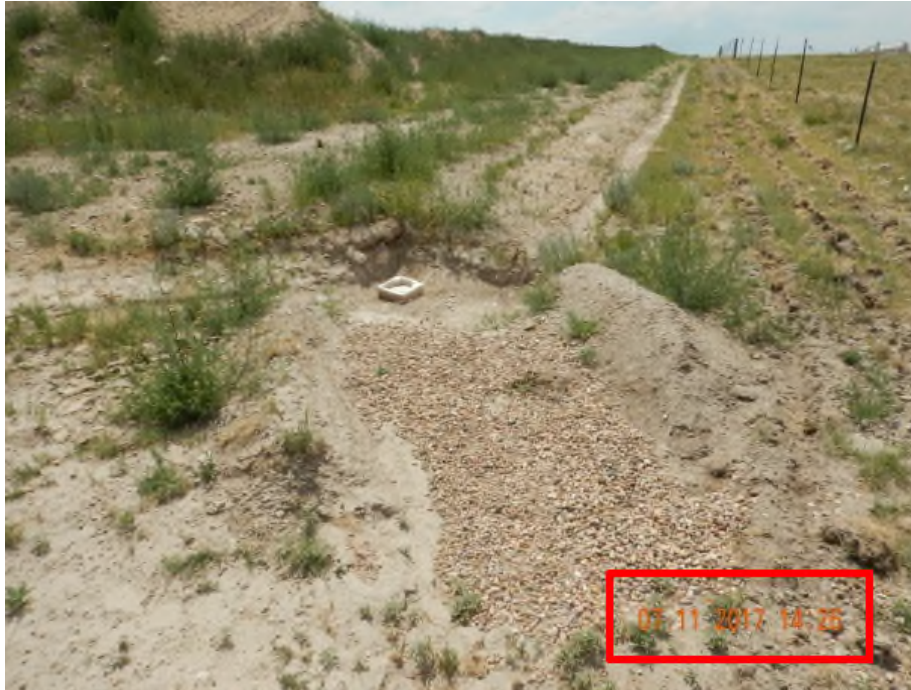
Photo 10. Photo taken of the sediment trap in Photo 9 from the July 11, 2017 inspection.

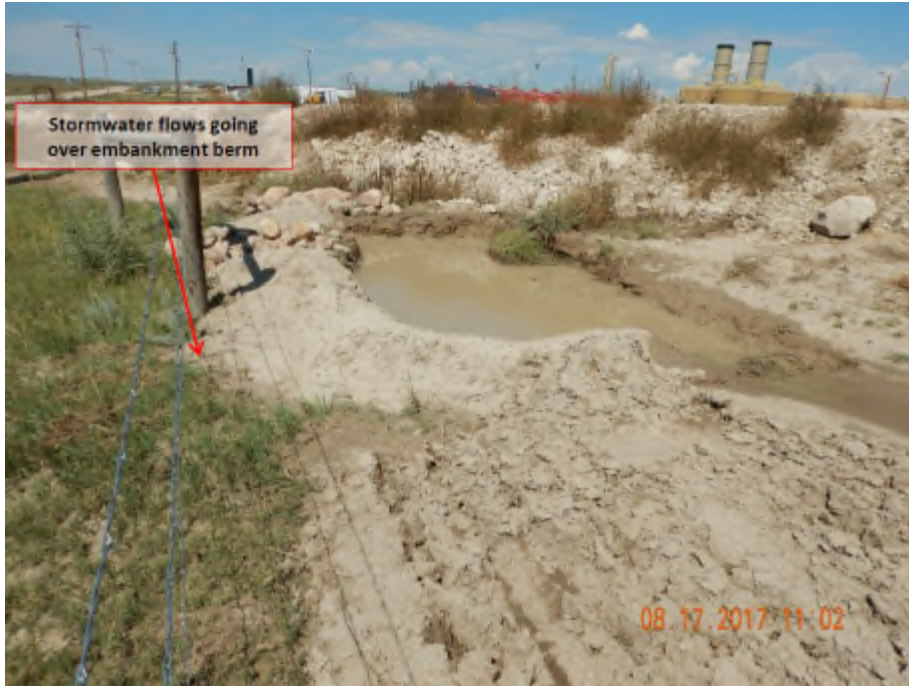
Photo 11. Photo taken from the southwest east well pad, facing West. Appears the Operator has enlarged the sediment trap size with two stabilized outlet areas. However, the sediment trap size could be enlarged because it appears flows have discharged over the embankment berms. Embankment material and embankment construction does not appear to be sufficiently compacted, as it appears unconsolidated material is contributing to sediment loss.

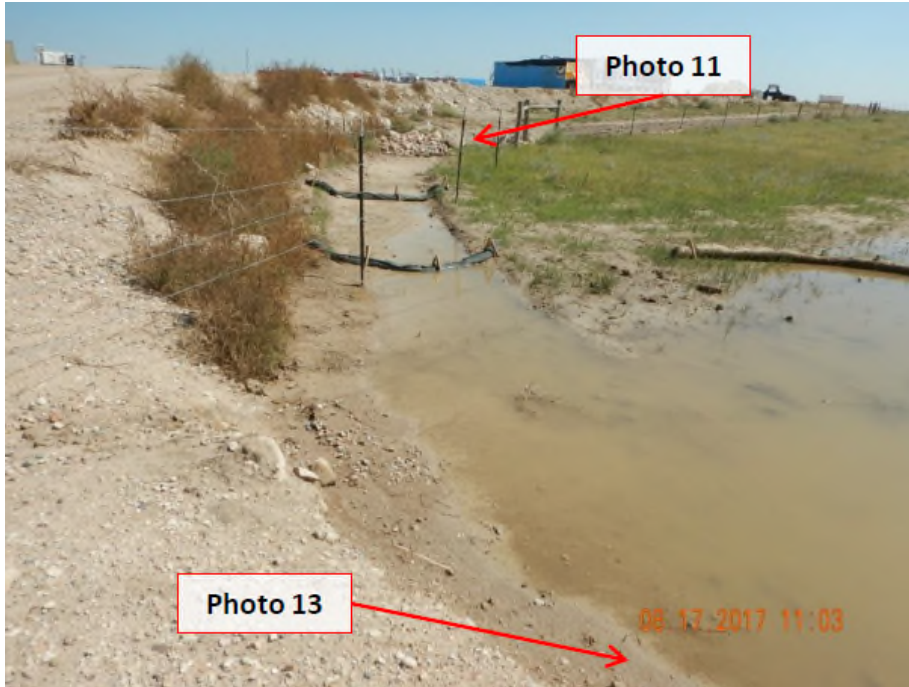
Photo 12. Photo taken from the east well pad, west entrance along the east side, facing Northeast. Operator has installed a shallow ditch from the outlet area of the sediment trap to a shallow depression area- refer to Photo 13. Because the sediment trap size is too small sediment would not have enough time to settle out before discharging out of the outlet. Wattles are intended to pool sheet flow (not filter sediment) and it appears the volume of stormwater sheet flow, likely sediment laden flow, is overtopping the wattles.

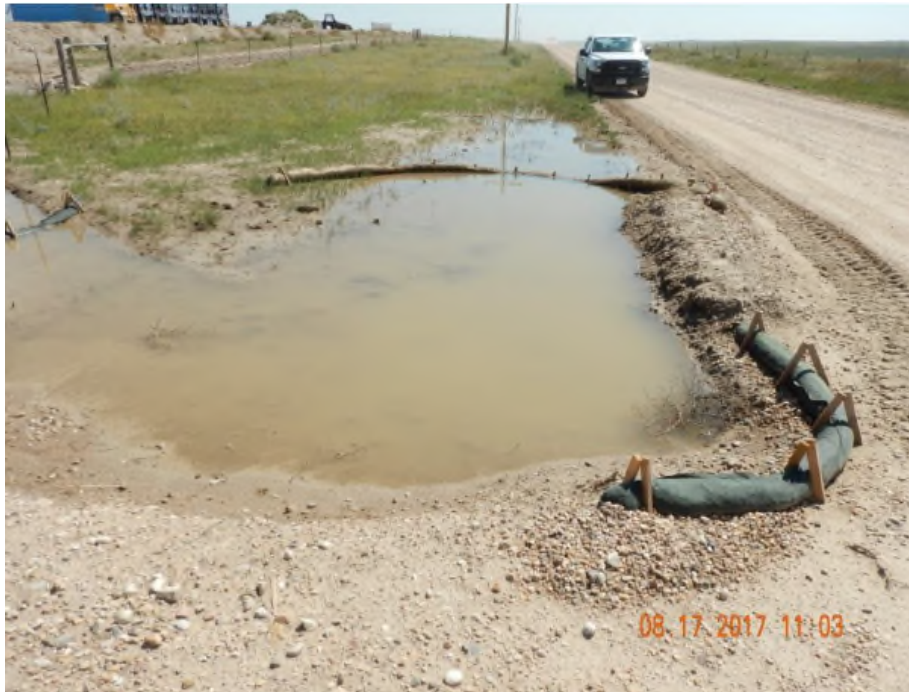
Photo 13. Photo taken from the previously mentioned shallow depression area, facing East. Does not appear the depression area with the wattles are pooling stormwater runoff. Appears the volume of stormwater sheet flow, likely sediment laden flow, is overtopping the wattle as shown in this photo.

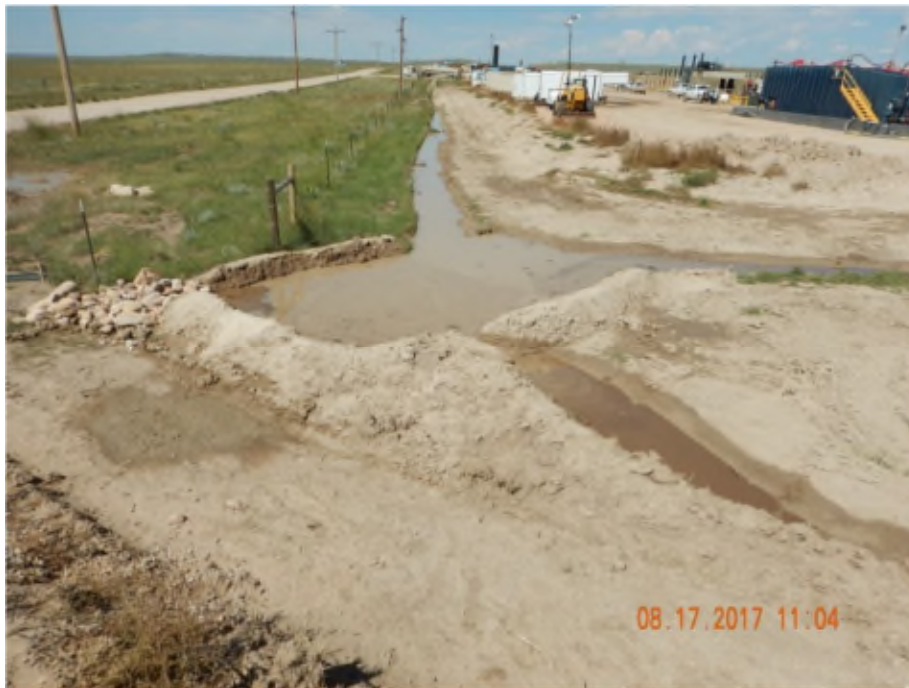
Photo 14. Photo taken from the southeast production facility pad, facing West. Appears the Operator has enlarged the sediment trap size. However, the sediment trap size could be enlarged because it appears flows have discharged over the embankment berms. Embankment material and embankment construction does not appear to be sufficiently compacted, as it appears unconsolidated material is contributing to sediment loss. Sediment trap outlet area does not appear to be properly constructed to capture outlet flows.

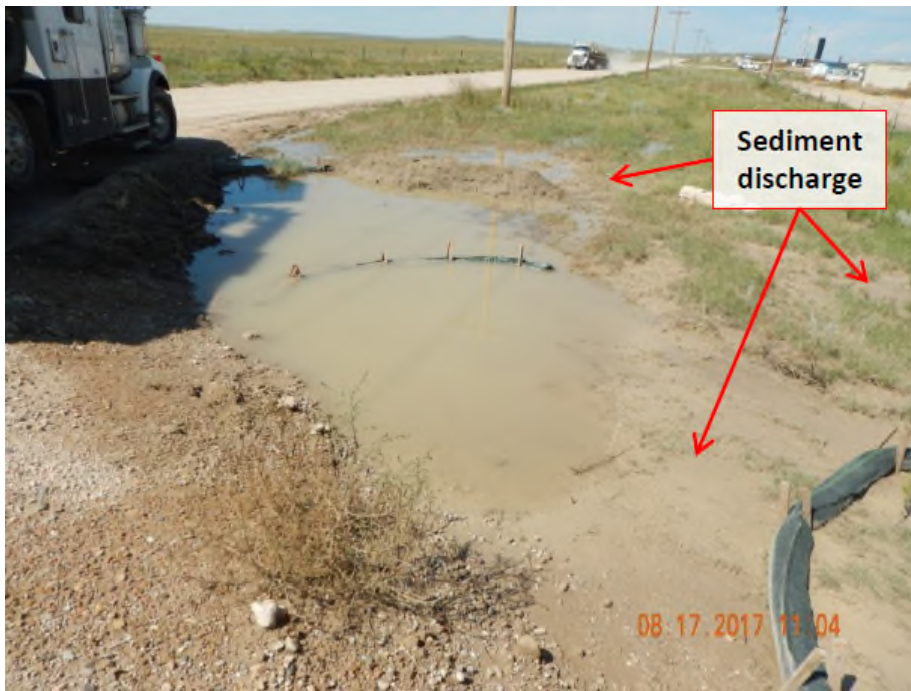
Photo 15. Photo taken from the previously shown sediment trap, facing Southwest. Does not appear the wattles are pooling stormwater runoff. Appears the volume of stormwater sheet flow is overtopping the wattle as shown in this photo. Sediment deposition is observed between the wattles and outside of the wattles as shown in this photo.

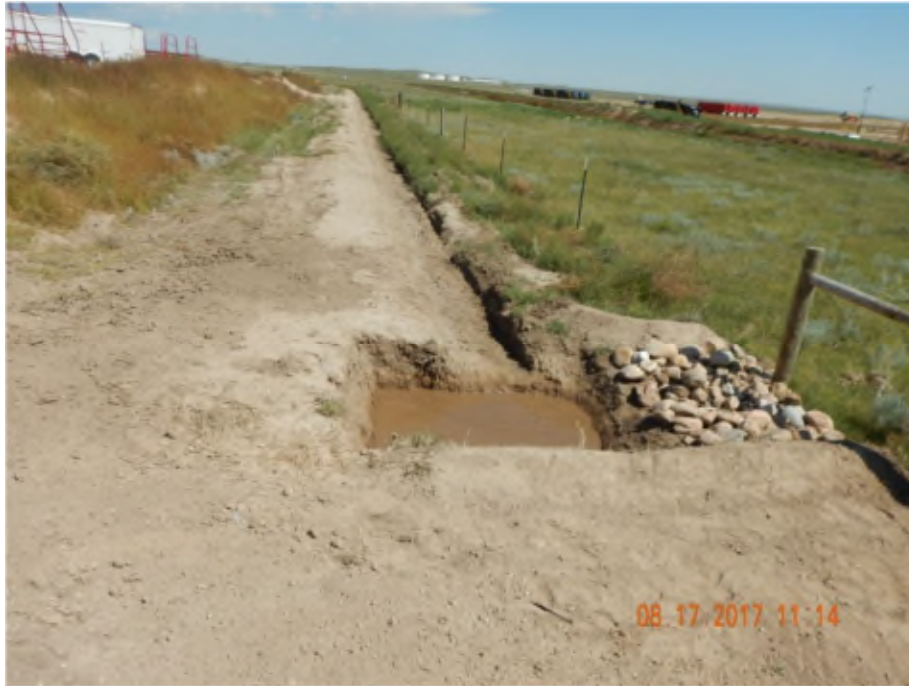
Photo 16. Photo taken from the west well pad, east entrance along the east side, facing North. Does not appear the sediment trap size has been enlarged. It appears the Operator has moved the position of the sediment trap outlet and constructed an embankment berm. However, embankment does not appear to be sufficiently compacted, as it appears unconsolidated material could be contributing to sediment loss.

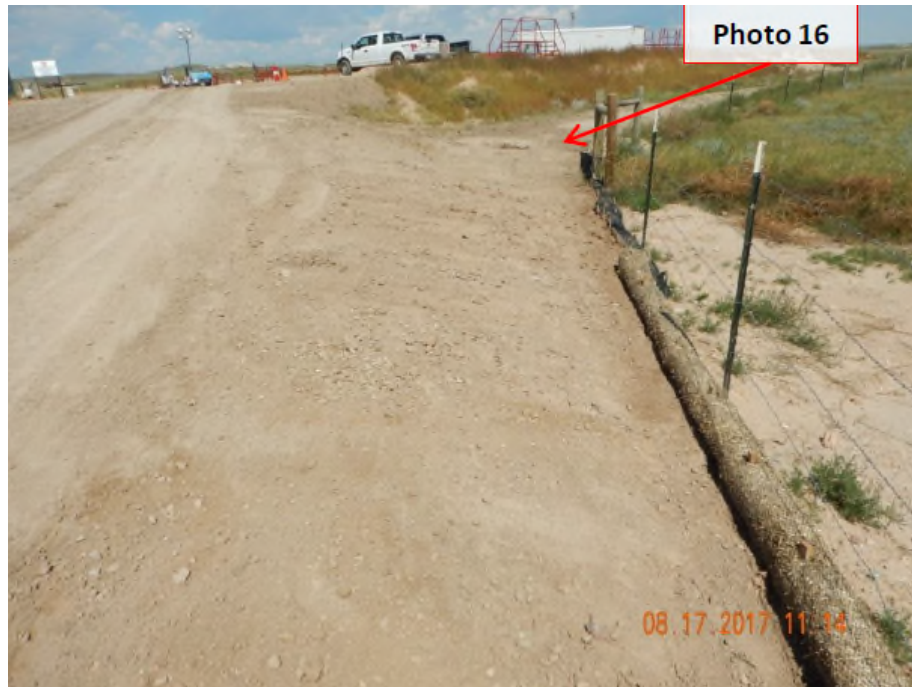
Photo 17. Photo taken from the west well pad, east entrance along the east side, facing Northwest. Appears the Operator has made repairs and re-installed wattles along the entrance.

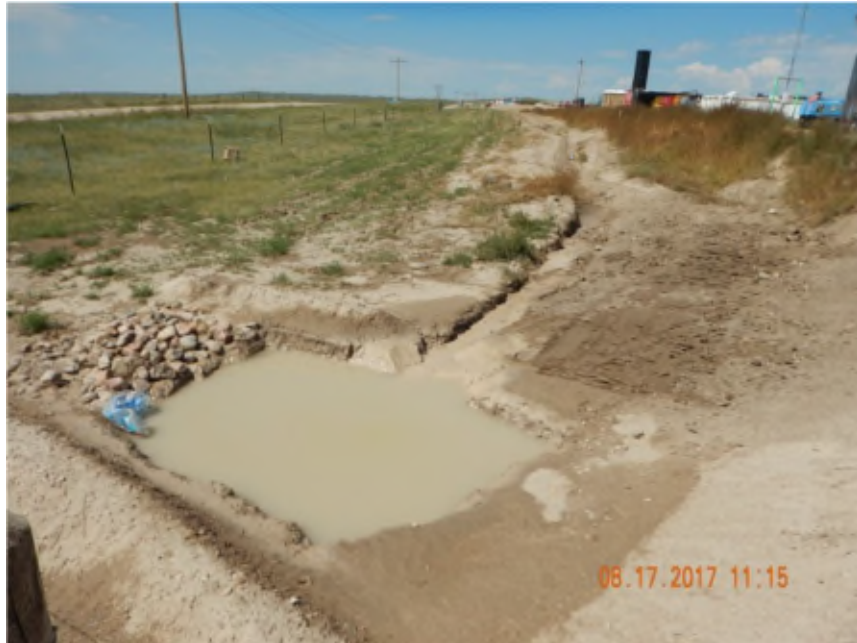
Photo 18. Photo taken from the west well pad, east entrance along the west side, facing West. Appears the Operator has installed a sediment trap. However, the sediment trap size could be enlarged because it appears flows have discharged over the embankment berms- see Photo 20. Embankment material and embankment construction does not appear to be sufficiently compacted, as it appears unconsolidated material is contributing to sediment loss. Refer to Photo 18 for a picture taken of this area from the July 11, 2017 inspection.

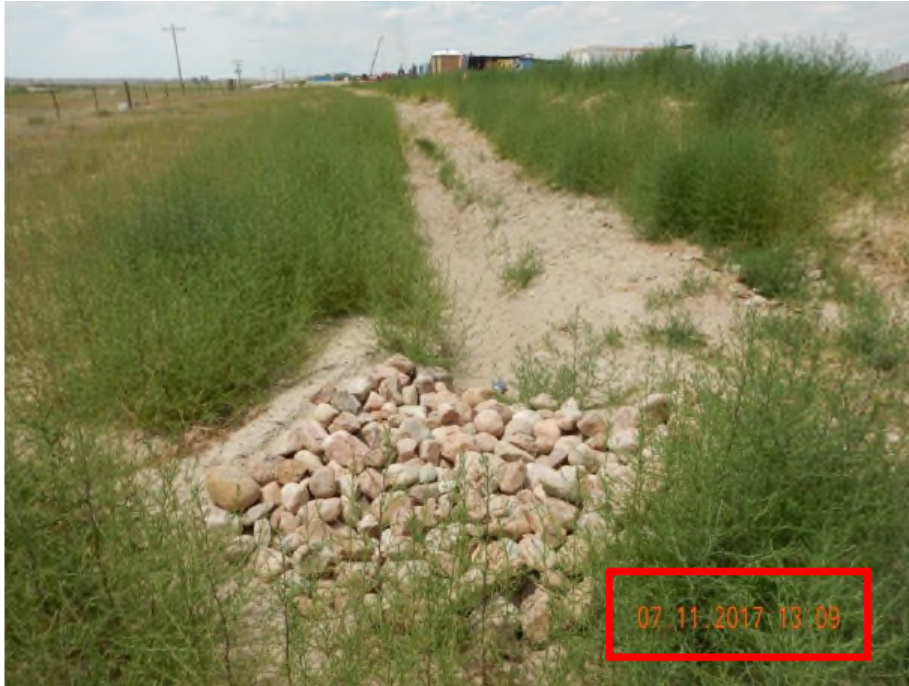
Photo 19. Photo taken from the area in Photo 18 from the July 11, 2017 inspection.

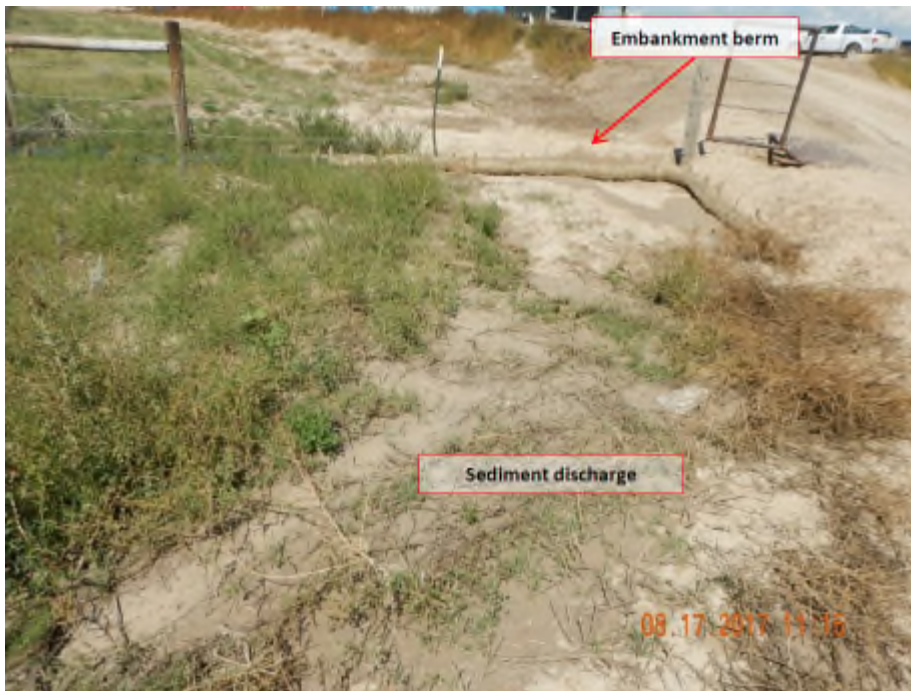
Photo 20. Photo taken east of the previously shown sediment trap in Photo 17. Photo illustrates sediment loss from stormwater overflowing from the sediment trap. Does not appear the wattles installed along the outer perimeter of the sediment trap are preventing sediment discharge. Wattles are intended to pool sheet flow (not filter sediment).
