Inspection Photos

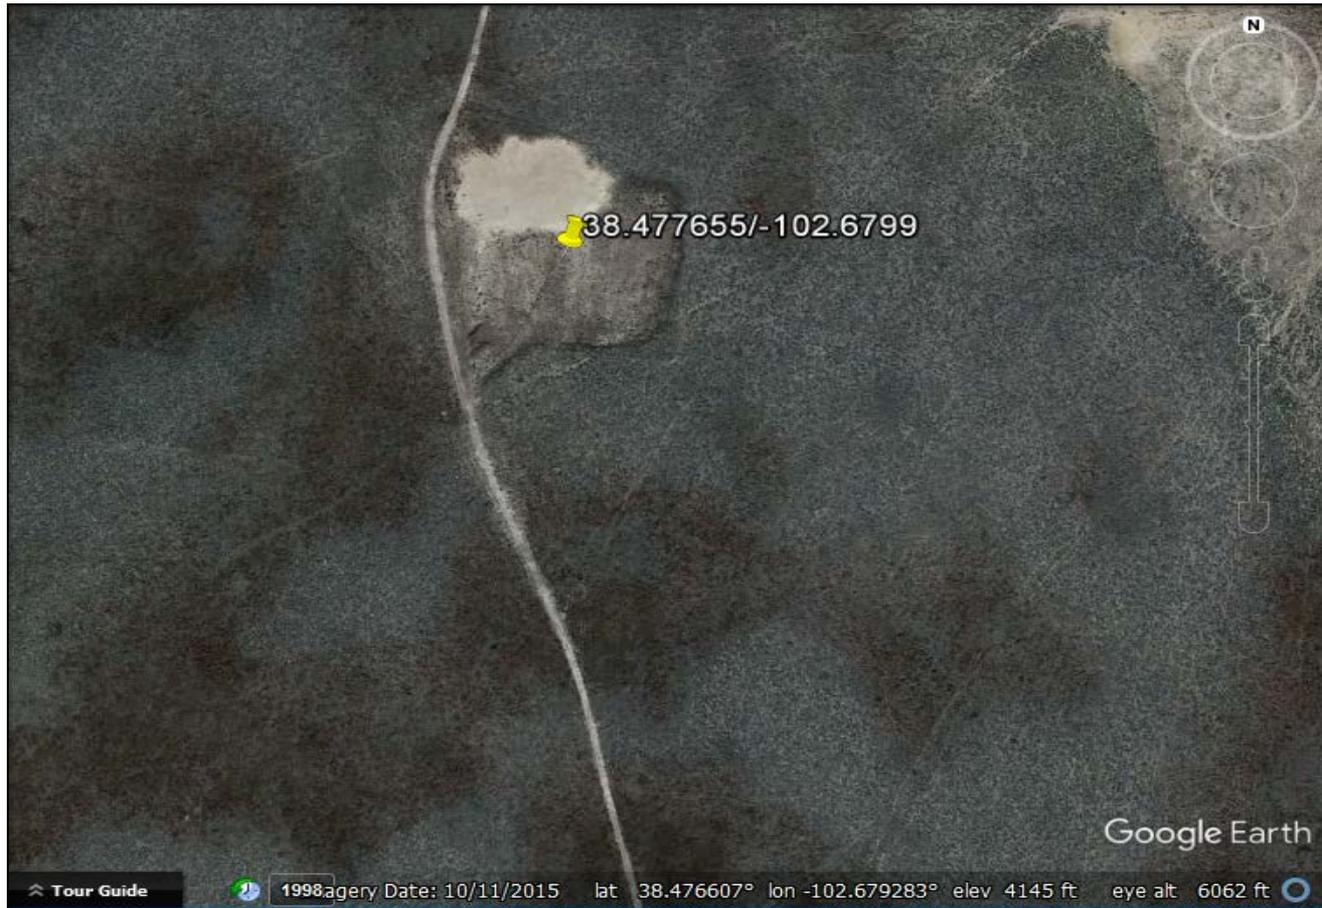
Photo 1. 2015 aerial image shows access road and location disturbance.

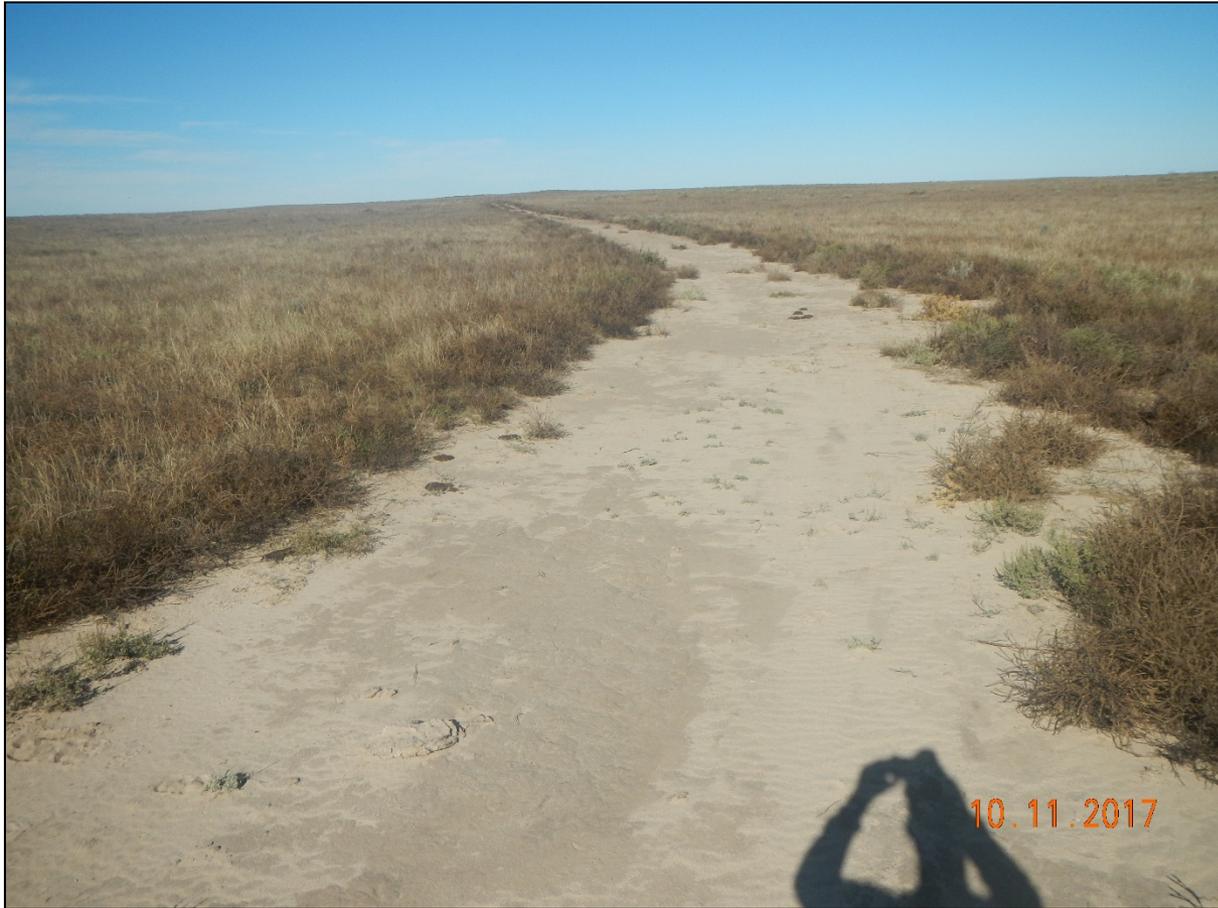
Photo 2. Facing northeast toward the access road which has not been reclaimed.

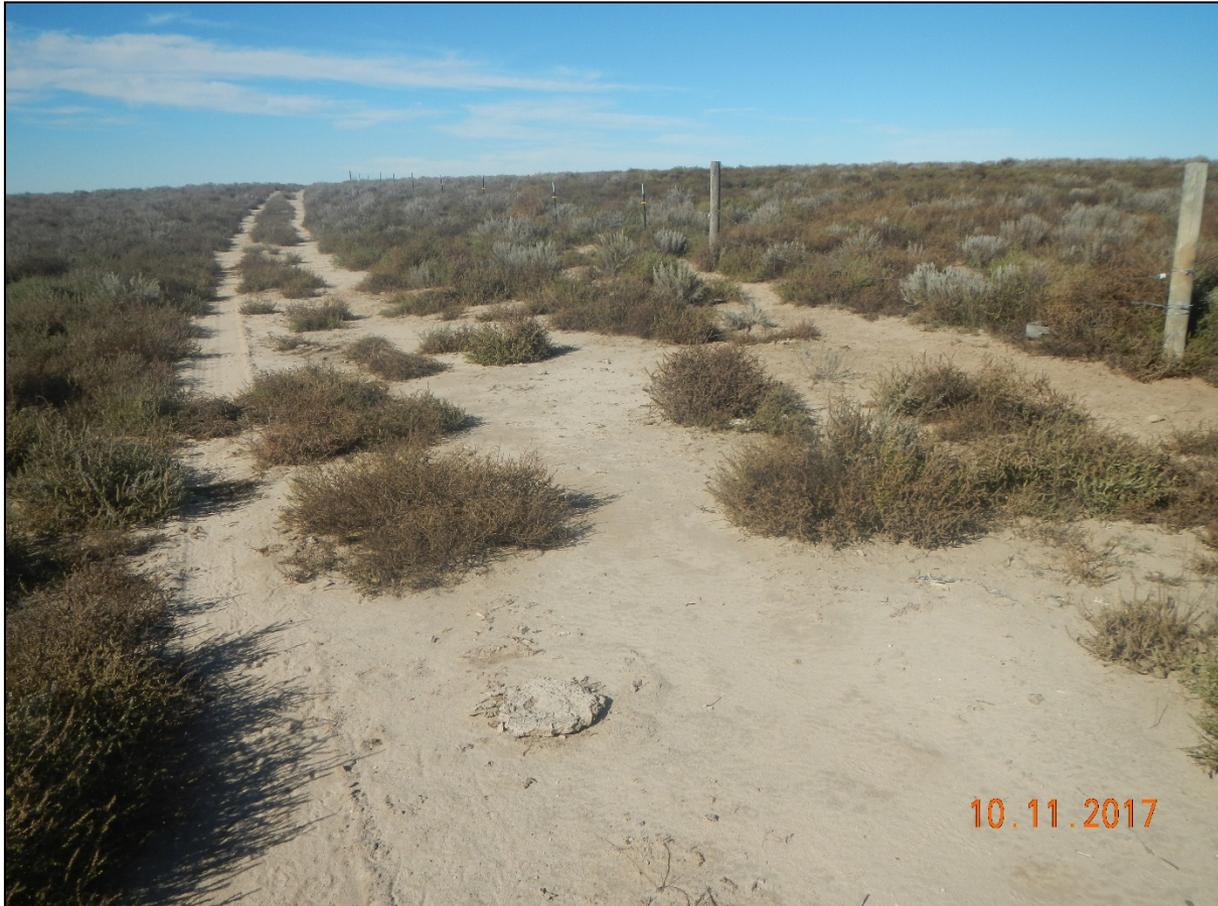
Photo 3. Facing northeast toward the location. The location has a perimeter fence that is not maintained.

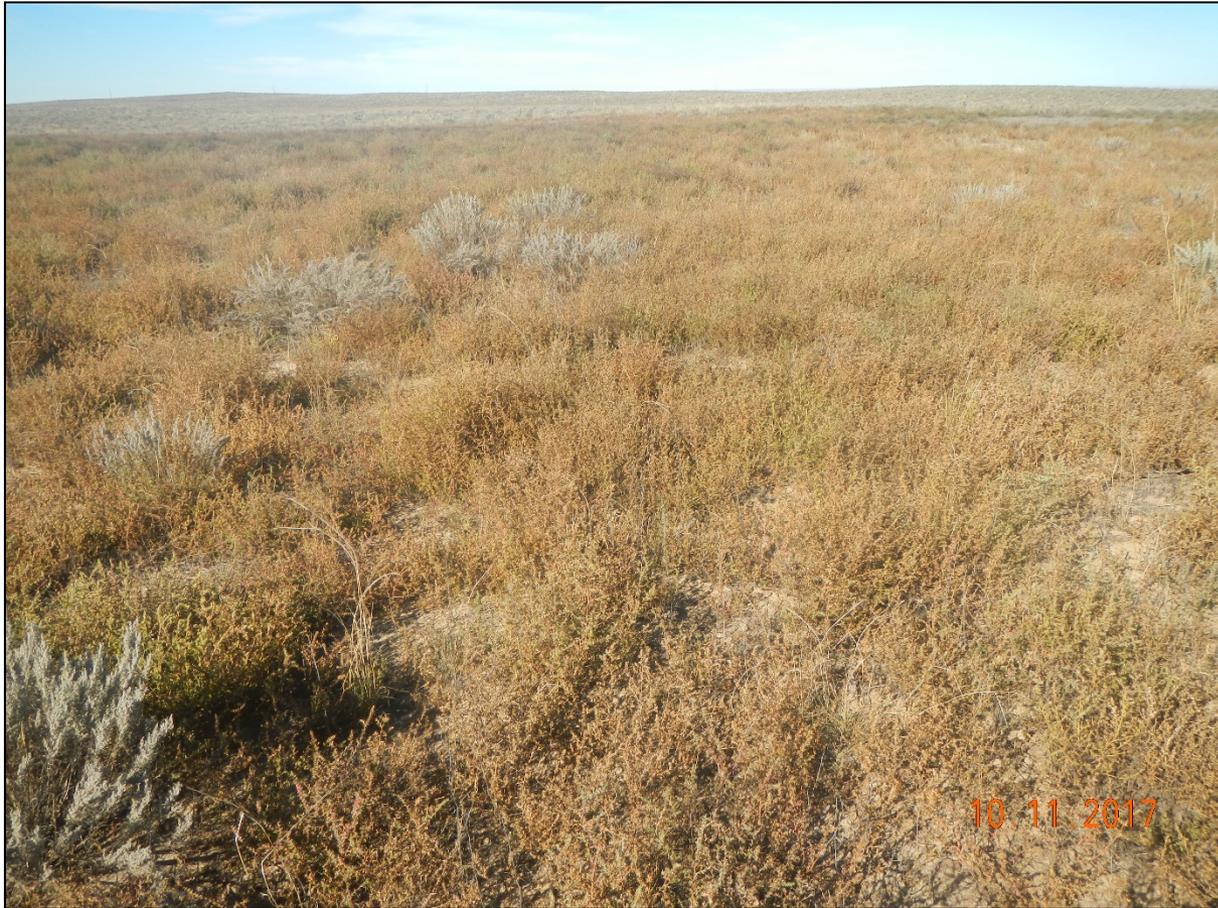
Photo 4. Center of the location facing north. There are undesirable weeds throughout the location (Russian thistle).

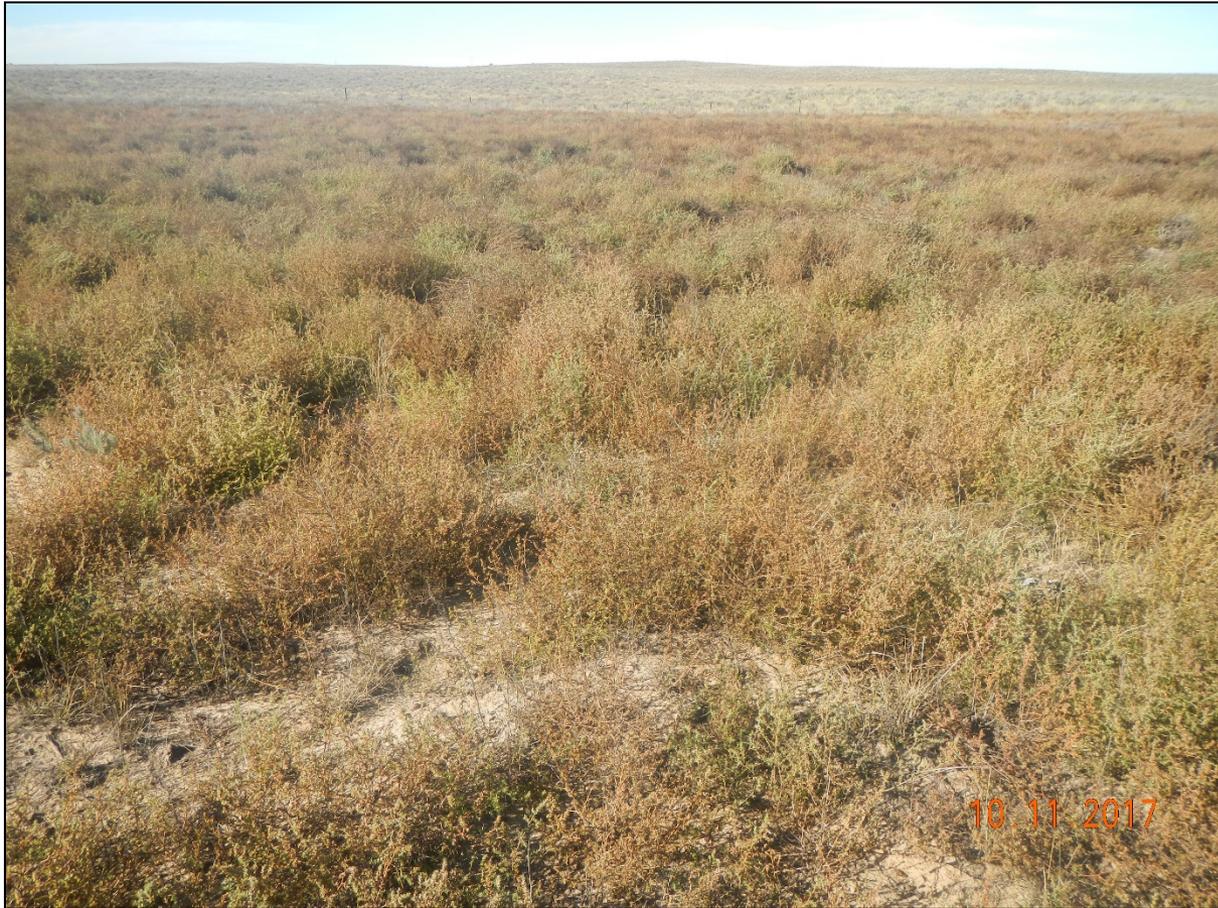
Photo 5. Center of the location facing west. There are undesirable weeds throughout the location (Russian thistle).

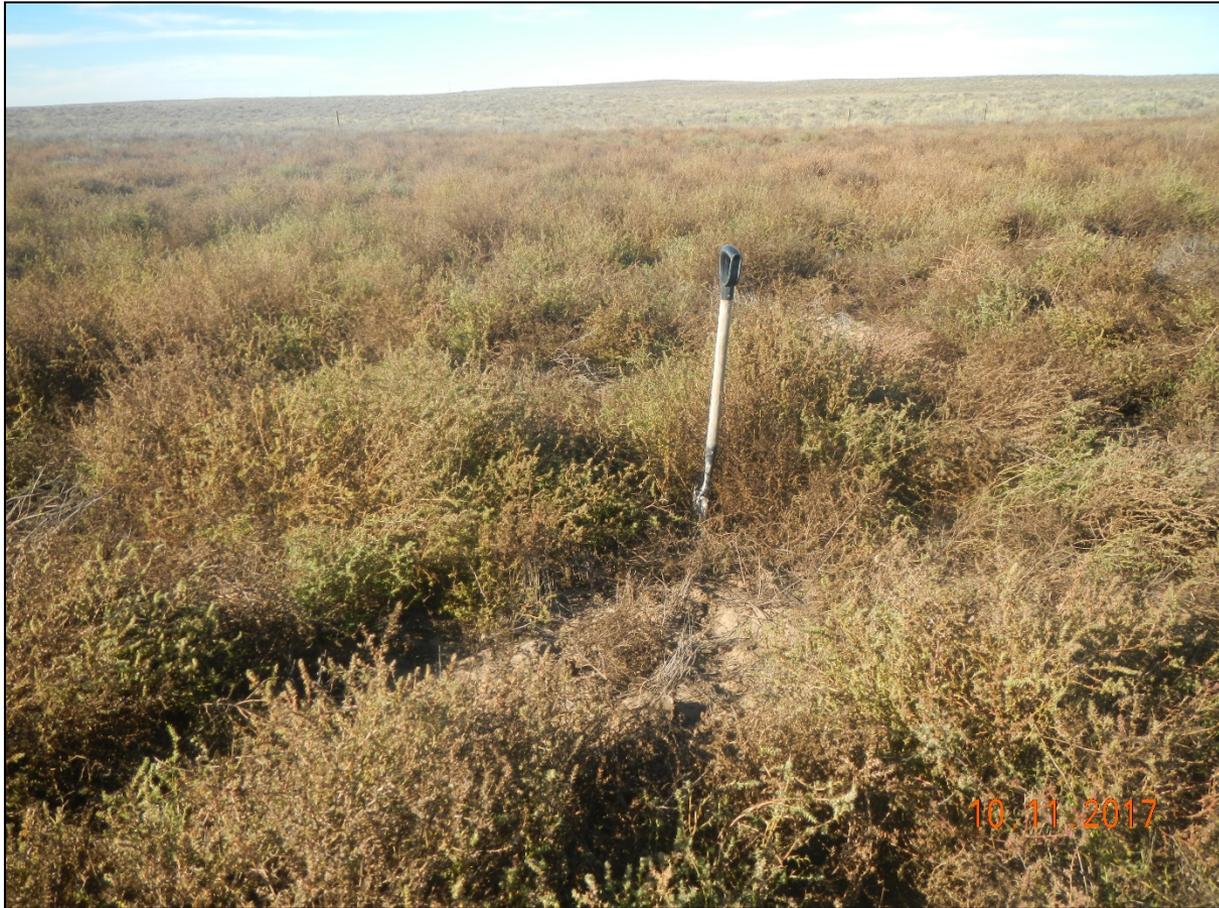
Photo 8. The 3.5 ft. shovel indicates height of weed debris throughout the location.

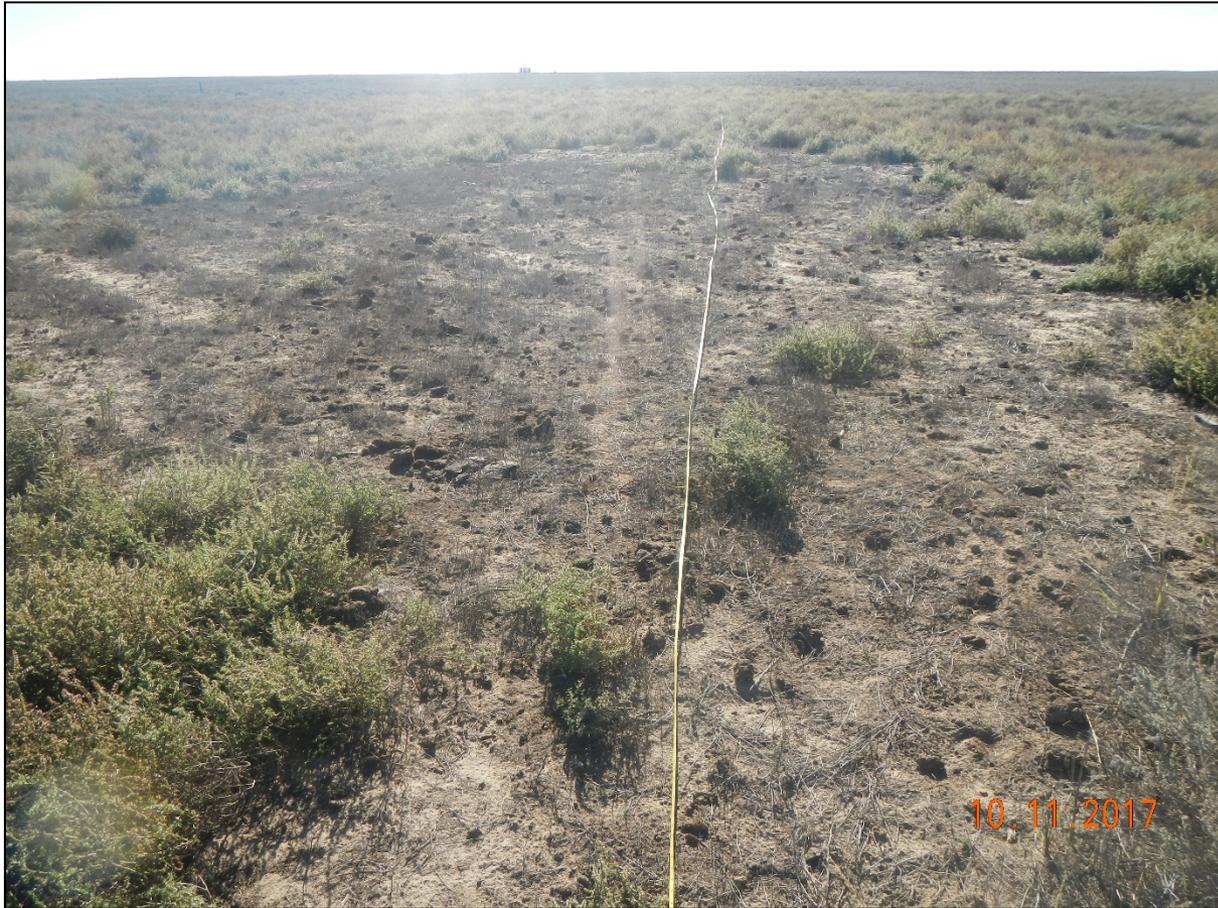
Photo 9. East side of the location facing west. A 100 ft. tape measure shows the extent of this portion of the location without any desirable vegetation establishment.

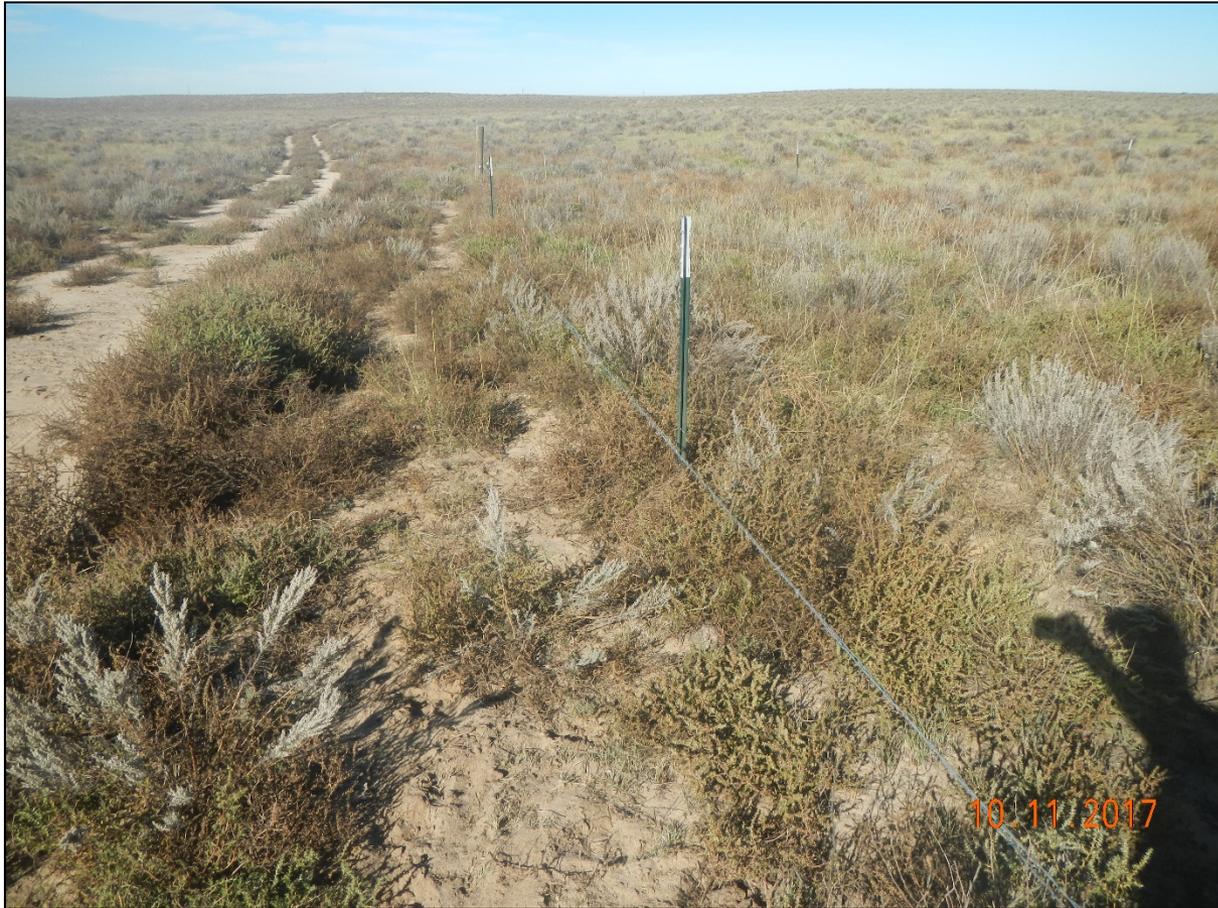
Photo 10. The fence around the location is not maintained. The barbed wire is only about 1 ft. off the ground and livestock can access the site.
