Inspection Photos

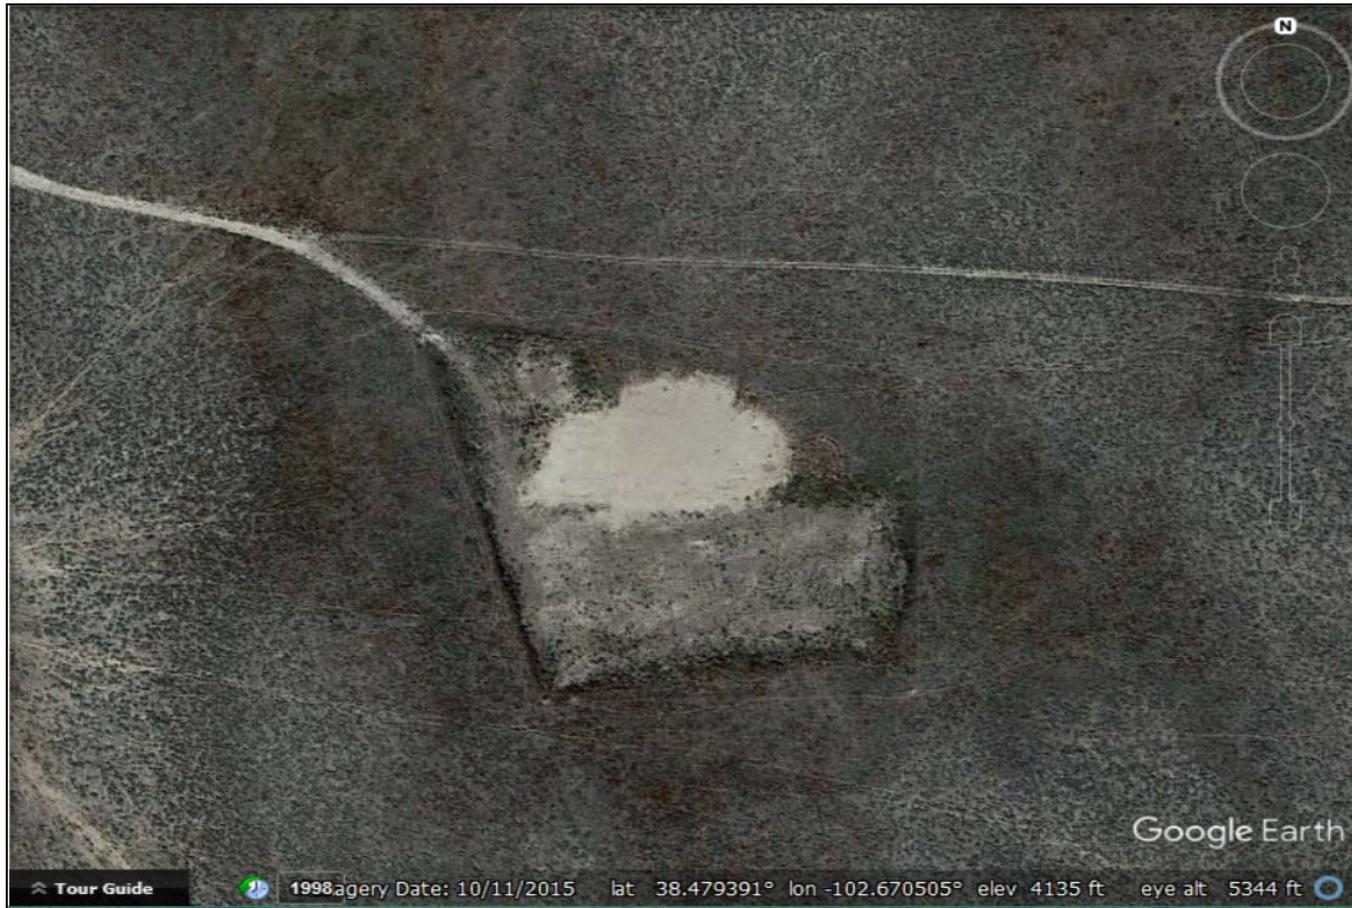
Photo 1. 2015 aerial image shows the location disturbance.

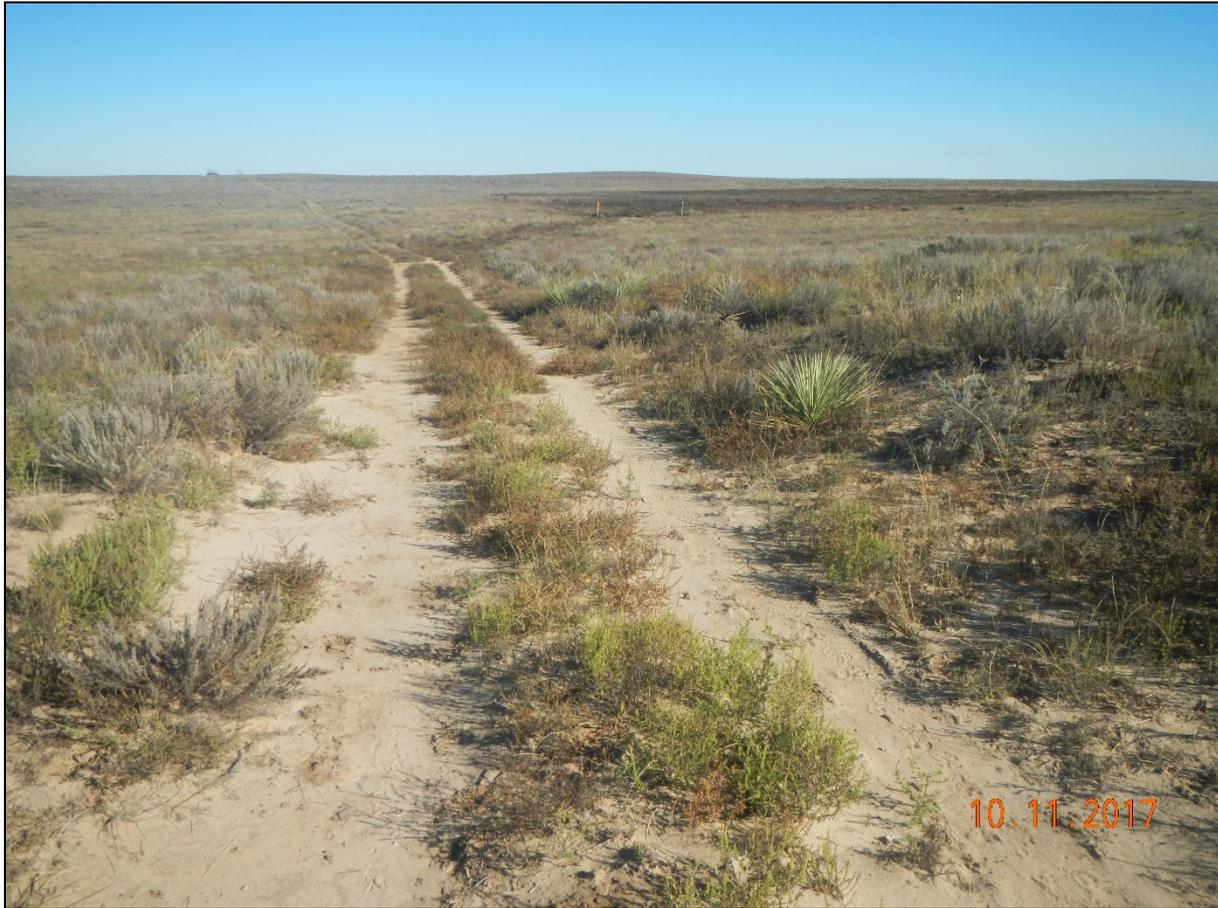
Photo 2. Facing east along the access road toward the location.

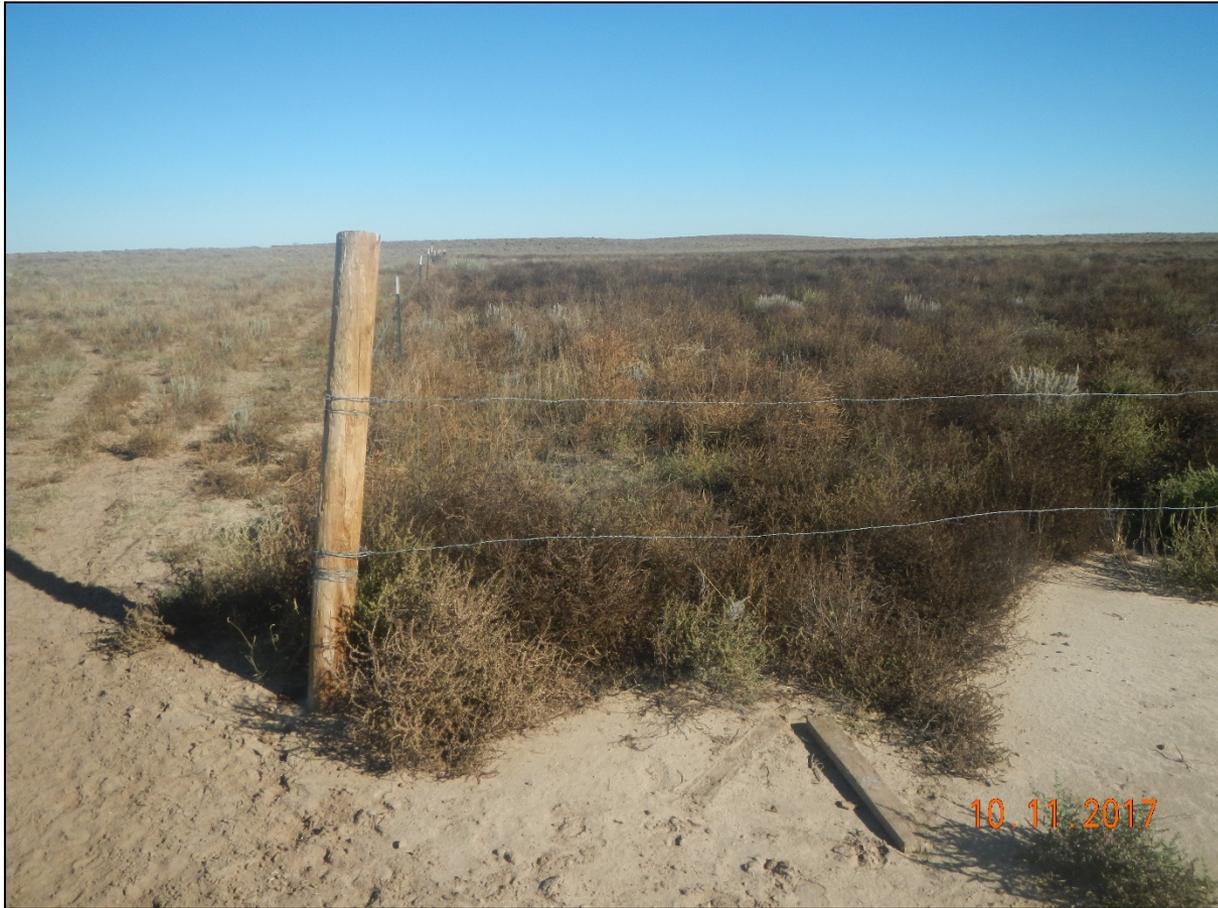
Photo 3. Facing southeast toward the location. The location has a perimeter fence that is not maintained.

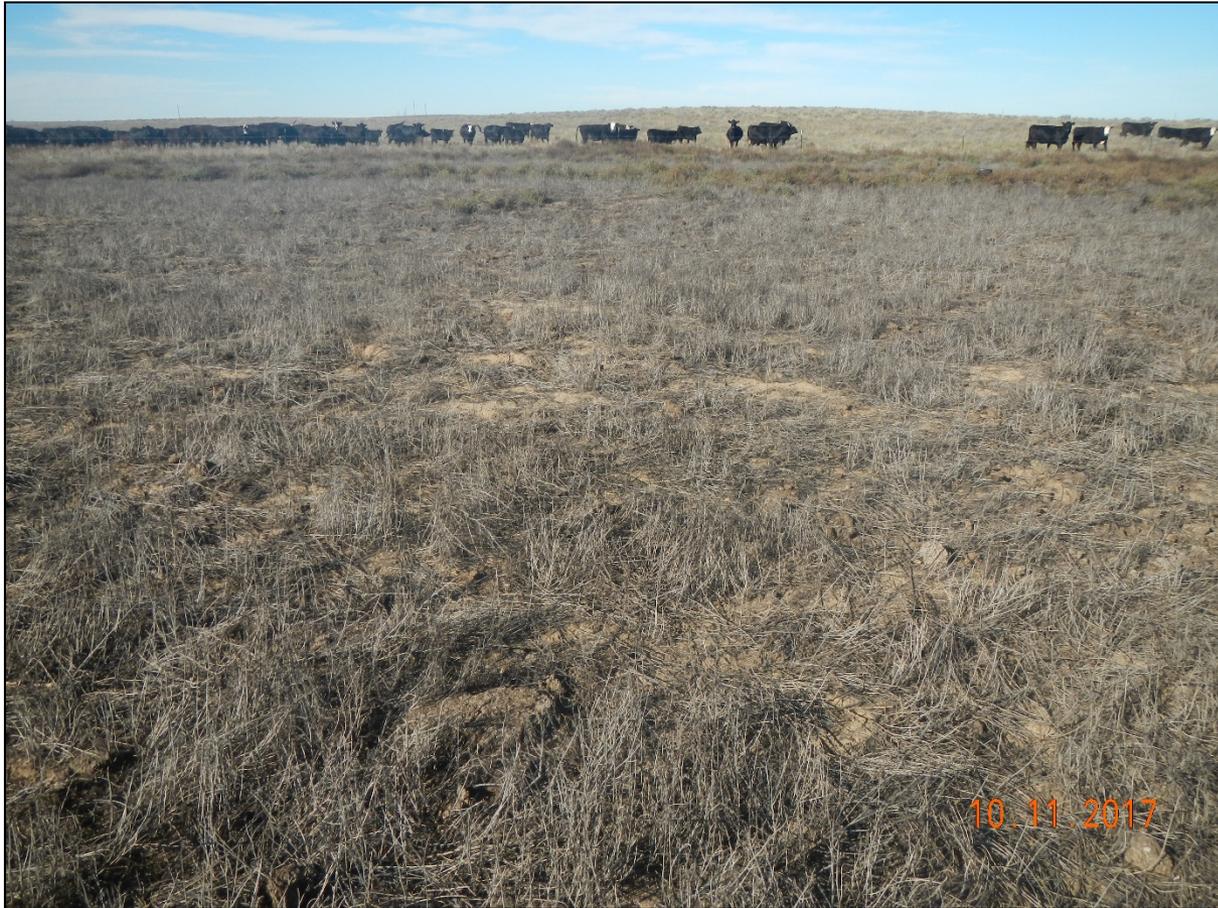
Photo 4. Center of the location facing north. There are undesirable weeds throughout the location (Russian thistle, Kochia sp.).

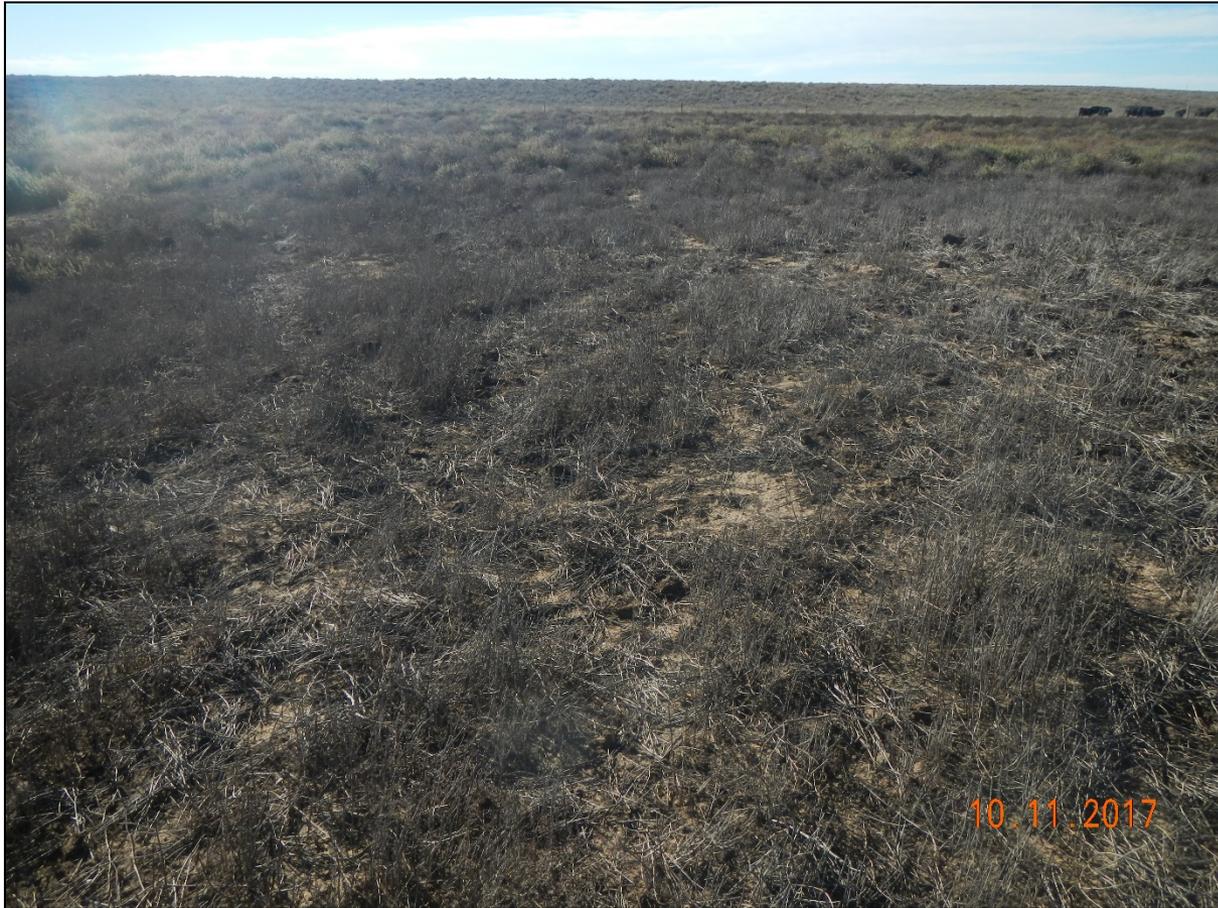
Photo 5. Center of the location facing west. There are undesirable weeds throughout the location (Russian thistle, Kochia sp.).

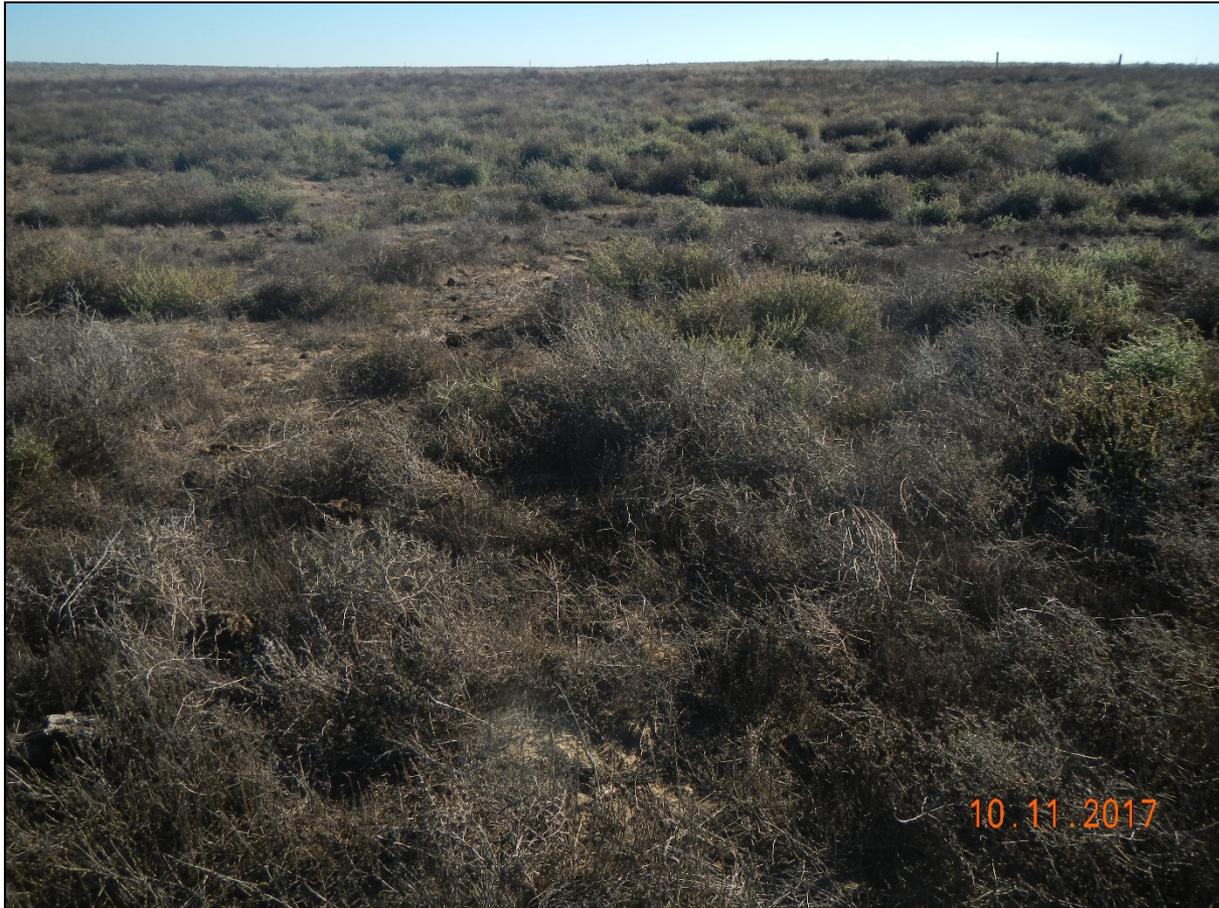
Photo 6. Center of the location facing south.

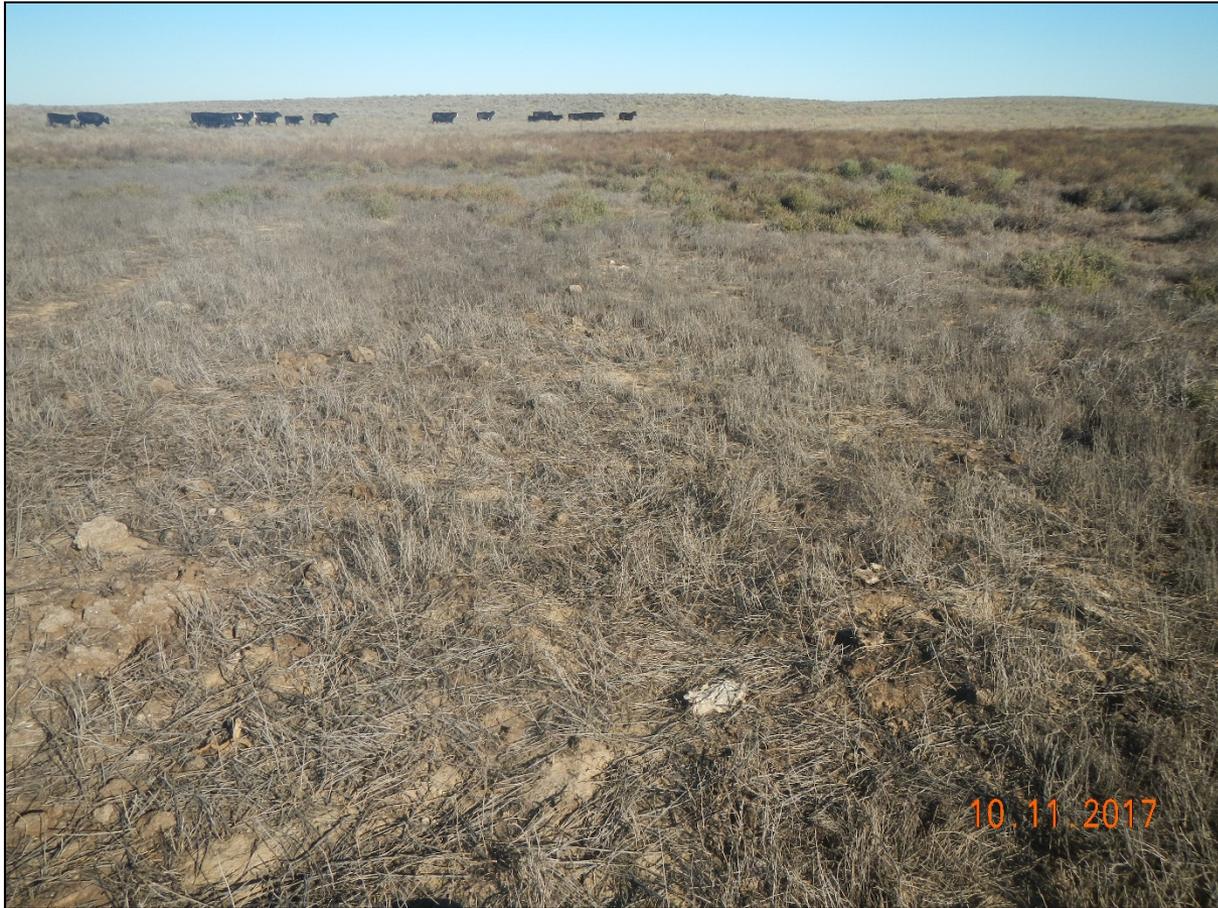
Photo 7. Center of the location facing east.

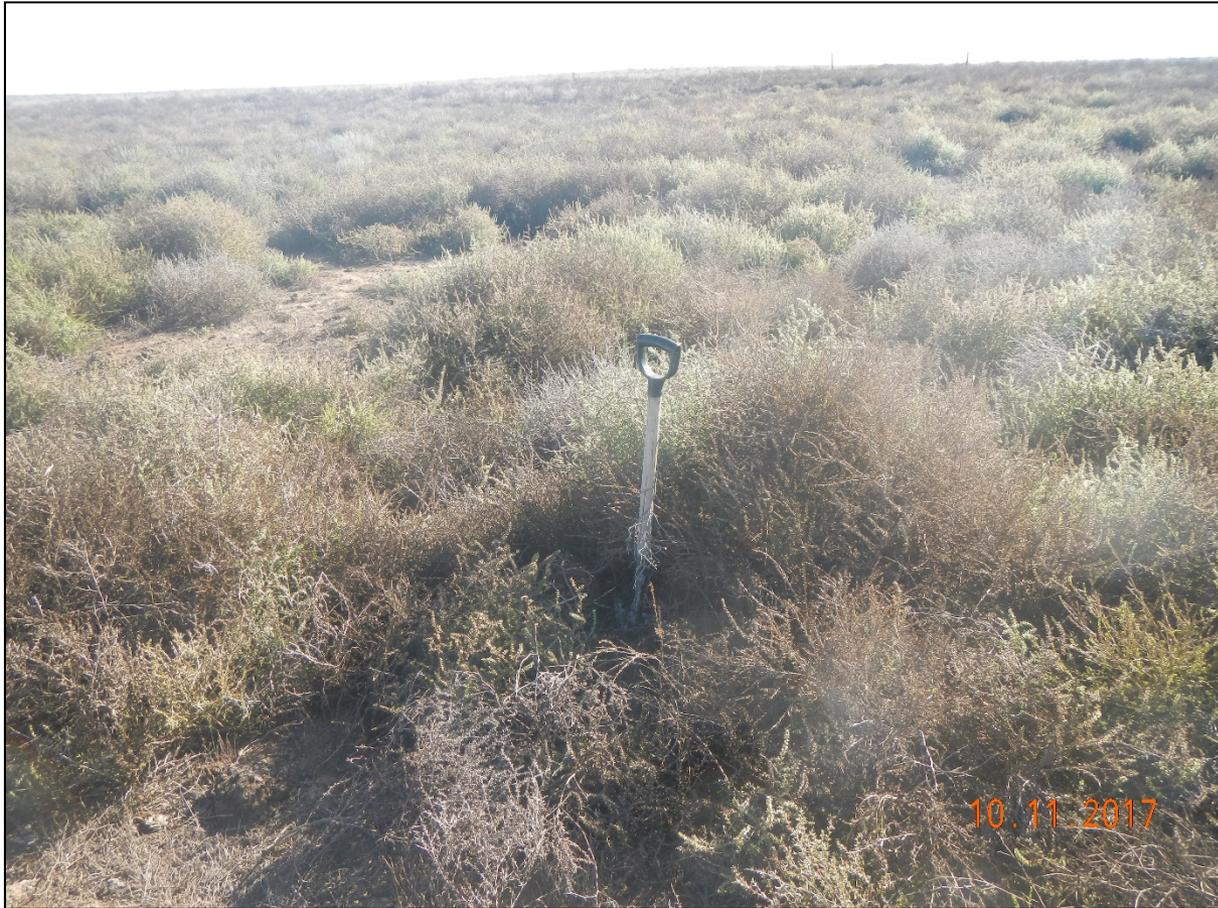
Photo 8. The 3.5 ft. shovel indicates height of weed debris throughout the location.

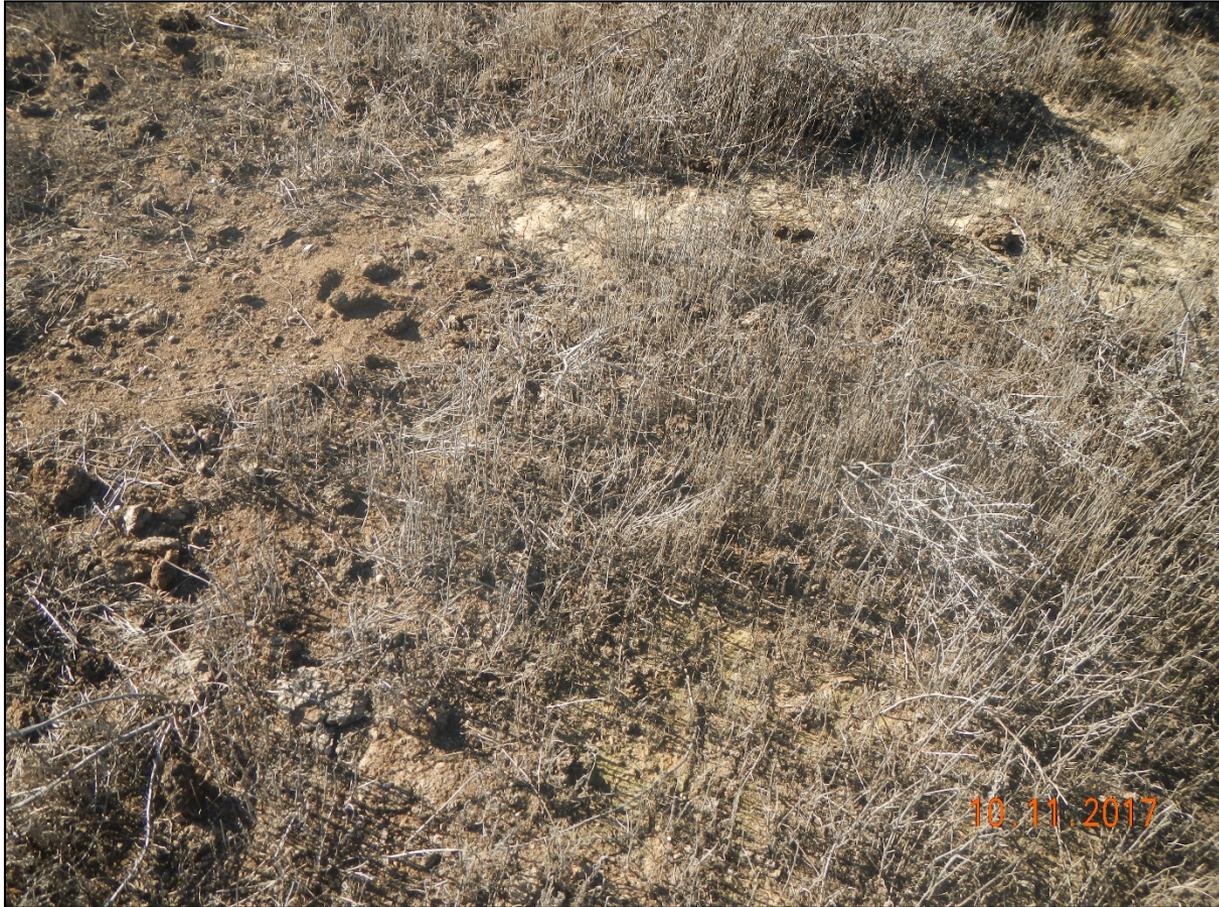
Photo 9. View of ground cover at the location. There is predominately undesirable vegetation (Russian thistle, Kochia sp.) and bare soil.

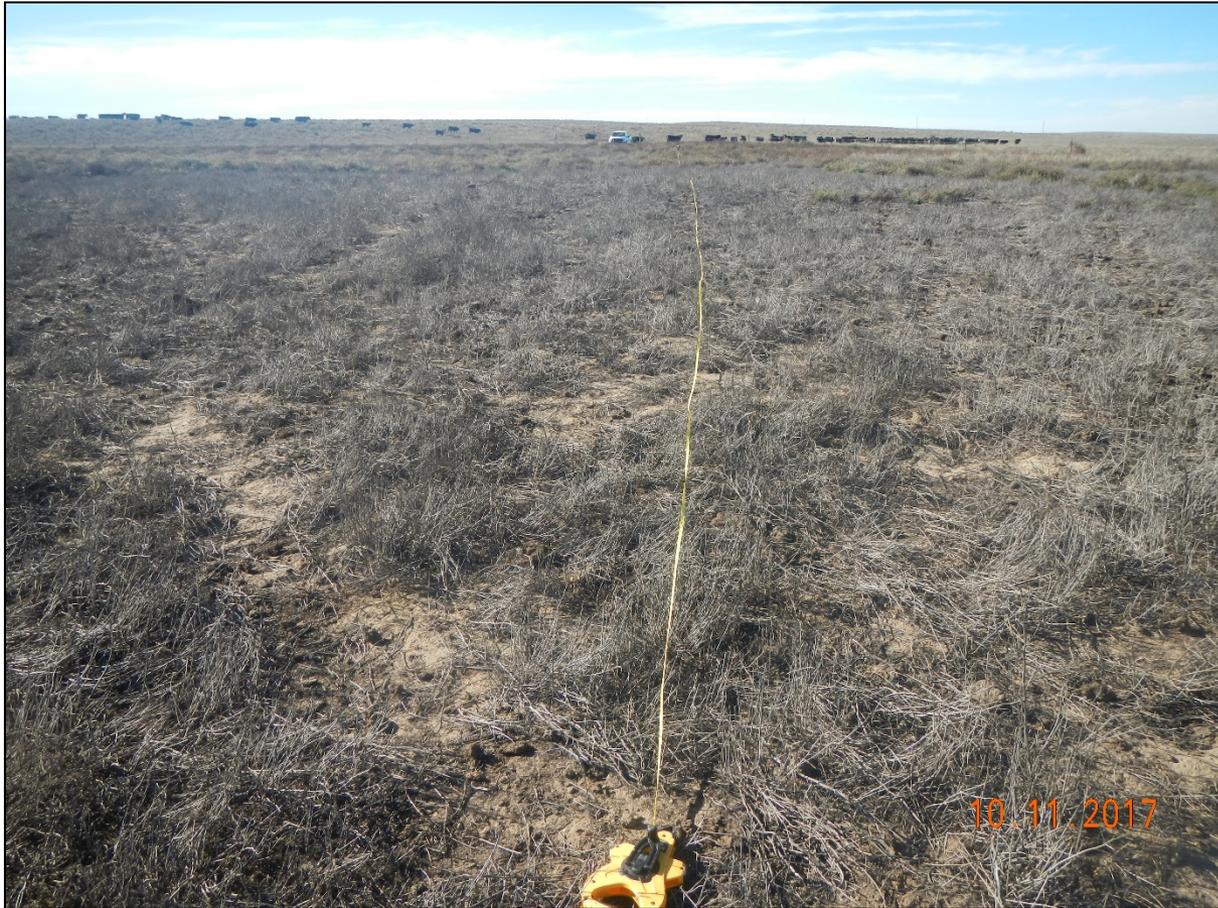
Photo 10. Facing northwest at the location. A 100 ft. tape measure shows the extent of this portion of the location without any desirable vegetation establishment.

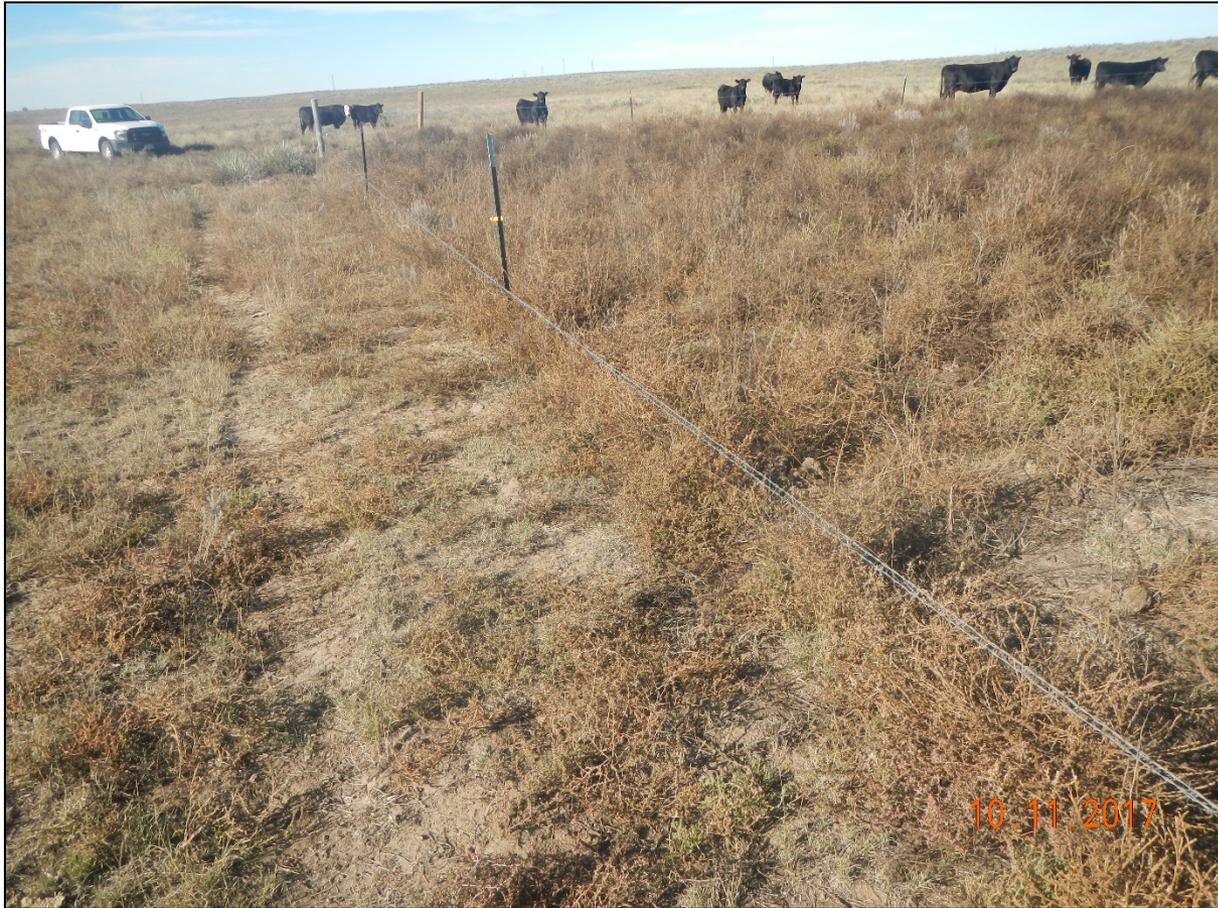
Photo 11. The fence around the location is not maintained. The barbed wire is only about 1 ft. off the ground and livestock can access the site.

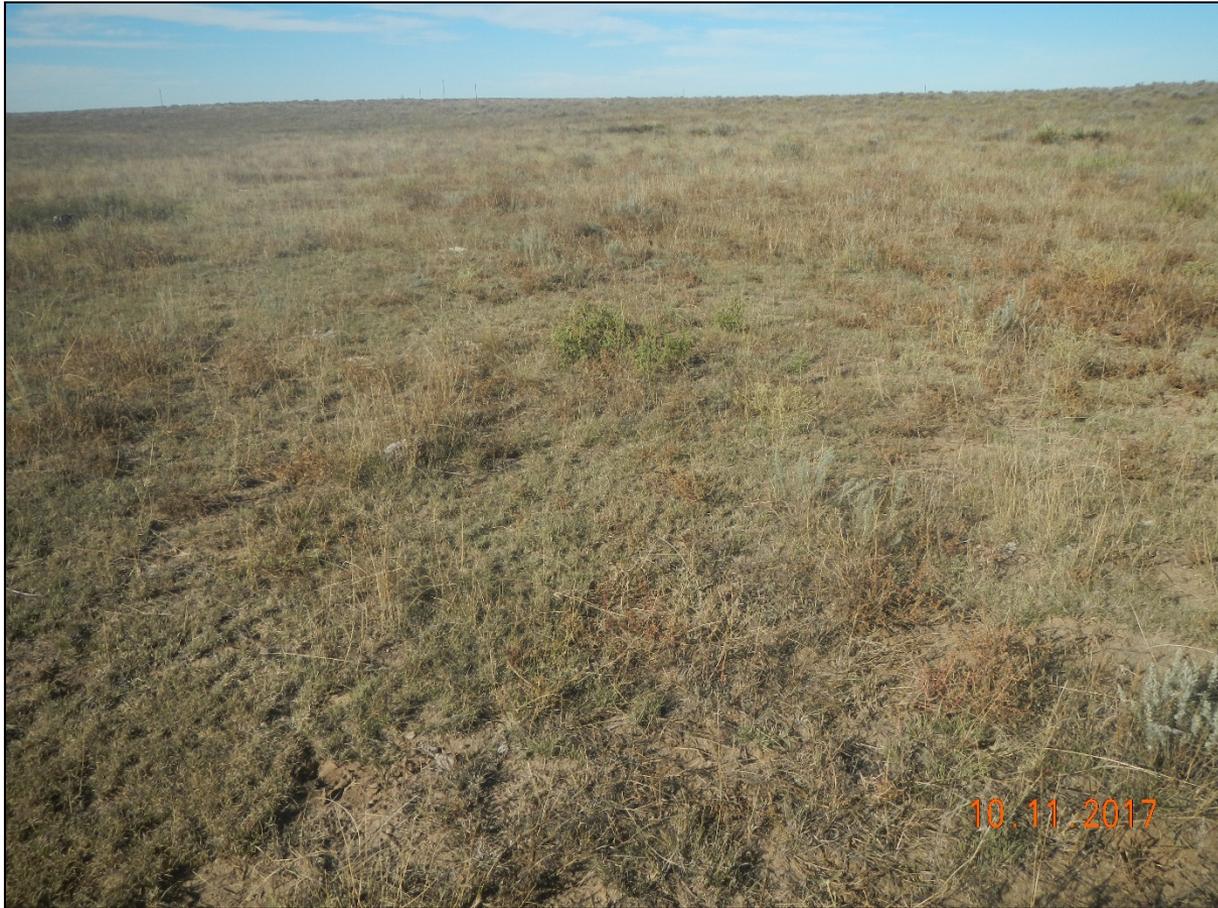
Photo 12. Facing north off the location toward the undisturbed vegetation.
