Inspection Photos

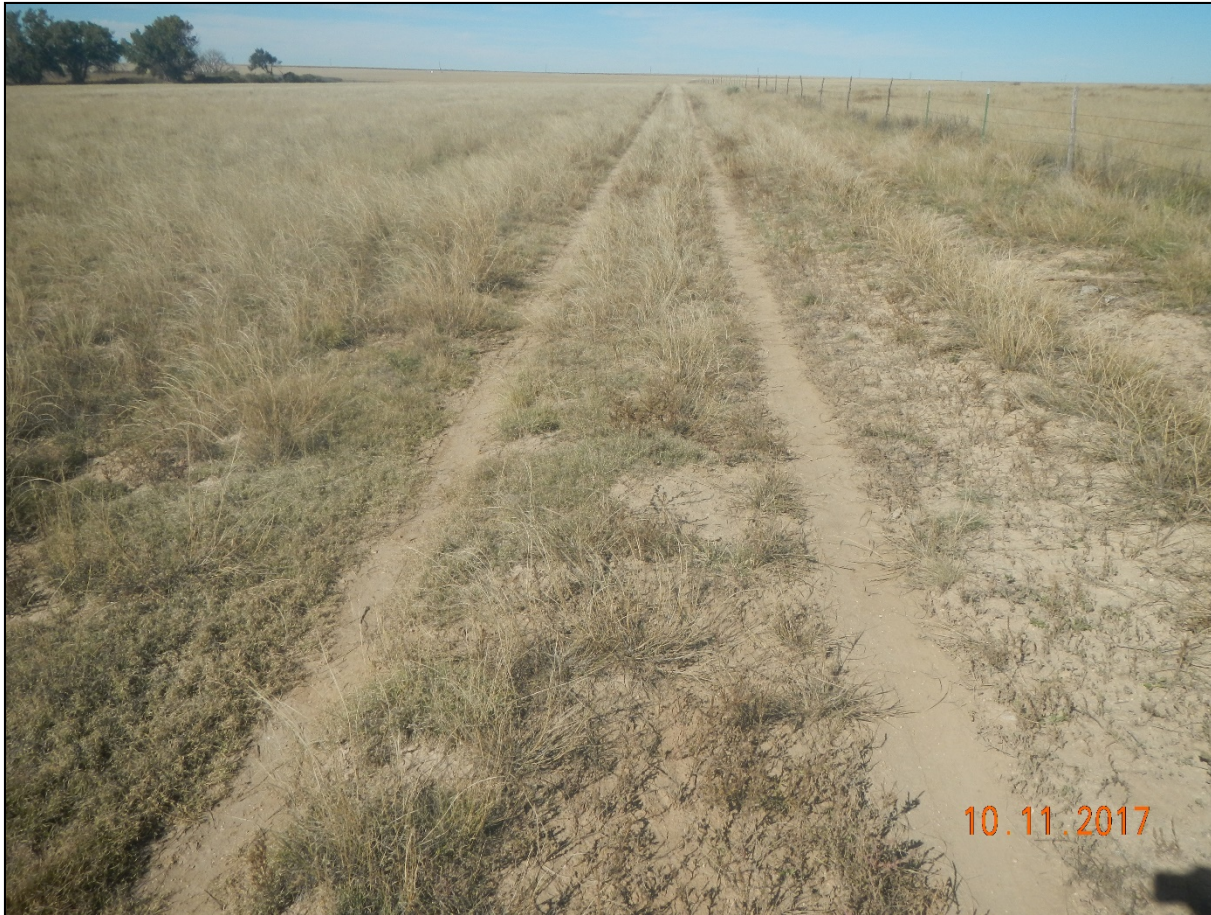
Photo 1. Facing north along the former access road which still present.

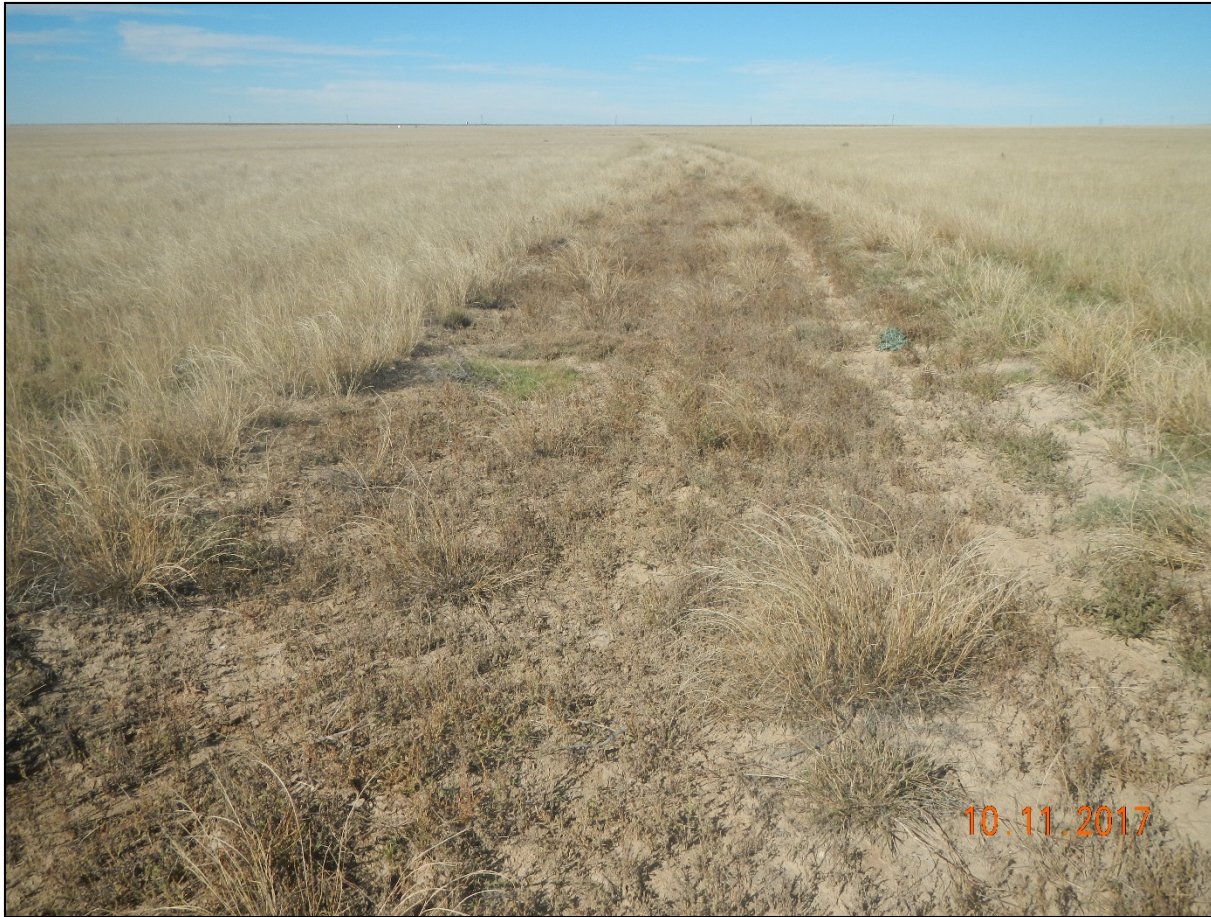
Photo 2. Facing north along the former access road which has not been reclaimed.

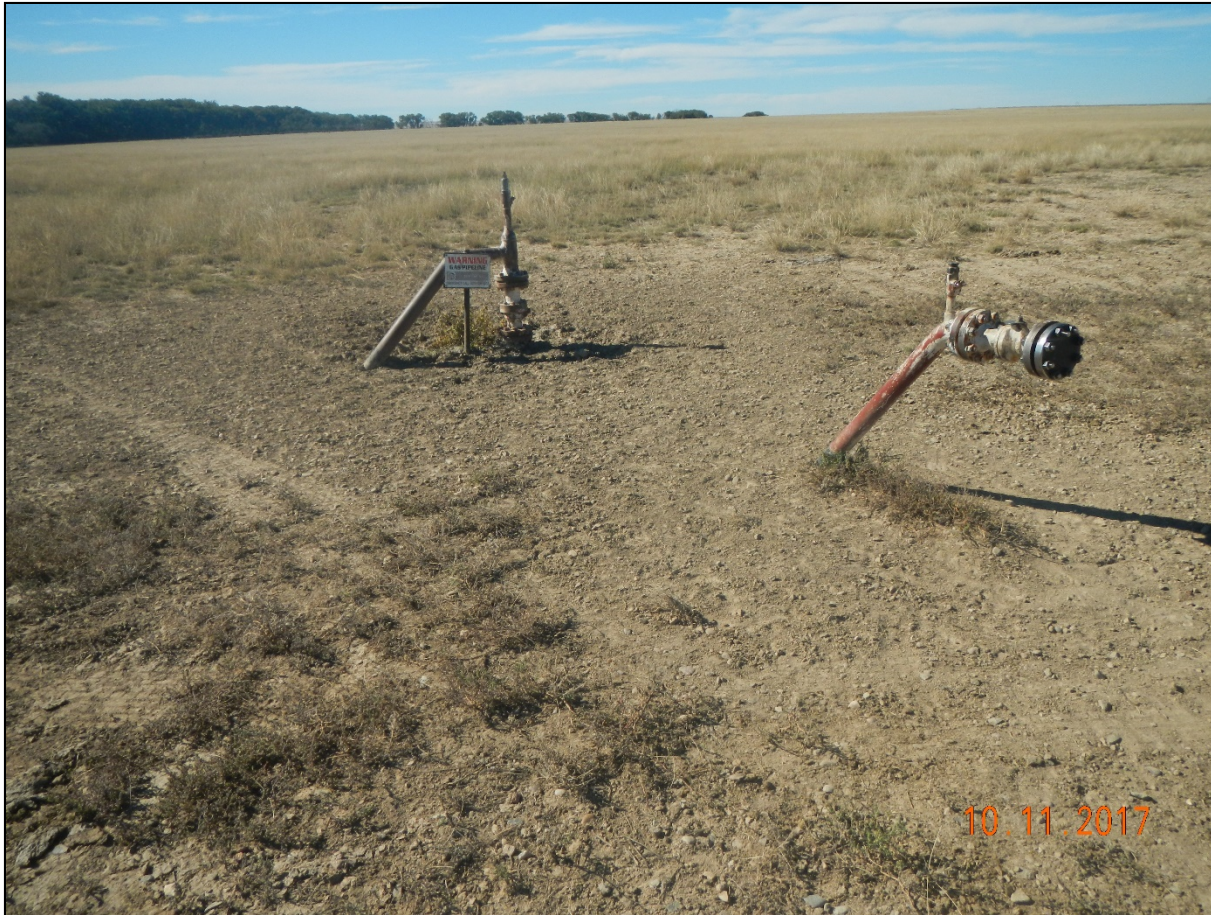
Photo 3. There are two pipe risers that remain at the location.

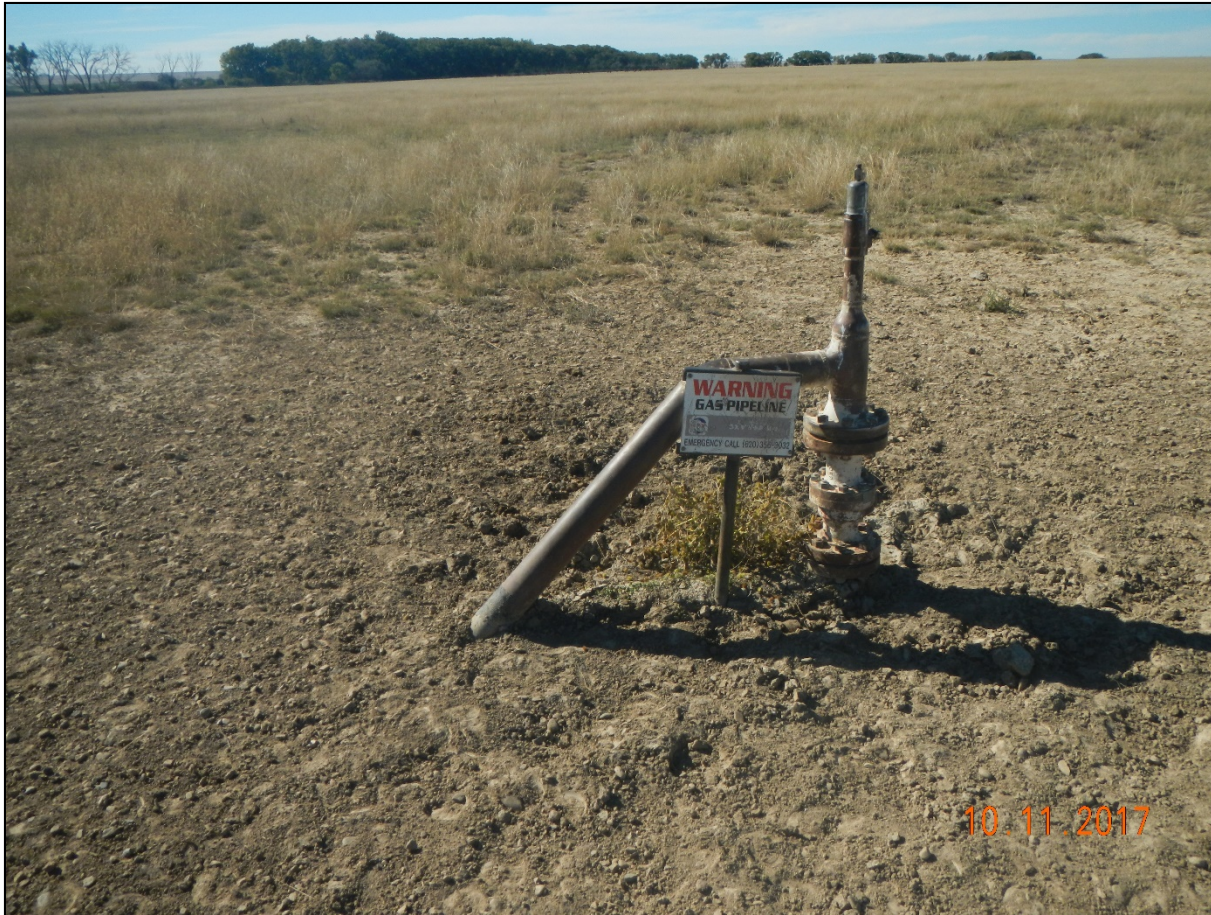
Photo 4. There is an OXY sign at one of the risers at the location.

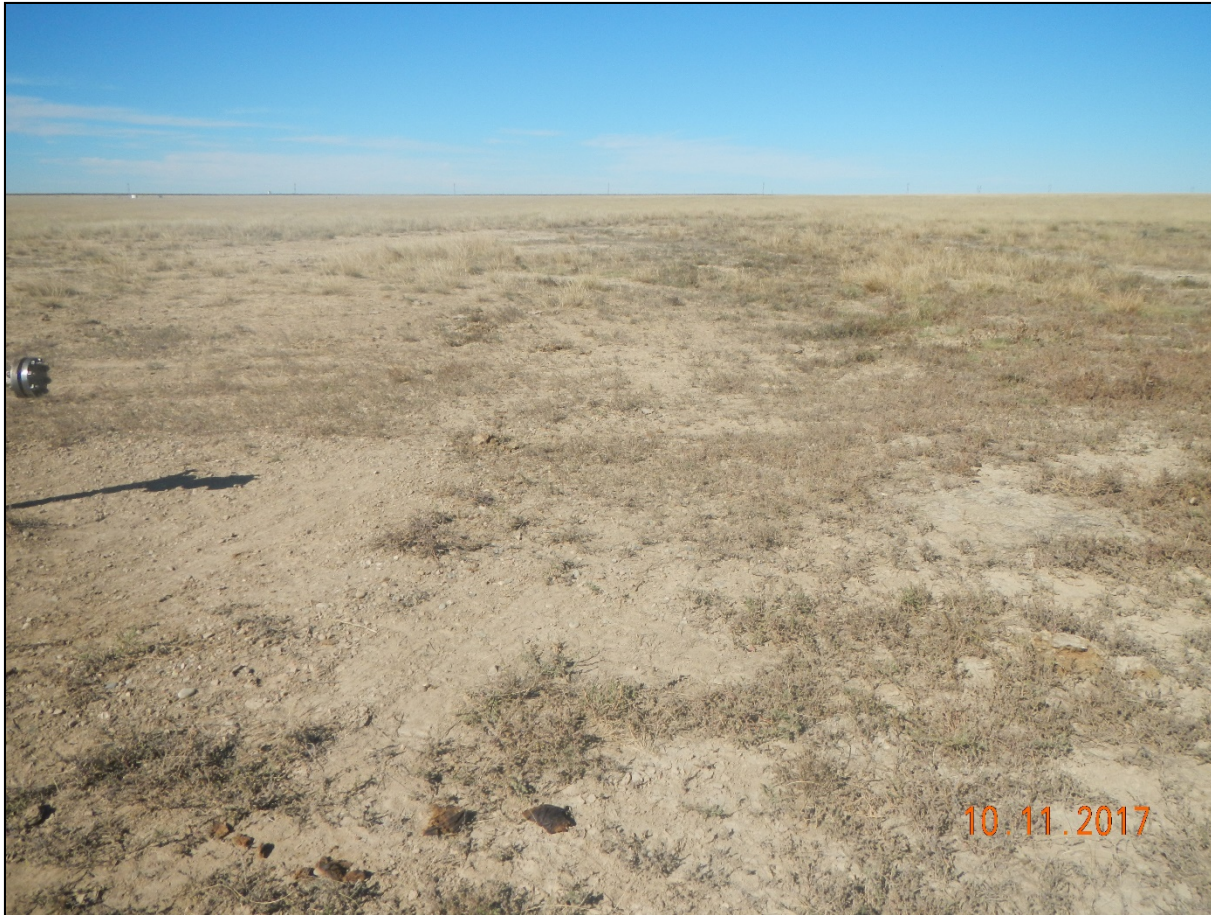
Photo 5. Facing north toward the location. The vegetation has not re-established at the location.

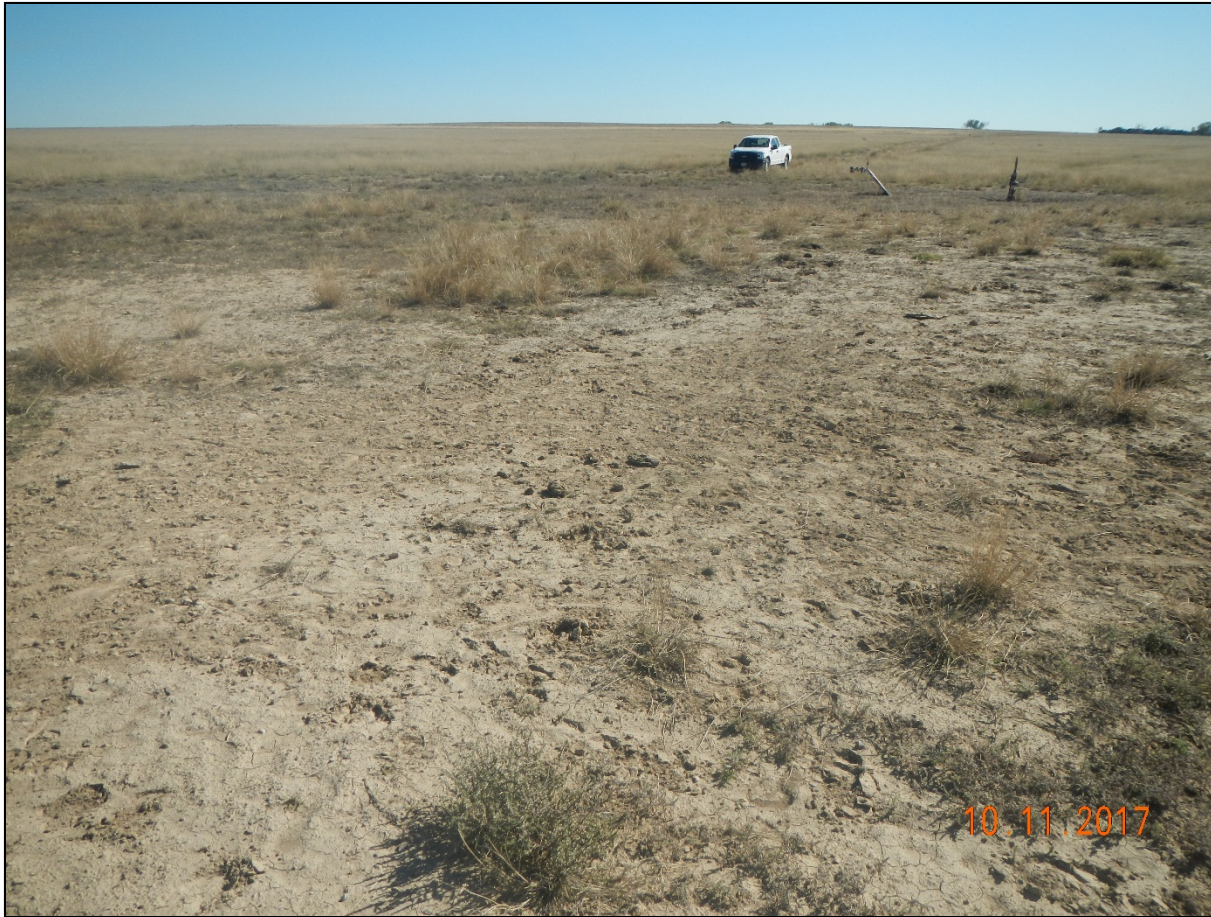
Photo 6. Facing south at the location. The vegetation has not adequately re-established and the soils appear to be compacted.

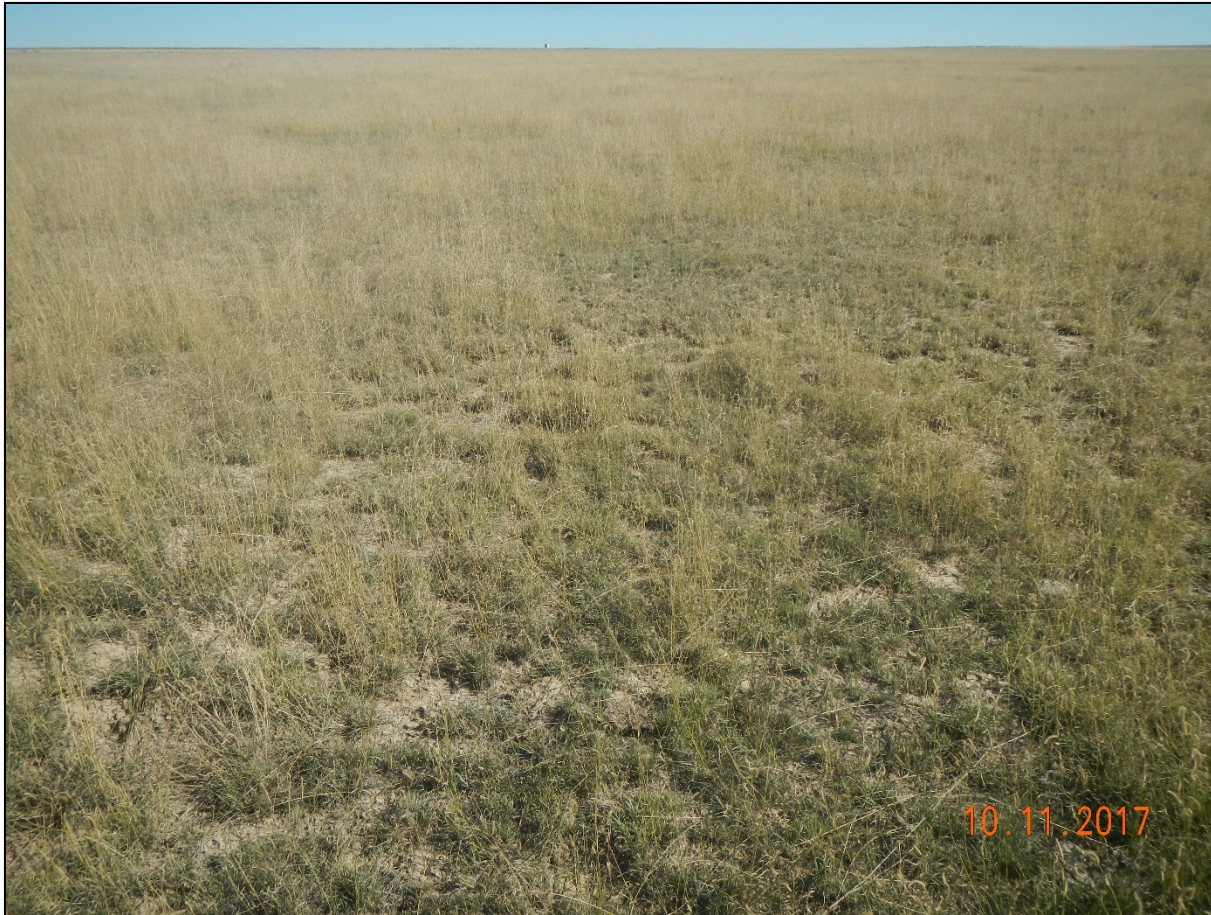
Photo 7. Facing east toward the surrounding undisturbed pasture.
