Inspection Photos
Location Name: Hiawatha Midle Oil 13 F
Wilson
API: 05-081-05564

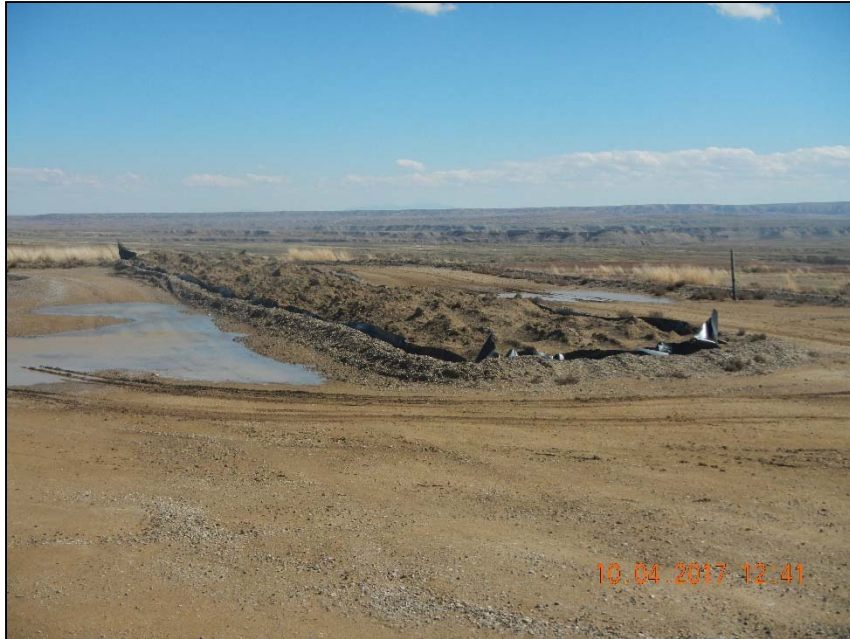
Photo 1. Landfarm area taken on west side facing east.

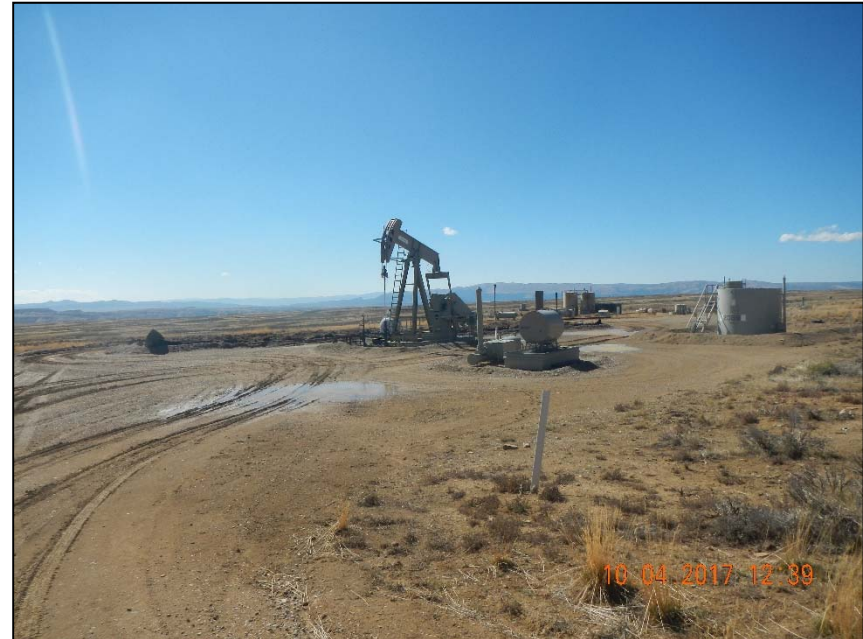
Photo 2. Overview of location taken at entrance facing southwest.
