Inspection Photos  
Location Name: Dakota Fee 1  
API: 05-06141  
Inspection Number: 685200403

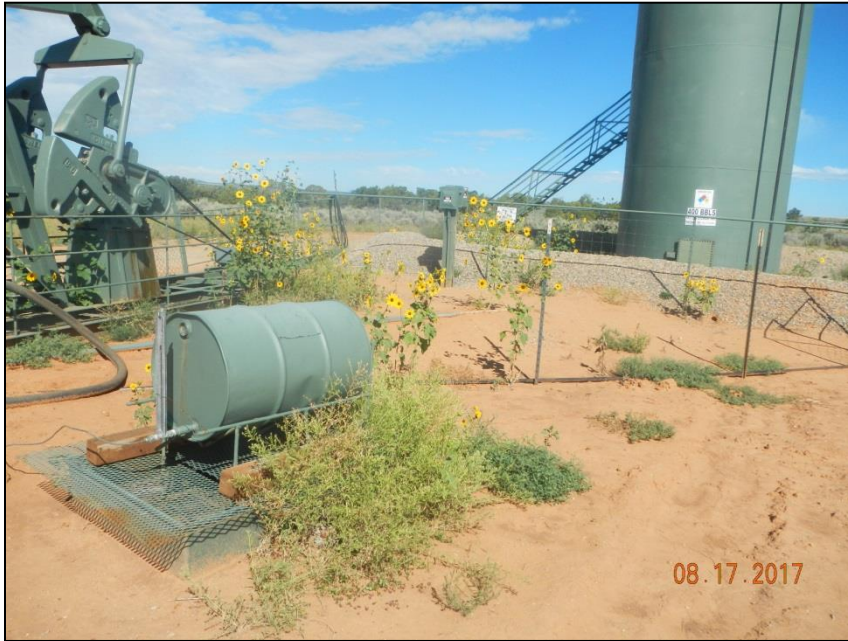
8.17.17 photo showing tall weeds within 25' of equipment

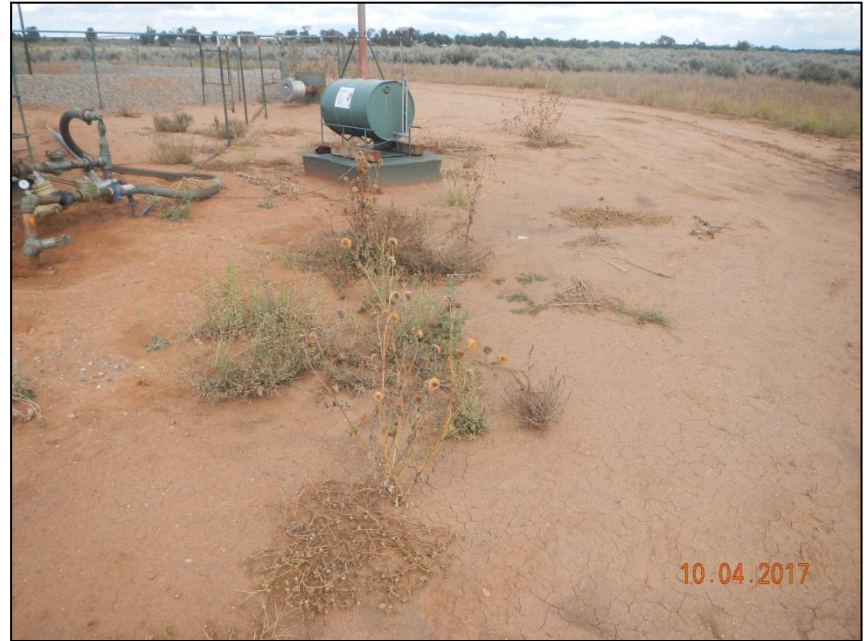
10.4.17 photo showing weeds not fully removed, now dead and combustibile

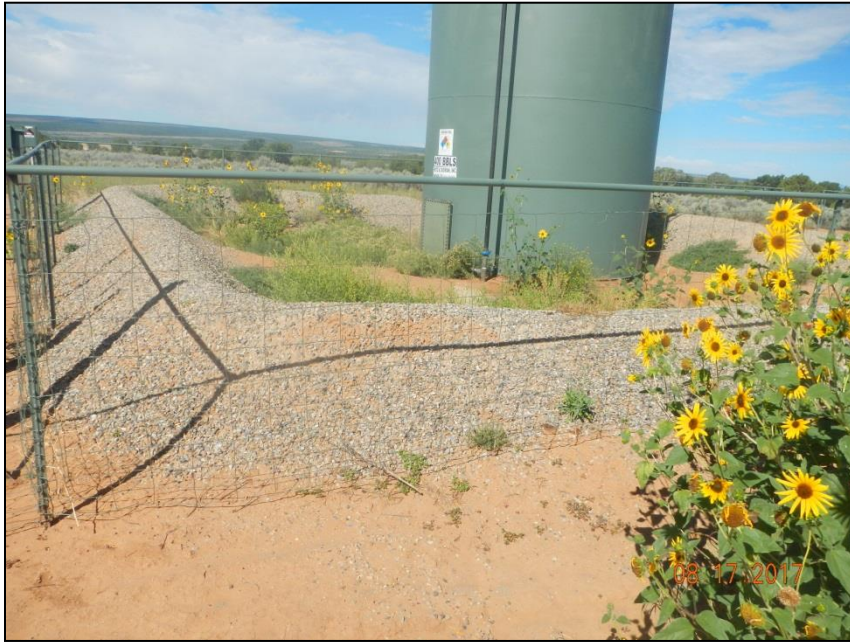
8.17.17 photo of tank berms

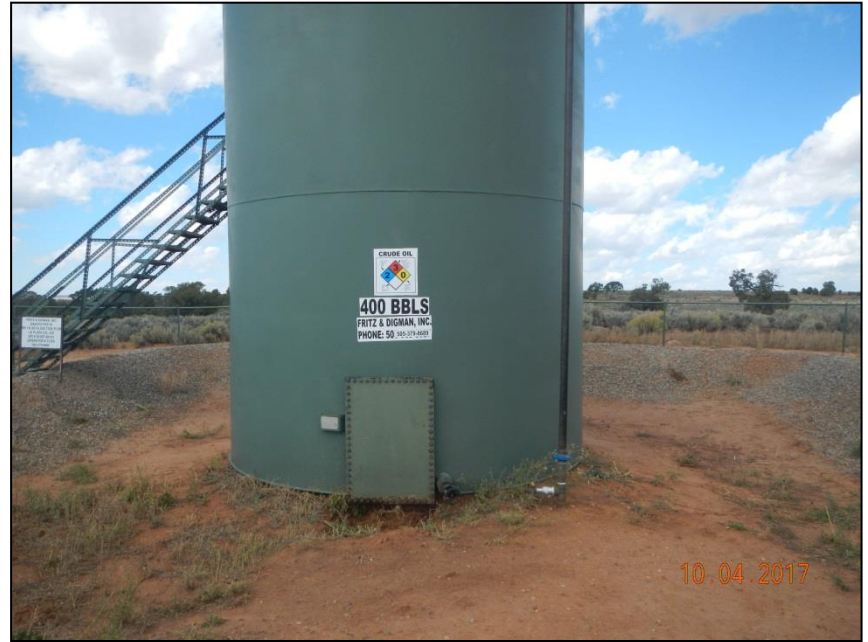
10.4.17 photo showing tall vegetation removed from inside berms (note: roots still present)

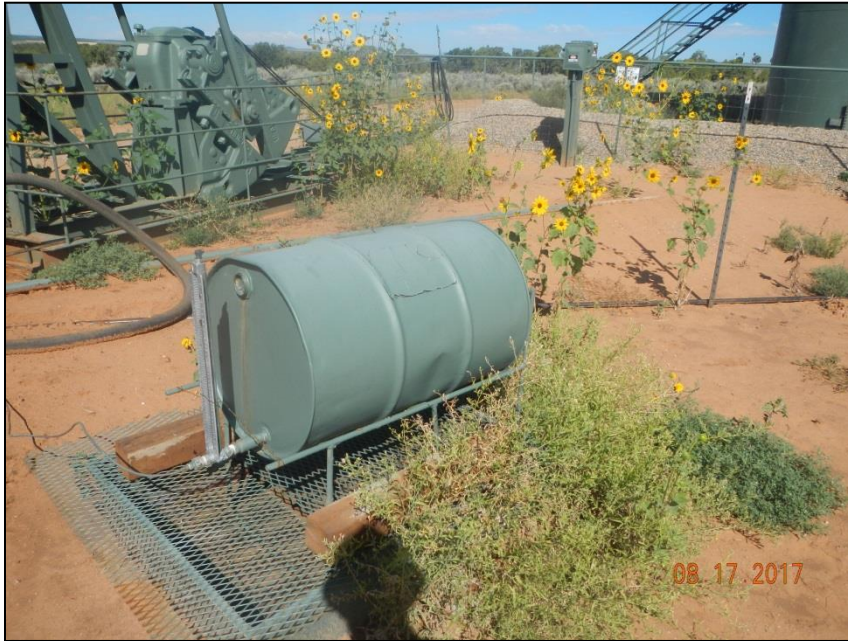
8.17.17 photo of unmarked container

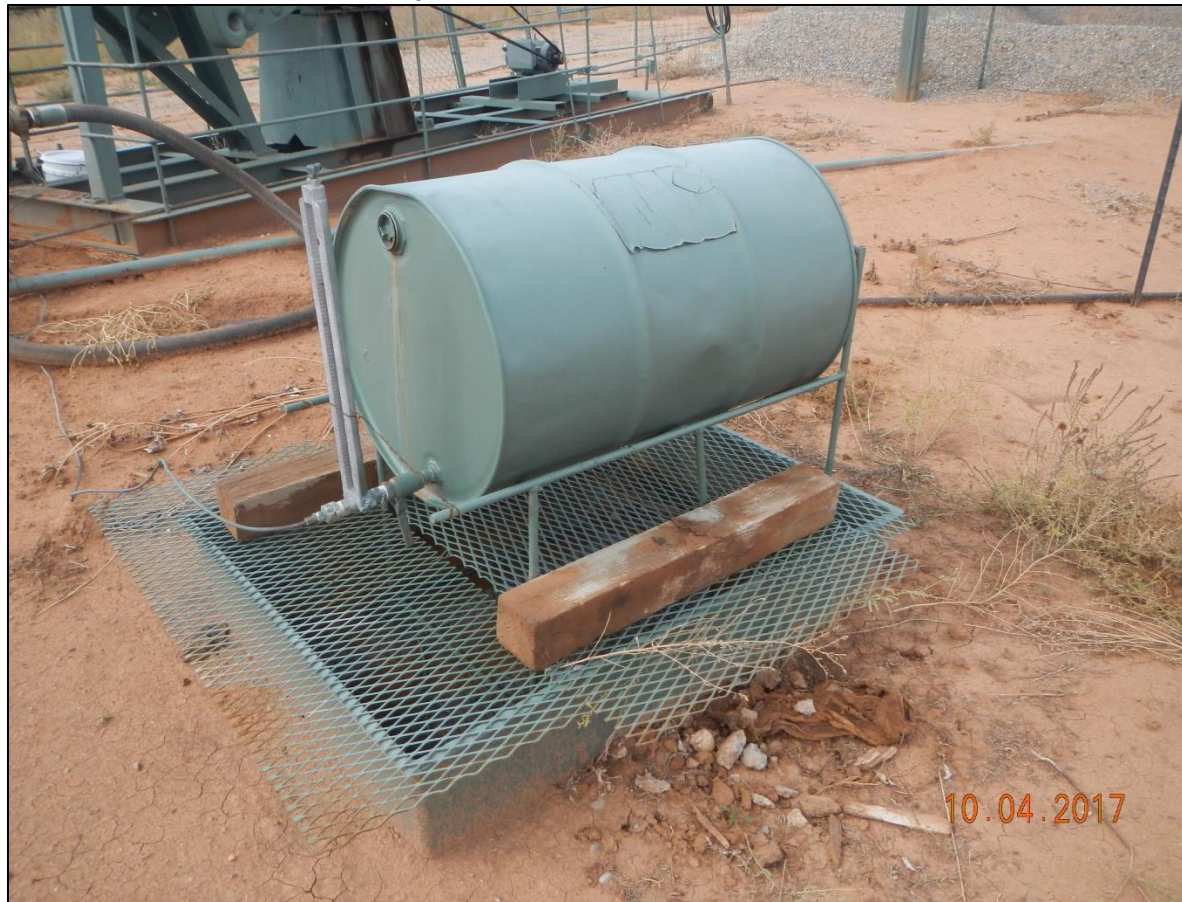
**Oily rag on ground**

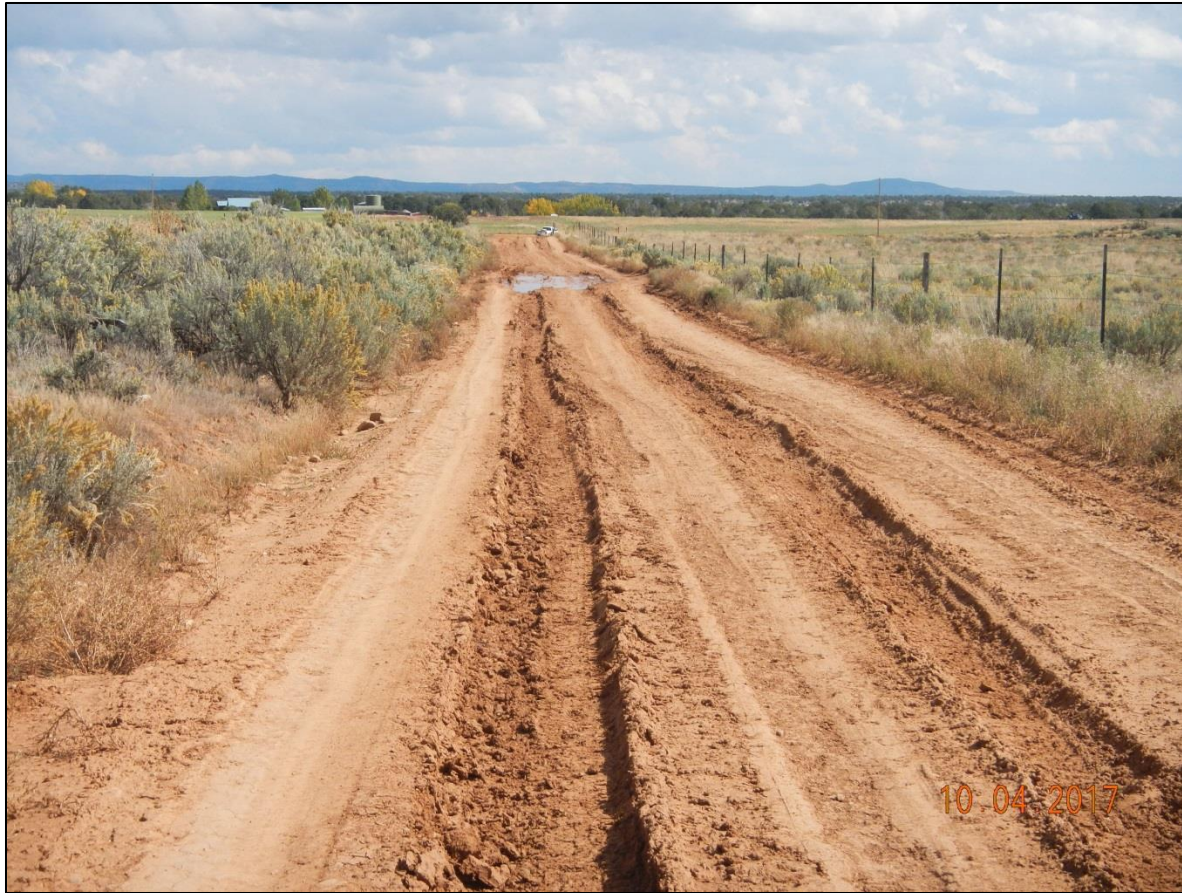
**Heavily rutted shared access road**

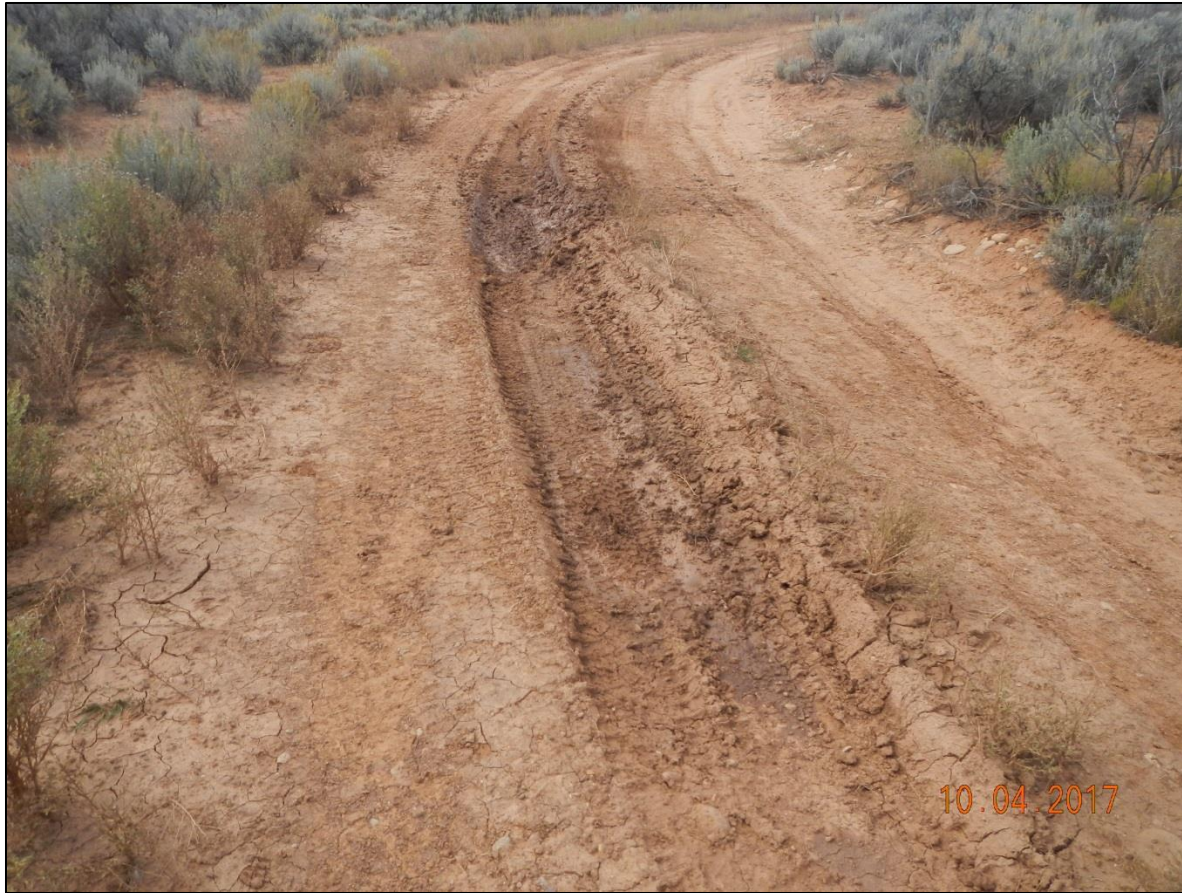
**Rutting and sediment migration on operator only portion of access (needs BMP such as but not limited to culvert)**
