## Inspection Photos

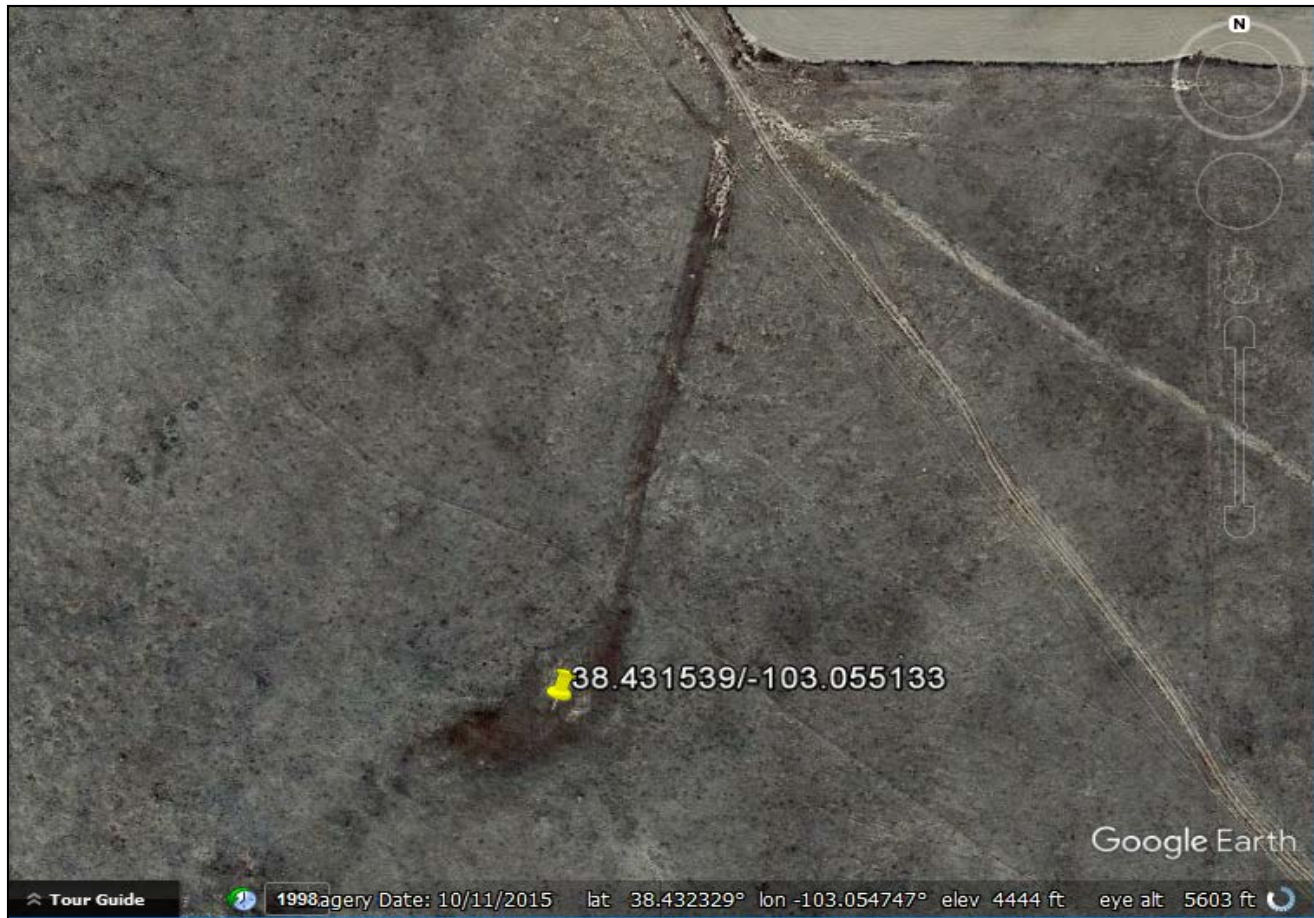
**Photo 1.** 2015 aerial image shows access road and location disturbance still exists.

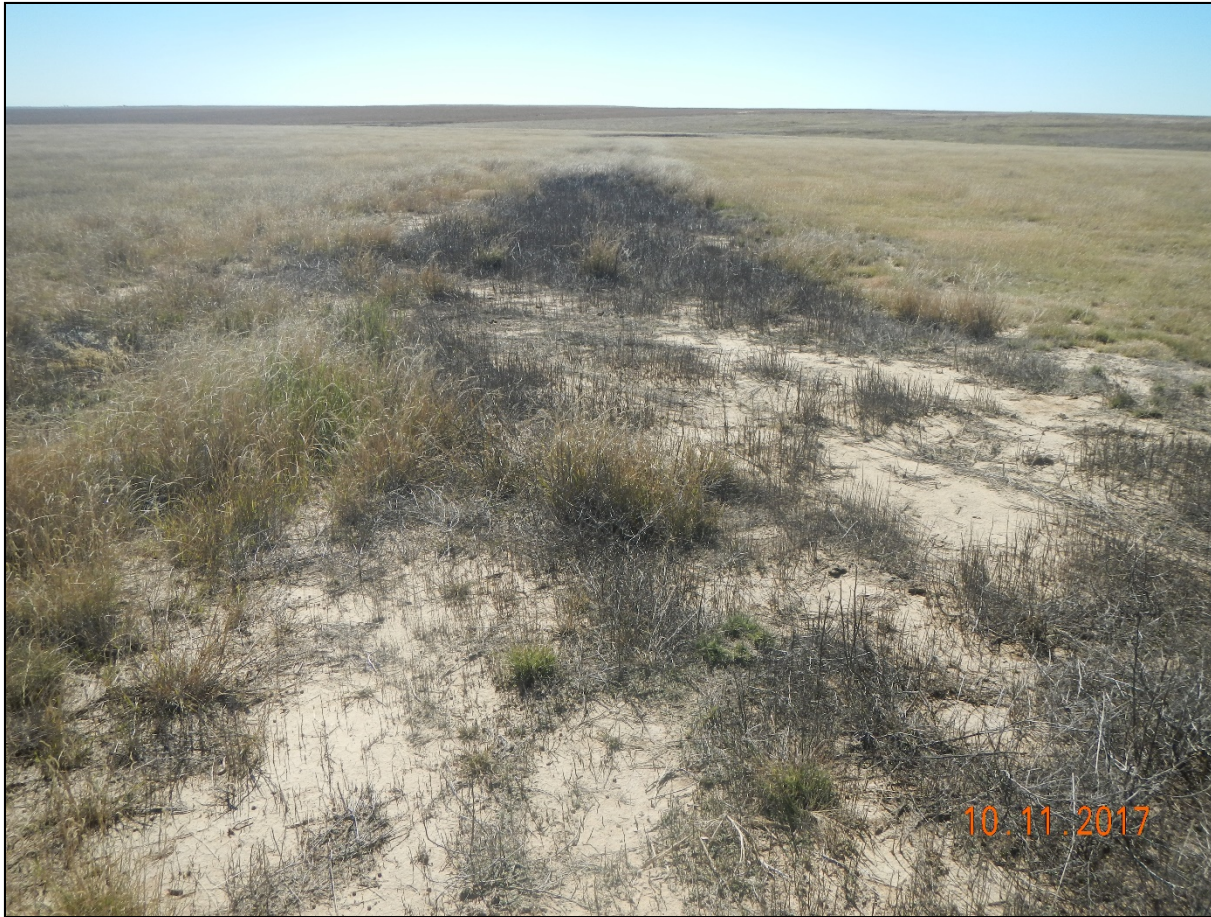
**Photo 2.** Facing south along the access road. The desirable vegetation has not re-established.

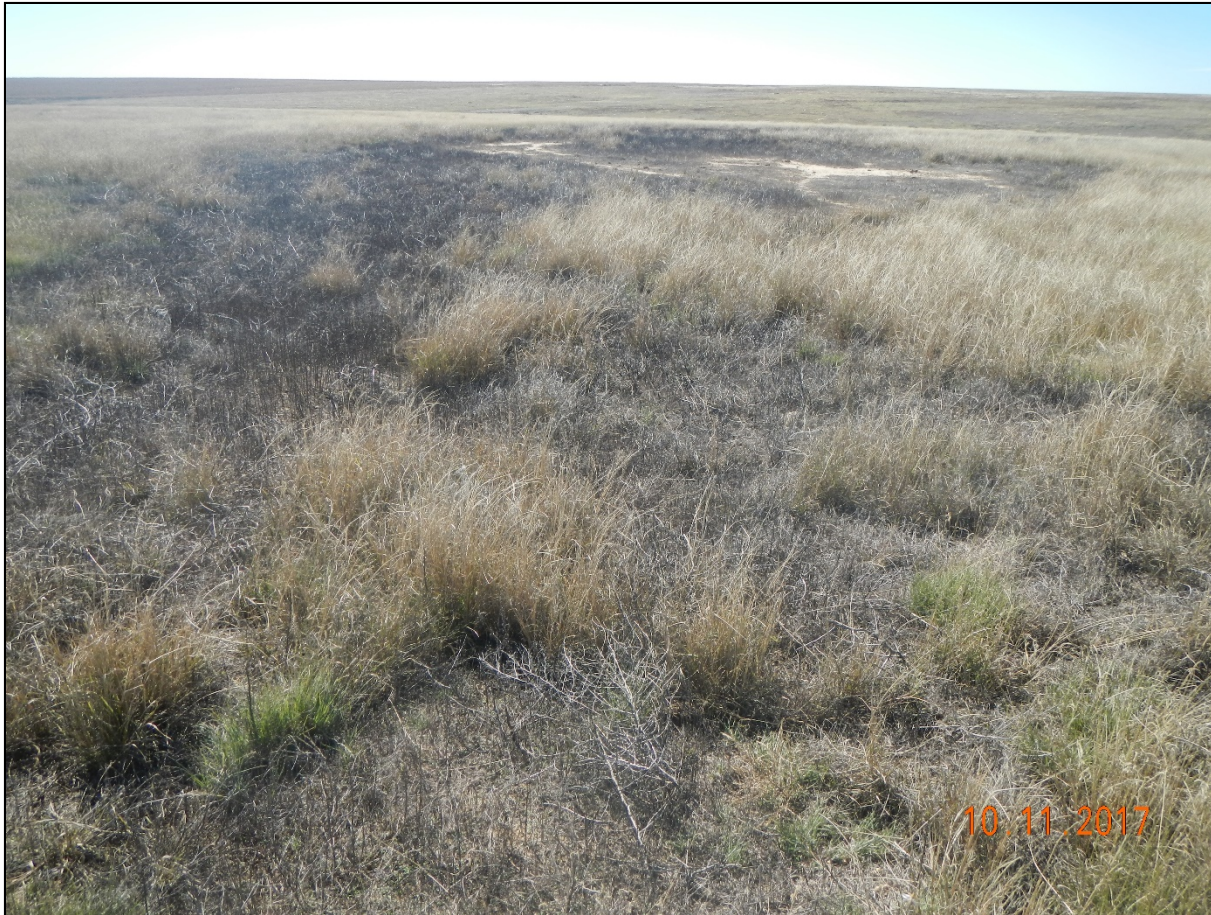
**Photo 3.** Facing south toward the location. The desirable vegetation has not re-established.

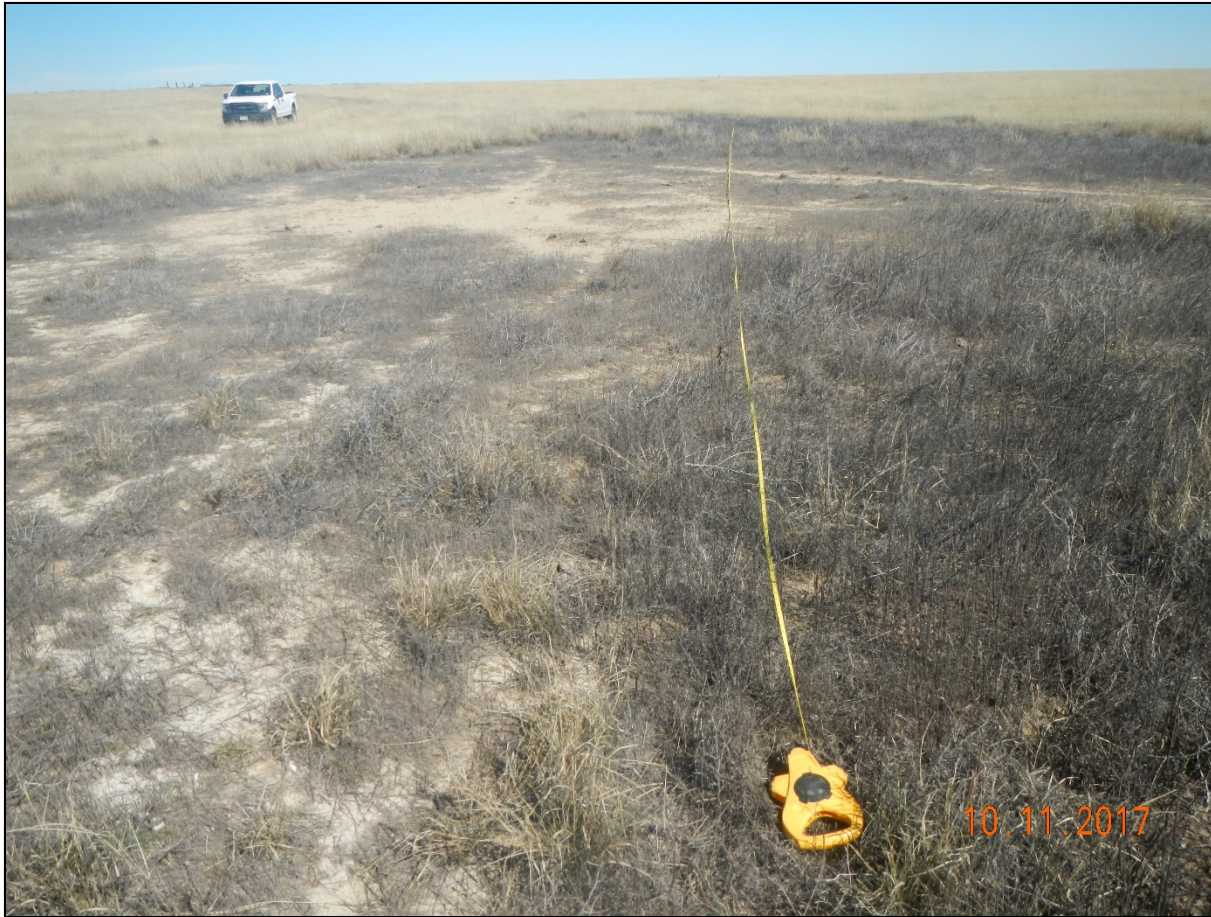
**Photo 4.** Facing north at the location. A 100ft. tape measure extent of inadequate vegetation establishment at the location.

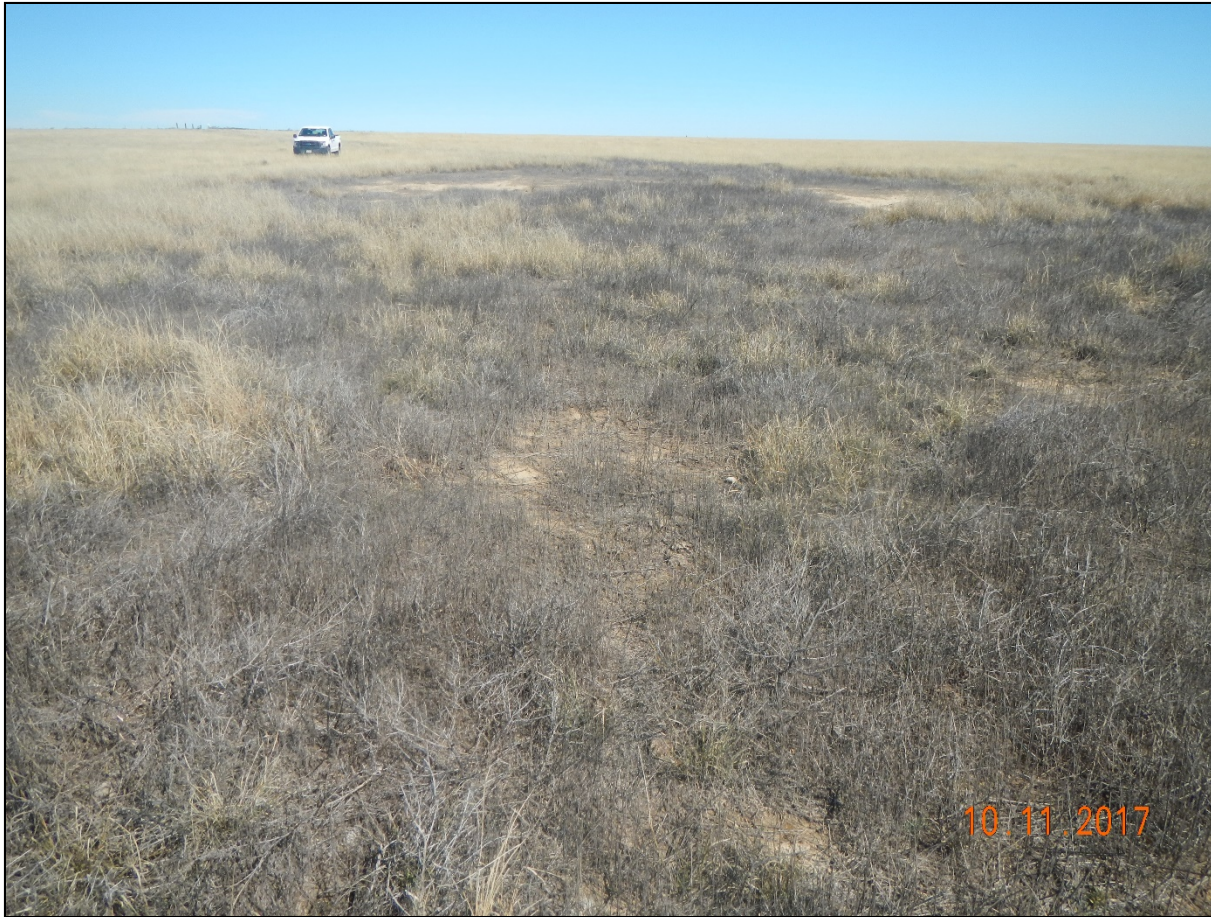
**Photo 5.** South side of the location facing north. The dark vegetation is undesirable weeds (Russian thistle, Kochia sp.) which have become debris.

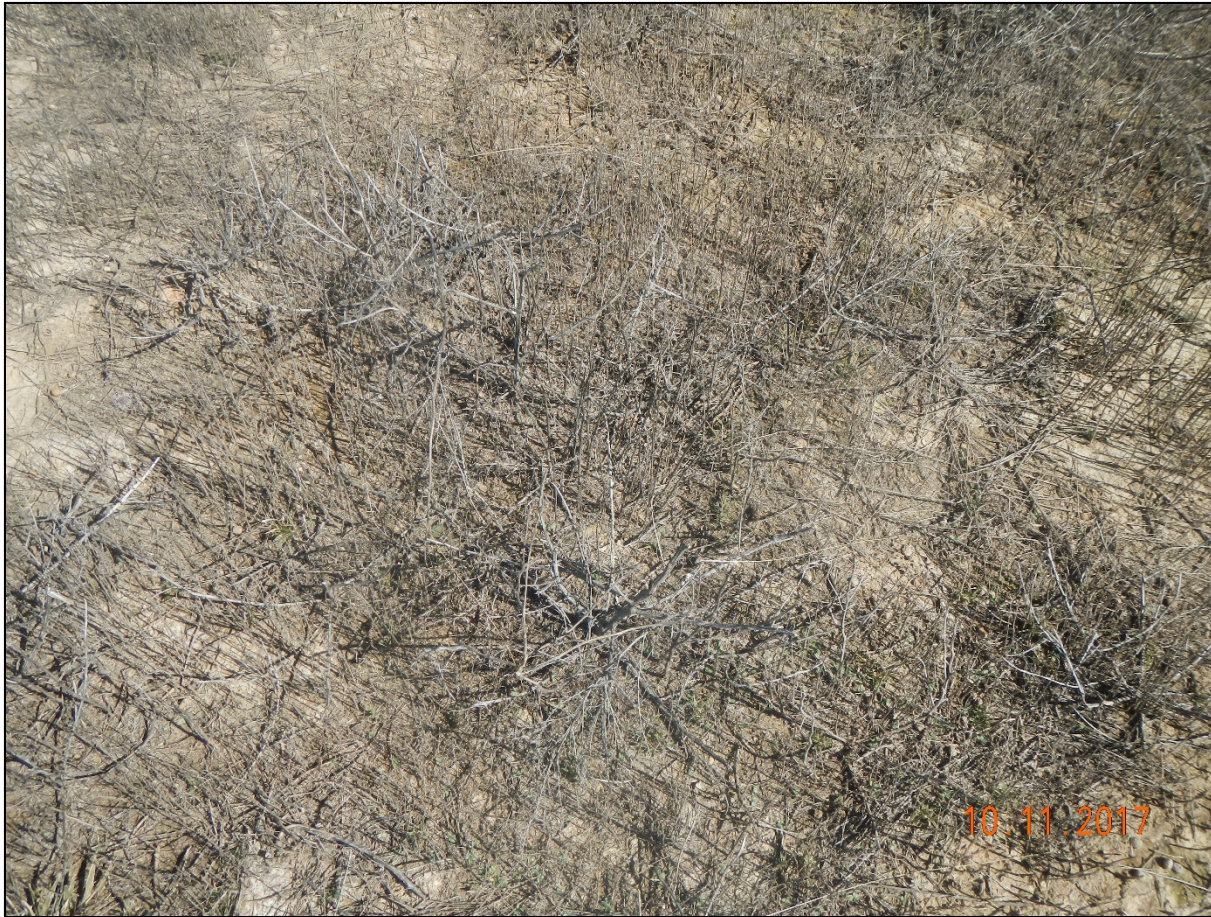
**Photo 6.** View of groundcover at the location. There is predominately undesirable weeds (*Kochia* sp., *R. thistle*) throughout the location.

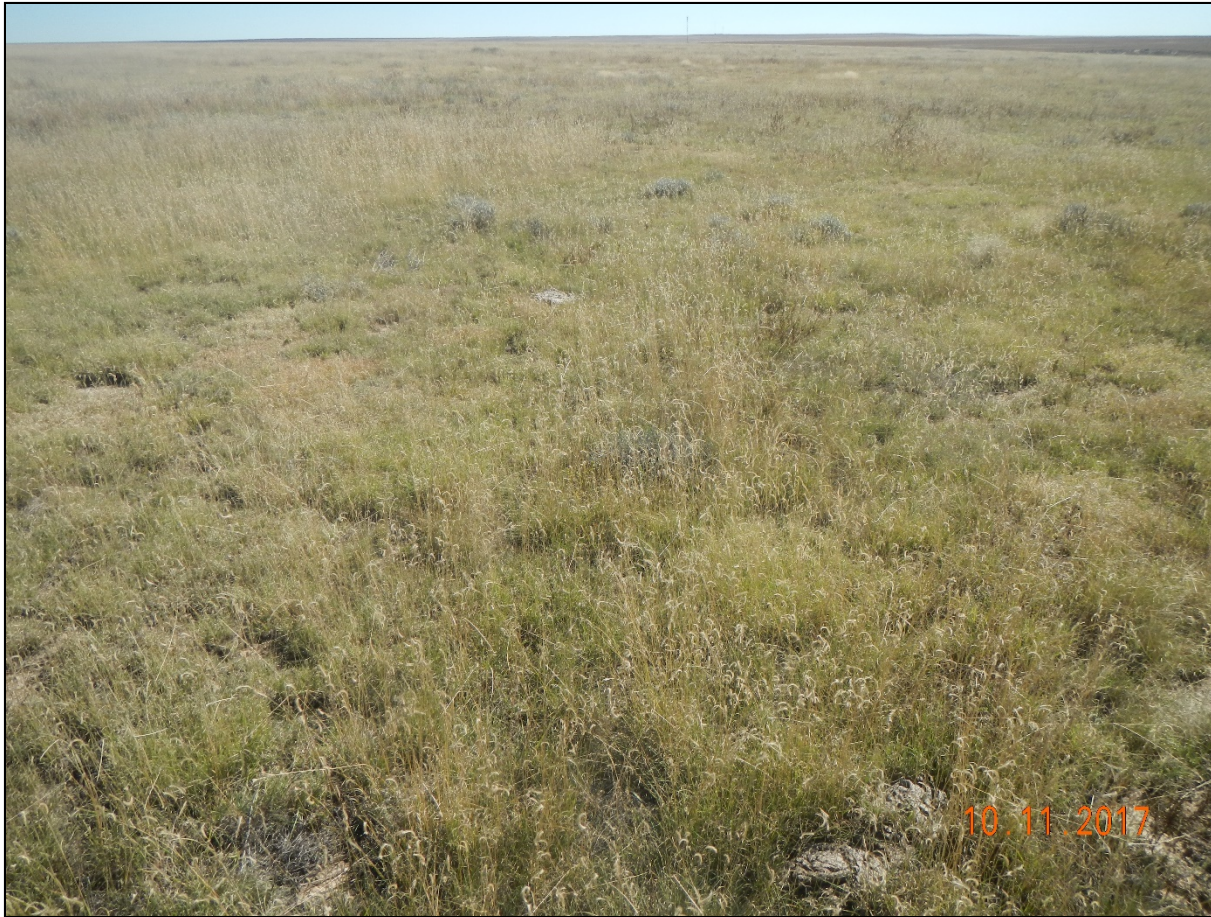
**Photo 7.** Facing east off the location toward the undisturbed vegetation.
