Inspection Photos

Operator: DONNELLY CASING PULLING CO -
24775

Location ID: 388374

Inspection Doc. Number: 6825026719
Logan County, CO

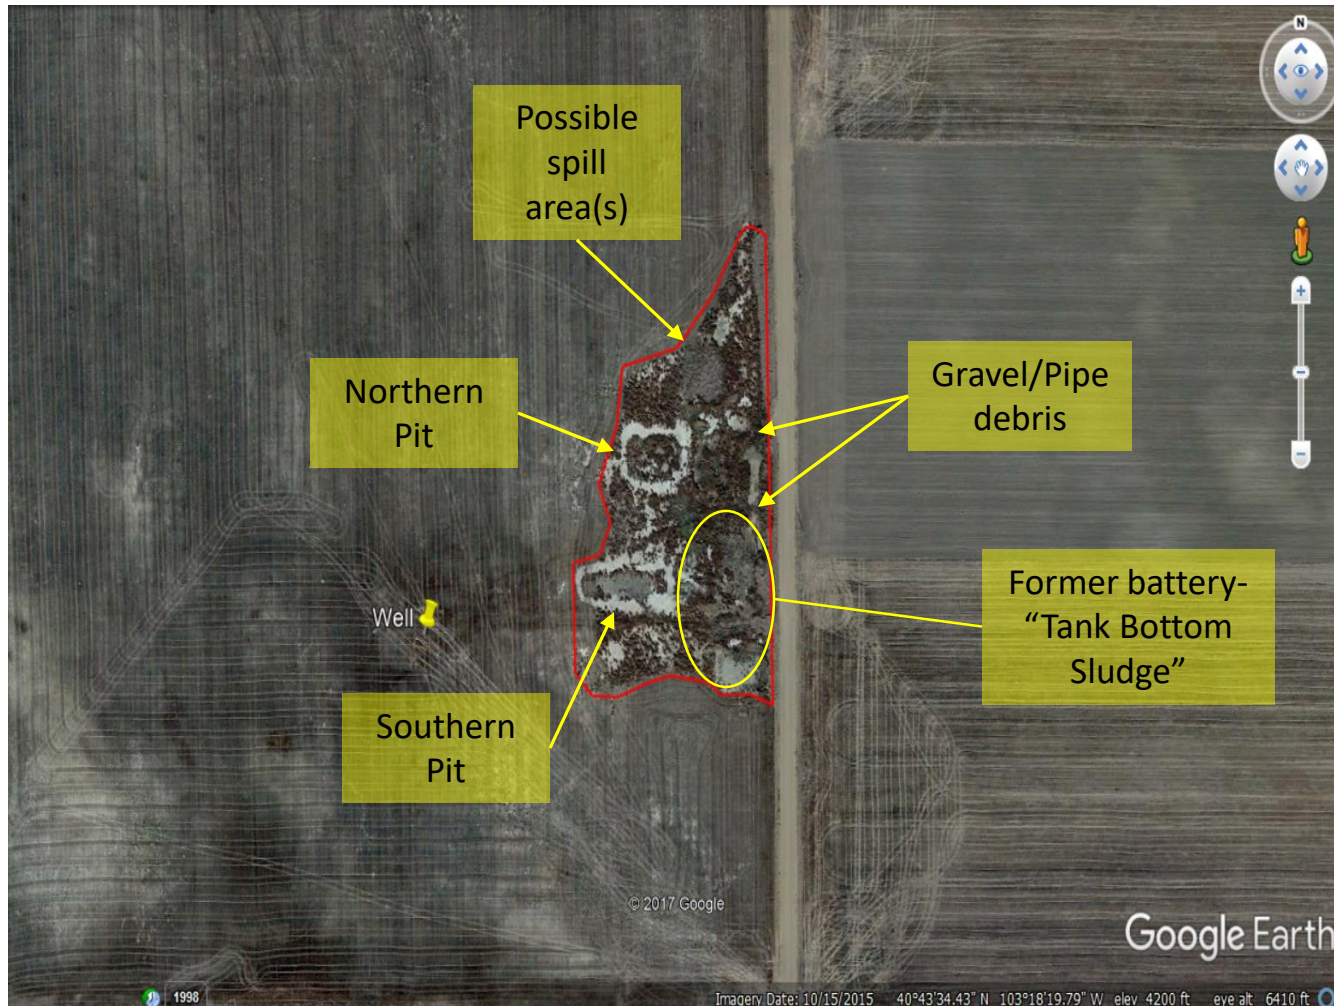
Photo 1: Current (2015) aerial imagery showing well location and former battery location (red). The disturbance size of the former battery location is ~4.3 acres in size. Photo also shows details as to what was observed in various areas of the location.

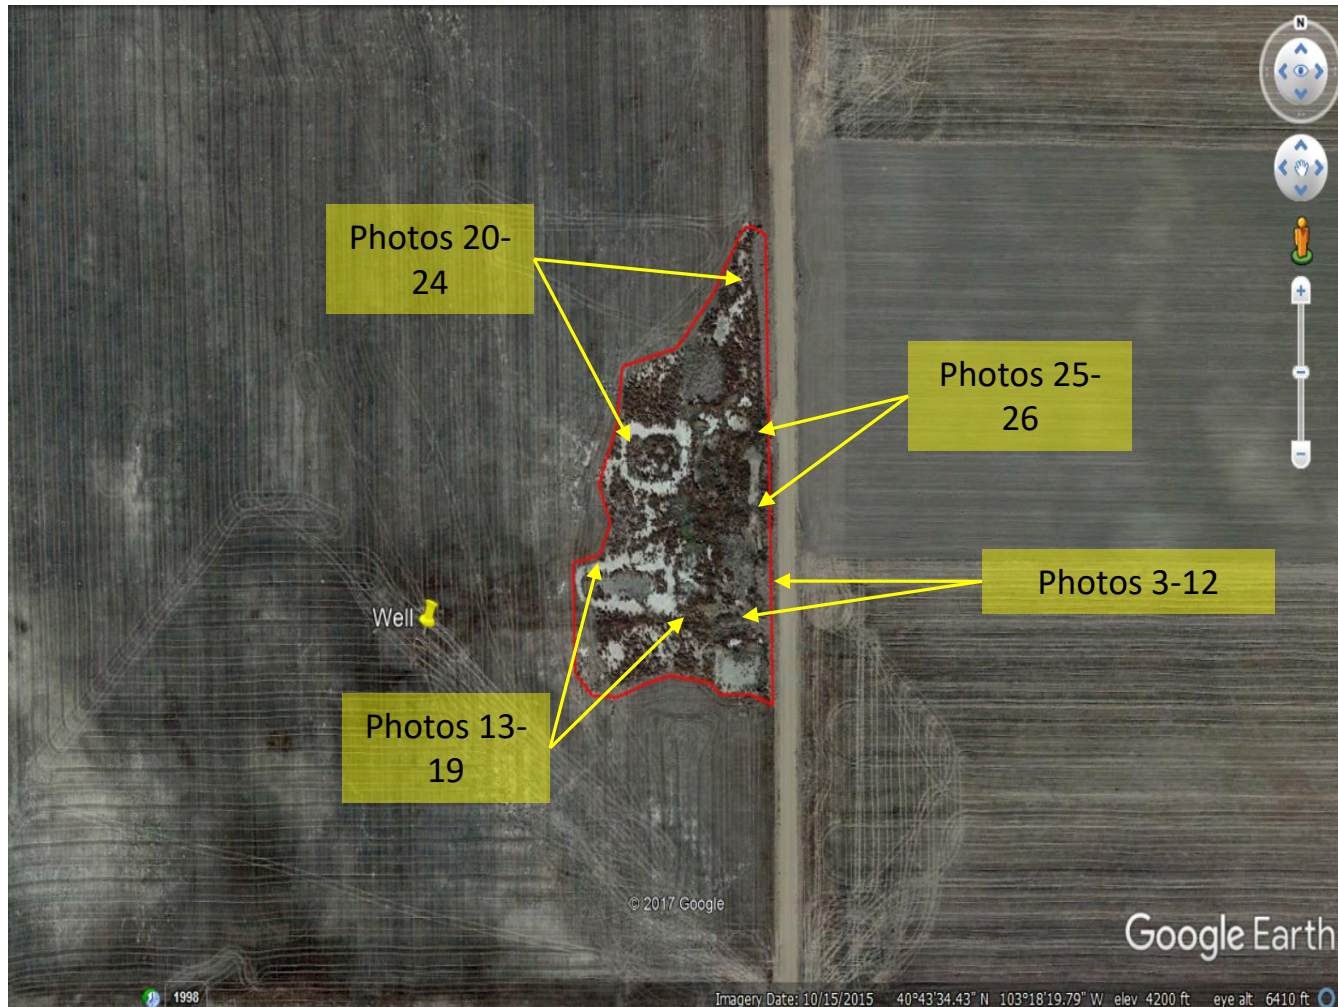
Photo 2: Image provides approximate locations of where photos in this document were taken from.

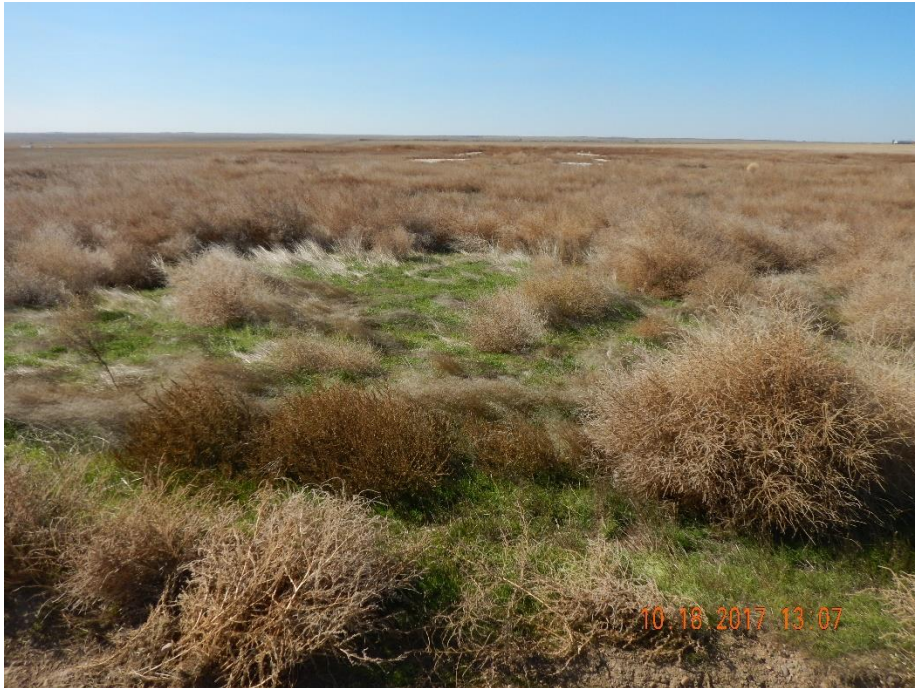
Photo 3: Photo taken from the southeast end of the former battery location, facing west. Photo shows location is predominantly undesirable weedy plant species such as Kochia, Russian thistle and Cheat grass. Well was PA'd 1992. It does not appear as though surface owner has made any attempts to farm within tank battery disturbance area.

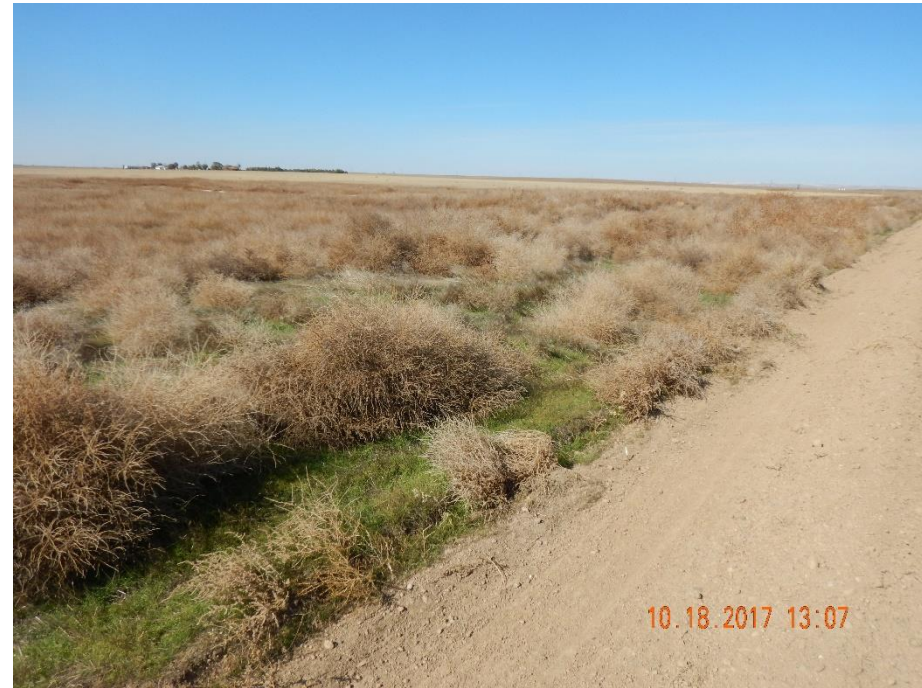
Photo 4: Photo taken from the southeast end of the former battery location, facing northwest. See comments under photo 3.

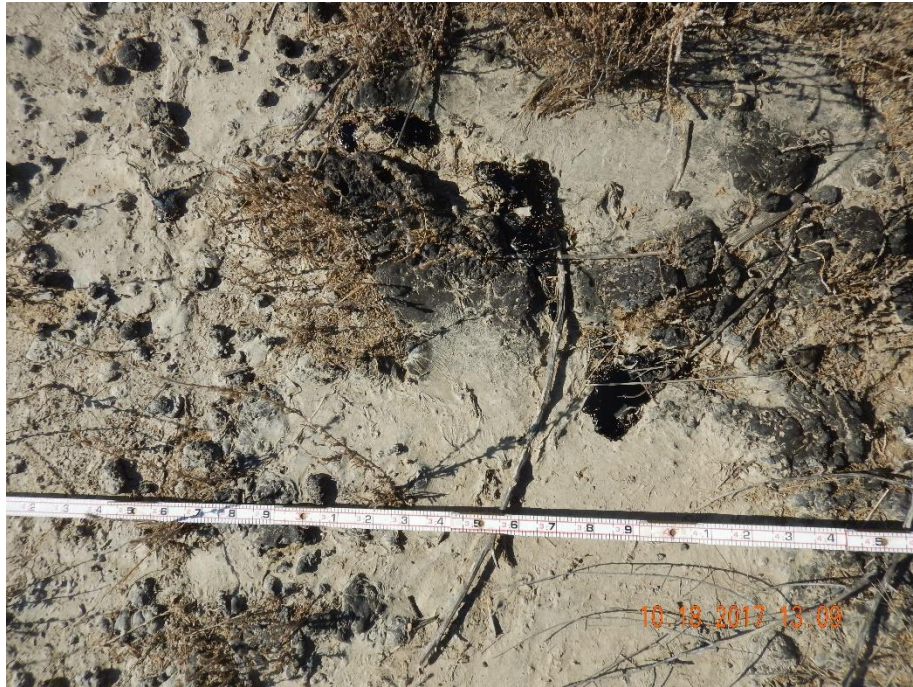
Photo 5: Photo taken from the southern end of the battery location. What appears to be oil waste, possibly from tank bottoms, covers large areas of the battery location. It is unclear as to how thick, or much thick there waste is. These areas feel soft when stood upon, are malleable and sticky.

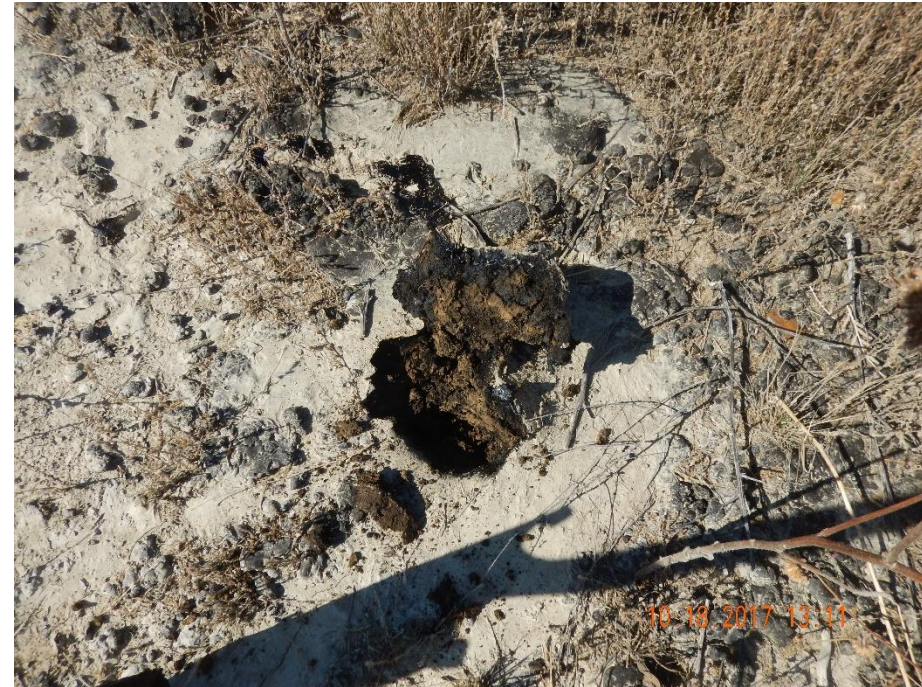
Photo 6: Continued from photo 3. Photo shows Inspector dug into the waste material for a more in-depth look.

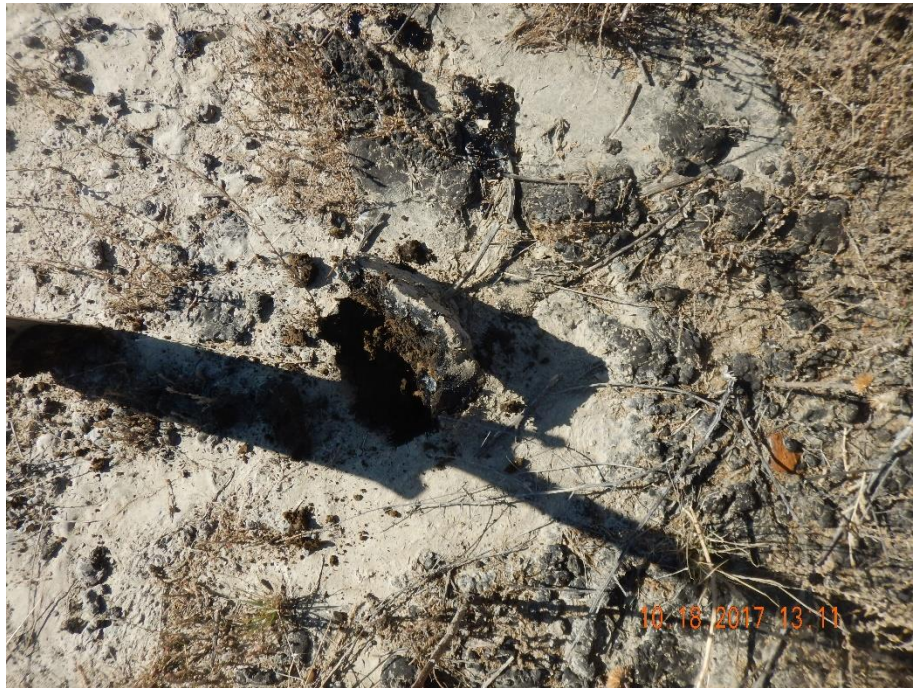
Photo 7: Continued from photo 3. Photo shows Inspector dug into the waste material for a more in-depth look.

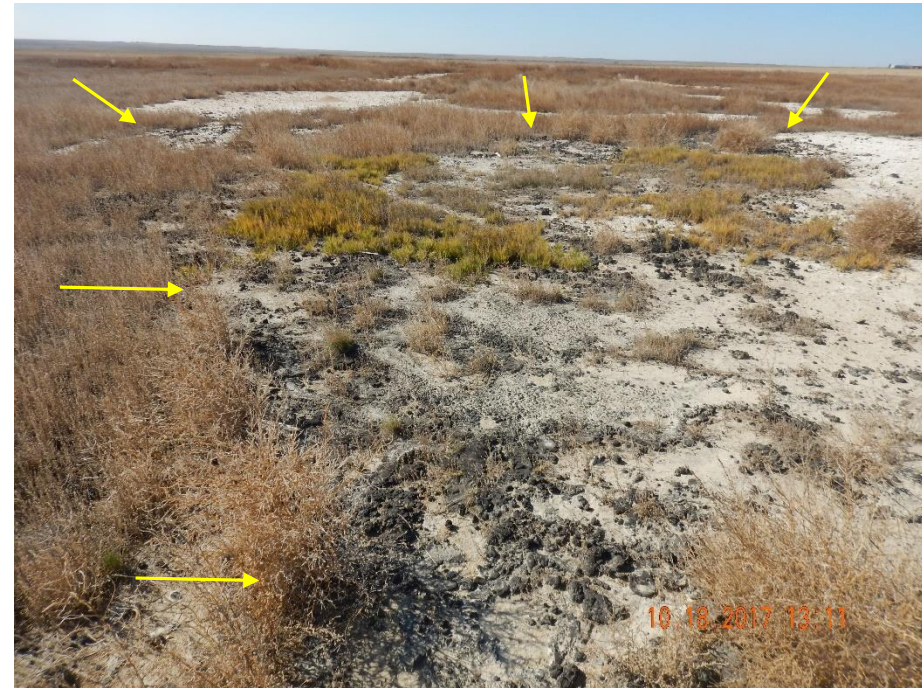
Photo 8: Photo taken from the south end of the battery location, facing west. Photo shows what appears to be oil waste, possibly from tank bottoms, covering large areas of the battery location.

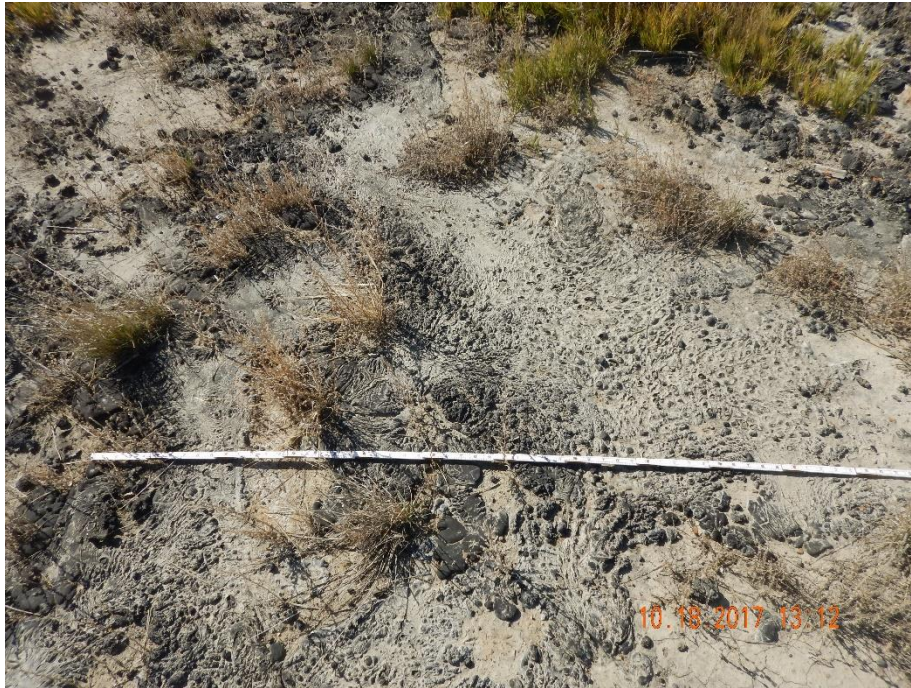
Photo 9: Photo taken from the south end of the battery location, facing west. Additional photo showing what appears to be oil waste left at the battery location.

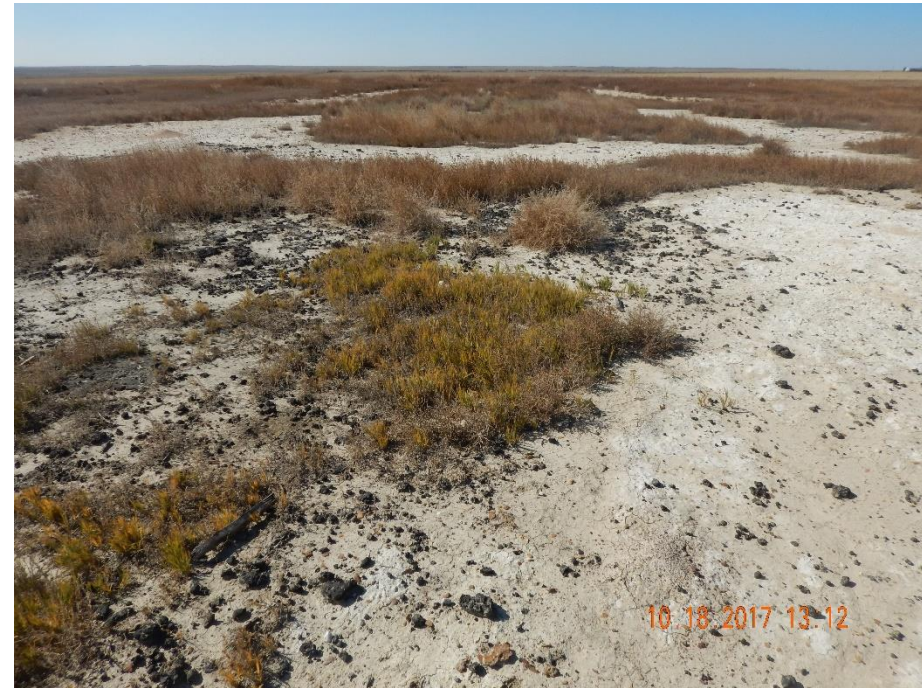
Photo 10: Photo taken from the east end of the southern pit. Photo shows additional areas where what appears to be oil waste has been left at the battery location. Photo also shows large areas around the pit that remains bare and exposed soil. Surface soil features are similar to those seen at salt kills.

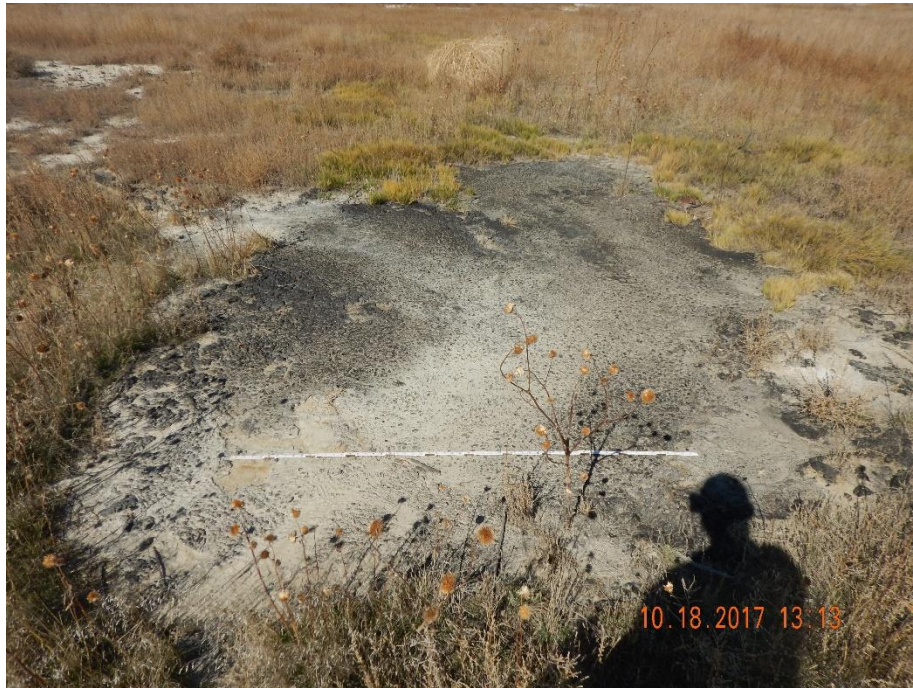
Photo 11: Photo taken from the south end of the battery location. Additional photo showing what appears to be oil waste left at the battery location.

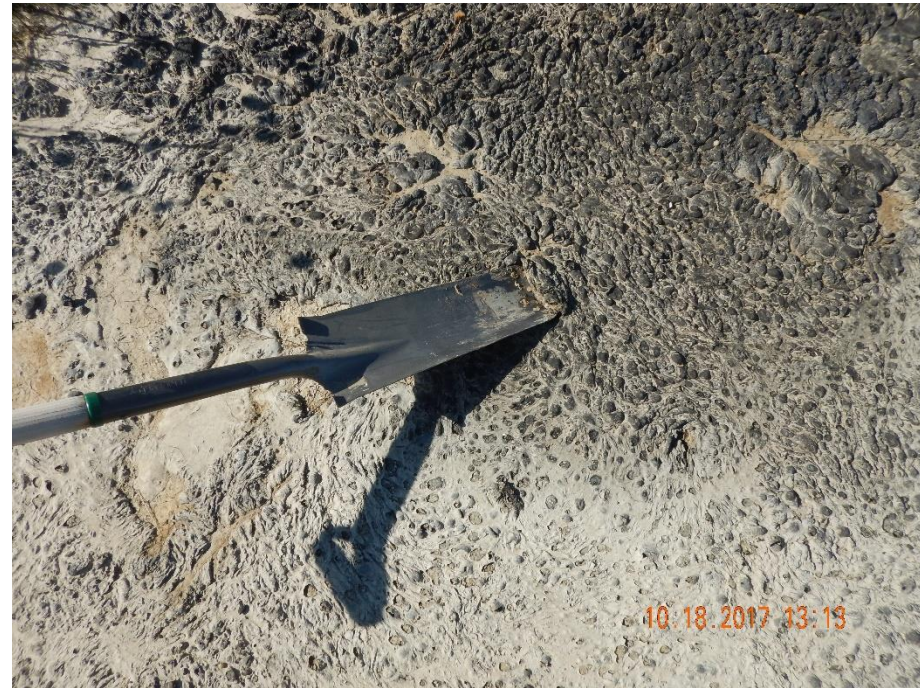
Photo 12: Continued from photo 11. Inspector easily placed the tip of his shovel into the waste material to show how malleable soft the waste material remaining on the location is.

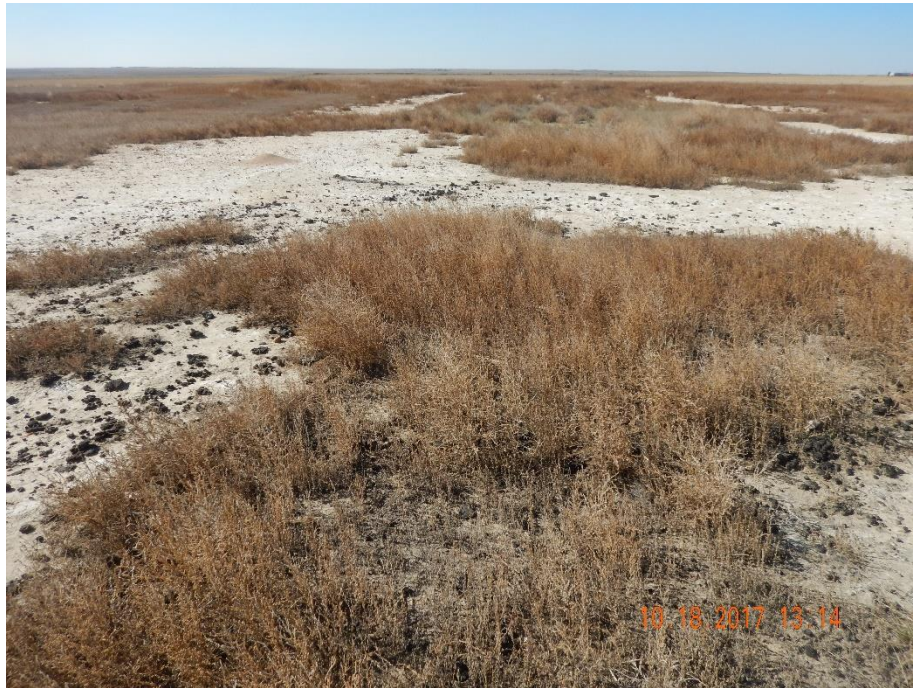
Photo 13: Photo taken from the southeast end of the southern pit, facing west. Photo shows large areas around the pit that remains bare and exposed soil. Surface soil features are similar to those seen at salt kills. Photos 13-15 shows a “panoramic view” from west to north, of the former battery from the southern end.

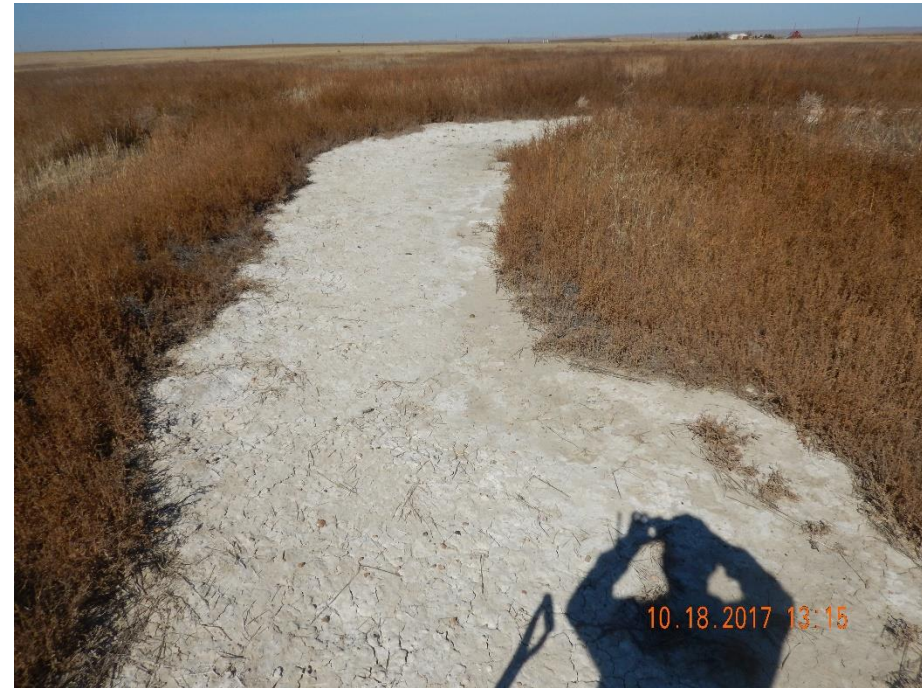
Photo 16: Photo taken from the southwest corner of the battery location, and the southern pit area, facing north. Photo shows large areas around the pit that remains bare and exposed soil. Surface soil features are similar to those seen at salt kills.

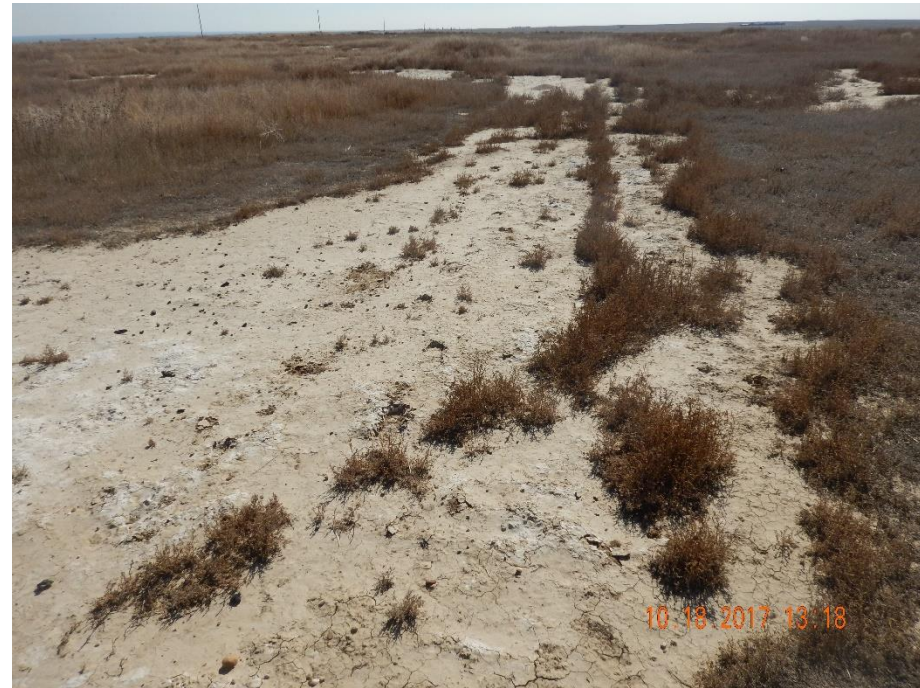
Photo 20: Photo taken from the northwest corner of the northern pit area, facing south. Photo shows large areas around the pit that remains bare and exposed soil. Surface soil features are similar to those seen at salt kills.

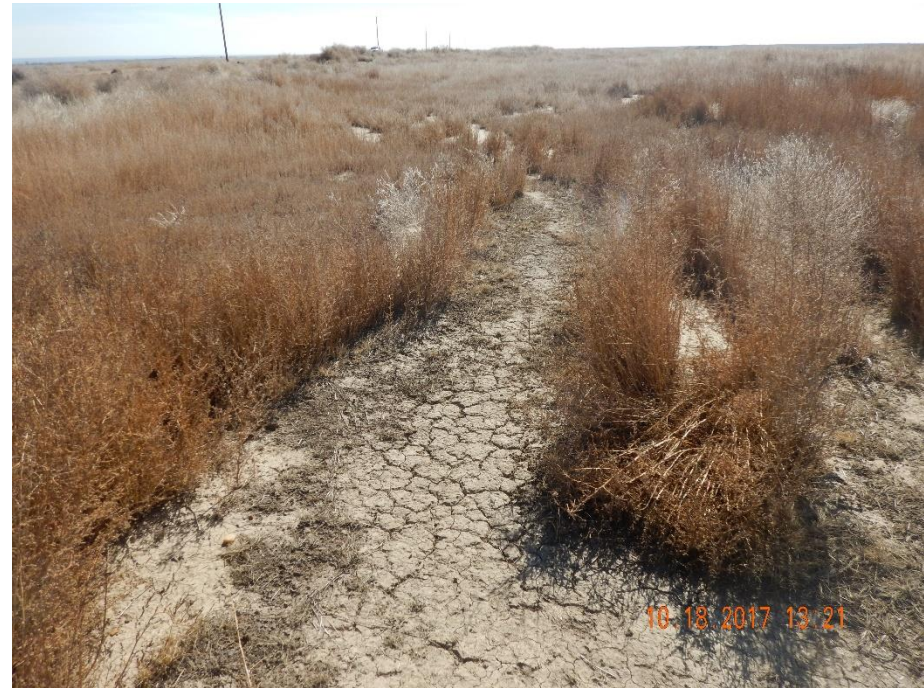
Photo 24: Photo taken from the north end of the location, facing south. Photo shows large areas beyond the pits that are bare and exposed soil, or predominantly undesirable weedy plant species. Surface soil features are similar to those seen at salt kills.

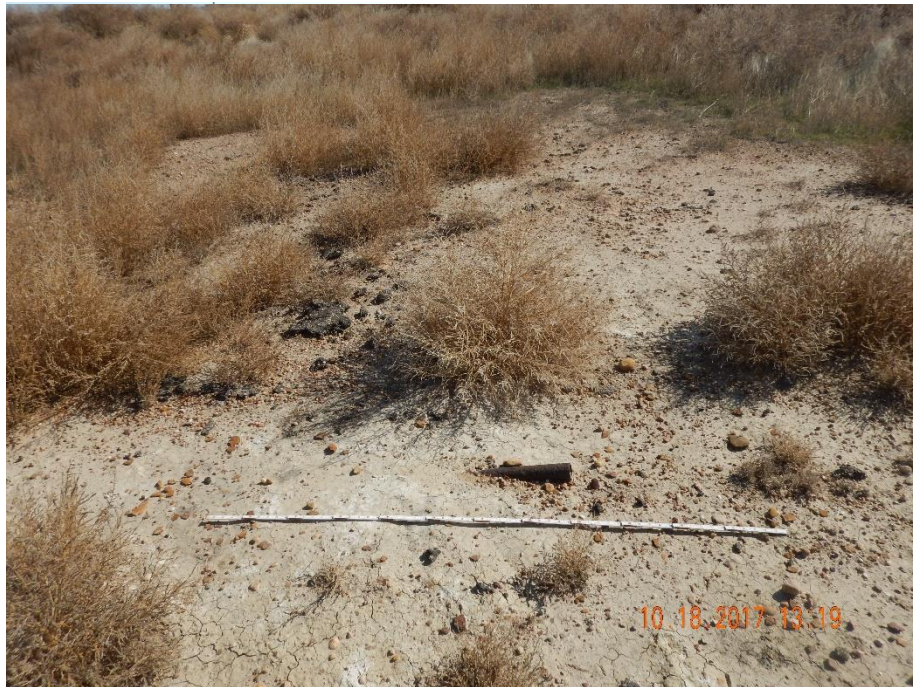
Photo 25: Photo taken from the east end of the location. Photo shows gravel and asphalt still remain on the location. Photo also shows pipe debris. 6 foot measuring stick for reference.

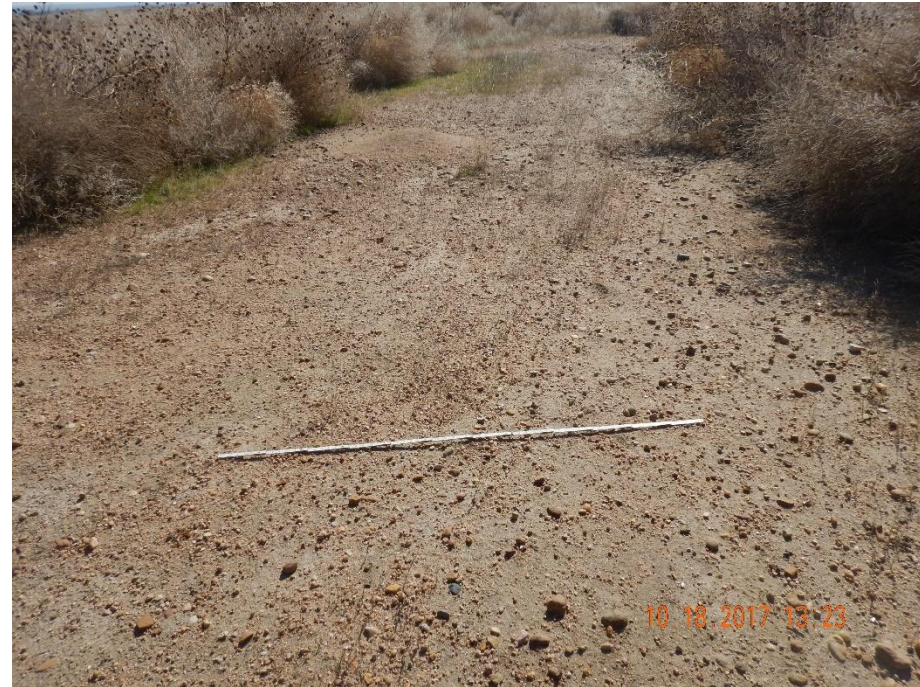
Photo 26: Photo taken from the east end of the location. Photo shows gravel remaining on the location. 6 foot measuring stick for reference.

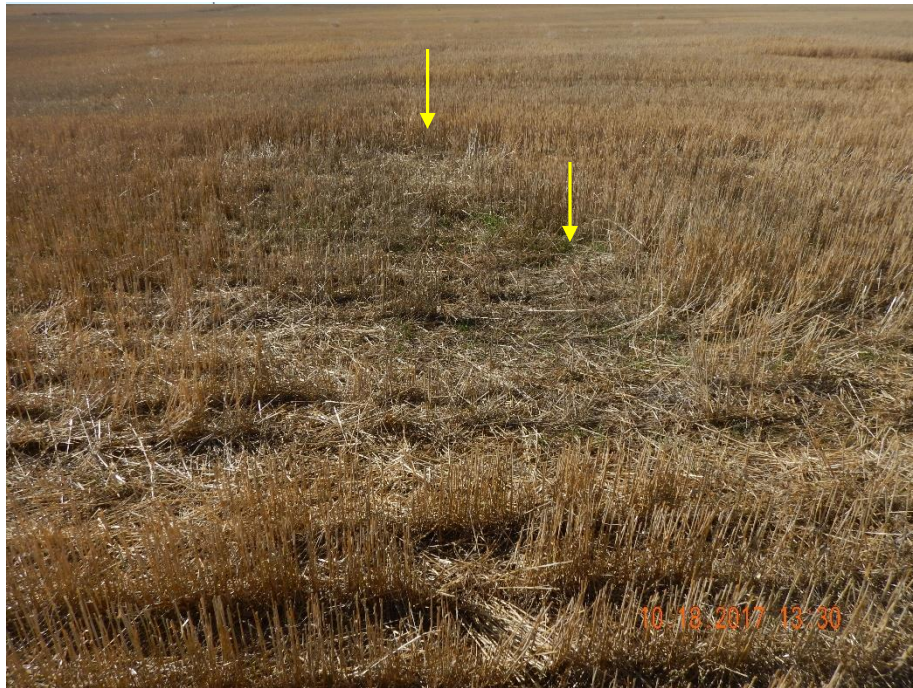
Photo 26: Photo taken from the well location, facing west. Well area does not appear to have established uniformly compared to reference. However, a follow-up will need to be performed when crop is growing to verify this.

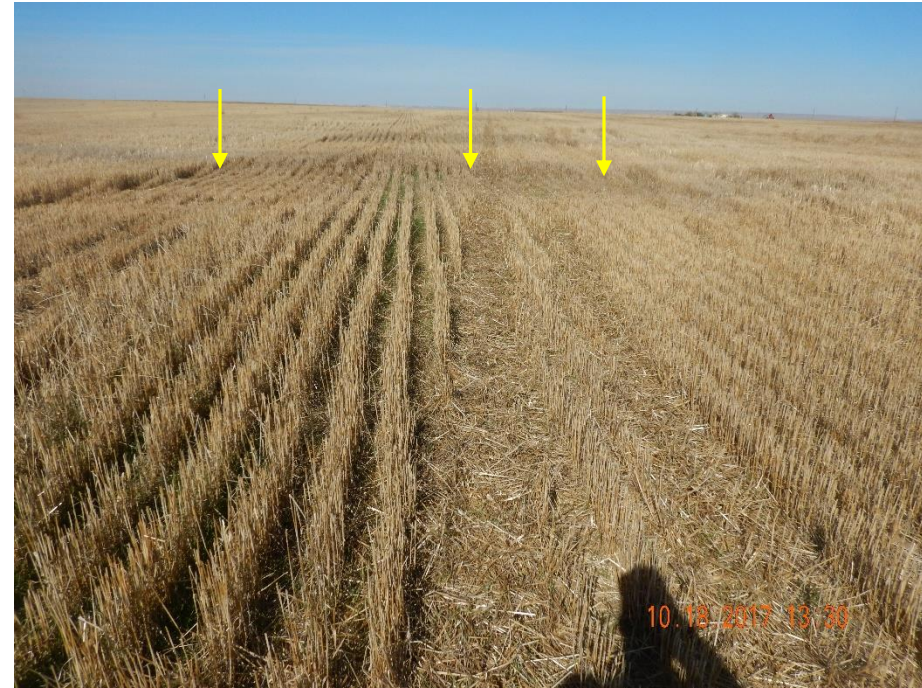
Photo 27: Photo taken from the well location, facing west. Areas of the well does not appear to have established uniformly compared to reference. However, a follow-up will need to be performed when crop is growing to verify this.
