Inspection Photos

10/18/2017

Operator: DENVER EAST MACHINERY COMPANY
- 24040

Location ID: 390528

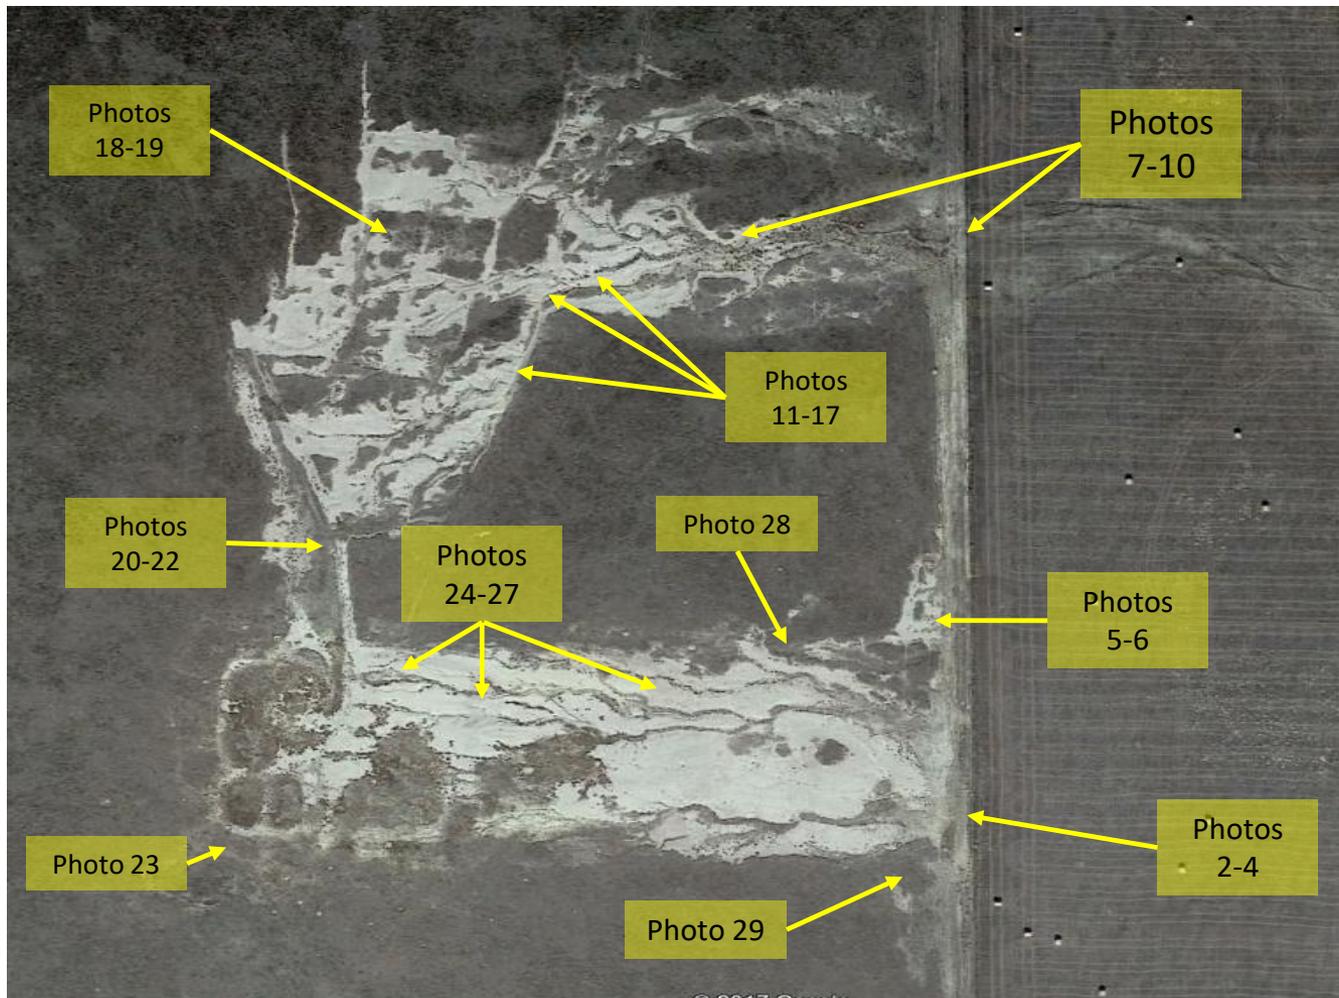
Photo 1: Current (2015) available aerial imagery. Photo shows overview of location and areas where the following photos were taken from.

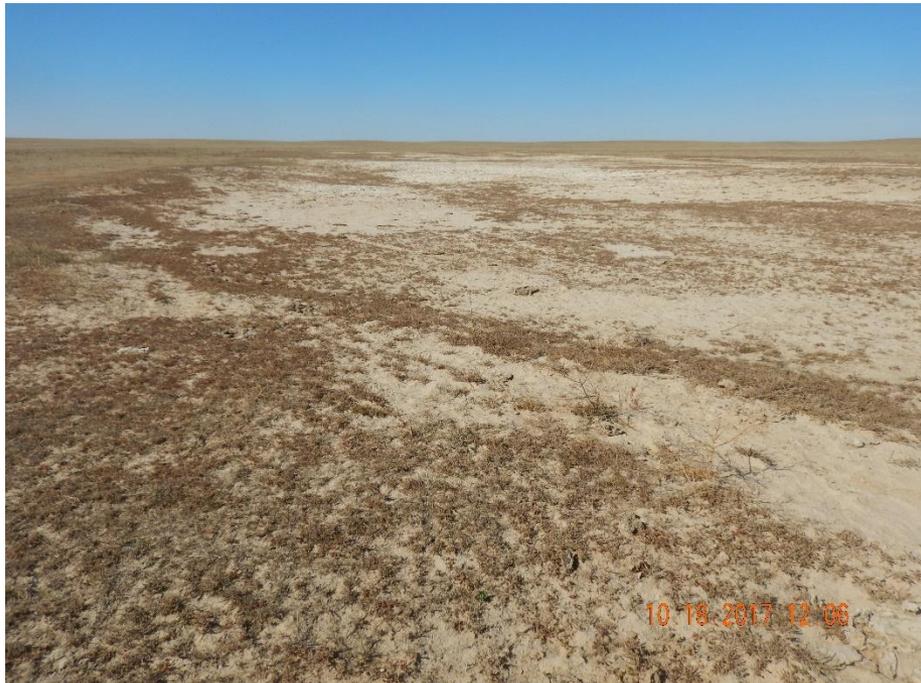
Photo 2: Photos 2-4 show a “panoramic image” taken from the southeast end of the disturbance area, beginning facing west and moving to the north, showing an overview of the disturbance area.

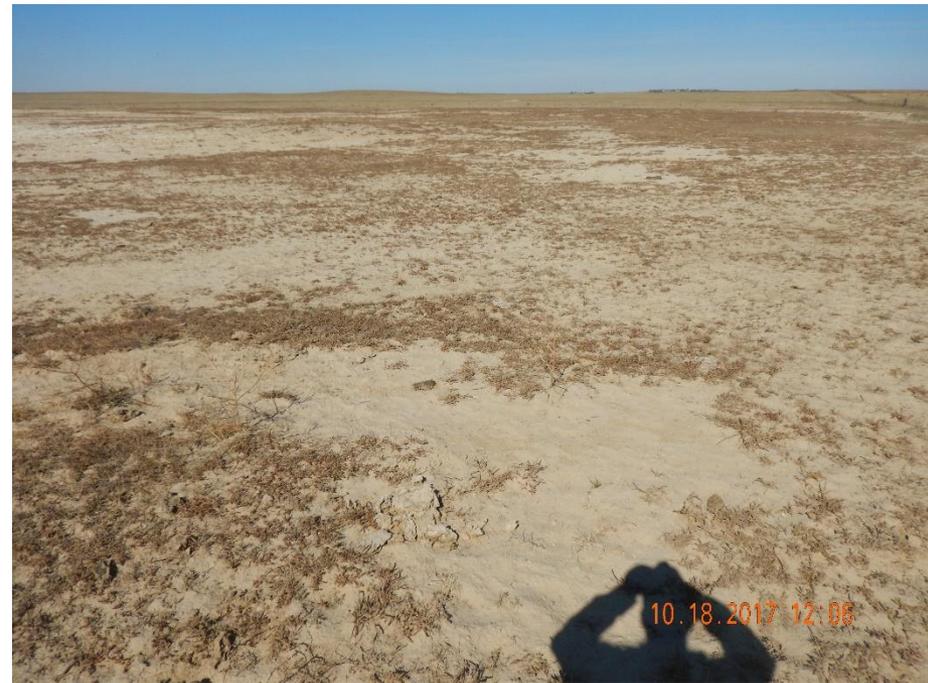
Photo 3: Photo taken from the southeast end, facing northwest.

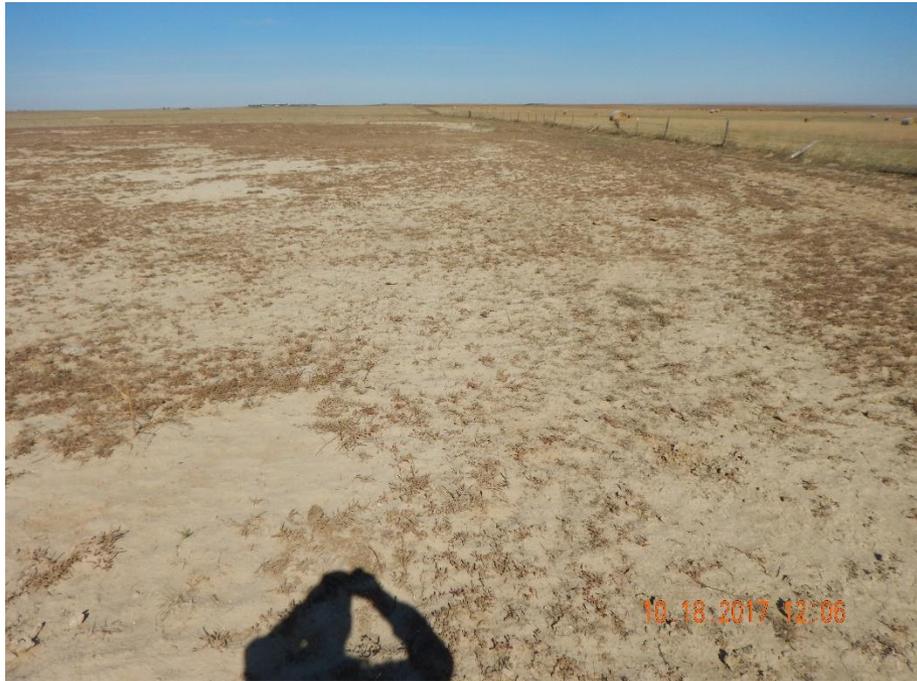
Photo 4: Photo taken from the southeast end, facing north.

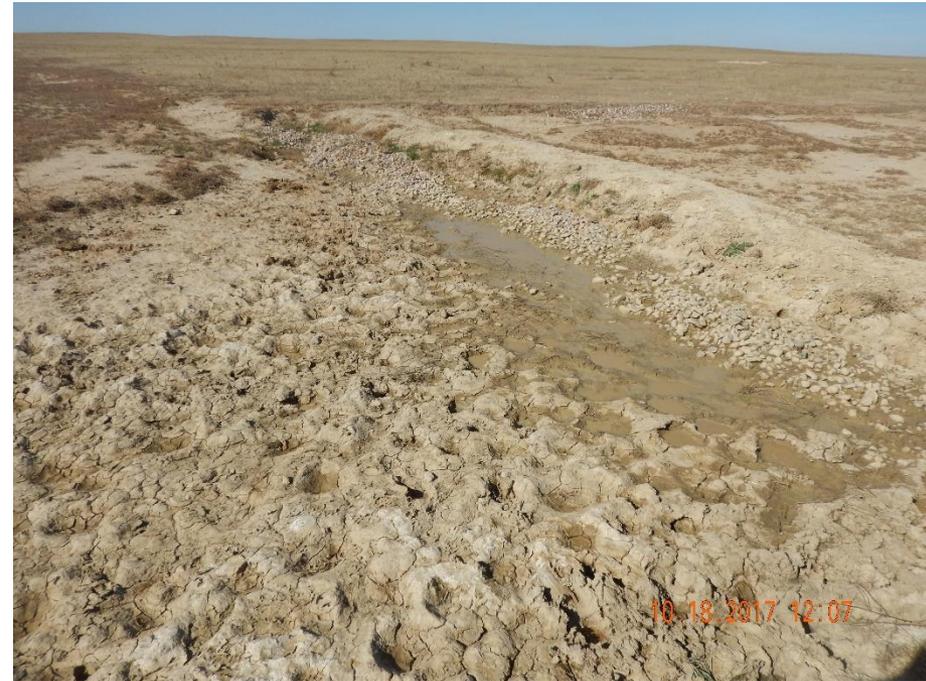
Photo 5: Photo taken from the east end of the location, facing west. Photo shows what appears to be a berm, with rock aggregate at the base to trap sediment. Aggregate appears to have filled with sediment in areas. Portions of the BMP on the east end (see photo 6) have eroded out.

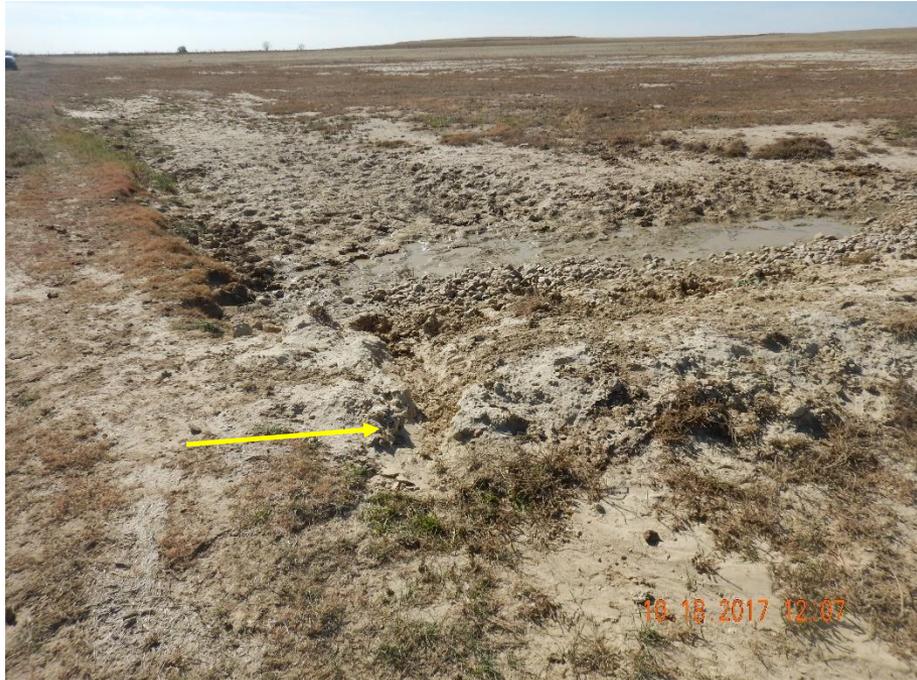
Photo 6: Photo taken from the east end of the location, facing southwest. Continued from photo 5. Photo shows area of the BMP that has been eroded out.

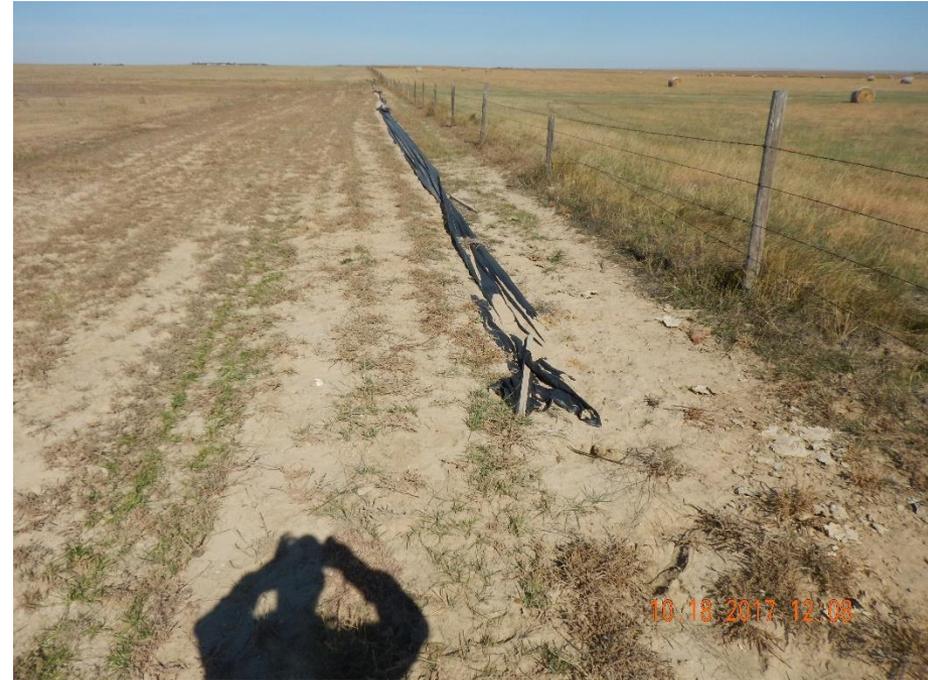
Photo 7: Photo taken from the east end of the disturbance, facing north. Photo shows silt fence BMP that is in disrepair and no longer in proper functioning condition.

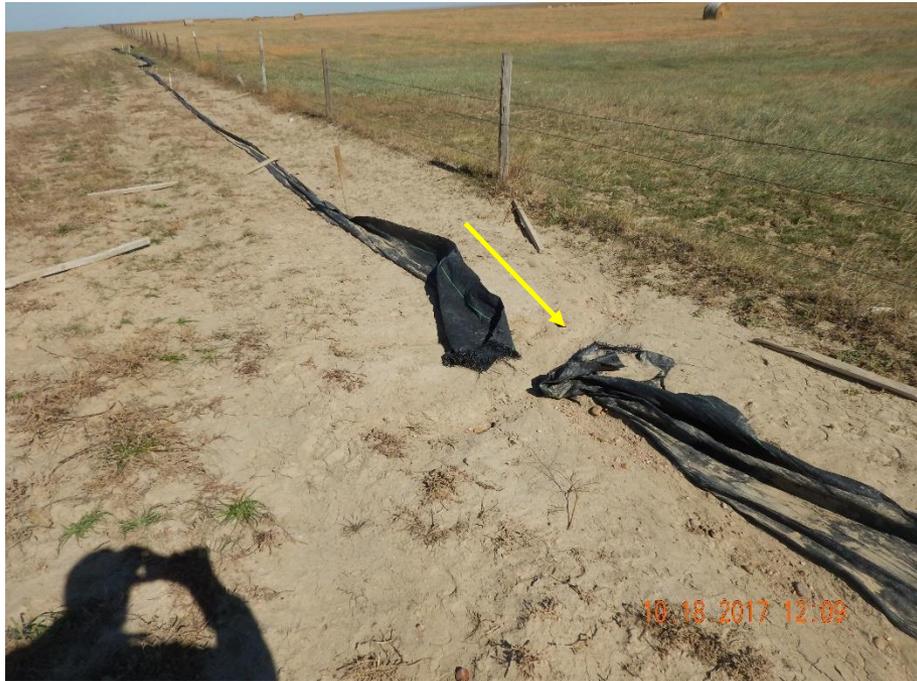
Photo 8: Photo taken from the east end of the disturbance, facing north. Photo shows silt fence BMP that is in disrepair and no longer in proper functioning condition. Photo also shows gully erosion beginning to reform and lead onto adjacent lands.

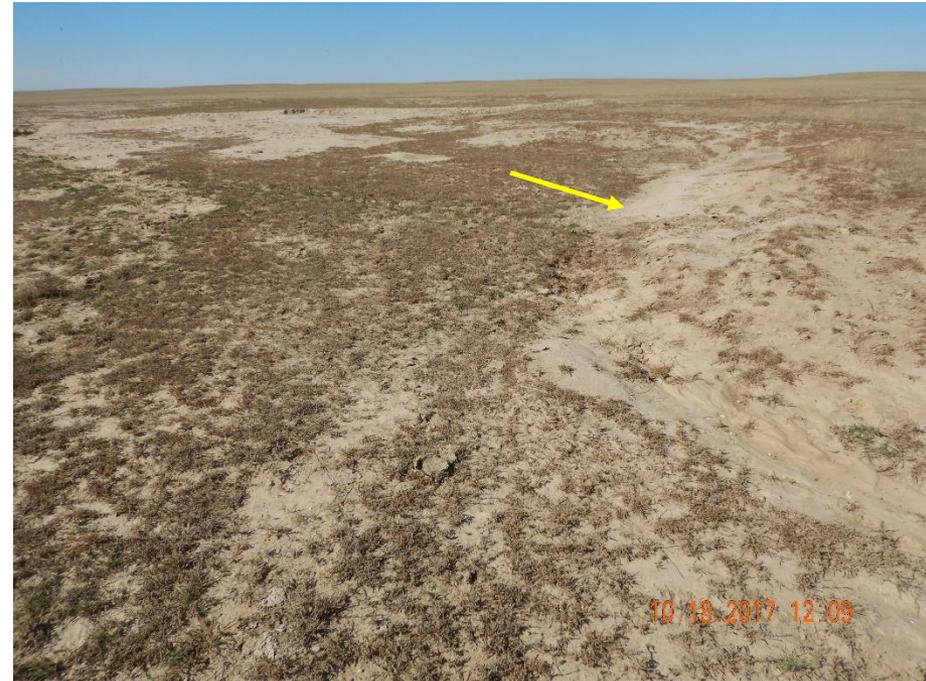
Photo 9: Photo taken from the northeast end of the disturbance, facing west. Photo shows sotrmwater erosion degradation reoccurring on the site.

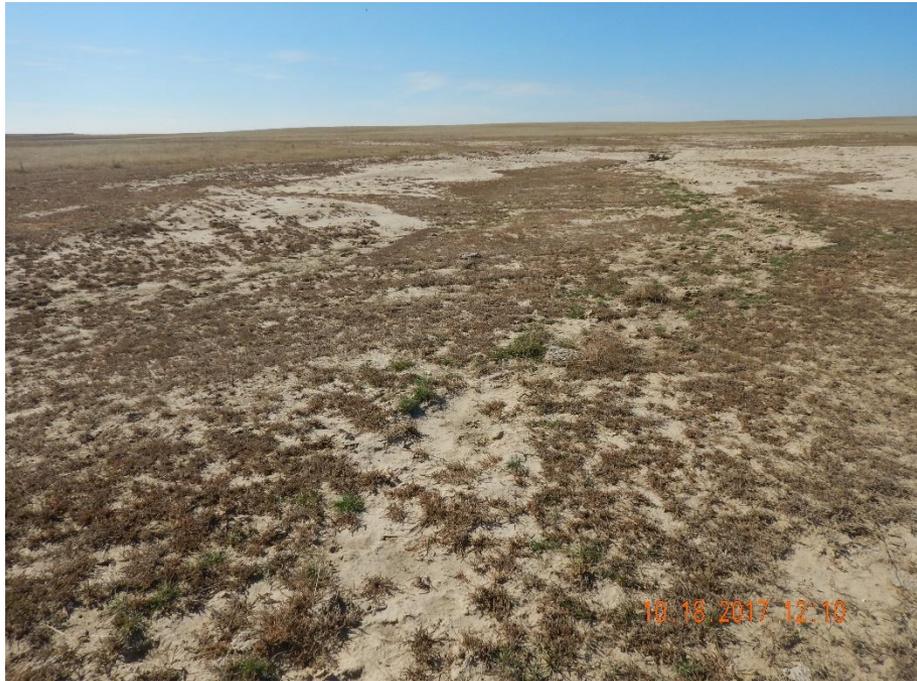
Photo 10: Photo taken from the northeast end of the disturbance, facing west

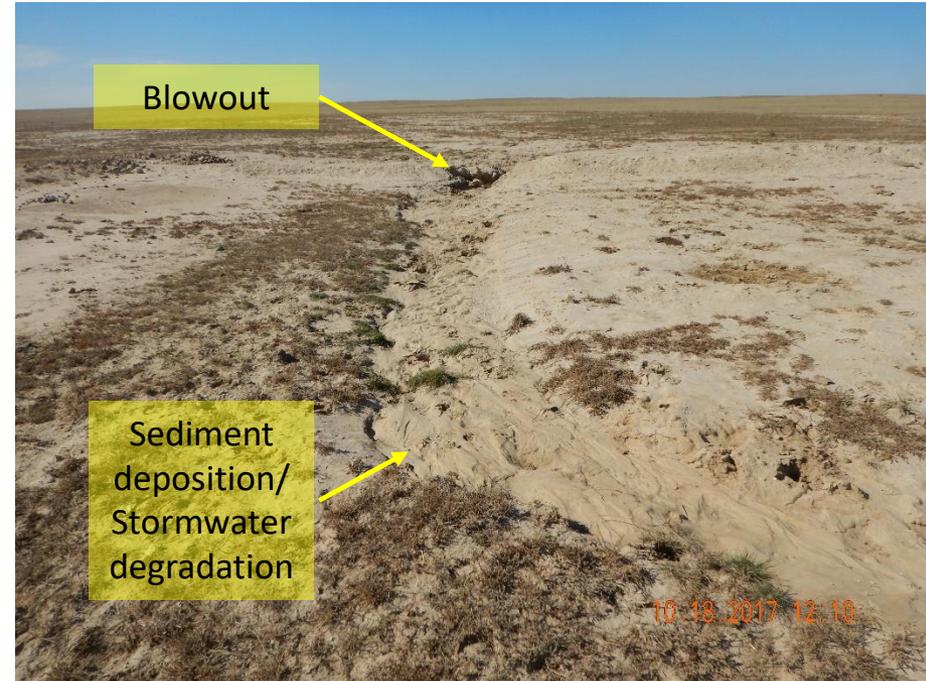
Photo 11: Photo taken from the north end of the disturbance, facing west. Photo shows what appears to be a berm used to pond stormwater installed by the operator no longer in proper functioning conduction. The berm has been blown out towards it's center, with stormwater causing degradation below grade. It does not appear BMP had been constructed with an appropriate spillway.

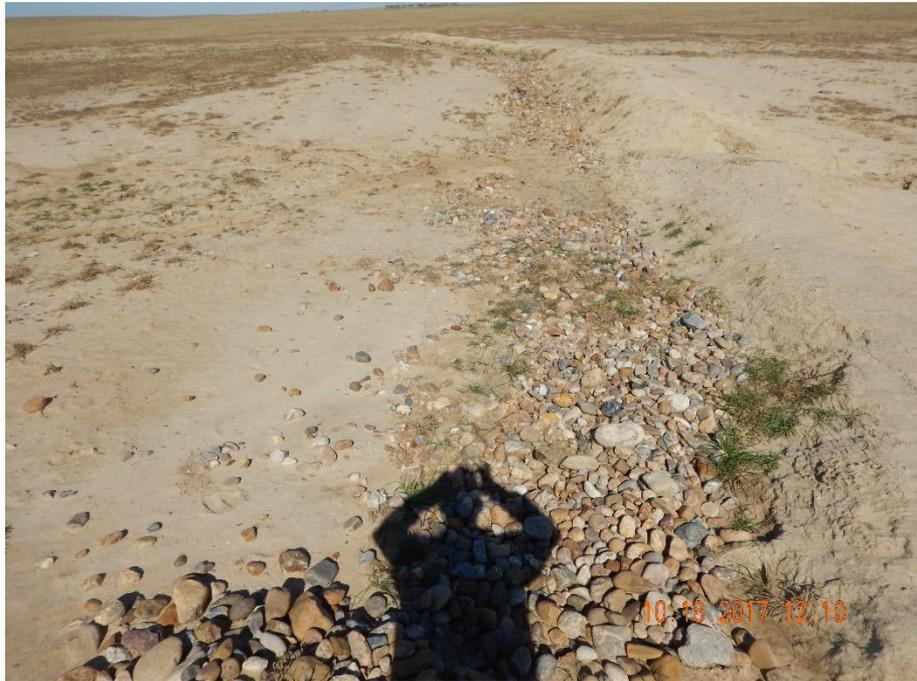
Photo 12: Photo taken from the south end of the south end of the catchment BMP seen in photo 11.

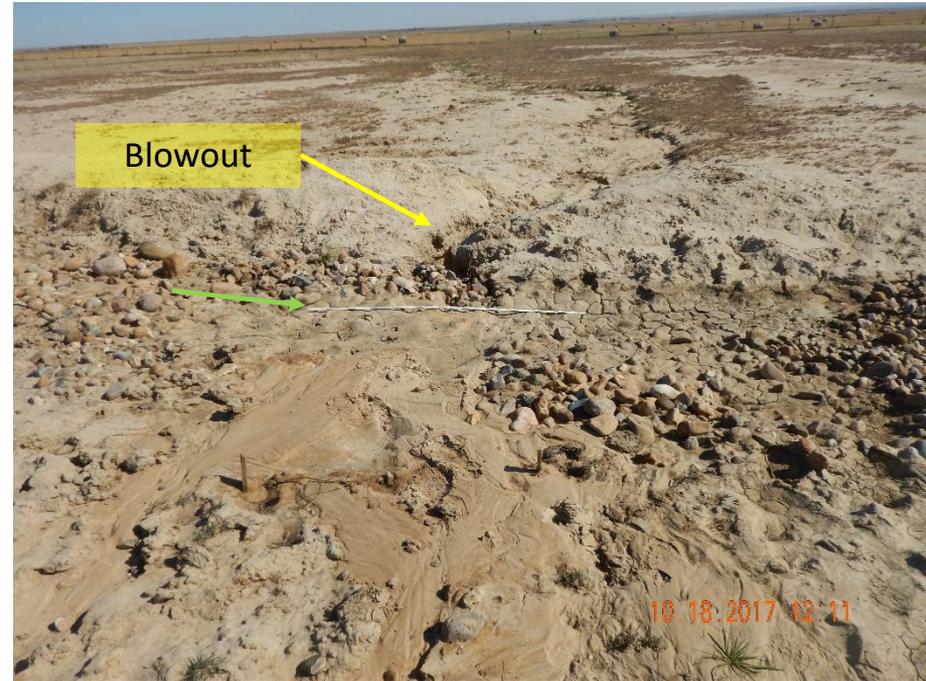
Photo 13: Photo taken from the west end of berm seen in photo 11, facing east. Photo shows sediment deposition has filled the rock aggregate lined at the base of the BMP. Photo also shows area where stormwater has blown out the dam. 6 foot measuring stick (green arrow) used for reference.

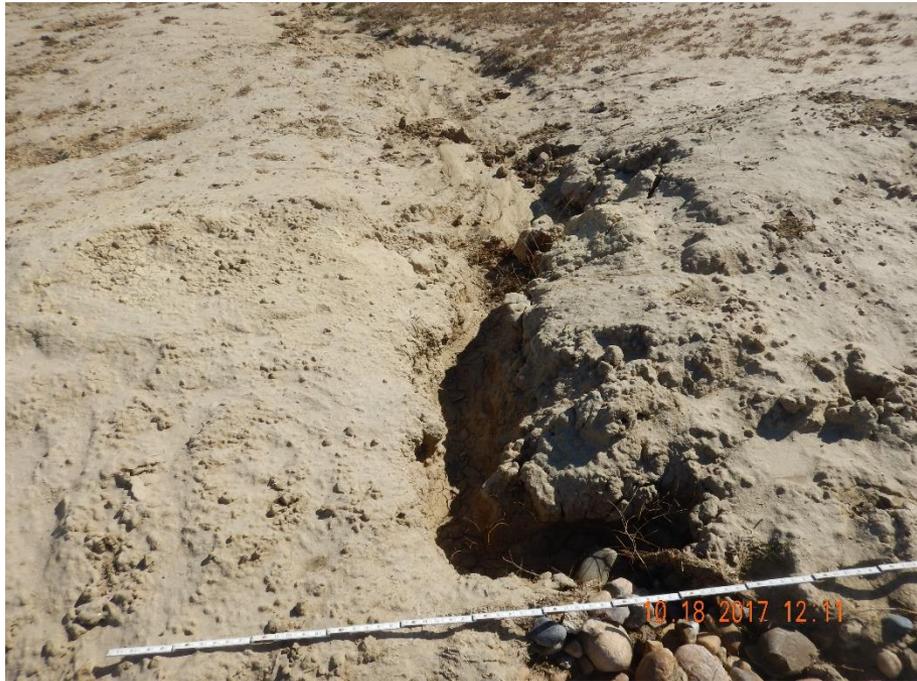
Photo 14: Closer look at blowout seen in previous photos. 6 foot measuring stick for reference.

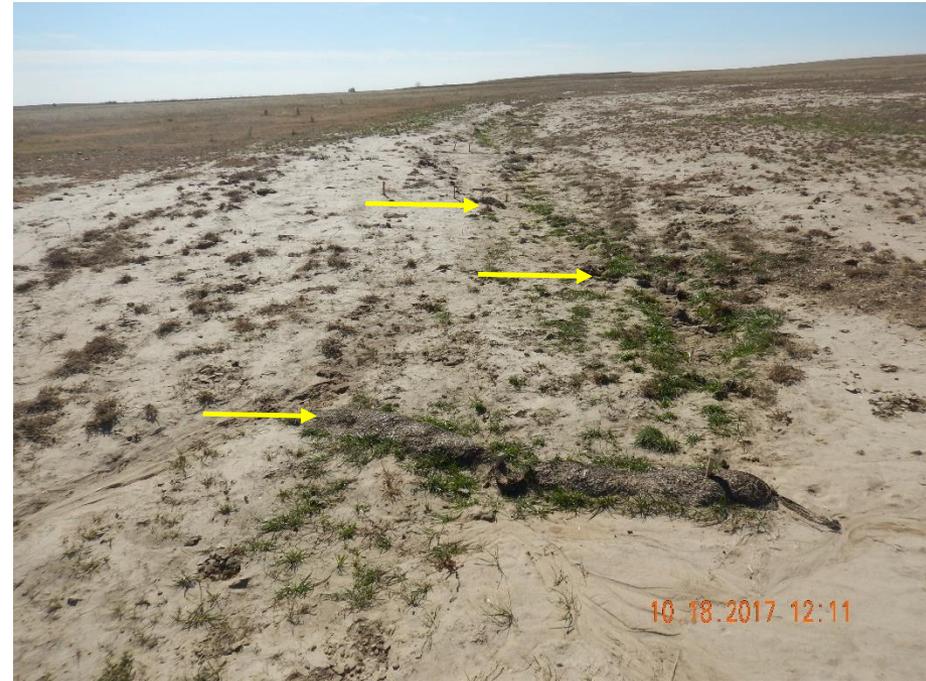
Photo 15: Photo taken from the south end of the berm in photos 11-14, facing south. Photo shows a drainage where operator had installed straw wattles. Wattles observed here were in disrepair and no longer in proper functioning condition. Stormwater BMPs have not been maintained.

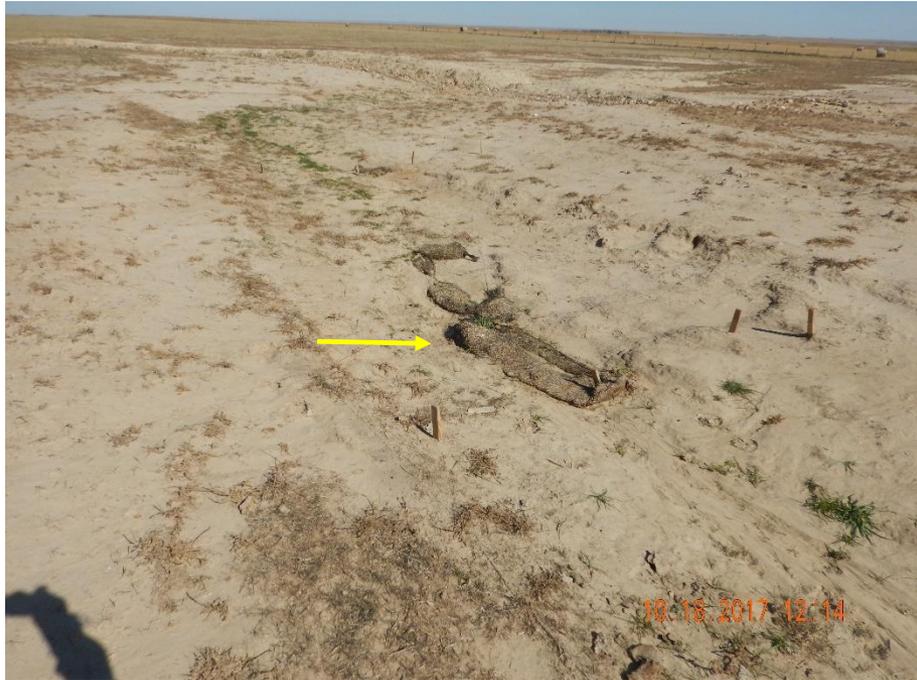
Photo 16: Additional photos continued from photo 15 showing straw wattle BMPs in disrepair. These wattles are now debris and needs to be repaired or removed and properly disposed.

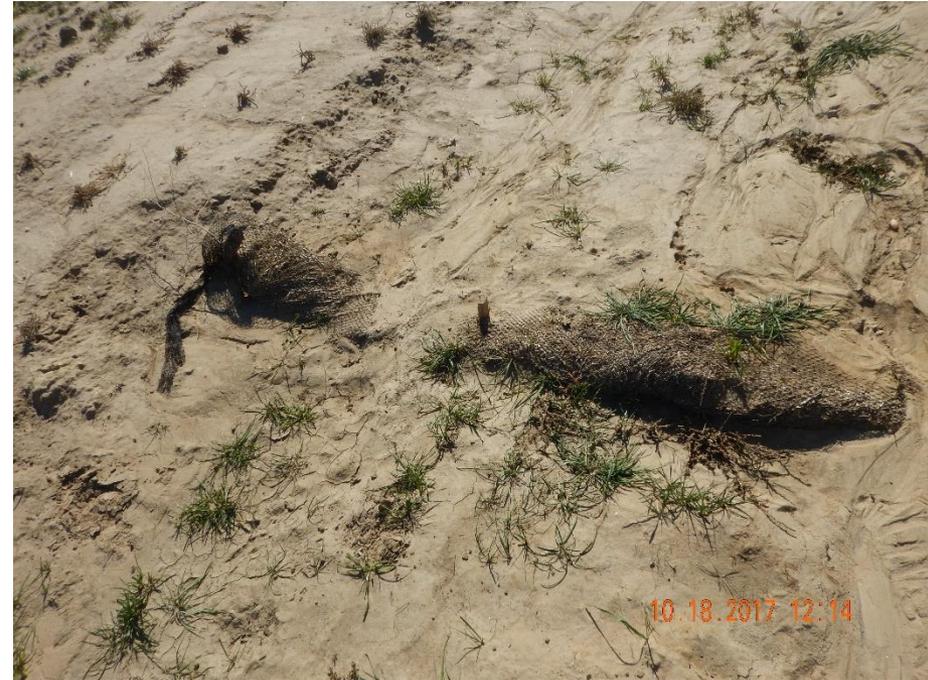
Photo 17: Continued from photo 16. Photo show straw wattle in disrepair.

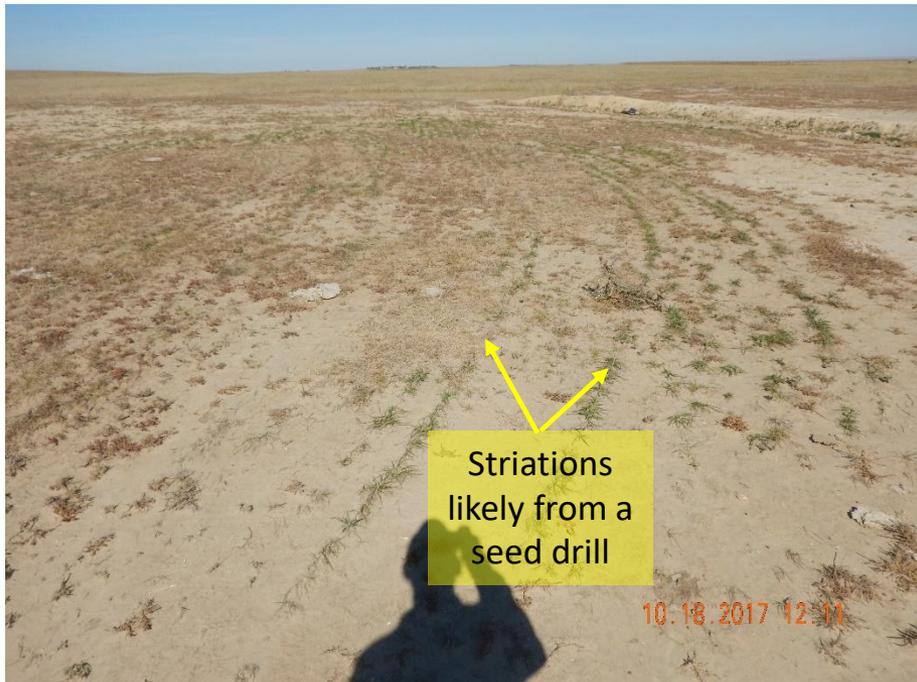
Photo 18: Photo taken from the north end of the disturbance area, facing north. Photo shows striations in the soil indicating areas of the site had previously been seeded. Though some germination is evident, it does not appear the site as a whole is progressing towards reclamation requirements.

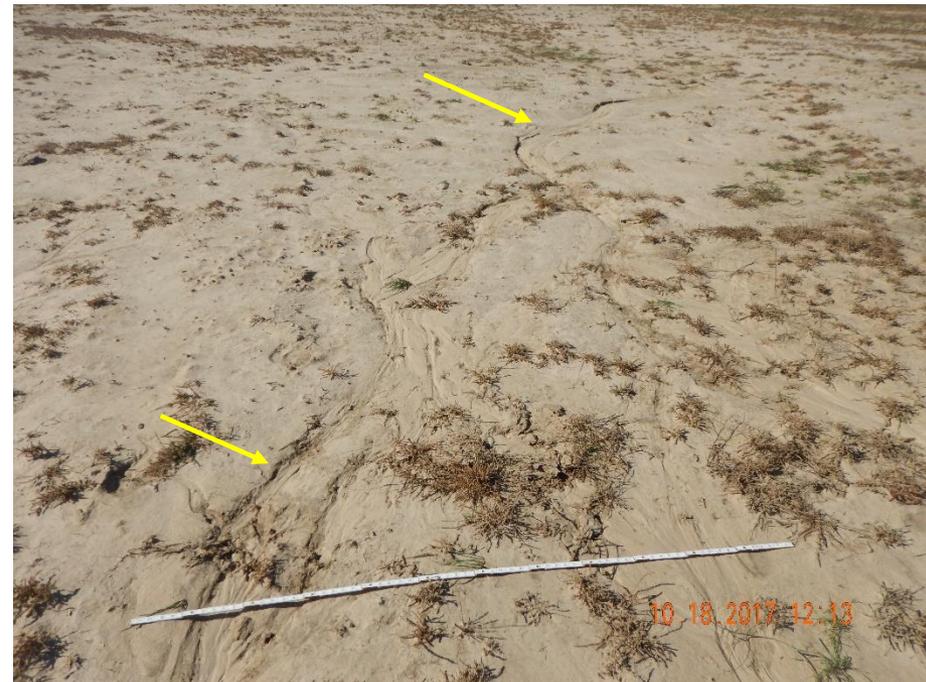
Photo 19: Photo taken from the north end of the disturbance area. Photo shows water movement patterns, and stormwater erosion beginning to reform shallow gullies and degrading the site. 6 foot measuring stick for reference

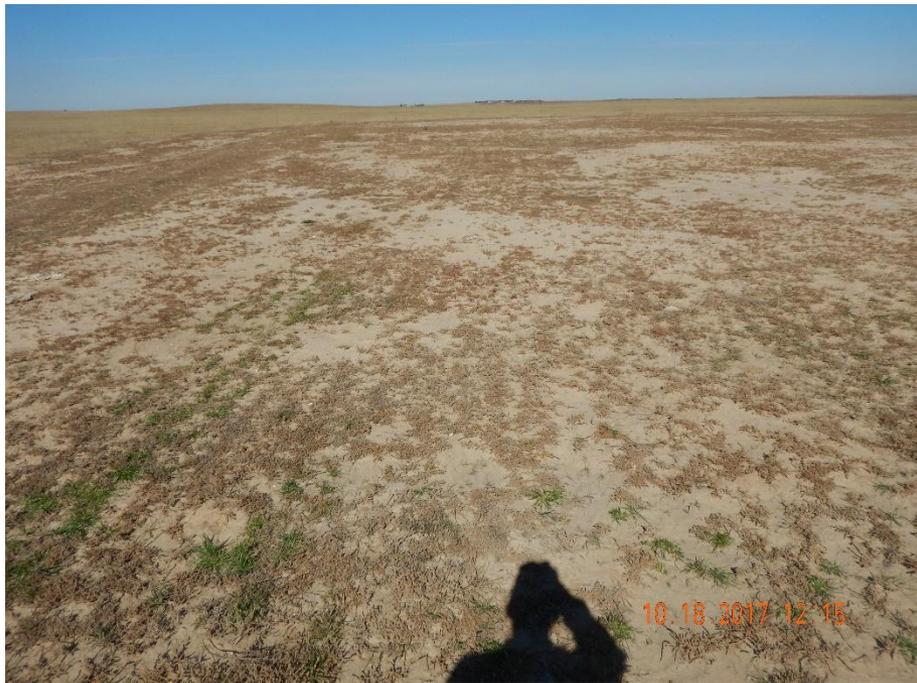
Photo 20: Photos 20- 21 show a “panoramic image” taken from the central, west end of the disturbance area, facing north moving to the northeast. Photos show overview of the disturbance area. Photo shows that despite a previous seeding, and additional reclamation activities earlier conducted by the operator, the location does not appear to be progressing towards COGCC 1000 series reclamation requirements.

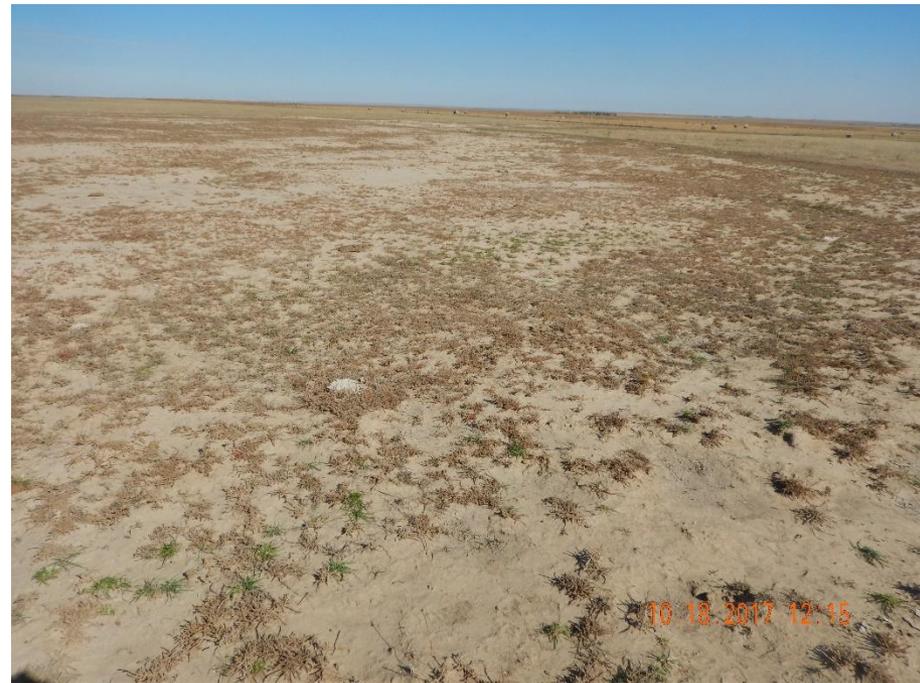
Photo 21: Continued from photo 20.

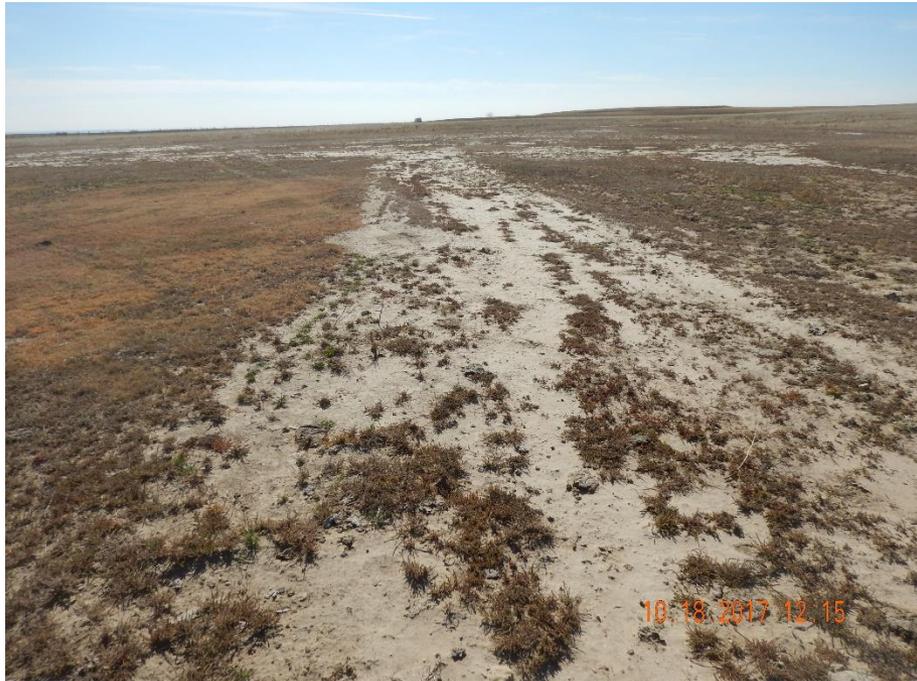
Photo 22: Photo taken from the central, west end of the disturbance area, facing south. See comments under photo 20

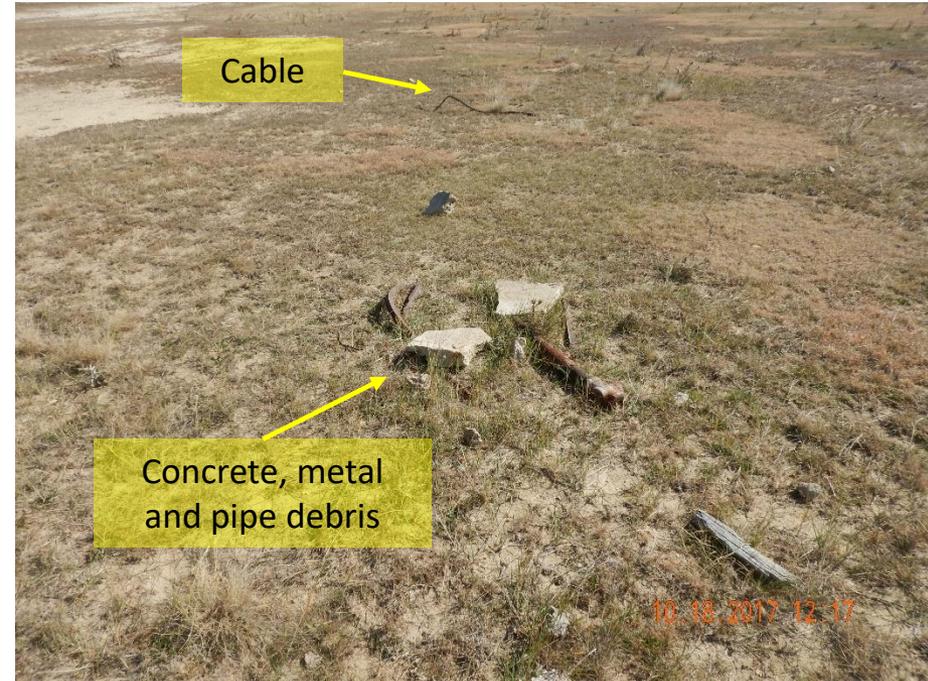
Photo 23: Photo taken from the southwest area of the disturbance, and the well location. Inspection #682501119 identified and documented this debris and required its removal. Refer to photos 9-11 in this inspection's photo document (#682501120). Debris has not been removed per the corrective action.

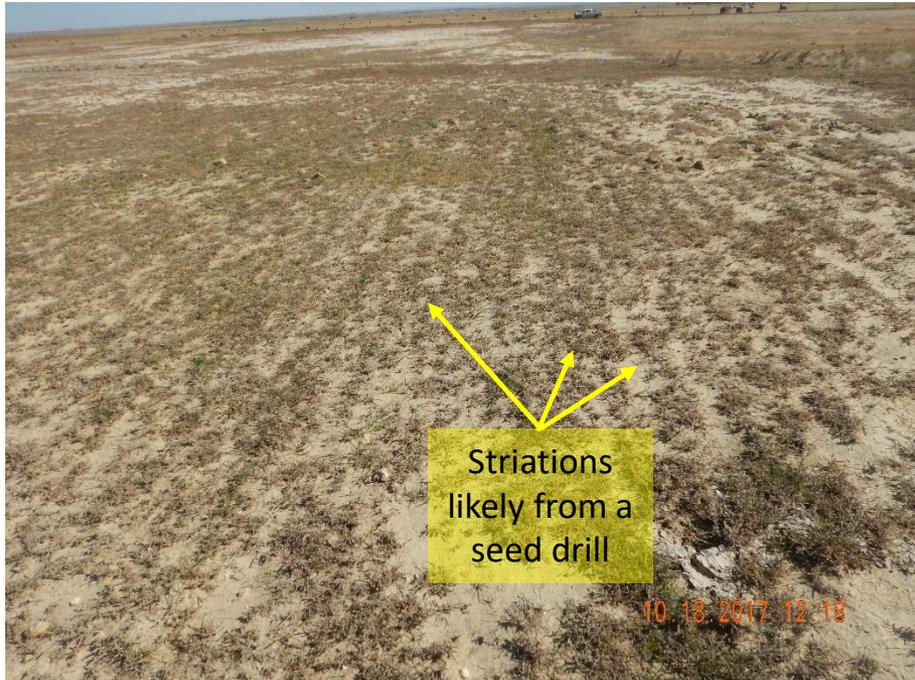
Photo 24: Photo taken from the southwest end of the disturbance area, facing east. Photo shows striations in the soil indicating areas of the site had previously been seeded. It does not appear the site as a whole is progressing towards reclamation requirements. Vegetation seen in the photo is predominantly undesirable weedy plant species such as Kochia and Russian thistle.

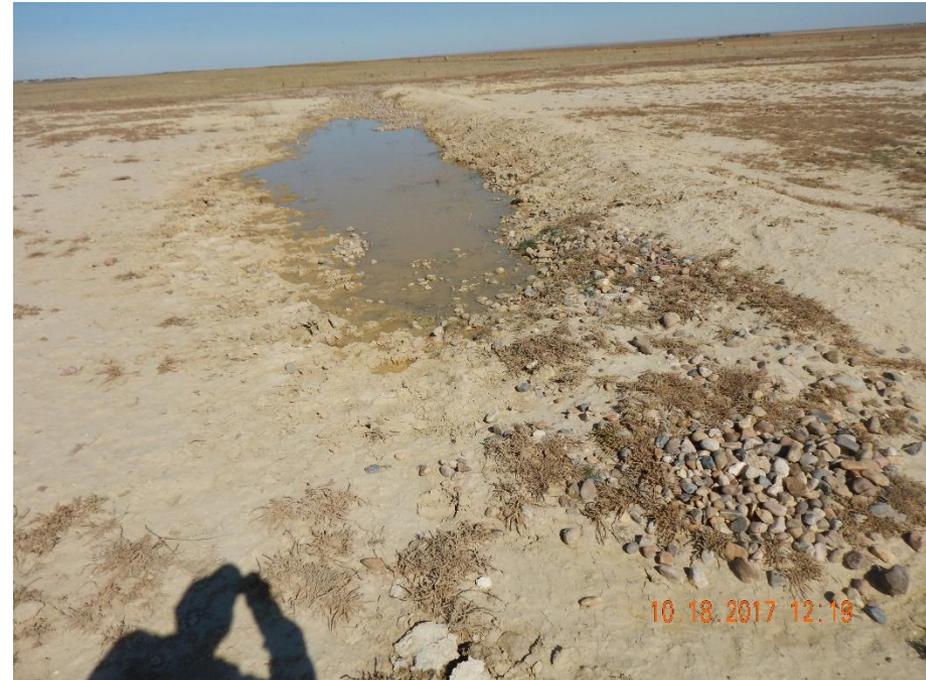
Photo 25: Photo taken from the south end of the disturbance, facing north. Photo shows what appears to be a berm used to pond stormwater installed by the operator. Rock aggregate at base of BMP has filled with sediment.

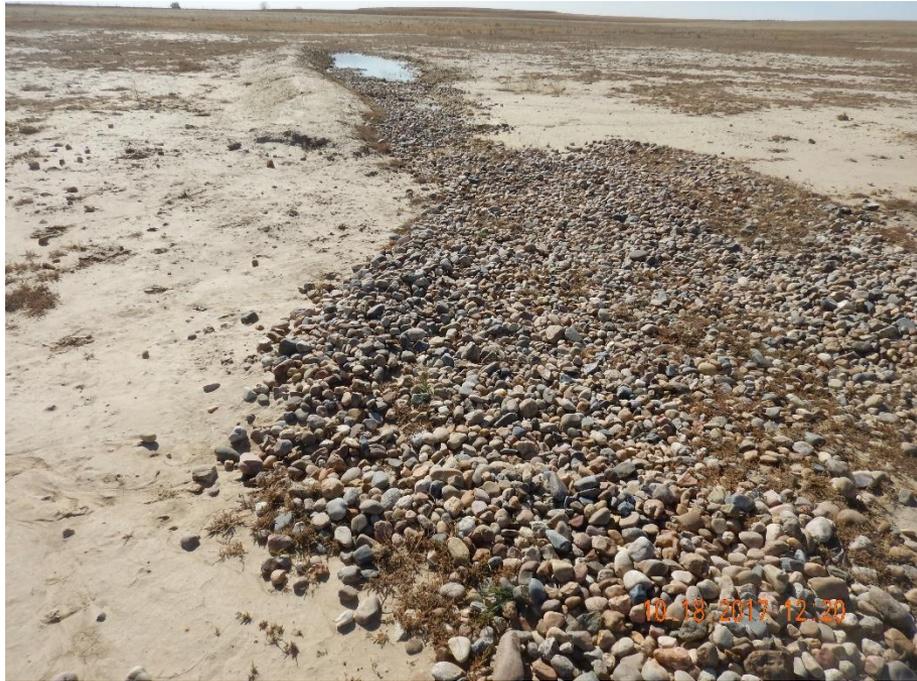
Photo 26: Photo taken from the north end of the BMP in photo 25, facing south.

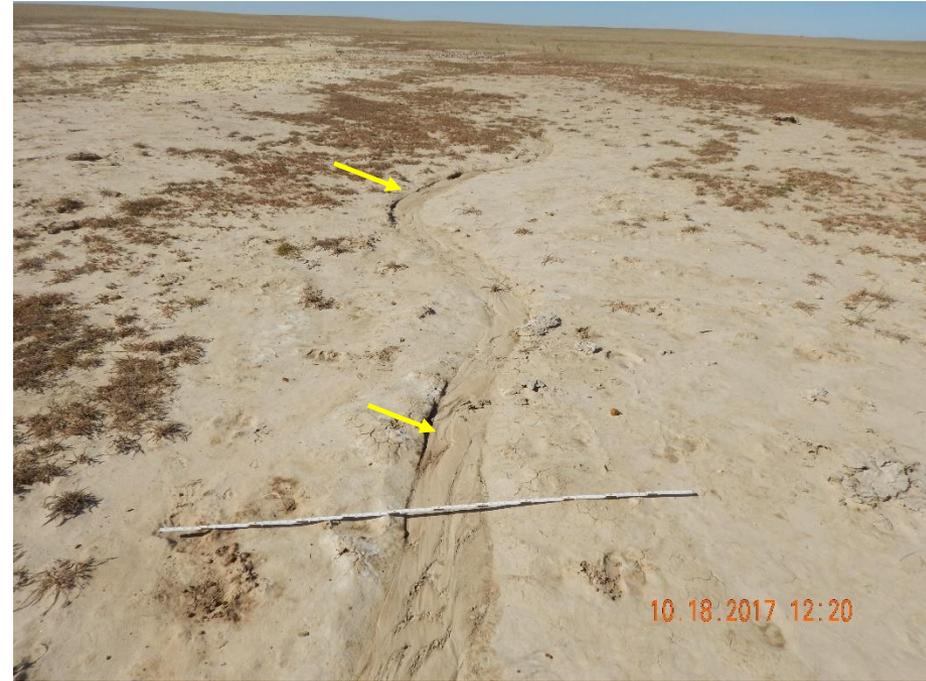
Photo 27: Photo taken from the southern end of the disturbance area, facing west. Photo shows water movement patterns, and stormwater erosion beginning to reform shallow gulleys and degrading the site. 6 foot measuring stick for reference

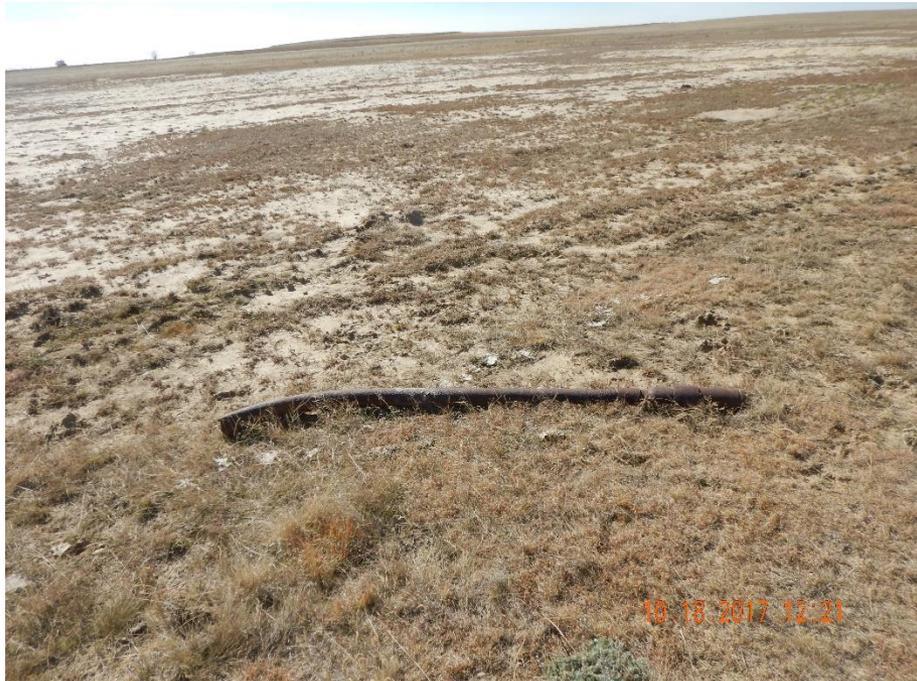
Photo 28: Photo taken from the north end , of the degradation area towards the south of the site (refer to photo 1). Photo shows pipe debris remaining on location.

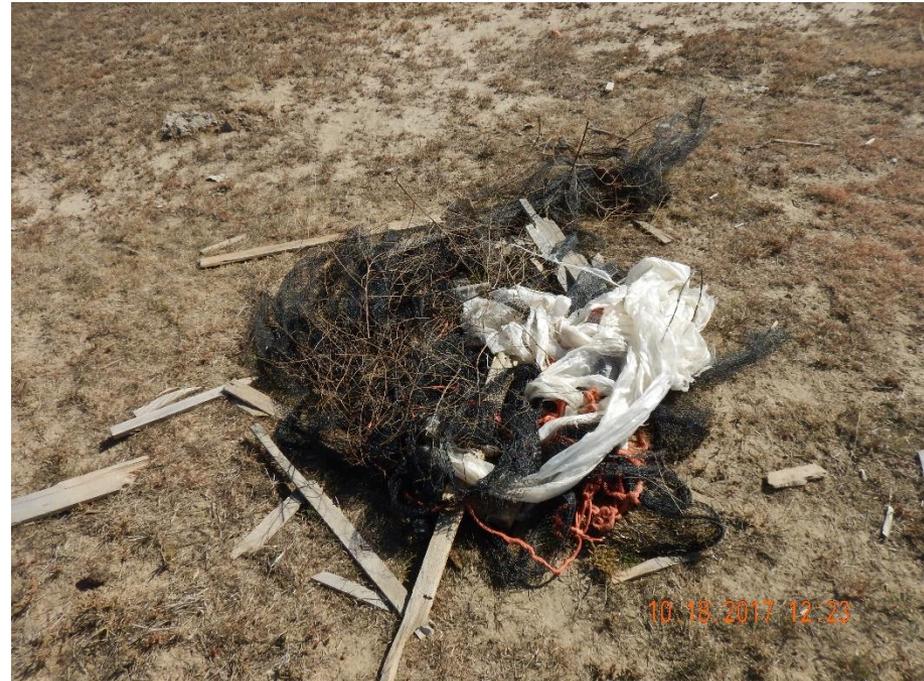
Photo 29: Photo taken from the southeast end of the disturbance. Photo shows trash debris. Netting, stakes and twine seen here likely remaining from materials brought in (matting, straw wattles, etc...) by the operator during reclamation and stormwater management activities. This needs to be removed and properly disposed.
