Inspection Photos
Location Name: Frye Farms Pad 44-32
API: 05-123-34946

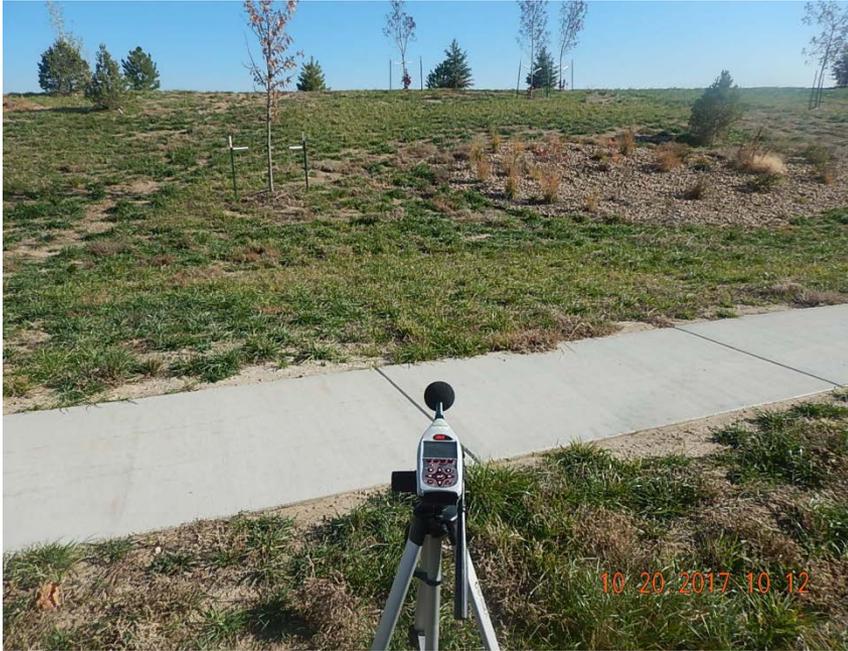
Photo 1: Sound study location, looking SE

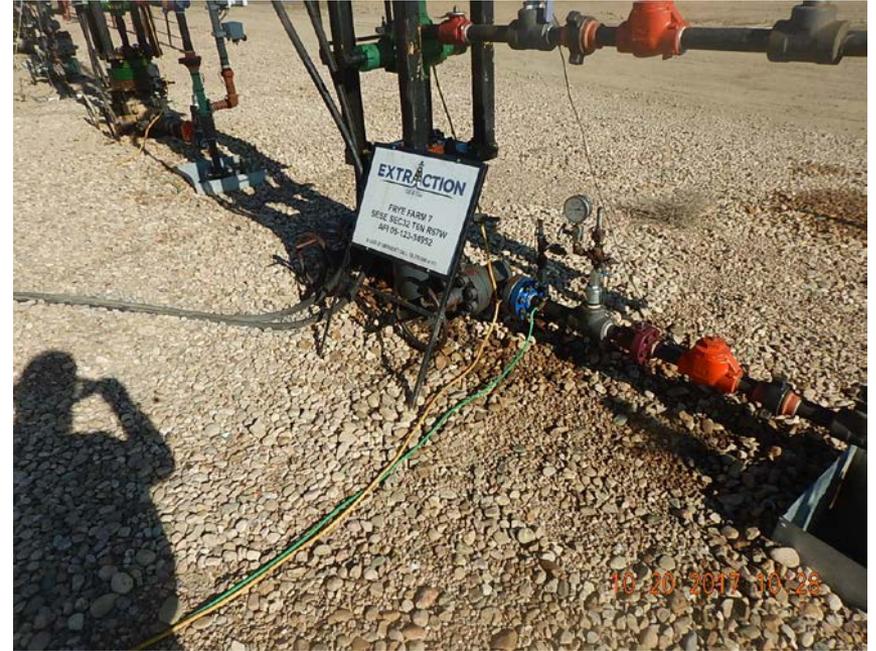
Photo 2: Stained soil at wellhead

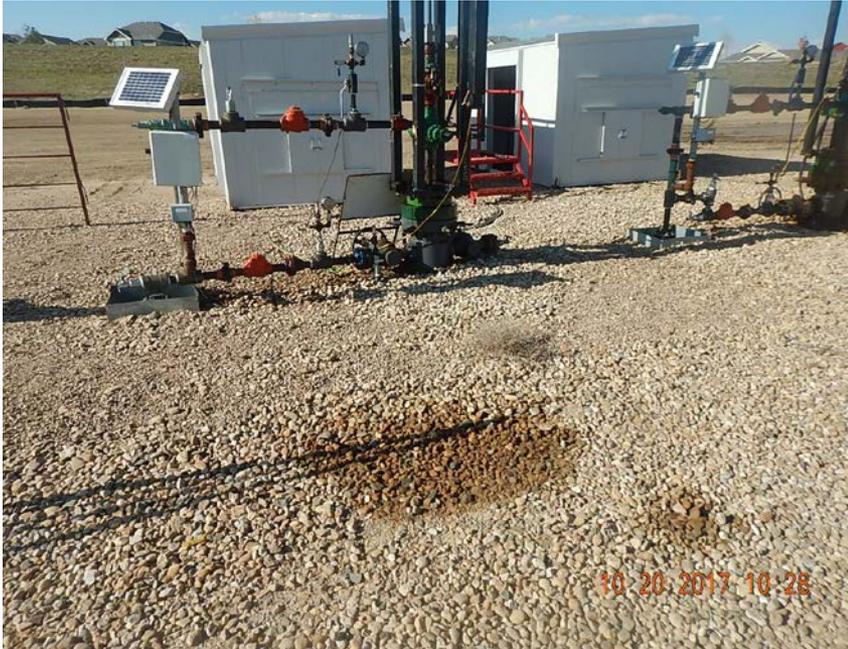
Photo 3: Stained soil at wellhead

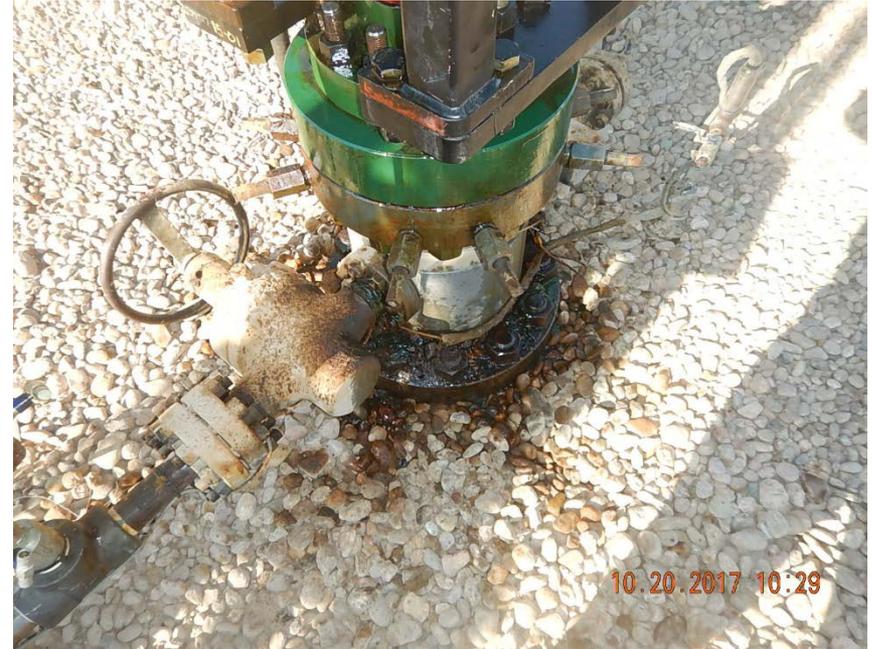
Photo 4: Stained soil at wellhead

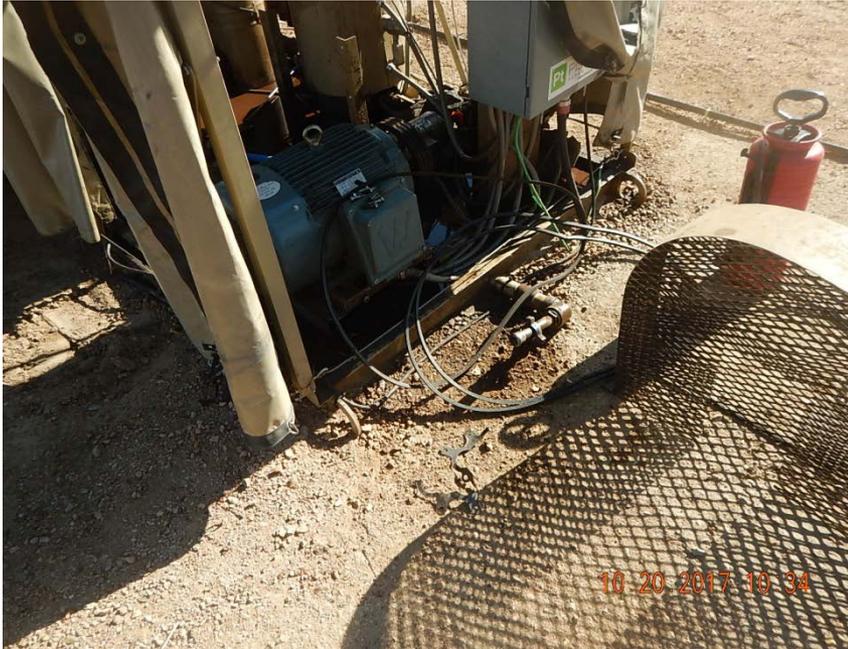
Photo 5: Stained soil at VRU

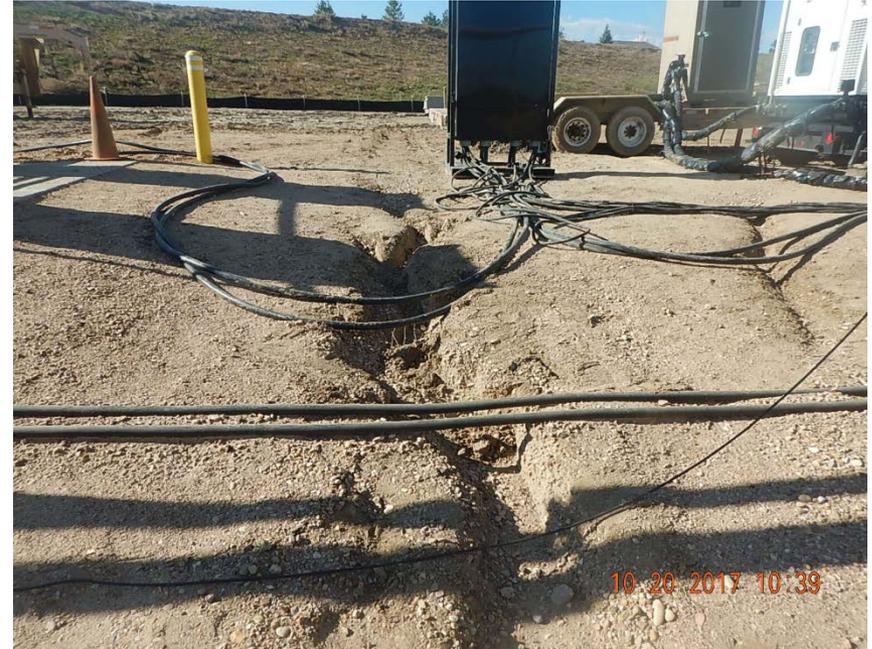
Photo 6: Stormwater erosion at SW corner of location, looking W

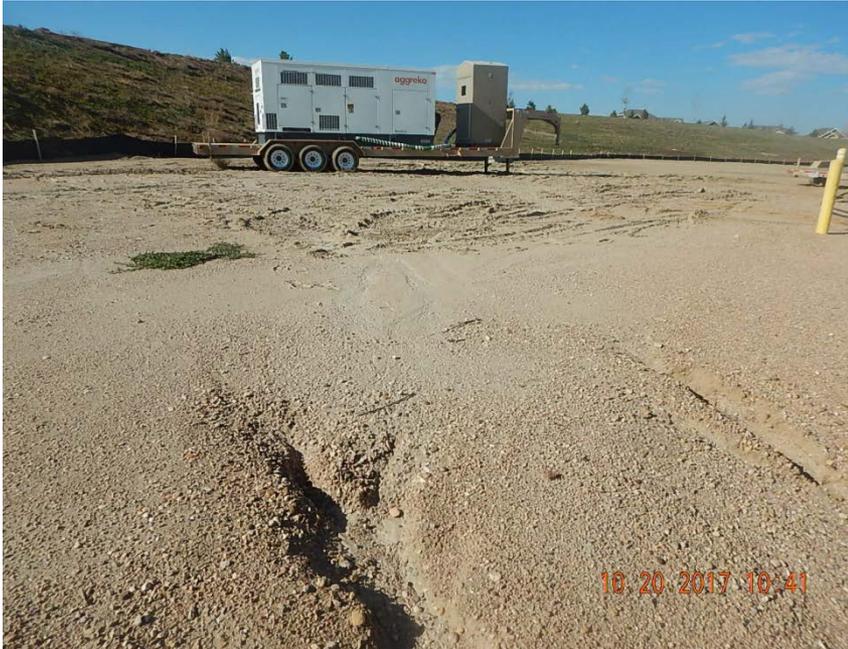
Photo 7: Stormwater erosion on W side of battery, looking W

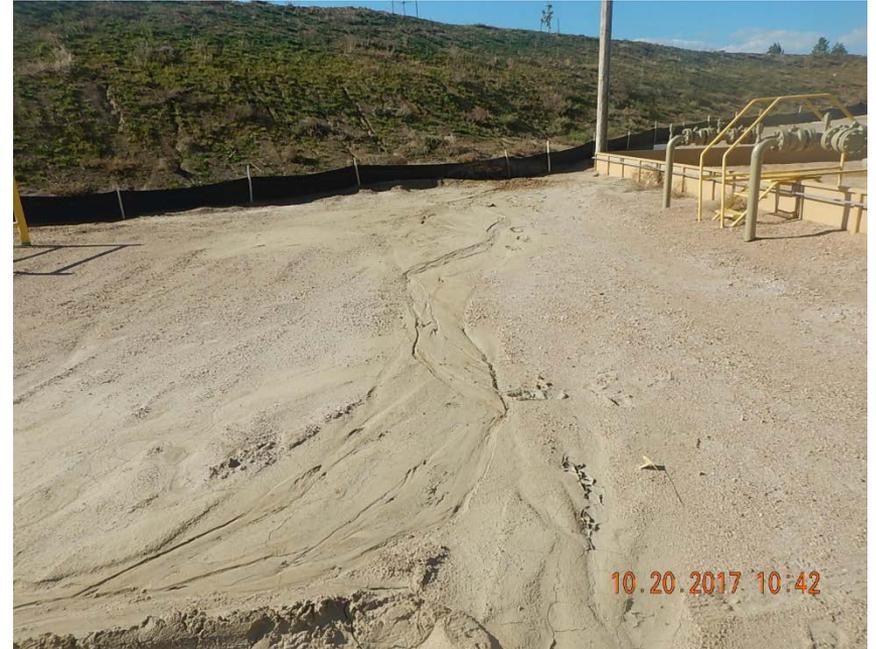
Photo 8: Stormwater erosion on S side of location, looking W
