Inspection Photos

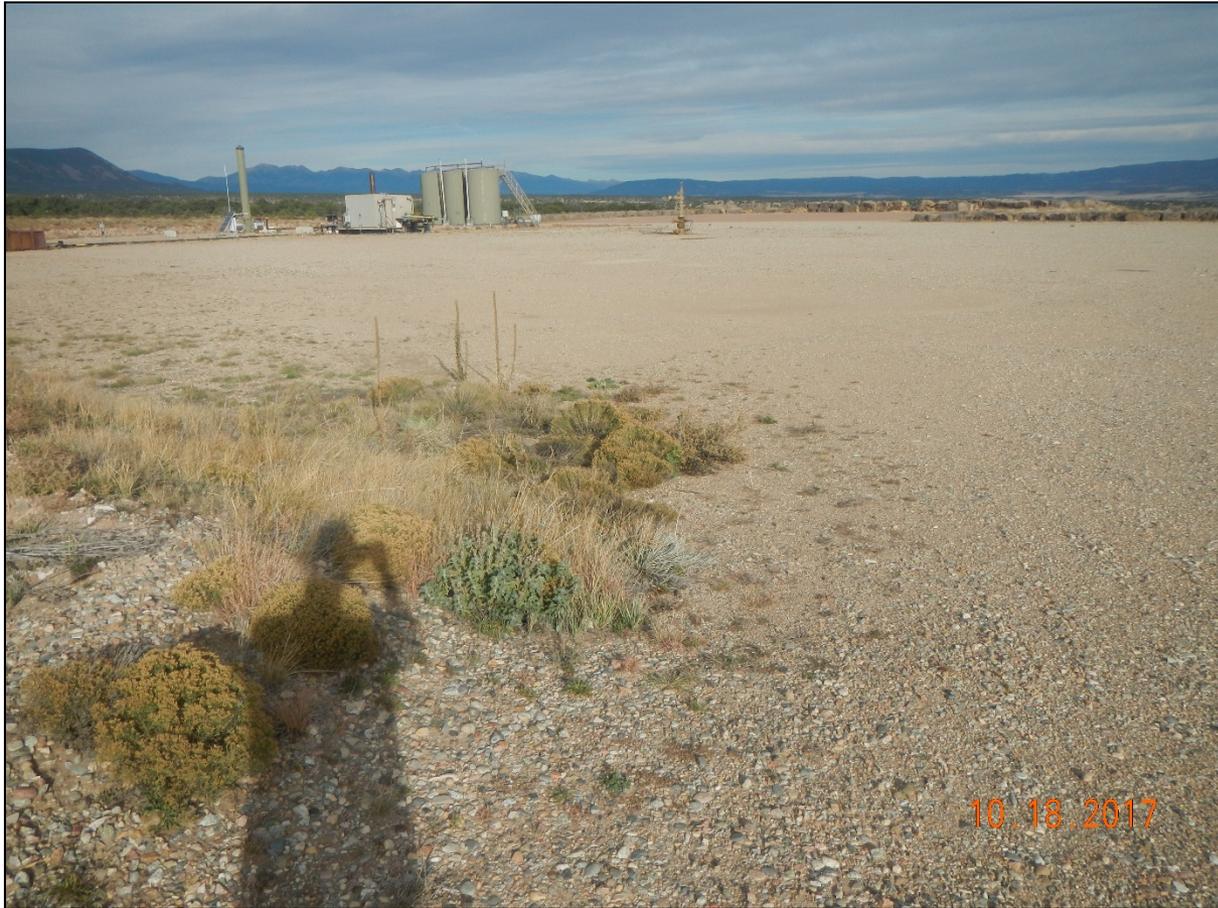
Photo 1. Facing northwest toward the location.

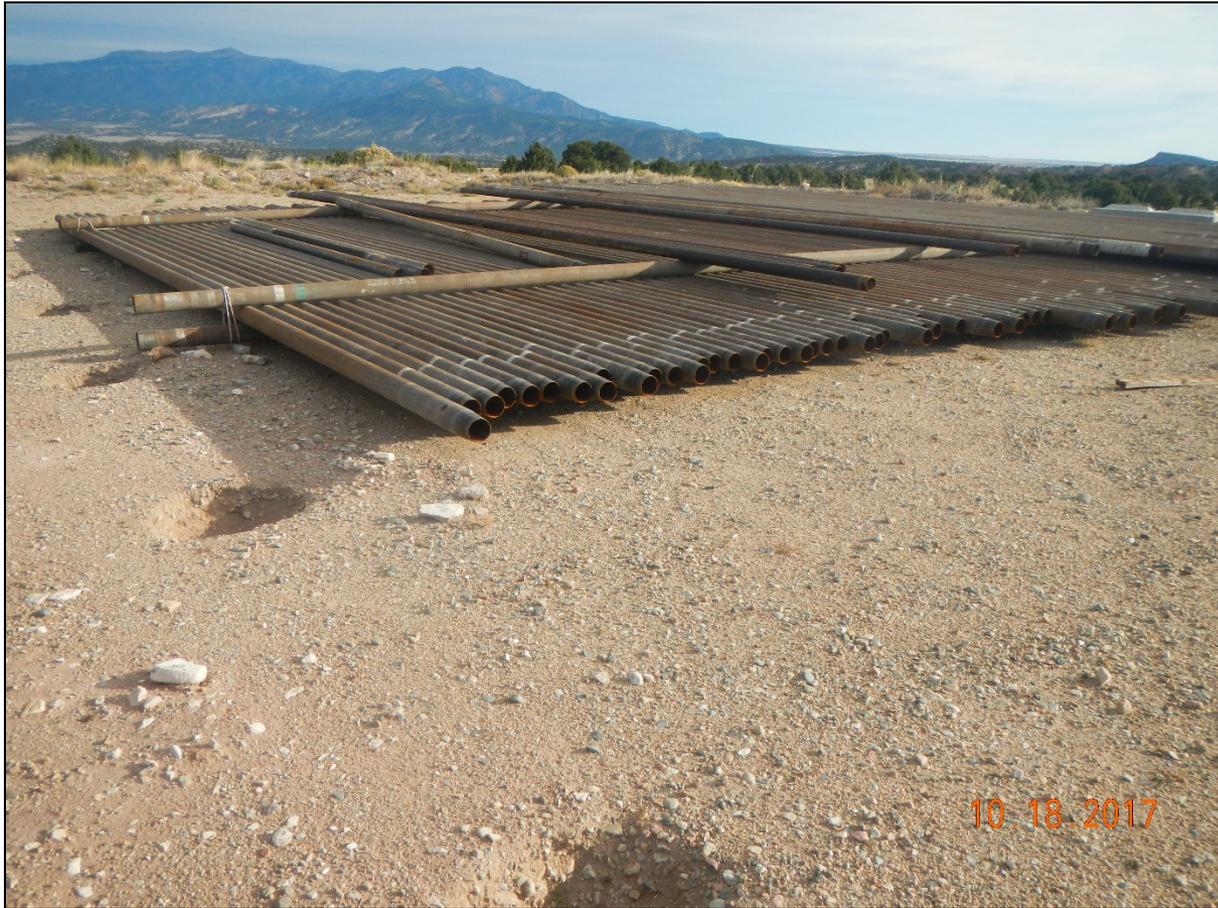
Photo 2. There is storage of pipe at the northeast corner of the location.

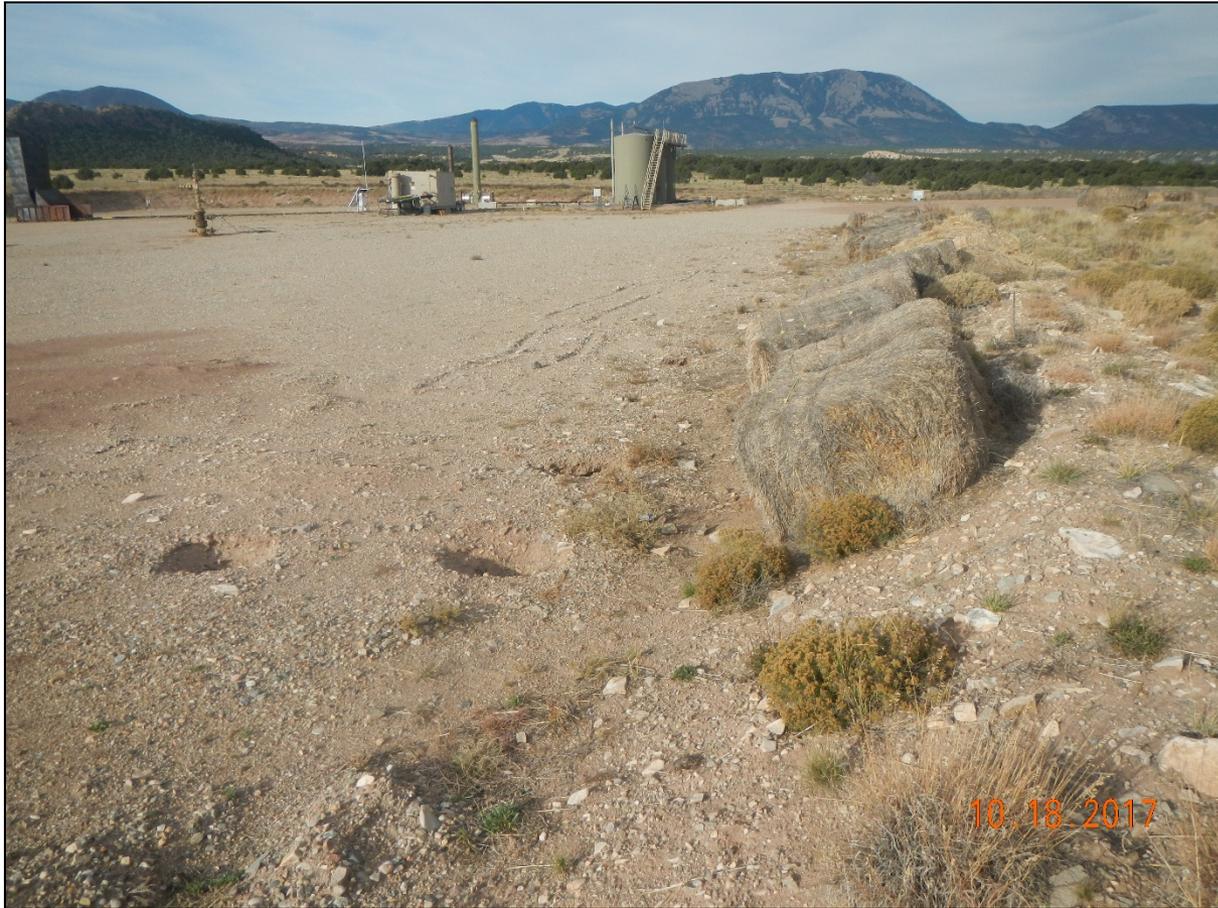
Photo 3. Northeast corner of the location facing west.

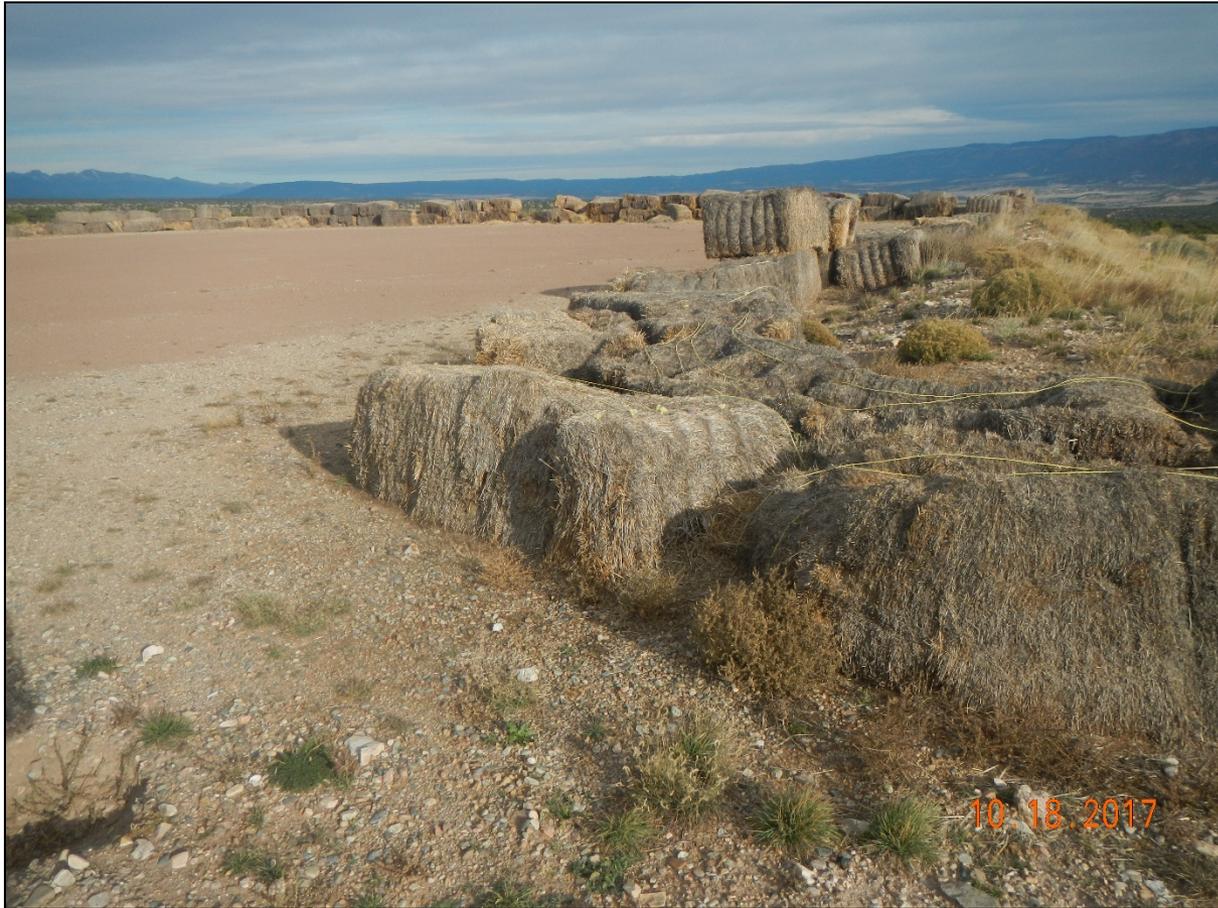
Photo 4. Facing northeast at the location. Unused areas of the location have not been reclaimed.

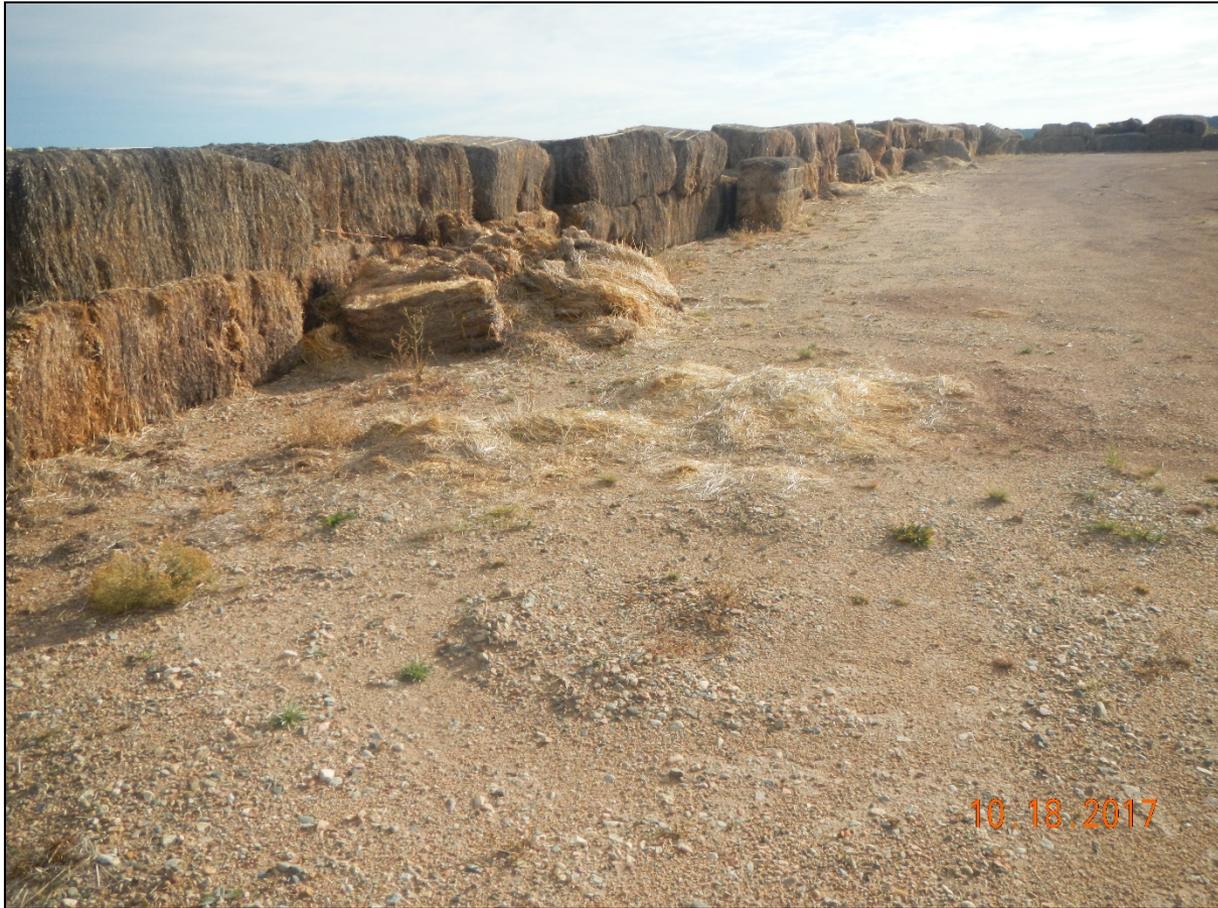
Photo 5. There are degraded hay bales that remain around the location that have not been removed.

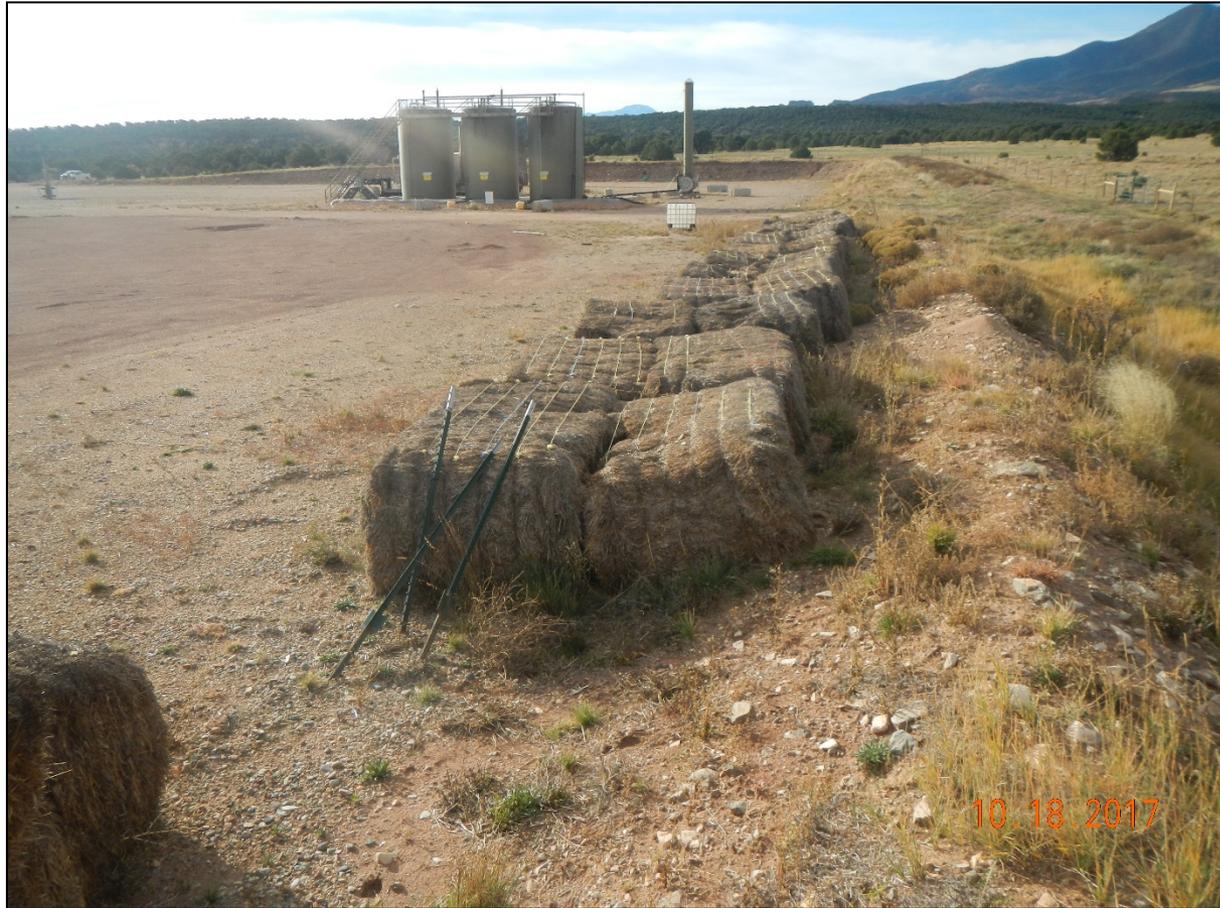
Photo 6. West side of the location facing south.

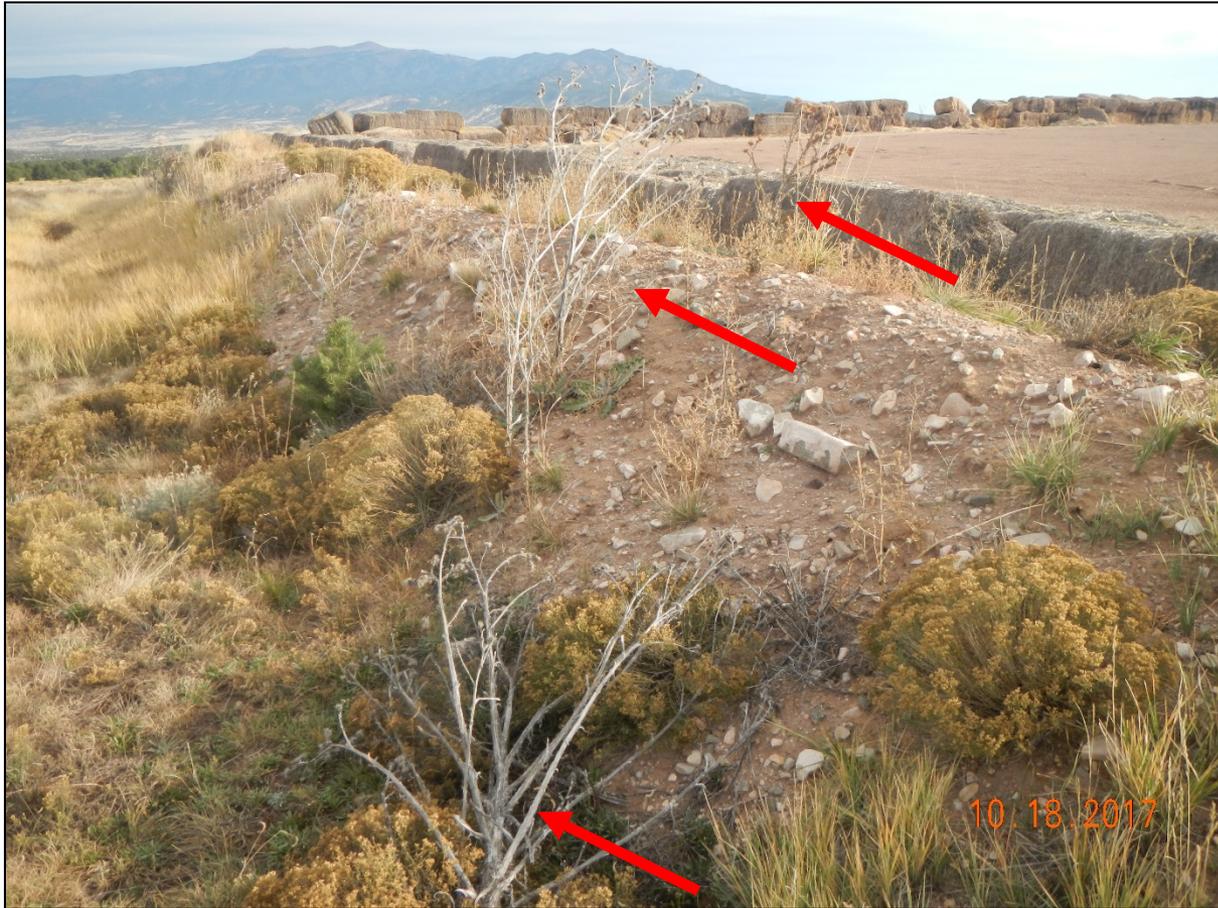
Photo 7. There are List B noxious weeds that have not been removed along the west side of the location. There were also numerous rosettes growing in this area. The red arrow points to the Scotch thistle which has dispersed seed.

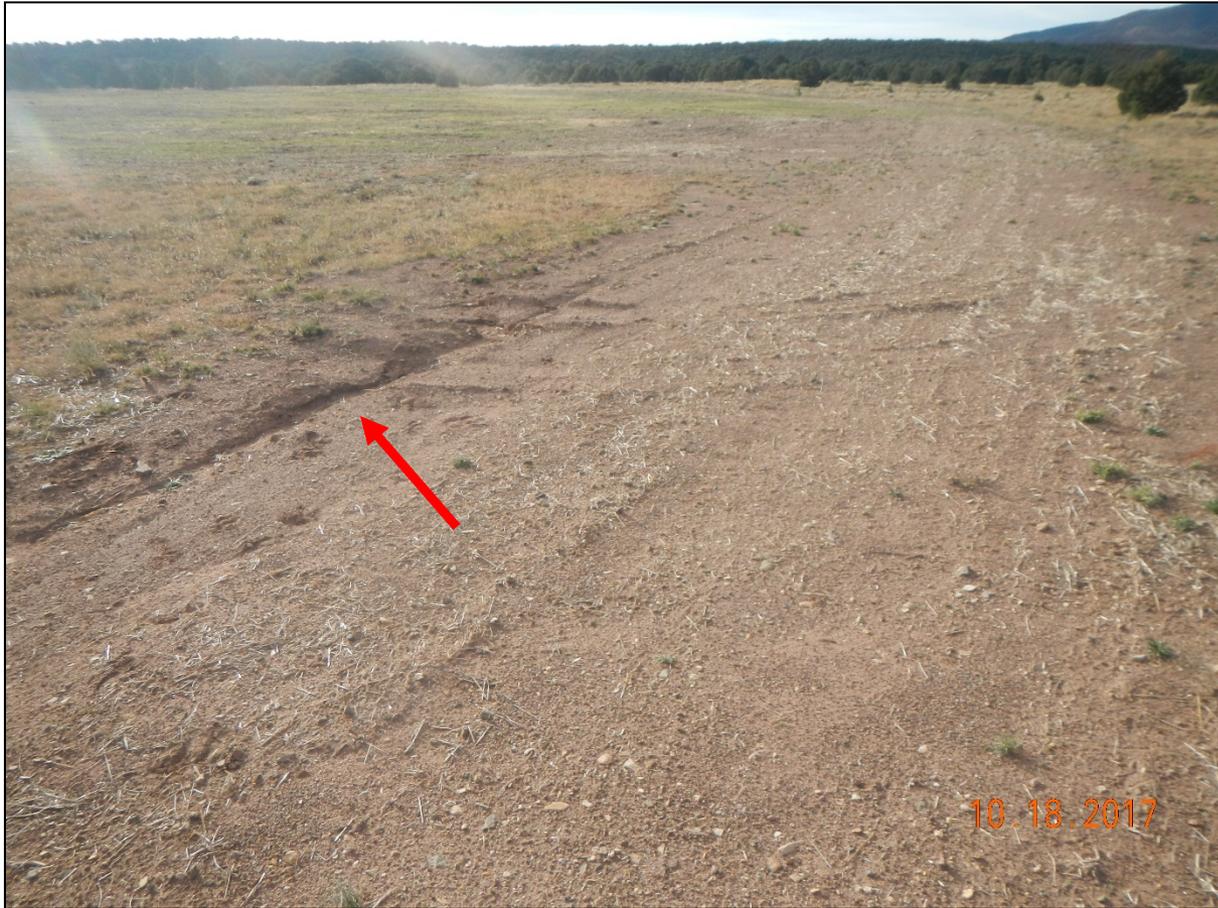
Photo 8. Facing south where the unpermitted disturbance occurred. The area where the access road was built does not have vegetation establishment. The soils appear to be compacted. The red arrow points toward an area of stormwater erosion rill.

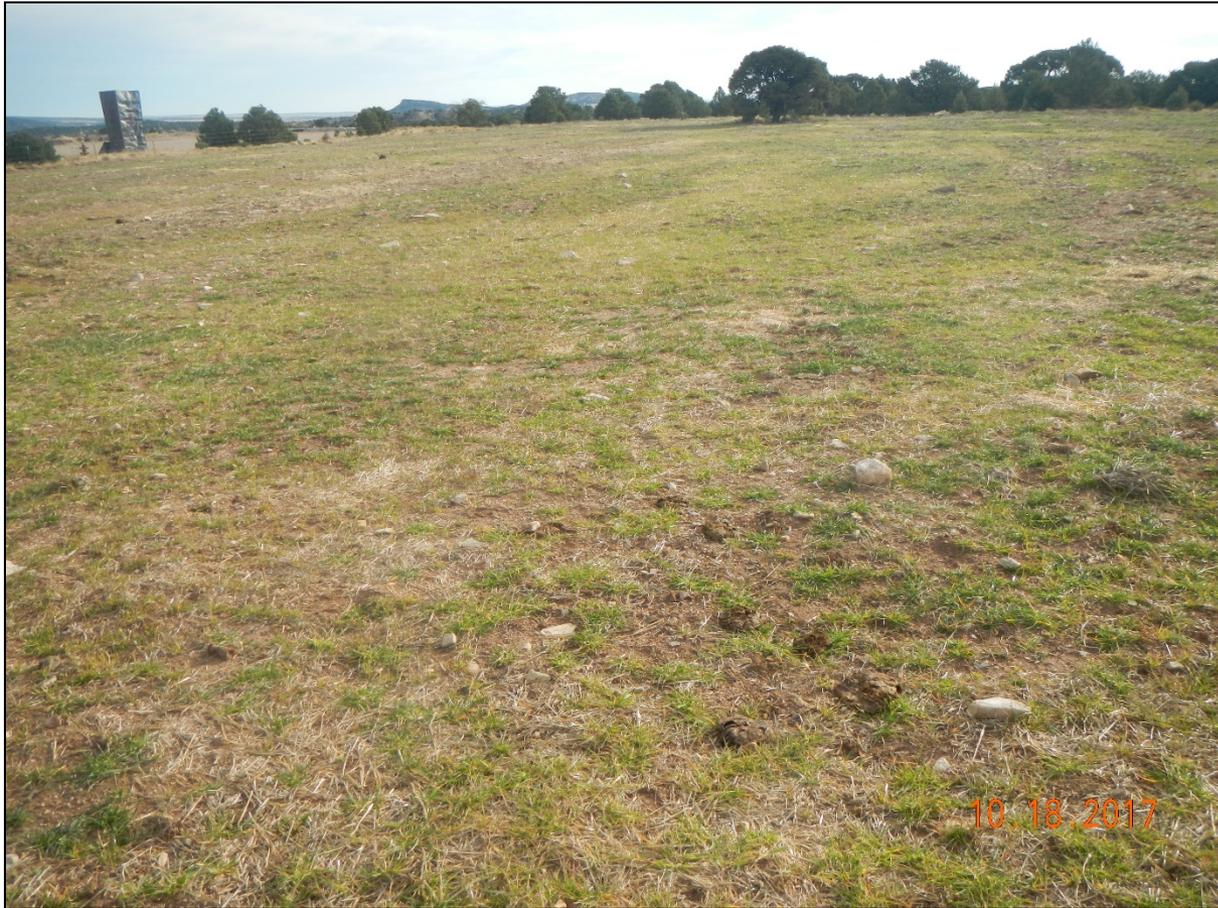
Photo 9. Facing east where the unpermitted disturbance occurred. The vegetation appears to be re-establishing and appears to be predominately Smooth brome.

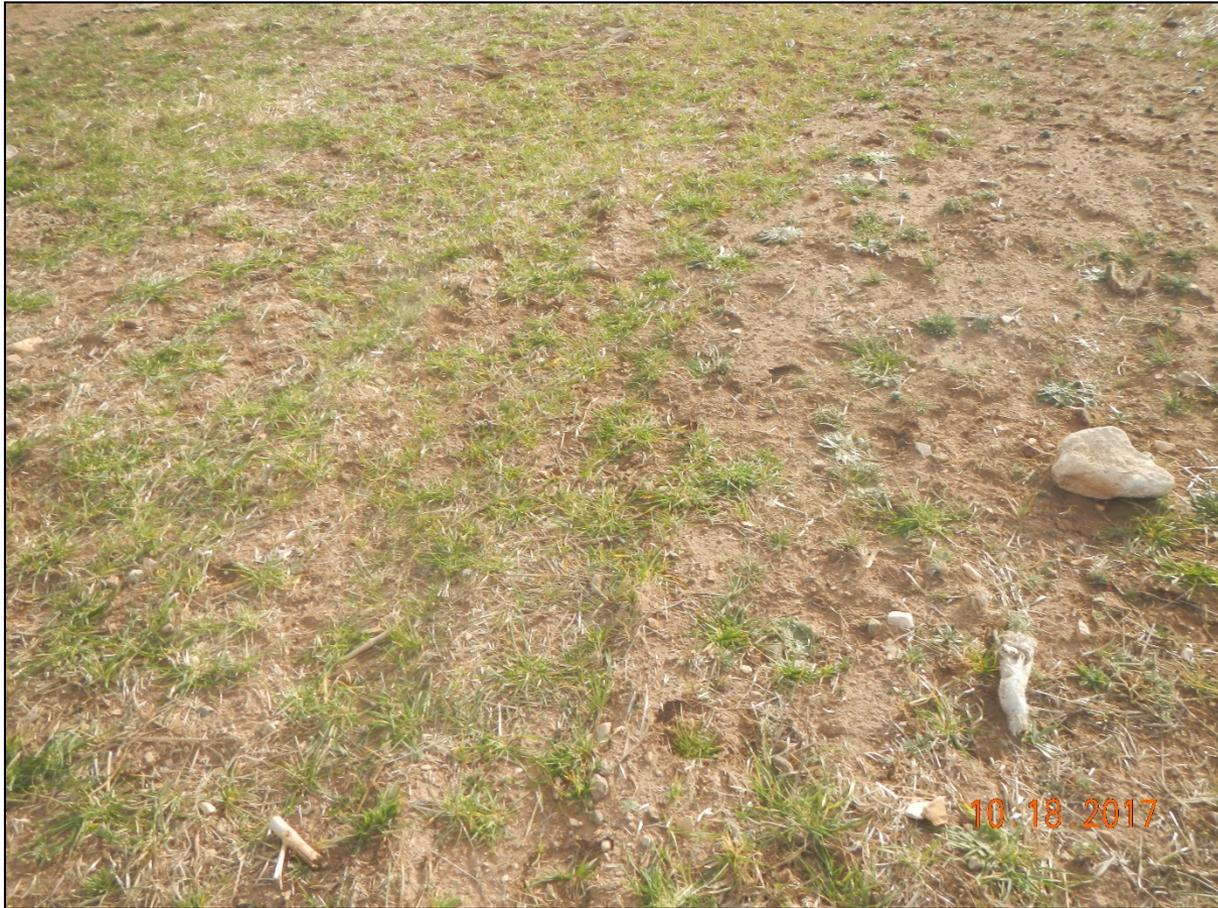
Photo 10. View of vegetation establishment which appears to be predominately Smooth brome.

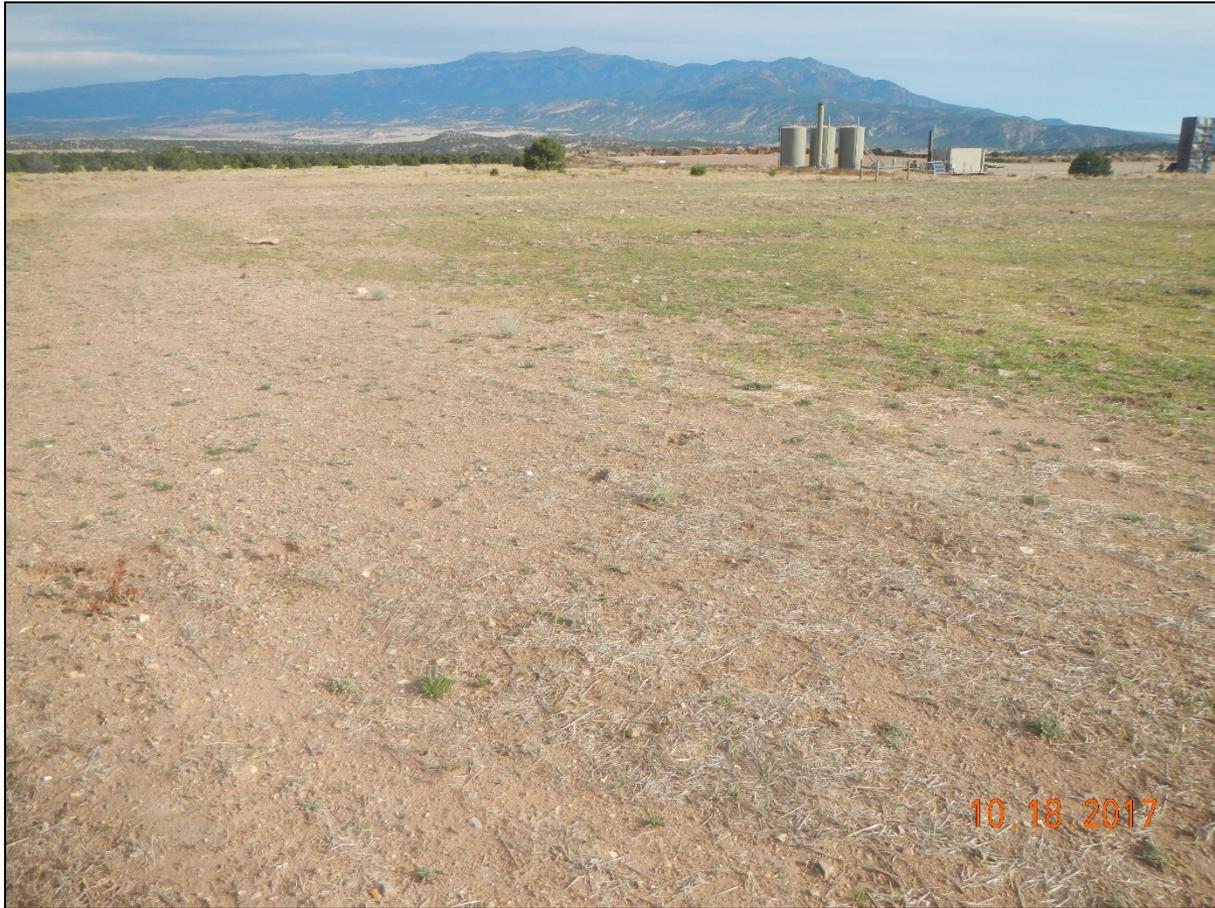
Photo 11. Facing north where the unpermitted disturbance occurred. The area where the access road was built (western side) does not have as much vegetation establishment. The soils appear to be compacted.

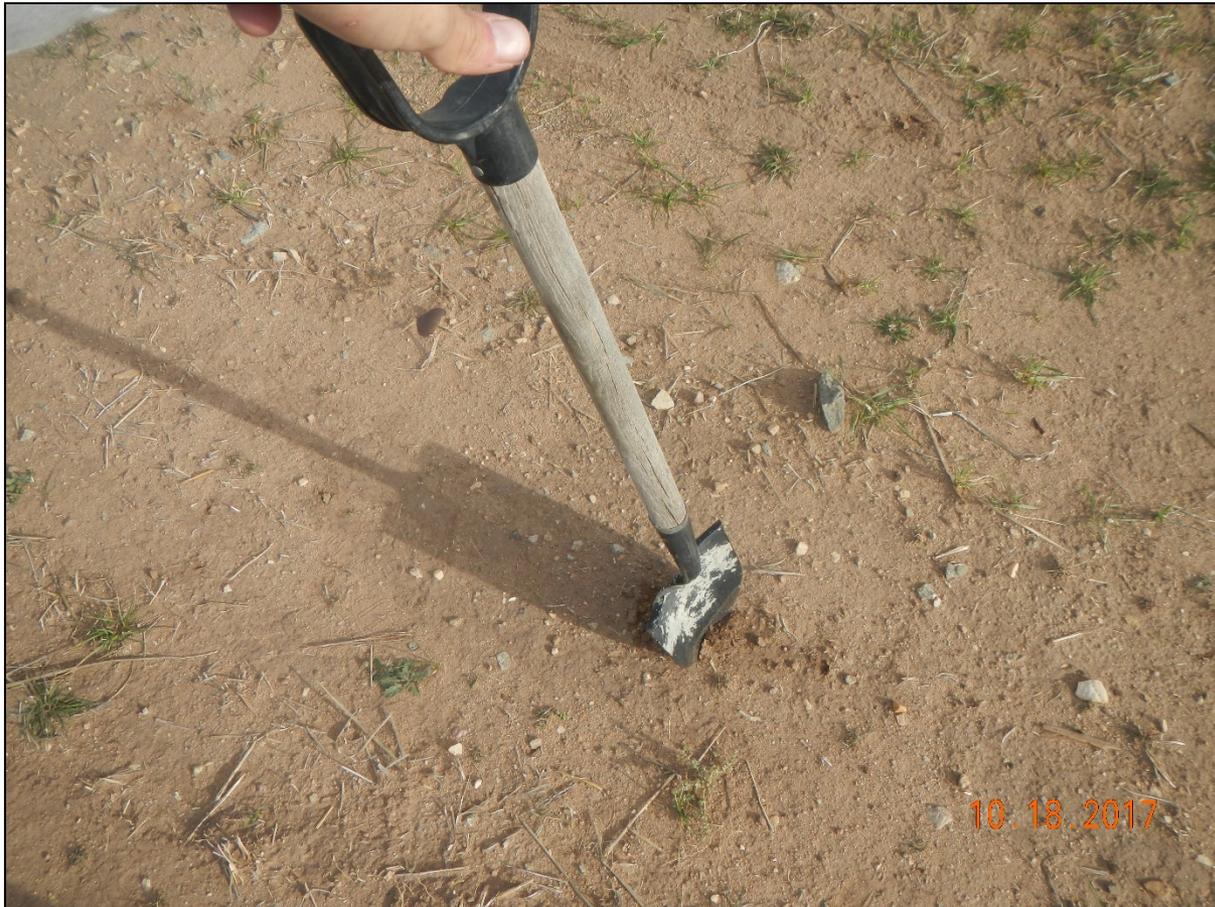
Photo 12. There are areas where the soils appear to be compacted. The shovel is unable to penetrate the soil surface.

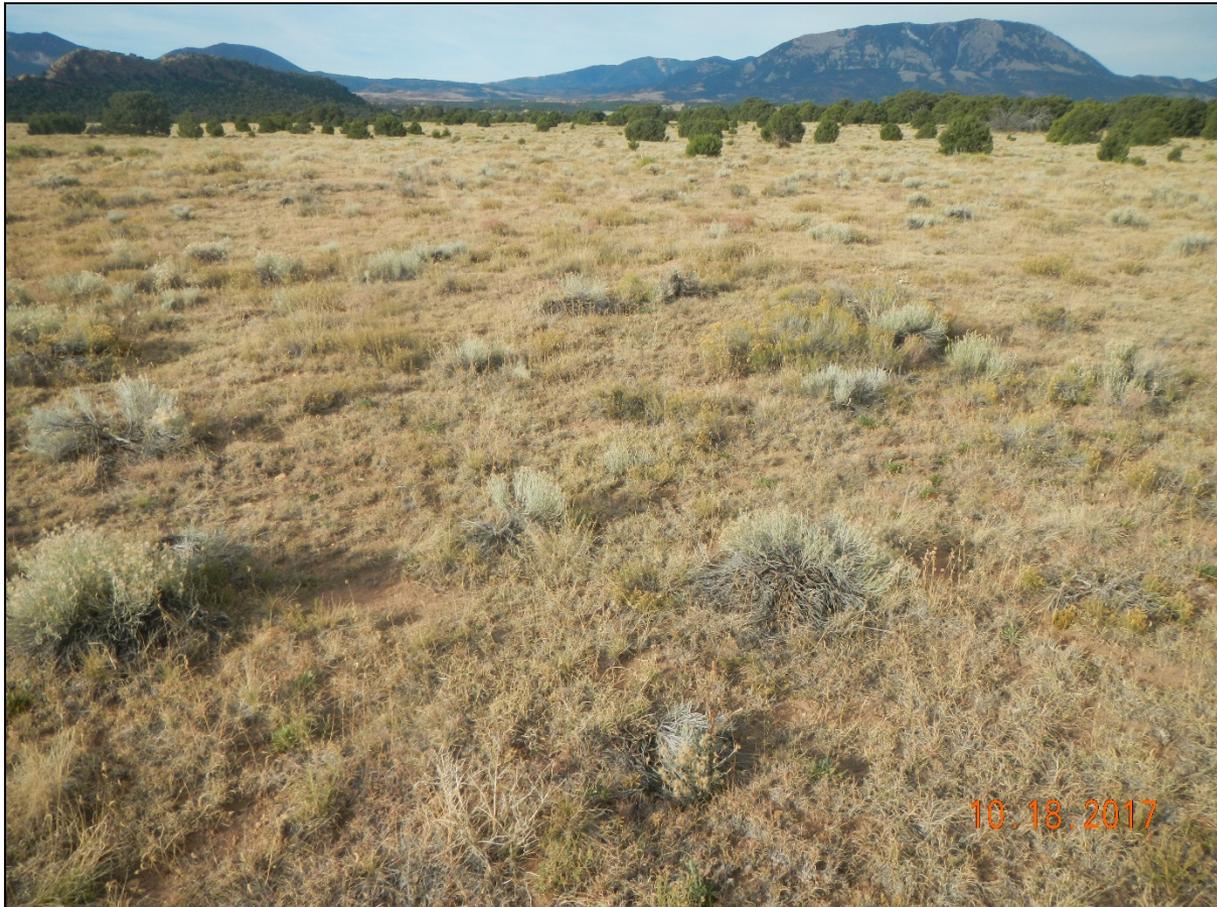
Photo 13. Facing west off the location toward the undisturbed vegetation.
