- Tyner – Lunt (EPA) 1
- 05-067-06140

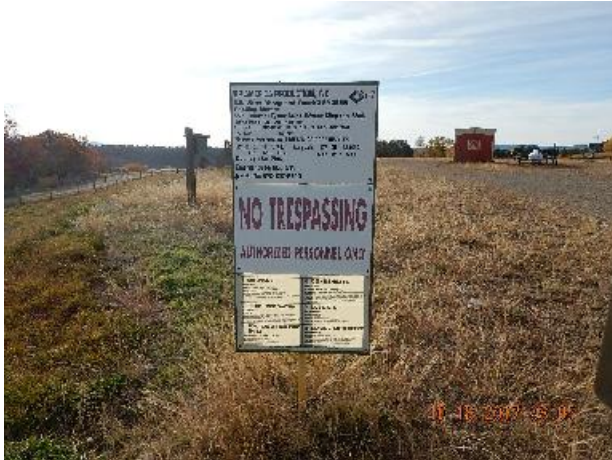
Photo 1: Wellhead sign.

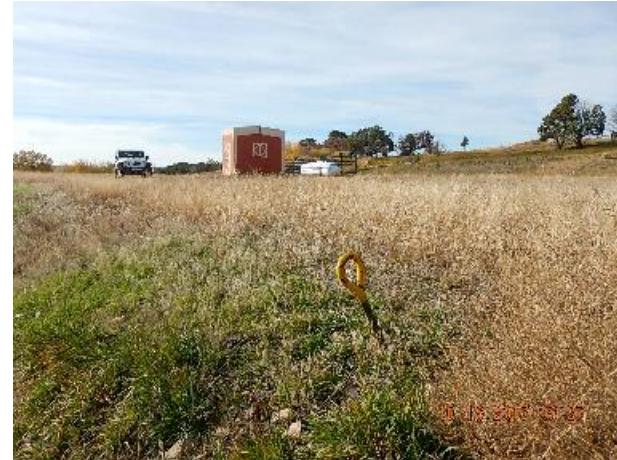
Photo 2: Unmarked anchor.

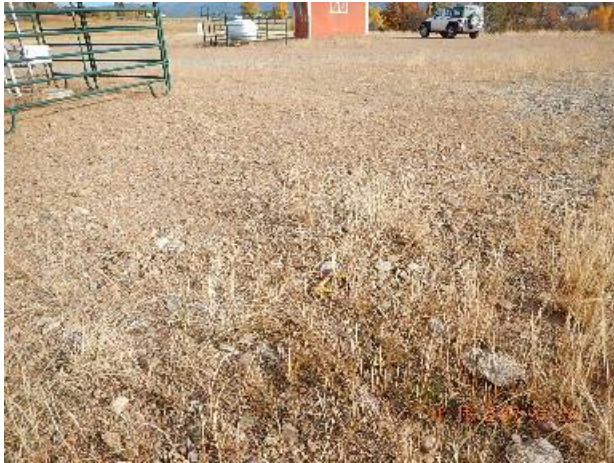
**Photo 3: Unmarked anchor.**

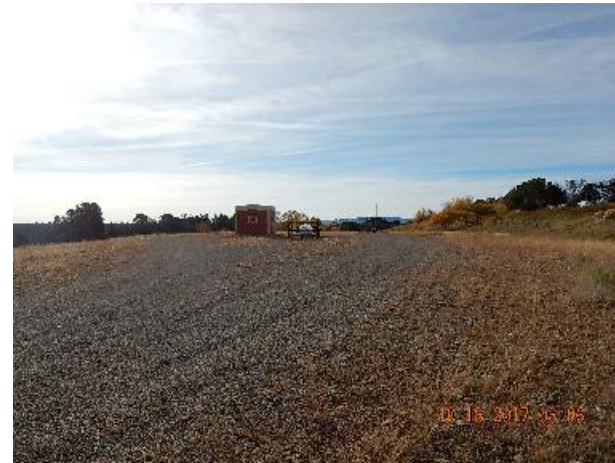
**Photo 4: Well pad overview.**

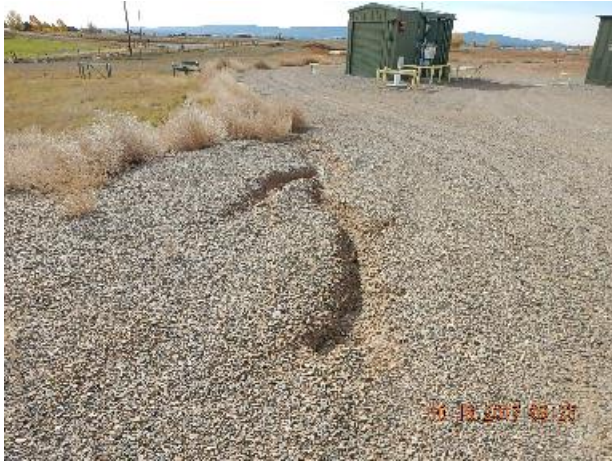
**Photo 5: Erosion channel at E side of tank battery.**

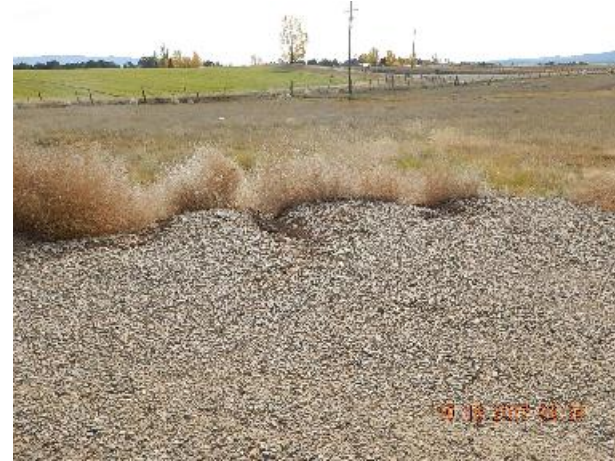
**Photo 6: Erosion channels along S perimeter.**

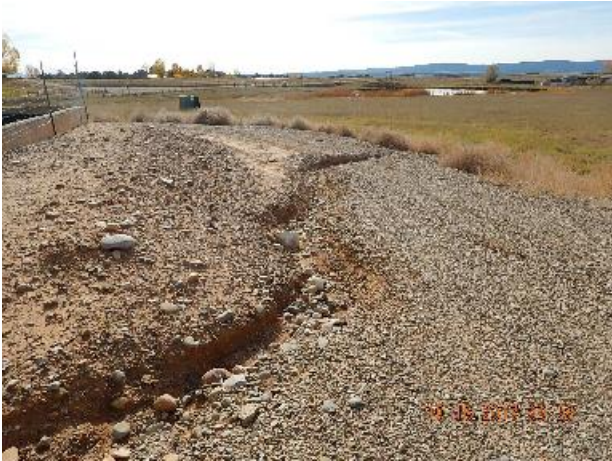
**Photo 7: Erosion channel on W side of tank battery.**

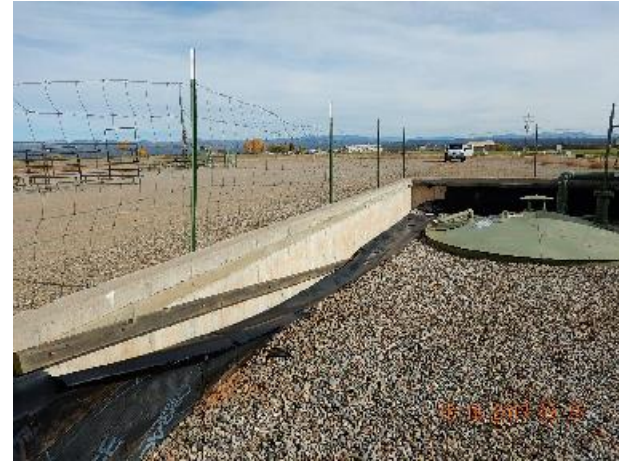
**Photo 8: Liner detached from wall.**

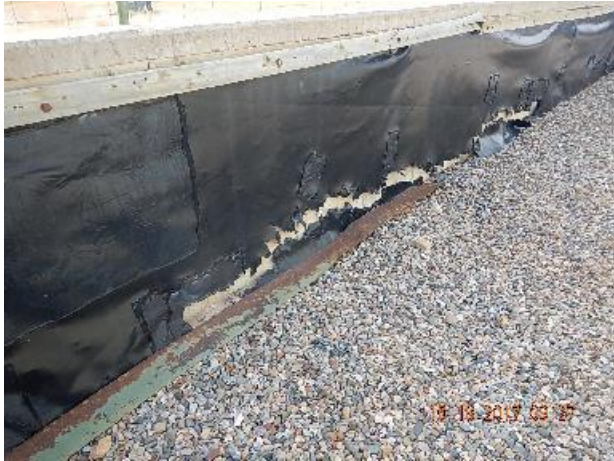
**Photo 9: Tears in bottom of liner.**

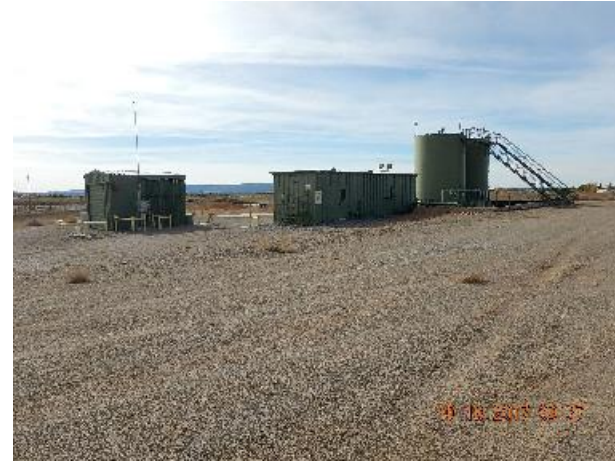
**Photo 10: Injection facility overview.**
