Inspection Photos
Location Name: E. Johnson 2-21
API #: 05-123-21260
Location ID: 331761

COLORADO
Oil & Gas Conservation
Commission
Department of Natural Resources

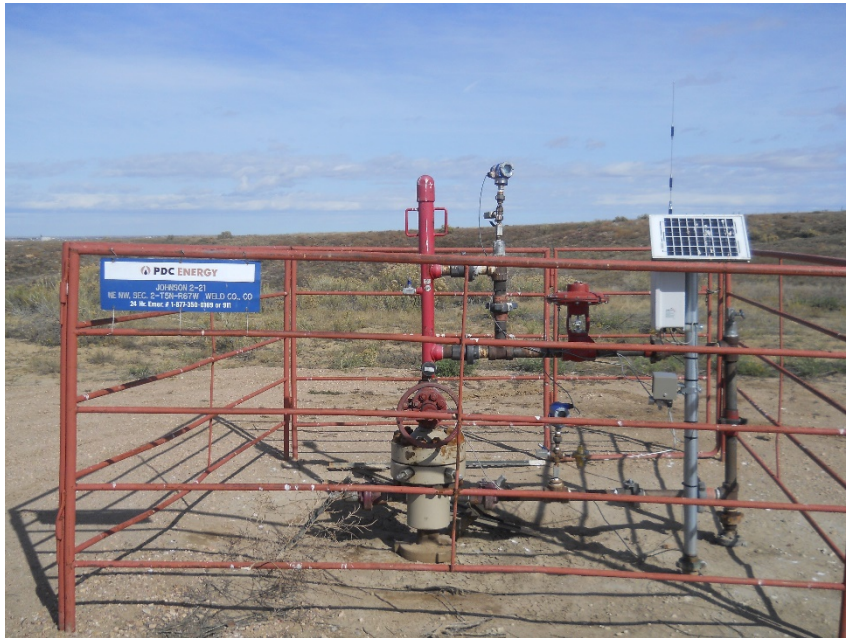
Wellhead looking north

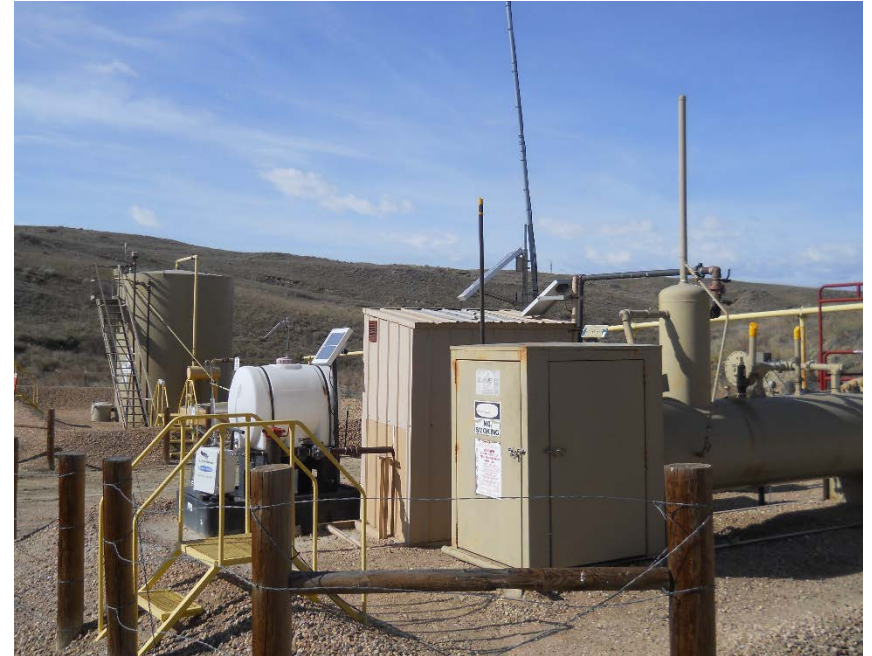
Battery looking west

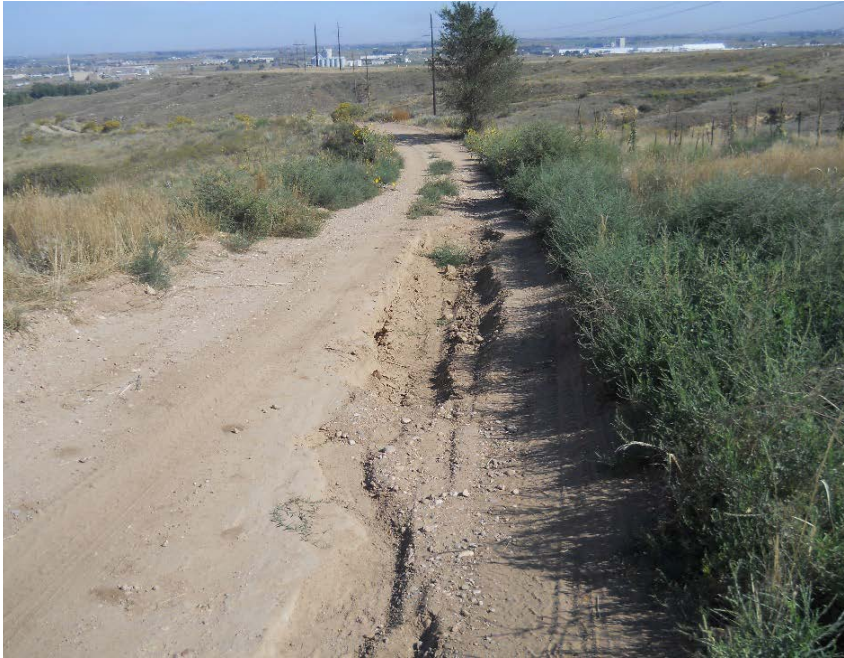
Access road to battery looking north 9-12-2017

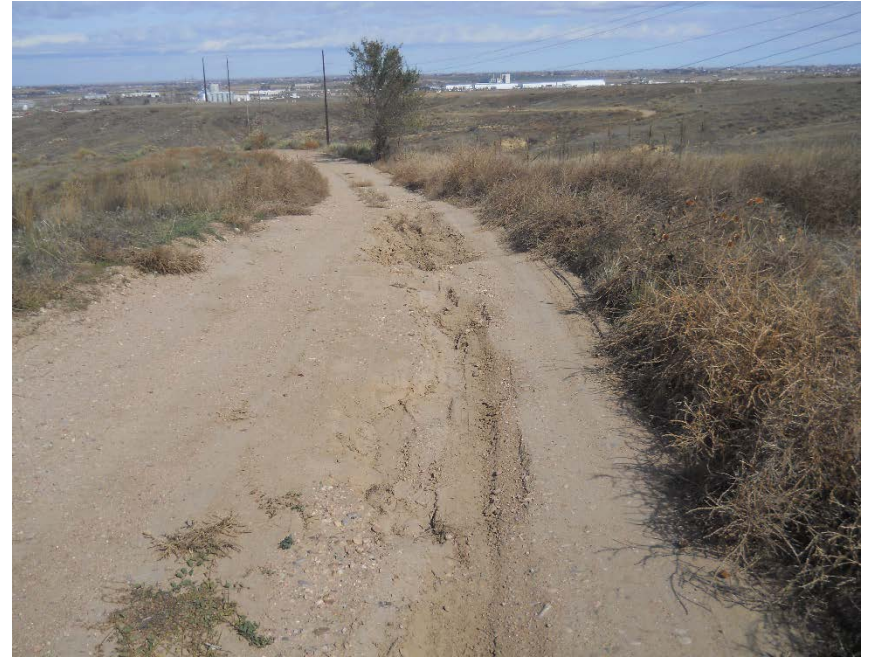
Access road to battery looking north 10-23-2017

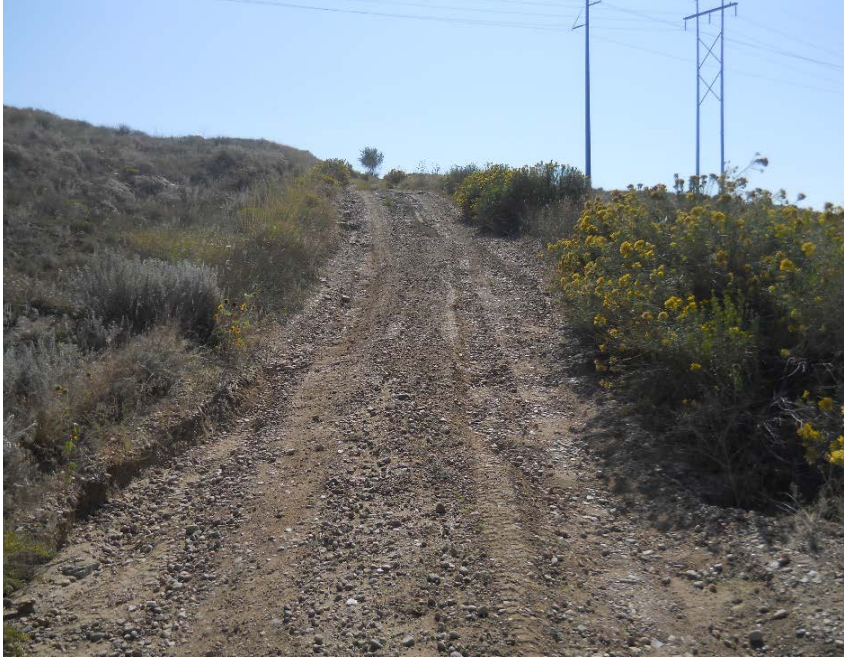
Access road to wellhead from battery looking southeast. Road is washing out on both sides 9-12-2017

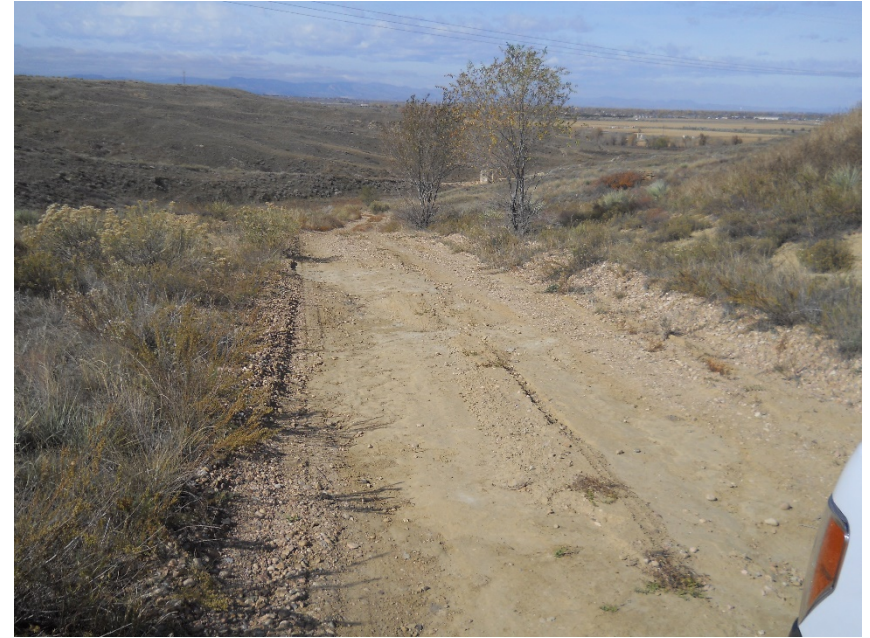
Access road from wellhead to battery looking northwest. Still washing out 10-23-2017

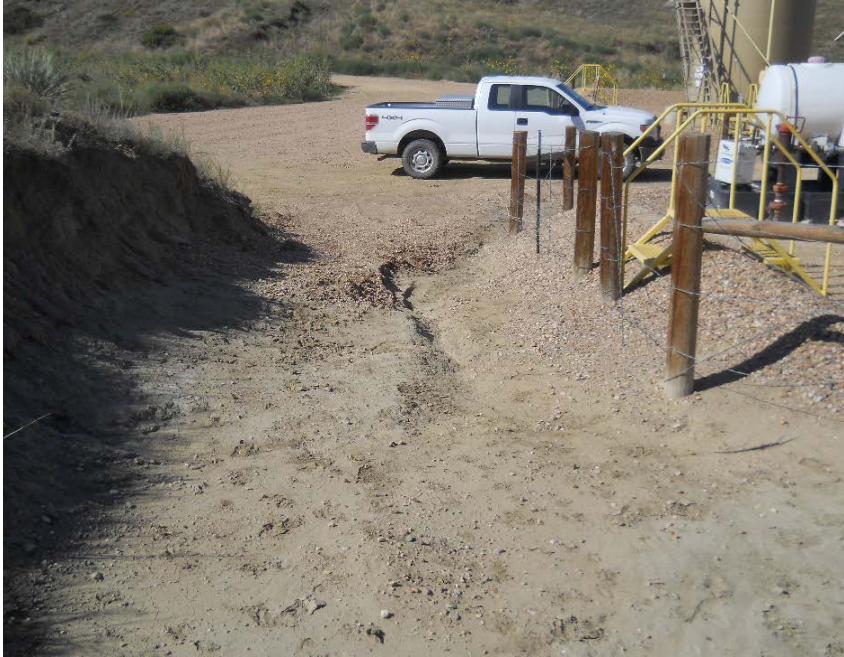
Location washing out south side of separator 9-12-2017

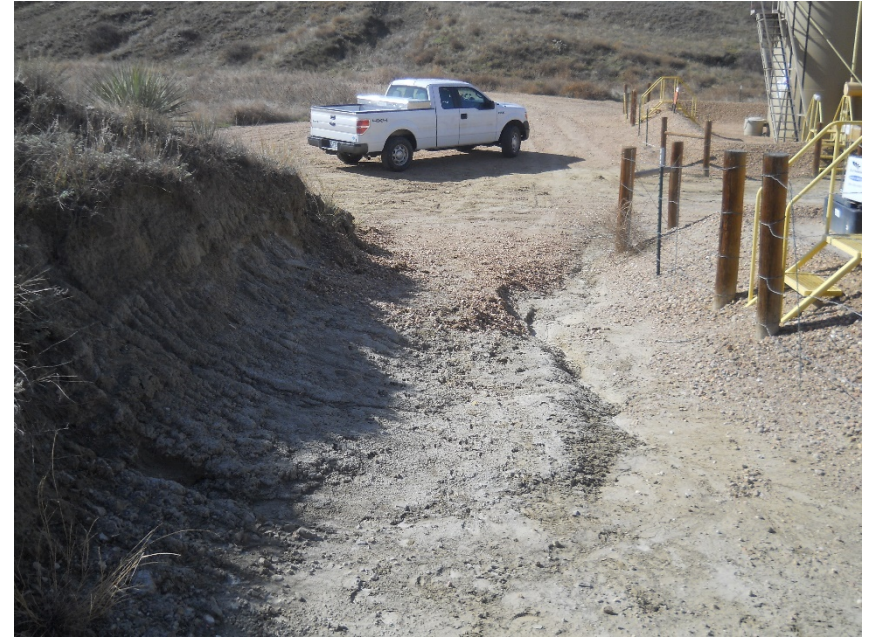
Location washing out south side of separator 10-23-2017

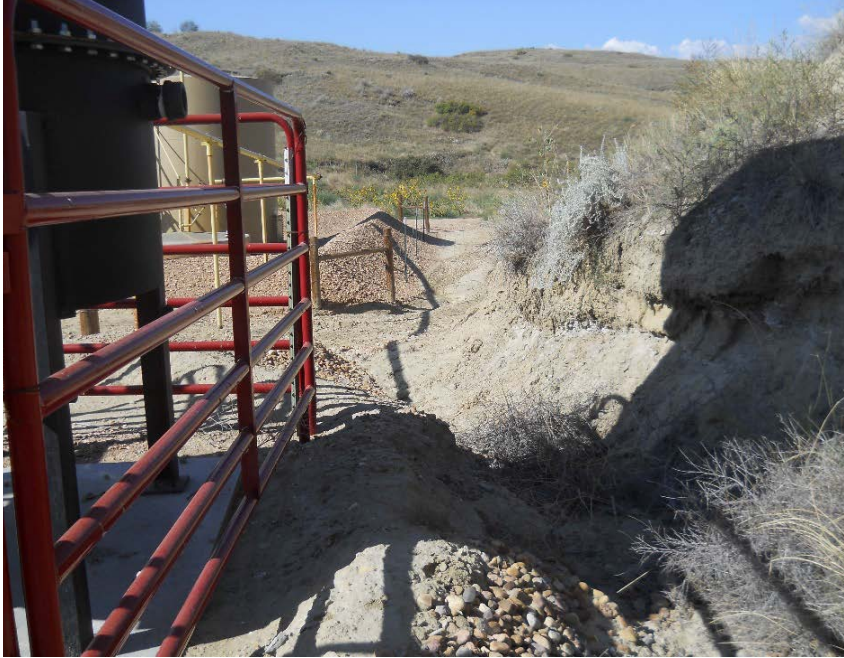
Location washing out north side of location, discharging northwest of tank battery with sediment carrying off into field 9-12-2017

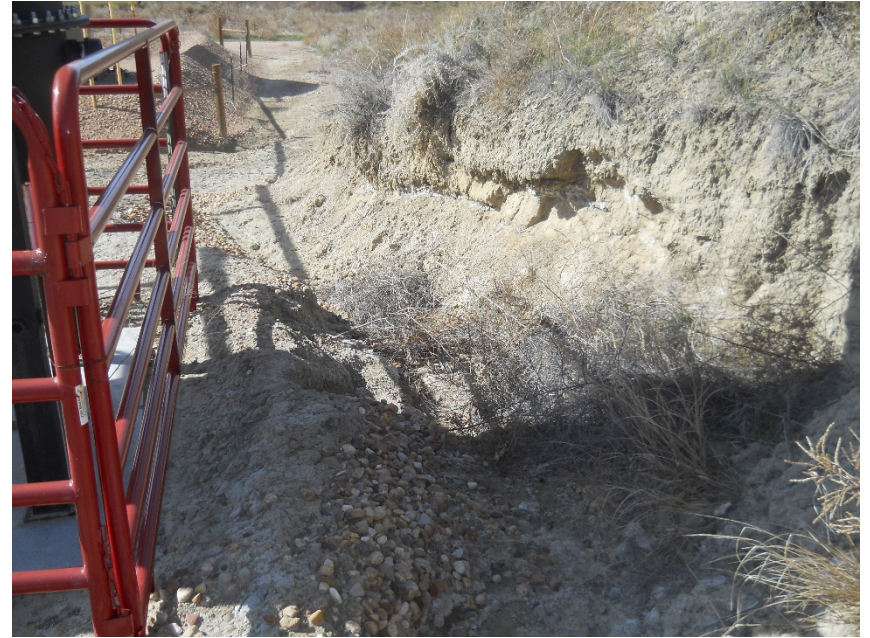
Location washing out north side of location, discharging northwest of tank battery with sediment carrying off into field 10-23-2017

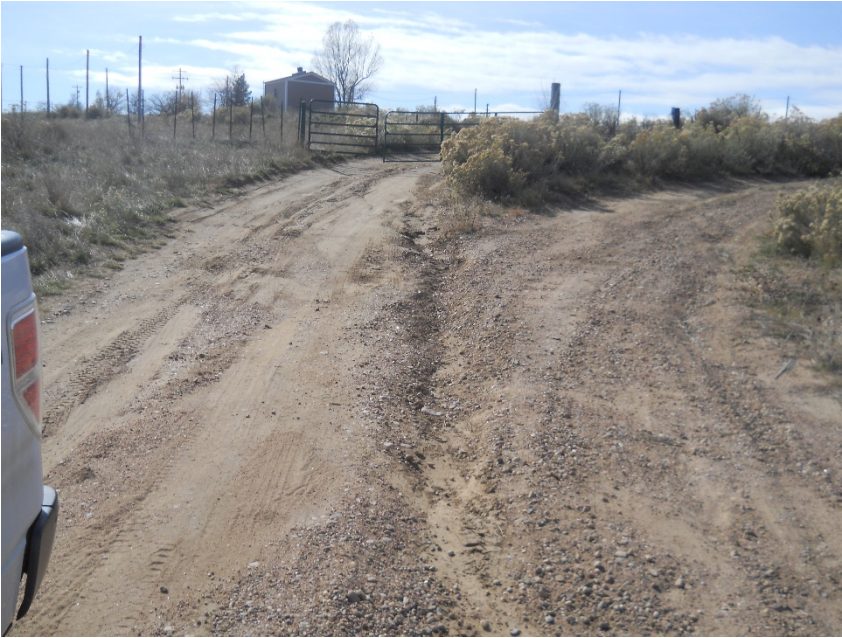
Entrance of location looking south, washing out 10-23-2017

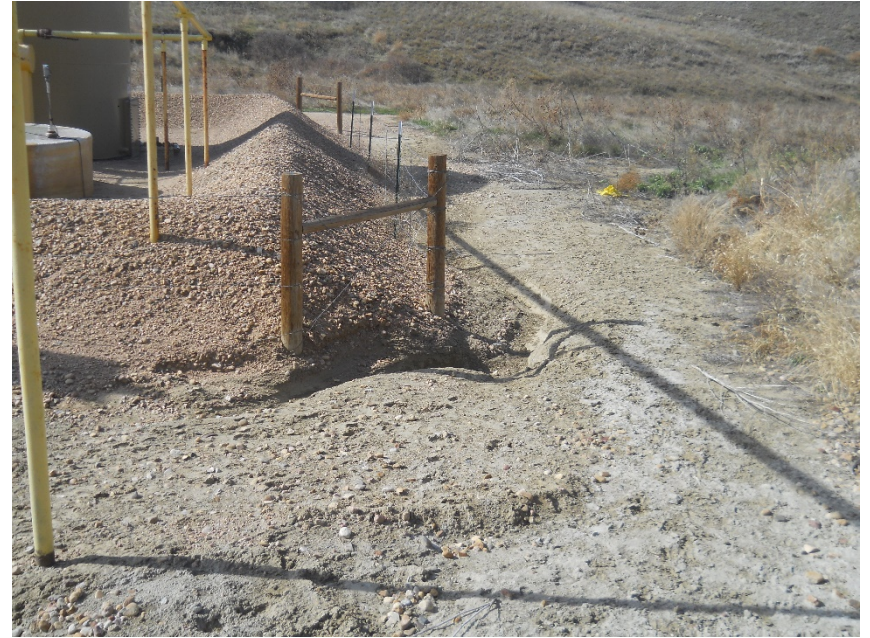
Northeast edge of tank battery is washing out 10-23-2017

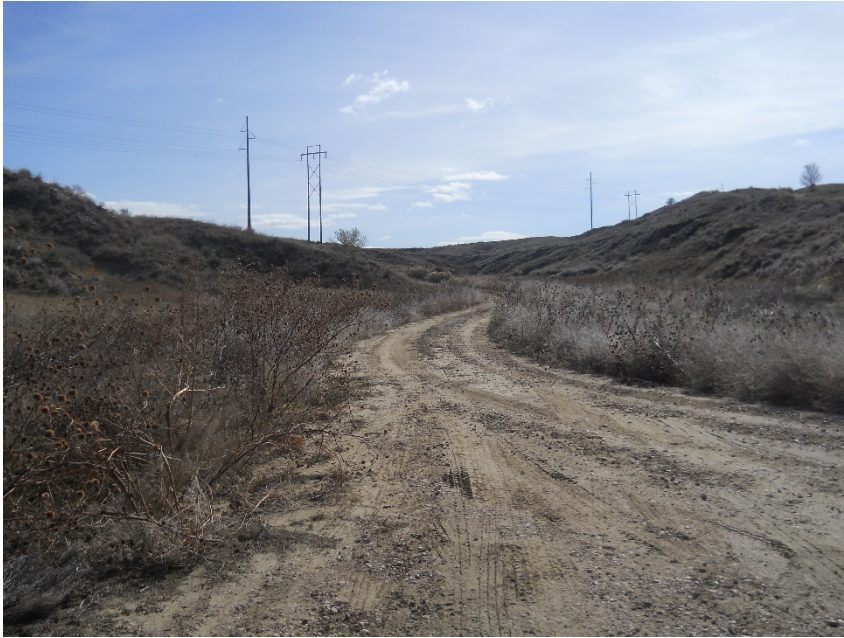
Actively growing weeds on access road from tank battery to wellhead. Needs to be controlled
